Building Information - Worthington City (45138) - Bluffsview Elementary School

Program Type	Assessment Only
Setting	Suburban
Assessment Name	Bluffsview Elementary School
Assessment Date (on-site; non-EEA)	2015-09-23
Kitchen Type	Full Kitchen
Cost Set:	2015
Building Name	Bluffsview Elementary School
Building IRN	112128
Building Address	7111 Linworth Road
Building City	Columbus
Building Zipcode	43235
Building Phone	614-450-5400
Acreage	12.12
Current Grades:	K-6
Teaching Stations	19
Number of Floors	1
Student Capacity	612
Current Enrollment	459
Enrollment Date	2015-09-14
Enrollment Date is the date in which the current enrollment was taken.	
Number of Classrooms	28
Historical Register	NO
Building's Principal	Cindy Fox
Building Type	Elementary

Bluffsvie Elementary School, which is not on the National Register of Historic Buildings, and originally constructed in 1991, is a single story, 60,089 square foot brick school building located in a suburban residential setting. The existing facility features a conventionally partitioned design, and does not utilize modular buildings. The structure of the overall facility contains brick and CMU type exterior wall construction, with CMU and meta

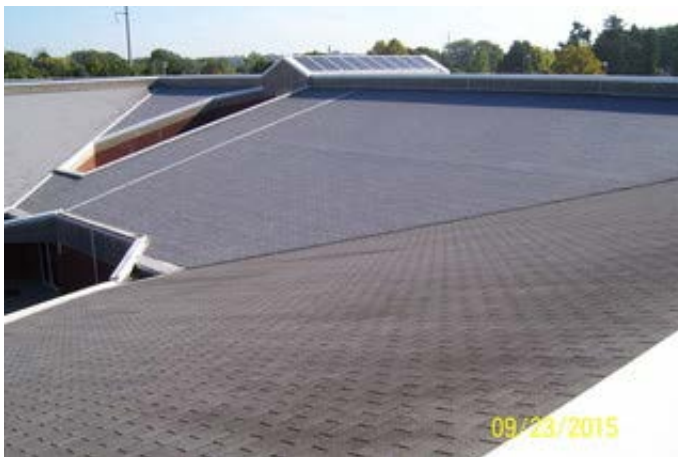
The roof over the overall facility is a combination of fully adhered EPDM membrane roof system, ballasted EPDM roof system, and 3-tab fiberglass shingle system, was installed in 1991, and is in poor condition. Signs of past leaking were observed during the physical assessment. Access to the roof was gained by access hatch that is in fair condition. Fall safety protection cages are not required, and are not provided. There were observations of standing water on the roof where the membrane was loose on the back of the parapet wall and caused ripples that restricted water flow. Metal cap flashings and copings are in poor condition. Roof storm drainage is addressed through a system of gutters and downspouts and roof drains which are properly located, and in fair condition. The roof is equipped with overflow roof drains in areas associated with the sloped roofs in sufficient quantity and in fair condition. Overflow drains are not provided in flat areas of the roof and should be provided in conjunction with recommended roof replacement. Problems requiring attention were encountered at several roof penetrations where membrane flashings had separated from the membrane roofing. There are not any covered walkways attached to this structure. The facility includes a skylight system throughout the roof that is in poor condition that needs to be resealed immediately and eventually replaced.

3 Needs Replacement

Typical Asphalt Shingles

The roof over the overall facility requires replacement to meet Ohio School Design Manual guidelines due to condition, age, and projected lifecycles of systems. The flashing and coping on the overall facility require replacement due to condition. Overflow drains should be added to the flat areas of the roof in conjunction with the recommended roof replacement.

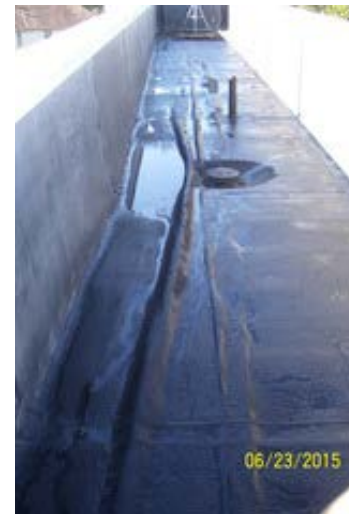
Area of Standing Water

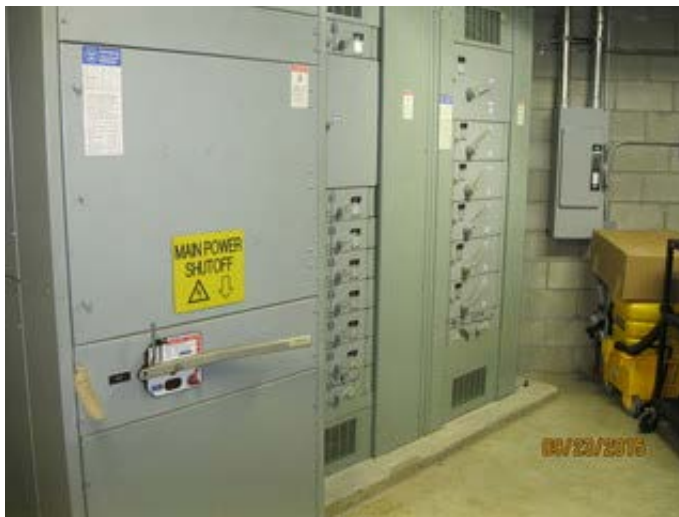
Description: The electrical system provided to the overall facility is a 120/208Y, 3-phase, 4-wire, 2,000-amp system installed in 1991, and is in good condition. Power is provided to the school by a single utility owned, pad-mounted transformer, located in exterior fenced-in area, and in poor condition. The panel system, installed in 1990, is in good condition, and can be expanded to add additional capacity. The Classrooms are not equipped with adequate electrical outlets. The typical Classroom contains 12 general purpose outlets, 2 dedicated outlets for each Classroom computer, and 2 dedicated outlets for each Classroom television. Some Classrooms are equipped with as many as 14 general purpose outlets, while others are equipped with as few as 2 general purpose outlets. There are not any spaces that have no electrical outlets. The Corridors are not equipped with adequate electrical outlets for servicing. Adequate GFI protected exterior outlets are not provided around the perimeter of the building. The facility is equipped with a suitable emergency generator. Adequate lightning protection safeguards are not provided. Stage lighting power system, including dimmers, is inadequately provided, in good condition, and does not meet OSDM requirements. The overall electrical system does not meet Ohio School Design Manual requirements in supporting the current needs of the school, and will be adequate to meet the facility's future needs.

Rating: 2 Needs Repair

Main Electrical Switchgear

Recommendations: Provide additional panels, circuits and outlets, to increase capacity for Classrooms and Corridors. Provide new transformer due to poor condition. Provide control panel, dimmers, and breakers to support the Stage lighting system. Provide adequate lightning protection safeguards.

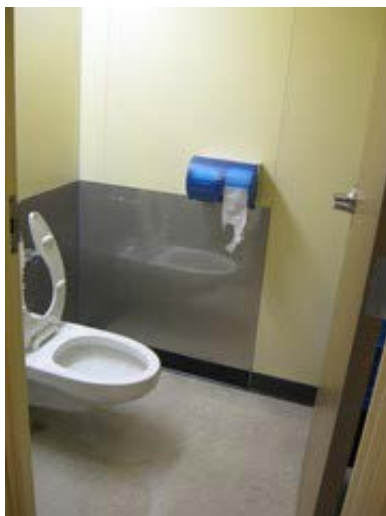
The service entrance is not equipped with a reduced pressure backflow preventer. A water treatment system is not provided. The domestic water supply piping in the overall facility is copper, was installed in 1991, and is in good condition. The waste piping in the overall facility is cast iron and PVC, was installed in 1991, and is in good condition. The facility is equipped with a gas water heater in good condition, with a separate 180-gallon storage tank in good condition. The school contains 2 Large Group Restrooms for boys, 2 Large Group Restrooms for girls, 4 Restrooms associated with specialty Classrooms, and 7 Restrooms for staff. Boys' Large Group Restrooms contain 0 ADA and 6 non-ADA wall mounted flush valve toilets, 4 ADA and 6 non-ADA wall mounted flush valve urinals, as well as 1 ADA and 8 non-ADA wall mounted lavatories. Girls' Large Group Restrooms contain 0 ADA and 13 non-ADA wall mounted flush valve toilets, as well as 1 ADA and 8 non-ADA wall mounted lavatories. Staff Restrooms contain 0 ADA and 7 non-ADA wall mounted flush valve toilets, 0 ADA and 0 non-ADA mounted urinals, as well as 0 ADA and 7 non-ADA wall mounted lavatories. Condition of fixtures is good. The facility is equipped with 0 ADA and 0 non-ADA drinking fountains, as well as 3 ADA and 3 non-ADA electric water coolers, in good condition. The 20 Elementary Classrooms are equipped with 20 ADA and 0 non-ADA sink mounted type drinking fountains, in good condition. Special Education Classroom is not equipped with the required Restroom facilities. Kitchen is equipped with the required Restroom, and fixtures are in good condition. Health Clinic is equipped with the required Restroom, and fixtures are in good condition. Kindergarten is all equipped with Restroom facilities, and fixtures are in good condition. Kitchen fixtures consist of 1 single compartment sink, double compartment sink, triple compartment sink, dishwasher, disposal, which are in good condition. The Kitchen is equipped with a satisfactory grease interceptor. The Kitchen is provided the required 140 degree hot water supply via a mixing valve, which is in good condition. The school does not meet the OBC requirements for fixtures. Relative to LEED requirements, the school is not equipped with low flow type fixtures. Per OBC and OSDM requirements this facility should be equipped with 34 toilets, 14 urinals, 40 lavatories, 20 Classroom sink mounted drinking fountains, and 20 electric water coolers. Observations revealed that the school is currently equipped with 30 toilets, 10 urinals, 29 lavatories, 20 Classroom sink mounted drinking fountains, and 6 electric water coolers. ADA requirements are not met for fixtures and drinking fountains (see Item O). Custodial Closets are properly located and are adequately provided with required service sinks or floor drain sinks, which are in good condition. Adequate exterior wall hydrants are provided.

3 Needs Replacement

Special Ed. Bathroom - Non-ADA

Provide reduced pressure backflow preventer. To facilitate the school's compliance with OBC and OSFC fixture requirements, provide 3 new toilets, 11 new lavatories, 4 new urinals, 14 new electric water coolers, new lavatory mounted type drinking fountains. Due to age, condition, LEED, and OSFC requirements, provide 3 new toilets, 11 new lavatories, 4 new urinals, 14 new electric water coolers, new lavatory mounted type drinking fountains. See Item O for replacement of fixtures related to ADA requirements.

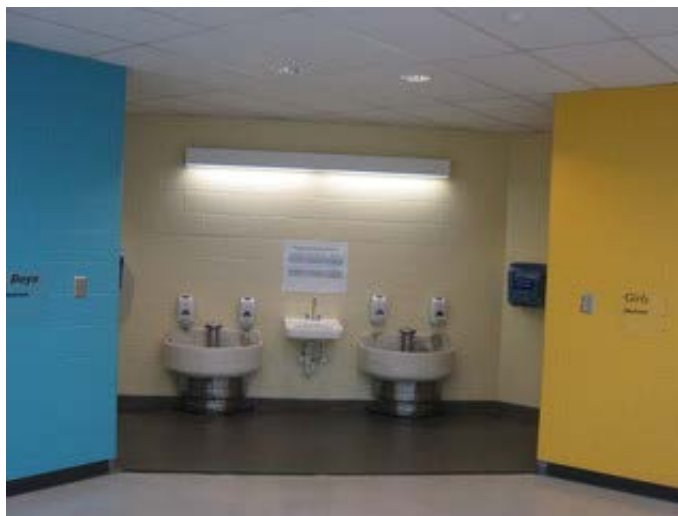
Typical Bathroom Area - Trough Sinks

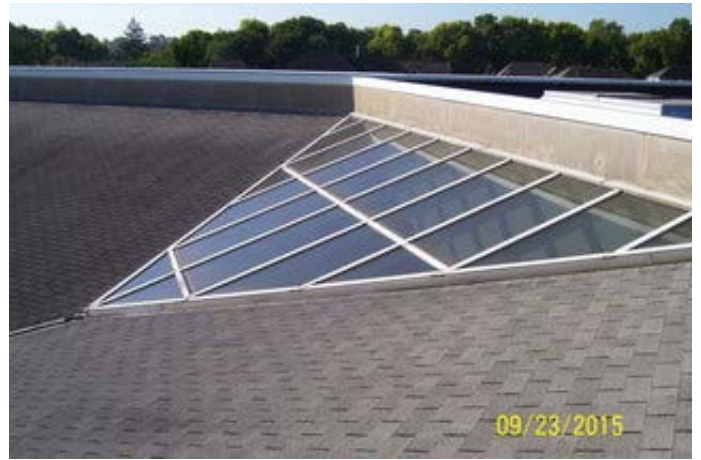
Description: The overall facility is equipped with thermally broken, aluminum windows with double glazed glazing type window system, which was installed in 1991, and is in fair condition. The window system features operable windows throughout the building, and operable windows are equipped with opening limiters in fair condition and insect screens in fair condition. Window system seals are in fair condition, with minimal air and water infiltration being experienced. Window system hardware is in fair condition. The window system features integral blinds, which are in fair condition. Aluminum frame curtain wall systems are found in the overall facility, in fair condition. This facility does not feature any glass block windows. The exterior doors in the overall facility are equipped with thermally broken aluminum frame sidelights and transoms with tempered glass, in good condition. Exterior door vision panels are tempered glazing. The school does contain 5 aluminum frame double glazed skylights in poor condition. The school does not contain any clerestories. Interior glass is OSDM-compliant. Window security grilles are not provided for ground floor windows. There is not a Greenhouse associated with this school.

Rating: 3 Needs Replacement

Skylight to be Replaced

Recommendations: Replace skylights in the overall facility.

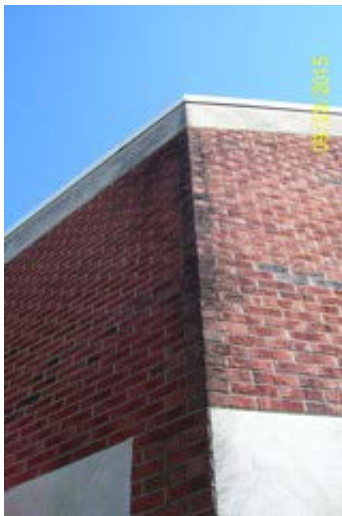
Description: The overall facility has a brick veneer on load bearing masonry wall system, which displayed minor instances of deterioration, and is in fair condition. The exterior masonry appears to have appropriately spaced and adequately caulked control joints in fair condition. Control joints are provided at lintel locations, at doors and windows, building corners, and wall offsets and are in fair condition. The school does have sufficient expansion joints, and they are in fair condition. Exterior walls in the overall facility are adequately insulated. Brick veneer masonry walls are cavity walls. Weep holes are provided in sufficient quantity (at 48" on center) below stone accents and above bricks, and are in fair condition. Weep holes are not rope type weeps; vents are not provided. The exterior masonry has not been cleaned and sealed in recent years, and shows no evidence of mortar deterioration. Efflorescence and mold were observed in several locations. Architectural exterior accent material consists of stone, which is in fair condition, with the exception of column covers in several locations, which should be replaced. Exterior building fenestration (including the skylight systems) in the overall facility represents 20% of the exterior surfaces. Interior corridor and demising walls are metal operable partition walls, do not project full height from floor to bottom of deck, and are in good condition. Interior masonry appears to have adequately spaced and caulked control joints in good condition. Interior soffits are of drywall and ACT type construction, and in good condition. The window sills are brick, and are in good condition. The exterior lintels are precast steel, and are in fair condition. There are no chimneys. Canopies over entrances are steel and masonry type construction, and are in fair condition. Exterior soffits are of suspended exterior gypsum board type construction, and in fair condition. There are several areas with minor damage that require repair of the gypsum board. The school is not equipped with a loading dock.

Rating: 2 Needs Repair

Brick to be Cleaned

Recommendations: Provide tuckpointing in all areas of mortar deterioration as required through the overall facility. Provide masonry cleaning, sealing, caulking as required through the overall facility. Recaulk existing control joints. Prep and paint exposed steel lintels through the overall facility. Replace stone column covers in several locations. Repair exterior soffit gypsum board where required.

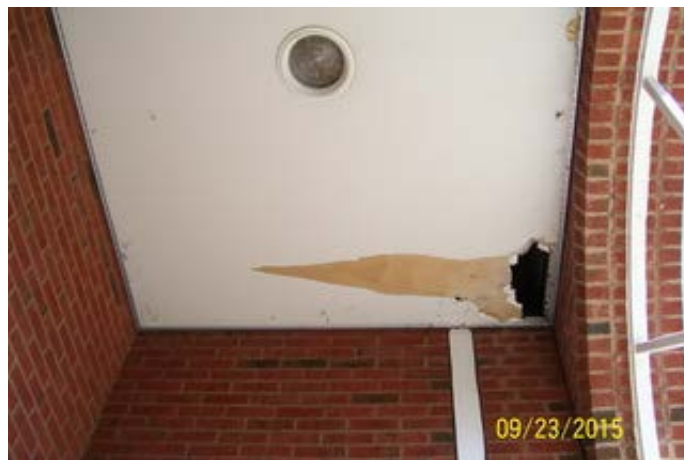
Soffit to be Repaired

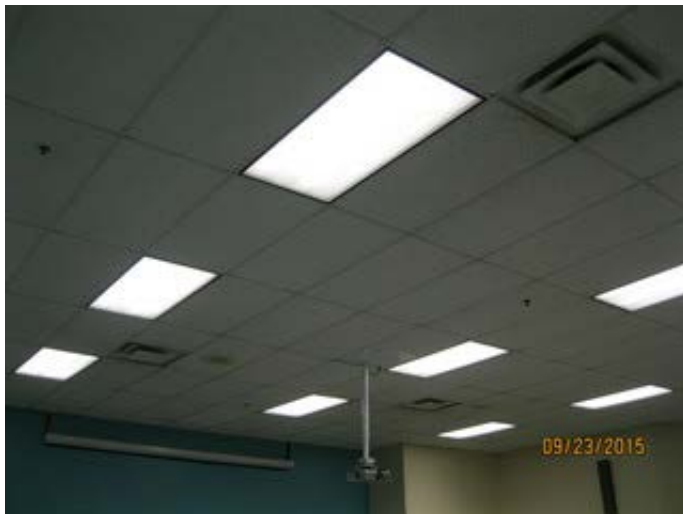
The typical Classrooms in the overall facility are equipped with T-8 lay-in 2x4 fluorescent fixtures with dual level switching. Classroom fixtures are in good condition, providing an average illumination of 32 FC, which is less than the 50 FC recommended by the OSDM. The typical Corridors in the overall facility are equipped with T-8 lay-in 2x4 fluorescent fixtures with single level switching. Corridor fixtures are in good condition, providing an average illumination of 6 FC, which is less than the 20 FC recommended by the OSDM. The Primary Gymnasium spaces are equipped with pendant T-8 2x4 fluorescent fixture type lighting, in good condition, providing an average illumination of 64 FC, thus complying with the 50 ES FC recommended by the OSDM. The Media Center is equipped with lay-in 2x4 T-8 fluorescent fixture type lighting in good condition, providing an average illumination of 24 FC, which is less than the 50 FC recommended by the OSDM. The Student Dining spaces are equipped with lay-in 2x4 T-8 fluorescent fixture type lighting with multi-level switching. Student Dining fixtures are in good condition, providing an average illumination of 12 FC, which is less than the 50 FC recommended by the OSDM. The Kitchen spaces are equipped with 1x4 surface mount T-8 fluorescent fixture type lighting with multi-level switching. Kitchen fixtures are in good condition, providing an average illumination of 65 FC, which is less than the 75-80 FC recommended by the OSDM. The Service Areas in the overall facility are equipped with 1x4 suspended and surface mount T-8 fluorescent fixture type lighting in good condition. The typical Administrative spaces in the overall facility are equipped with lay-in 2x4 T-8 fluorescent fixture type lighting in good condition, providing adequate illumination based on OSDM requirements. The overall lighting systems of the facility are not compliant with Ohio School Design Manual requirements due to inadequate lighting levels and lack of multi-level switching.

3 Needs Replacement

Student Dining Lighting

Provide complete replacement of lighting system due to lighting levels and lack of multi-level switching.

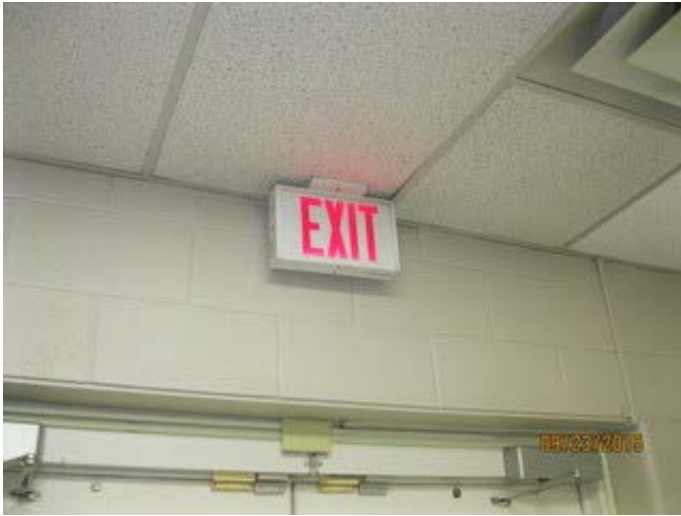
Description: The overall facility is equipped with an emergency egress lighting system consisting of non-compliant plastic construction, as well as OSDM compliant red lettered, LED illuminated exit signs, and the system is in good condition. The facility is not equipped with emergency egress floodlighting, but is equipped with fluorescent lighting used as emergency egress lighting, and the system is in good condition. The system is provided with an appropriate emergency generator on separate circuits. The system is adequately provided throughout, and does not meet Ohio School Design Manual and Ohio Building Code requirements.

Rating: 2 Needs Repair

Exit Sign

Recommendations: Provide replacement of non-compliant plastic exit signs to meet Ohio School Design Manual and Ohio Building Code guidelines.

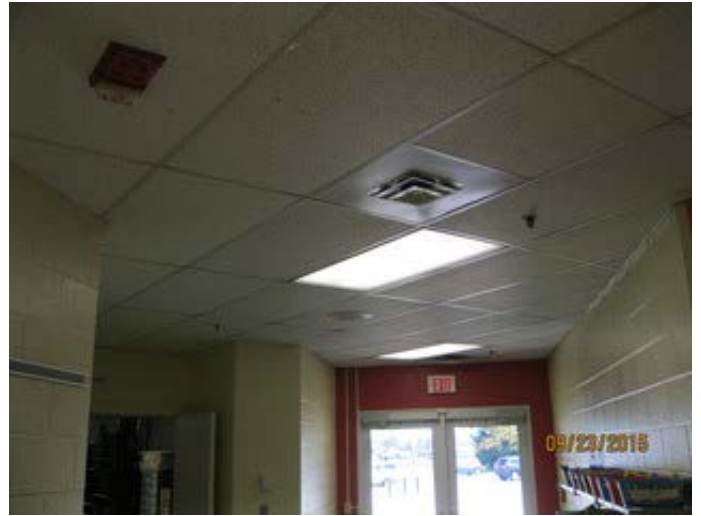
Corridor Exit Sign

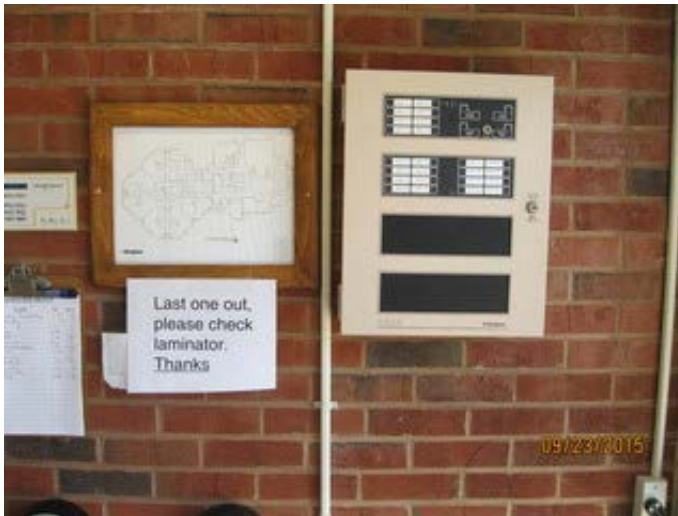
Description: The overall facility is equipped with a Simplex type fire alarm system, installed in 1990, and in good condition, consisting of manual pull stations, bells, and horn and strobe indicating devices. The system is automatic and is monitored by a third party. The system is equipped with sufficient audible horns, strobe indicating devices, flow switches, and tamper switches. The system is not equipped with sufficient smoke detectors or heat sensors. The system thus will support future fire suppression systems. The system is adequately provided throughout, and does not have additional zone capabilities. The system is not fully compliant with Ohio Building Code, NFPA, and Ohio School Design Manual requirements.

Rating: 3 Needs Replacement

Fire Alarm Remote Annunciator

Recommendations: Provide complete replacement of the fire alarm system to meet OBC, NFPA, and Ohio School Design Manual guidelines.

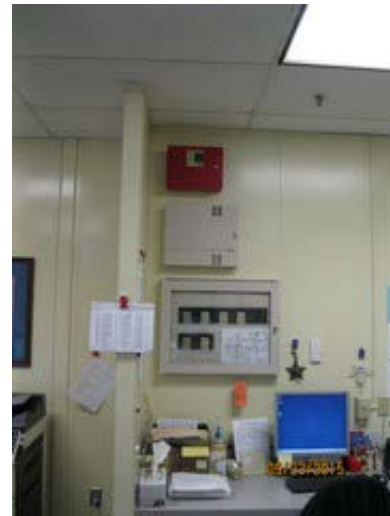
Fire Alarm Control Panel

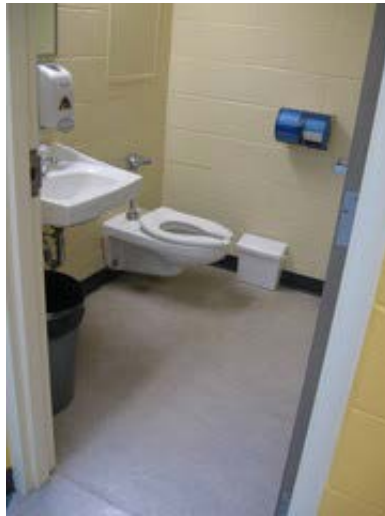
Rating: 3 Needs Replacement

Non-ADA Bathroom

Recommendations: Provide ADA-compliant signage, electric water coolers, toilets, sinks, urinals, showers, toilet partitions and accessories, in the overall facility to facilitate the school's meeting of ADA requirements. Provide a lift for stage access.

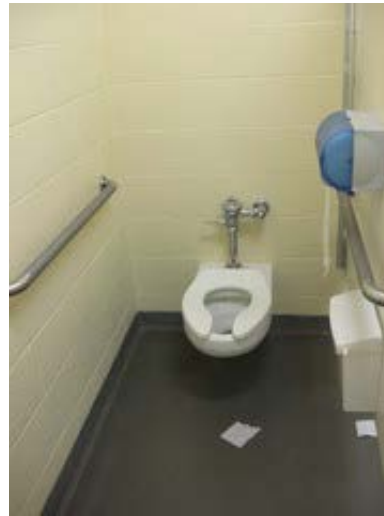
Ambulatory Toilet - Non-ADA

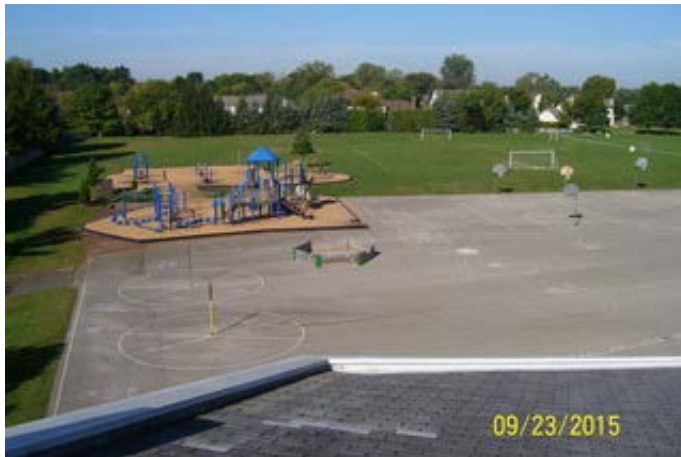
Rating: 3 Needs Replacement

Typical Play Areas

Recommendations: Replace playground equipment to provide more ADA-compliant play structures.
