**Building Information - Worthington City (45138) - Colonial Hills Elem**

Program Type	Assessment Only
Setting	Suburban
Assessment Name	Colonial Hills Elementary
Assessment Date (on-site; non-EEA)	2015-09-22
Kitchen Type	Full Kitchen
Cost Set:	2015
Building Name	Colonial Hills Elem
Building IRN	6999
Building Address	5800 Greenwich
Building City	Worthington
Building Zipcode	43085
Building Phone	(614) 450-5400
Acreage	12.53
Current Grades:	K-6
Teaching Stations	20
Number of Floors	1
Student Capacity	498
Current Enrollment	402
Enrollment Date	2015-09-14
Enrollment Date is the date in which the current enrollment was taken.	
Number of Classrooms	19
Historical Register	<b>NO</b>
Building's Principal	Madeline Partlow
Building Type	Elementary

Colonial Hills Elementary, which is not on the National Register of Historic Buildings, and originally constructed in 1955, is a 1 story, 43,578 square foot brick school building located in a suburban residential setting. The existing facility features a conventionally partitioned design, and does utilize modular buildings. The structure of the overall facility contains brick on CMU type exterior wall construction, with brick, painted CMU, and meta

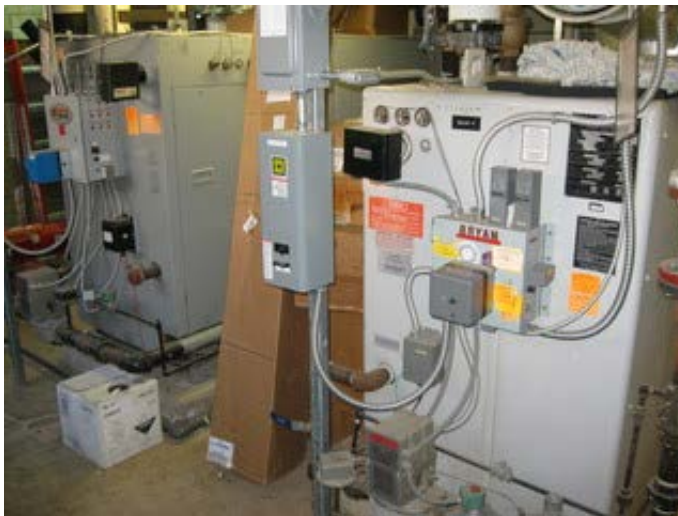
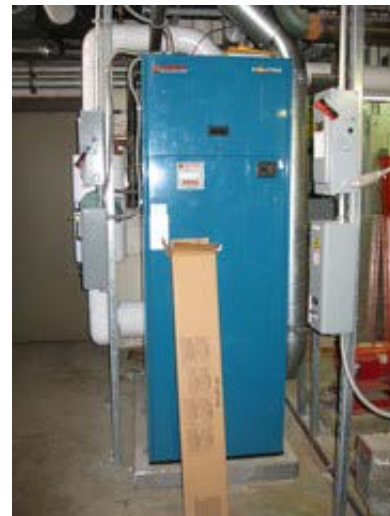
The existing system for the overall facility is a gas fired heating hot water system, installed in 1955, and is in poor condition. The heating and chilled water system in the overall facility is a 2-pipe system, without a capacity for simultaneous heating and cooling operation, which is not compliant with the OSDM requirements for basic system type. The 3 gas fired boilers, manufactured by Bryan and Thermal Solutions, were installed in 1955, 2008, and 2015 and are in poor-to-good condition. Heating water is distributed to terminal units consisting of unit ventilators, cabinet heaters, unit heaters, and air handlers. The terminal equipment was installed in 2012 and is in good condition. The system does not comply with the 15 CFM per person fresh air requirements of the Ohio Building Code mechanical code and Ohio School Design Manual. The DDC type system temperature controls were installed in 2008 and are in good condition. The system does feature individual temperature controls in all spaces required by the OSDM. The overall system does not feature any central energy recovery systems. The facility is not equipped with louvered interior doors to facilitate Corridor utilization as return air plenums. The existing system is ducted in the Gymnasium, Dining, Library, Main Office, and 1966 Addition, but the ductwork cannot be integrated into a possible future system due to arrangement, air volume, and routing of existing ductwork. The existing system is not ducted in the Classrooms, and floor to structural deck heights will not accommodate the installation of properly sized ductwork for a future Ohio School Design Manual approved system. The overall heating system is evaluated as being in safe but inefficient working order, and long term life expectancy of the existing system is not anticipated. The structure is equipped with central air conditioning. The site does not contain underground fuel tanks.

Gas Fired Boilers

Gas Fired Boiler

Provide new overall heating, ventilating, and air conditioning system to achieve compliance with Ohio Building Code and Ohio School Design Manual standards. Convert to ducted system to facilitate efficient exchange of conditioned air. Provide architectural soffits to accommodate the installation of ductwork.

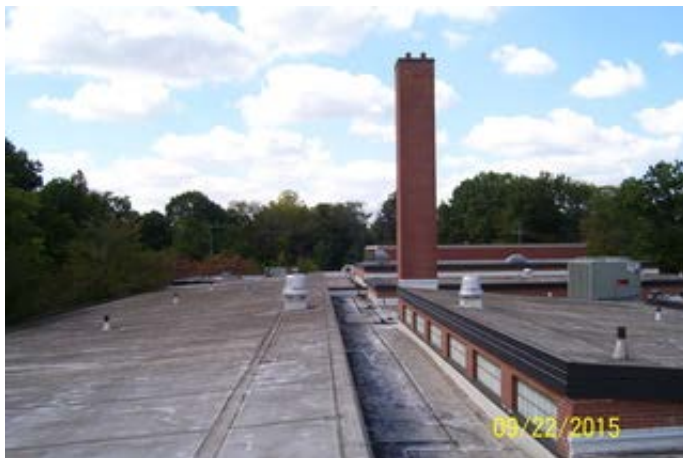
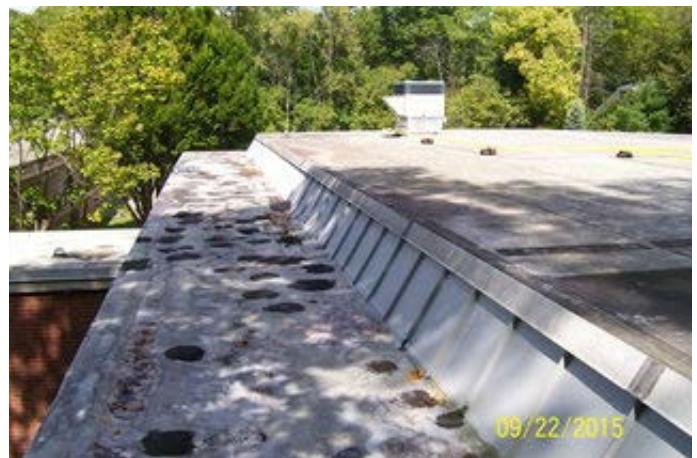
The roof over the Original Construction is an EPDM system that was installed in 2001 and is in fair condition. Metal cap flashings are in fair to poor condition. Roof storm drainage is addressed through a system of gutters and downspouts, roof drains, and through-wall scuppers with downspouts, which are properly located, and in fair condition. The roof is not equipped with overflow roof drains though they are needed on this building. The roof over the 1966 Classroom Addition is a combination standing seam metal and built-up asphalt system that is original to the addition and is in poor condition. Metal cap flashings are in poor condition. Roof storm drainage is addressed through a system of roof drains, which are properly located, and in poor condition. The roof is not equipped with overflow roof drains though they are needed on this building. The roof over the 1966 Multi-Purpose Room Addition is a membrane system that was installed in 2001, and is in fair to poor condition. The roof over the 1979 Addition is an EPDM system that was installed in 2001, and is in fair condition. The roof over the 1988 Addition is a combination membrane and ballast system that is original to the addition and is in fair condition. There are no District reports of current leaking, however, signs of past leaking were observed during the physical assessment. Access to the majority of the roof was gained by an access hatch located in the 1966 Classroom Addition that is in fair condition, but poorly located. Fall protection should be provided adjacent to the opening. Access to the highest roof was not available. The Gymnasium roof has a separate roof hatch that is in fair condition. Fall safety protection cages are not required, and have not been provided. There were observations of standing water on the roof near the recently installed mechanical units above the boiler room in the Original Building, and on the 1966 Classroom Addition. Metal cap flashings are in fair condition. Roof storm drainage is addressed through a system of gutters and downspouts, roof drains, and through-wall scuppers, which are properly located, and in fair condition. The roof is not equipped with overflow roof drains though they are needed on this building. No problems requiring attention were encountered with any roof penetrations. There are no covered walkways attached to this structure. A report provided by the District summarized the roof as the following: "The roof on Colonial Hills Elementary consists of two different roof systems. A mechanically attached heat welded roof system, and a ballasted EPDM roof system are installed on this facility. The roof area is typical of a school facility and rooftop equipment and projections are moderate. The roof area drains to internal roof drains. With recommended preventative maintenance and repairs the mechanically attached heat welded roof system should afford 4 to 5 more years of satisfactory service life. The ballasted EPDM roof system is failing and is in very poor condition. The ballasted EPDM roof system over the gym should be replaced immediately."

Typical 2001 Roof

1966 Classroom Addition Roof

The roof over the overall facility requires replacement to meet Ohio School Design Manual guidelines due to condition, age, and projected lifecycles of systems. Replace cap flashings through the overall facility. Add overflow drains as required in conjunction with the roof replacement. Provide fall protection adjacent to existing roof hatch.

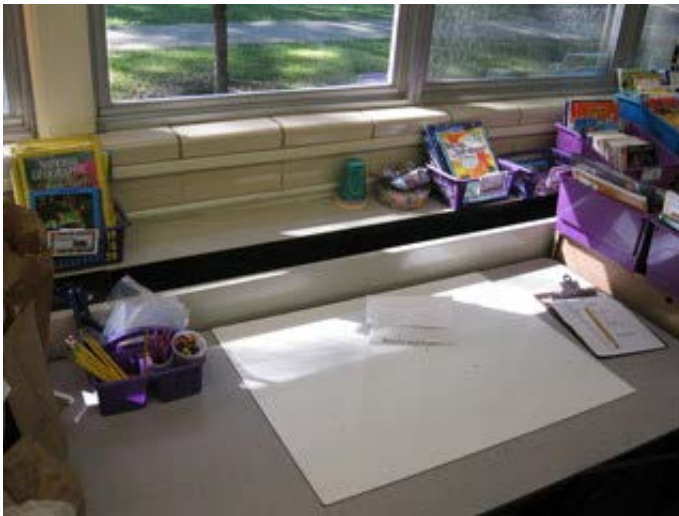
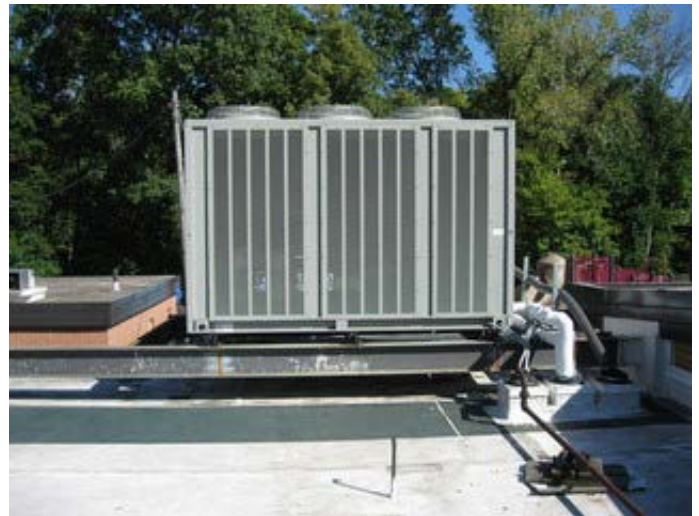
**Description:** The overall facility is equipped with a chilled water type central air conditioning system, which is in fair condition. An air cooled condenser supplies refrigerant to an evaporator that provides chilled water to terminal units. The equipment is in good condition. Rooftop units are provided in the 1966 Addition and Main Office locations. The ventilation system in the overall facility consists of unit ventilators, installed in 2012 and in good condition, providing fresh air to Classrooms, and air handlers, installed in 2012 and in good condition, providing fresh air to other miscellaneous spaces such as Gymnasiums, Student Dining, and Media Center. Relief air venting is provided by ceiling plenums. The ventilation system does not meet the Ohio Building Code 15 CFM per occupant fresh air requirement. The overall system is not compliant with Ohio Building Code and Ohio School Design Manual requirements. Dust collection systems are not required in this facility. The Art program is equipped with a kiln, and existing kiln ventilation is adequate, and in good condition. General building exhaust systems for Restrooms and Storage Rooms are adequately placed, and in fair condition.

Unit Ventilator

Air Cooled Condenser

**Recommendations:** Provide an air conditioning system to meet with Ohio Building Code and Ohio School Design Manual requirements. Replace general building exhaust systems located in Restrooms, Storage Rooms, and Custodial Closets. Pricing included in Item A.

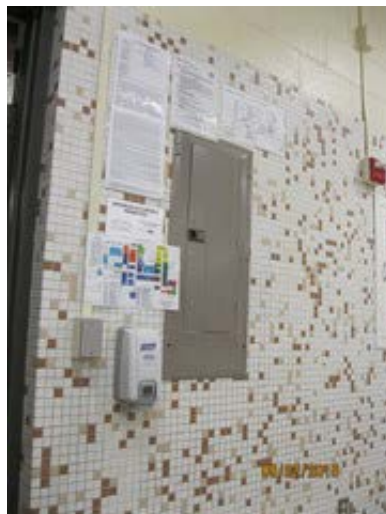
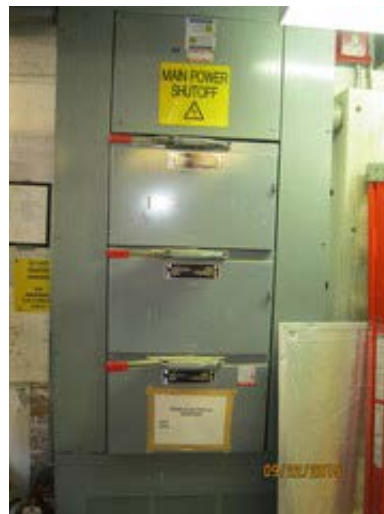
**Description:** The electrical system provided to the overall facility is a 120/208-volt, 3-phase, 4-wire, 1,200-amp main fused switch system installed in the 1980s, and is in good condition. Original equipment was installed in 1955 and is in poor condition. Power is provided to the school by a multiple utility owned, pole-mounted transformer located in exterior parking lot, and in good condition. The panel system, installed in 1955 and the 1980s, is in poor condition, and cannot be expanded to add additional capacity. The Classrooms are not equipped with adequate electrical outlets. The typical Classroom contains 18 general purpose outlets, 2 dedicated outlets for each Classroom computer, and 2 dedicated outlets for each Classroom television. Some Classrooms are equipped with as many as 20 general purpose outlets, while others are equipped with as few as 16 general purpose outlets. There are not any spaces that have no electrical outlets. The Corridors are not equipped with adequate electrical outlets for servicing. Adequate GFI protected exterior outlets are not provided around the perimeter of the building. The facility is not equipped with an emergency generator. Adequate lightning protection safeguards are not provided. Stage lighting power system including control panel, breakers, and dimmers is inadequately provided and does not meet OSDM requirements. The overall electrical system does not meet Ohio School Design Manual requirements in supporting the current needs of the school, and will be inadequate to meet the facility's future needs.

**Rating:** 3 Needs Replacement

Electrical Panelboard

Main Switchgear

**Recommendations:** The entire electrical system requires replacement to meet Ohio School Design Manual guidelines for overall capacity, Classroom capacity, due to condition and age, lack of OSDM-required features, and to facilitate the scope of work outlined in Item U.

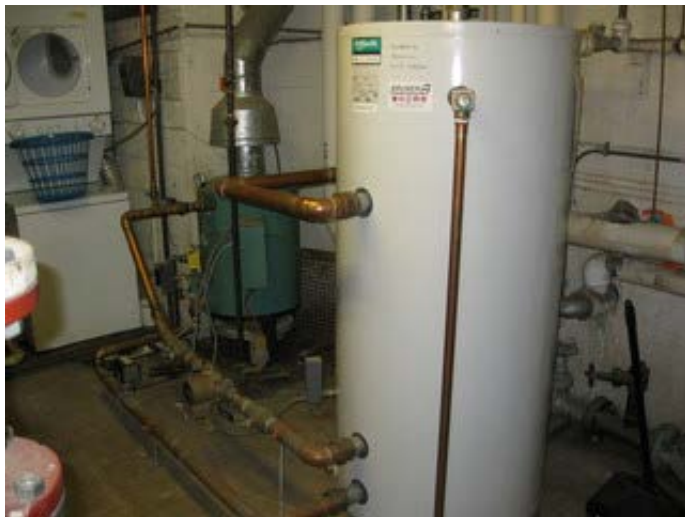
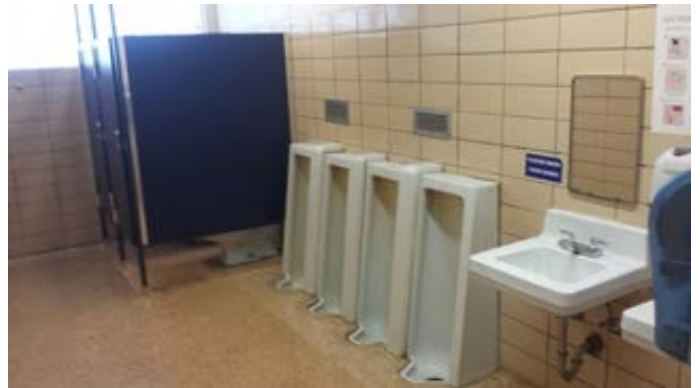
The service entrance is not equipped with a reduced pressure backflow preventer. A water treatment system is not provided. The domestic water supply piping in the overall facility is copper, is original to each addition, and is in good condition. The waste piping in the overall facility is cast iron and galvanized, is original to each addition, and is in fair condition. The facility is equipped with a gas water heater in poor condition, with a separate 119-gallon storage tank in good condition. The school contains 2 Large Group Restrooms for boys, 2 Large Group Restrooms for girls, 0 Locker Room Restrooms for boys, 0 Locker Room Restrooms for girls, 0 Restrooms associated with specialty Classrooms, and 2 Restrooms for staff. Boys' Large Group Restrooms contain 0 ADA and 6 non-ADA floor mounted flush valve toilets, 0 ADA and 10 non-ADA floor mounted central flush urinals, as well as 0 ADA and 4 non-ADA wall mounted lavatories. Girls' Large Group Restrooms contain 0 ADA and 12 non-ADA floor mounted flush valve toilets, as well as 0 ADA and 4 non-ADA wall mounted lavatories. There are no student locker rooms due to grade level. Staff Restrooms contain 0 ADA and 3 non-ADA floor mounted flush valve toilets, 0 ADA and 1 non-ADA wall mounted urinals, as well as 0 ADA and 2 non-ADA countertop lavatories. Condition of fixtures is fair. The facility is equipped with 0 ADA and 0 non-ADA drinking fountains, as well as 2 ADA and 5 non-ADA electric water coolers, in fair condition. The 18 Elementary Classrooms are equipped with 0 ADA and 18 non-ADA sink mounted type drinking fountains, in poor condition. Special Education Classroom is not equipped with the required Restroom facilities. Kitchen is equipped with the required Restroom, and fixtures are in fair condition. Heath Clinic is equipped with the required Restroom, and fixtures are in fair condition. Kindergarten / Pre-K Classrooms are not equipped with Restroom facilities. The school does not meet the OBC requirements for fixtures. Relative to LEED requirements, the school is not equipped with low flow type fixtures. Per OBC and OSDM requirements this facility should be equipped with 59 toilets, 15 urinals, 55 lavatories, 18 Classroom sink mounted drinking fountains, and 11 electric water coolers. Kitchen fixtures consist of 1 hand sink and 1 triple-compartment sink, which are in fair condition. The Kitchen is not equipped with a satisfactory grease interceptor. The Kitchen is provided the required 140 degree hot water supply via a mixing valve, which is in good condition. Observations revealed that the school is currently equipped with 25 toilets, 11 urinals, 14 lavatories, 18 Classroom sink mounted drinking fountains, and 7 electric water coolers. ADA requirements are not met for fixtures and drinking fountains (see Item O). Custodial Closets are properly located and are adequately provided with required service sinks or floor drain sinks, which are in fair condition. Science Classroom / Lab utility sinks, gas connections, compressed air connections, and safety shower / eyewash are not provided, but are not required due to existing grade configuration. Due to existing grade configuration, no Biology or Chemistry Classroom acid waste systems are required. Adequate exterior wall hydrants are provided.

Domestic Hot Water System

Boy's Restroom - Central Flush Urinals

To facilitate the school's compliance with OBC and OSFC fixture requirements, provide 34 new toilets, 41 new lavatories, 4 new urinals, 4 new electric water. See Item O for replacement of fixtures related to ADA requirements. Replace required sink mounted type drinking fountains in Elementary Classroom spaces. Provide a new Backflow Preventer. Replace existing water heater with new. Provide Grease Interceptor.

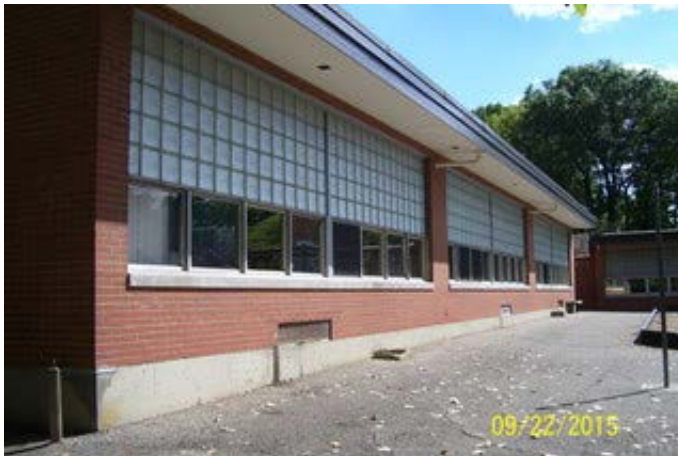
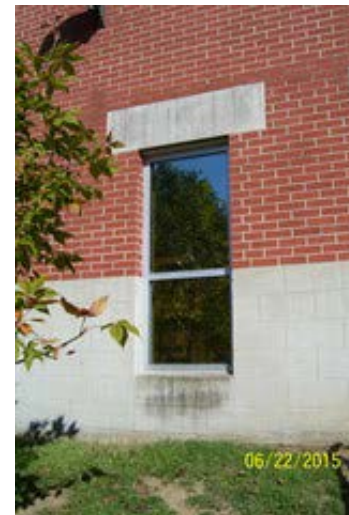
The Original Building, 1957 Addition, and 1966 Additions are equipped with aluminum frame windows with single glazed type window system, which were installed in each respective construction year, and are in poor condition. The window system features operable windows throughout the additions and operable windows are equipped with opening limiters in fair condition and insect screens in poor condition. Window system seals are in poor condition, with moderate air and water infiltration being experienced. Window system hardware is in poor condition. The window system features surface mounted blinds, which are in poor condition. The 1979 Addition is equipped with aluminum frame windows with single glazed type window system, and is in fair to poor condition. The window system features operable windows throughout the additions and operable windows are equipped with opening limiters in fair condition and insect screens in poor condition. Window system seals are in poor condition, with moderate air and water infiltration being experienced. Window system hardware is in poor condition. The window system features surface mounted blinds, which are in poor condition. The 1987 Addition is equipped with aluminum frame windows with double glazed, insulated type window system, and is in fair condition. The window system features inoperable windows throughout the addition. Window system seals are in fair condition, with minimal air and water infiltration being experienced. The window system features no blinds. This facility is not equipped with any curtain wall systems. There are glass block windows in the 1955 Original Construction and in the 1957 Addition, in poor condition. The exterior doors in the 1955 Original Construction and in the 1957, 1966, 1979 Addition are equipped with wood framed sidelights and transoms with single pane glazing, in poor condition. Exterior door vision panels are single pane. The exterior doors in the 1987 Addition are equipped with aluminum sidelights and transoms with tempered, in good condition. Exterior door vision panels are tempered. The school does not contain skylights. The school does contain glass block type clerestories, and clerestory windows are in poor condition. Interior glass is not OSDM-compliant due to non-compliance with current Ohio Building Codes. Window security grilles are not provided for ground floor windows. There is not a Greenhouse associated with this school.

Typical Windows to be Replaced

Typical 1987 Addition

Replace the existing non-insulated window system and glass block in the Original Building, 1957 Addition, 1966 Additions, and 1979 Addition with a new insulated window system to match existing insulated system in the 1987 Addition and comply with Ohio School Design Manual requirements.

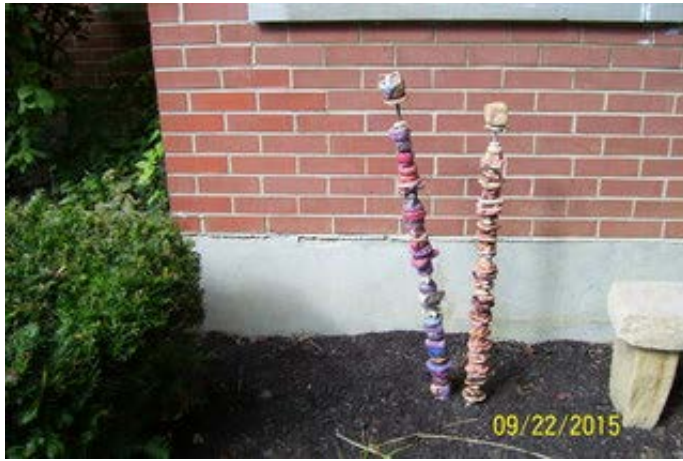
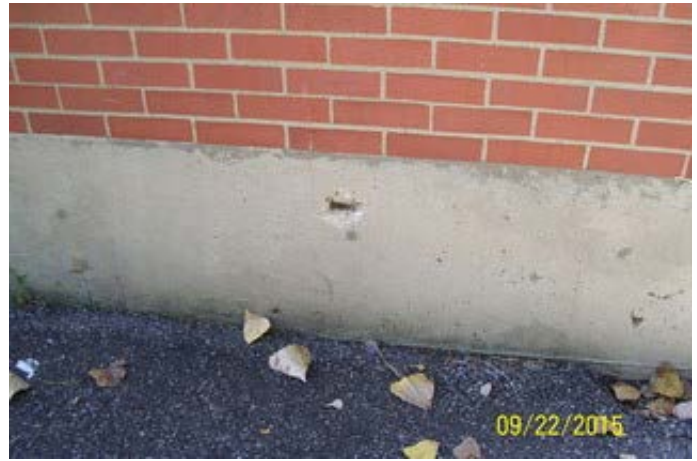
**Description:** The overall facility is equipped with poured concrete and concrete masonry unit foundation walls on concrete footings, which displayed no locations of significant differential settlement, cracking, or leaking, and are in fair condition. Areas of minor cracking and spalling were observed through the overall facility. The District reports that there has been no past leaking. No grading or site drainage deficiencies were noted around the perimeter of the structure that are contributing or could contribute to foundation and wall structural deterioration.

**Rating:** 2 Needs Repair

Typical Foundation

Spalling to be Repaired

**Recommendations:** Repair areas of cracking and spalling through the overall facility.

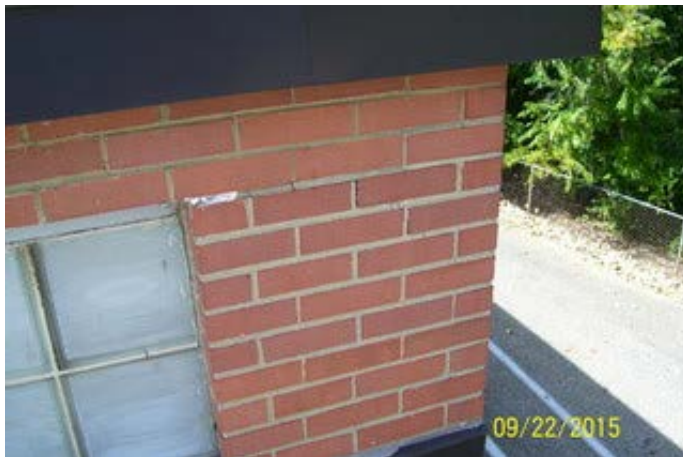
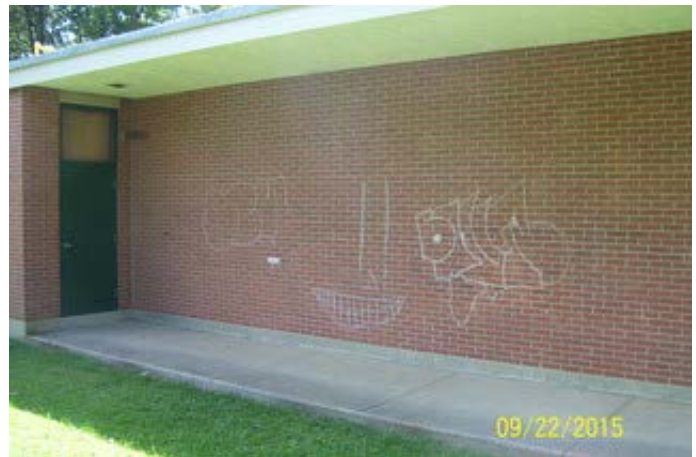
**Description:** The Original Building, 1957 Addition, 1966 Additions, and 1979 Addition have a brick veneer on load bearing masonry wall system, which displayed locations of deterioration, and is in fair condition. The 1987 Addition has a brick veneer on load bearing masonry wall system, which displayed no locations of deterioration, and is in good condition. The exterior masonry appears to have appropriately spaced and adequately caulked control joints in fair condition. In the Original Building and 1957 Addition, control joints are not provided at lintel locations, at doors and windows, building corners, and wall offsets. In the 1966 Additions, 1979 Addition, and 1987 Addition control joints are provided at lintel locations, at doors and windows, building corners, and wall offsets. The school does have sufficient expansion joints, and they are in fair condition. Exterior walls in the Original Building, 1957 Addition, and 1966 Additions are inadequately insulated. Brick veneer masonry walls are not cavity walls. Exterior walls in the 1979 Addition and 1987 Addition are adequately insulated. Brick veneer masonry walls are cavity walls. Weep holes are not provided in the locations where the walls are not cavity walls. Weep holes are provided in sufficient quantity in the 1979 Addition and 1987 Additions at lintels, below sills, and the base of masonry cavity walls, and are in fair condition. Weep holes are not rope type weeps. Vents are not provided. The exterior masonry has not been cleaned and sealed in recent years, and has locations of efflorescence, mold, and graffiti. Architectural exterior accent materials consist of ashlar stone and cast, which are in fair condition. Exterior building fenestration in the Original Building represents 37% of the exterior surfaces, in the 1957 Addition represents 40% of the exterior surfaces, in the 1966 Additions represents 8% of the exterior surfaces, in the 1979 Addition represents 15% of the exterior surfaces, and in the 1987 Addition represents 5% of the exterior surfaces. Interior Corridor and demising walls are brick, CMU, and metal partitions which project full height from floor to bottom of deck, and are in fair condition. Interior masonry appears to have adequately spaced and caulked control joints in fair condition. Interior soffits are of stud and gypsum board type construction, and in fair condition. The window sills are stone and brick veneer over masonry, and are in fair condition. The exterior lintels are steel, and are in fair condition. The chimney is in fair condition. Exterior soffits are of exterior drywall type construction, and in fair condition. The school is not equipped with a loading dock.

**Rating:** 2 Needs Repair

Typical Brick to be Tuckpointed

Typical Brick to be Cleaned

**Recommendations:** Provide tuckpointing in all areas of mortar deterioration as required through the overall facility. Provide masonry cleaning and sealing as required through the overall facility.

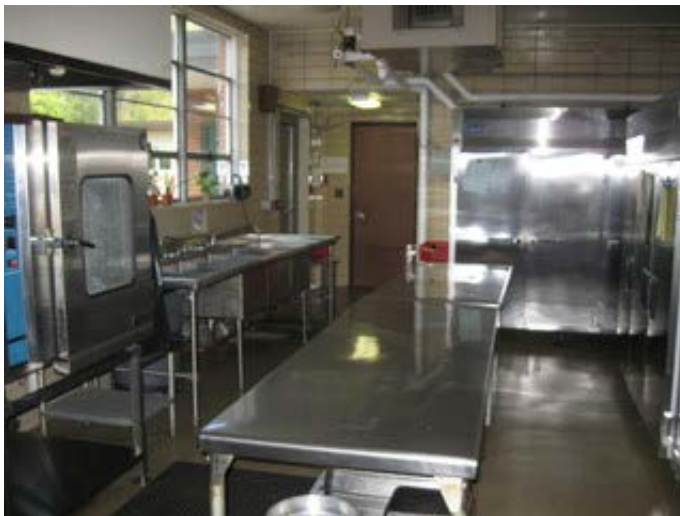
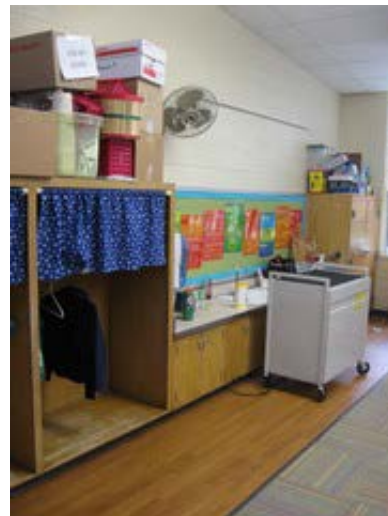
The overall facility features conventionally partitioned Classrooms with carpet tile and vinyl type flooring, 2x4 ACT type ceilings, as well as metal partition and paint CMU type wall finishes, and they are in good condition. The overall facility has Corridors with terrazzo type flooring, 2x4 ACT type ceilings, as well as painted CMU, tile, and metal partition type wall finishes, and they are in fair condition. The overall facility has Restrooms with terrazzo type flooring, gypsum type ceilings, as well as painted CMU, tile type wall finishes, and they are in fair condition. Toilet partitions are plastic, and are in good condition. Classroom casework in the overall facility is wood type construction with plastic laminate tops, is adequately provided, and in good condition. The typical Classroom contains 12 lineal feet of casework, and Classroom casework provided ranges from 9 to 12 feet. Classrooms are provided adequate chalkboards, markerboards, tackboards which are in good condition. The lockers / Classroom storage cubbies, located in the Classrooms, are adequately provided, and in fair condition. The Art program is not equipped with a kiln. The facility is equipped with wood louvered interior doors that are flush mounted with proper ADA hardware and clearances, and in good condition. The Gymnasium space(s) have VCT type flooring, open type ceilings, as well as painted CMU type wall finishes, and they are in good condition. Gymnasium basketball backboards are electrically operated type, and are in good condition. The Media Center, located in the 1955 Addition, has carpet type flooring, 2x4 ACT type ceilings, as well as painted CMU type wall finishes, and they are in good condition. Student Dining, located in the 1966 Addition, has VCT type flooring, 2x4 ACT type ceilings, as well as painted CMU and tile type wall finishes, and they are in fair condition. OSDM-required fixed equipment for Stage is inadequately provided, and in poor condition. Existing Gymnasium, Student Dining, Media Center, and Music spaces are adequately provided with appropriate sound attenuation acoustical surface treatments. The existing Kitchen is full service, is undersized based on current enrollment, and the existing Kitchen equipment, installed in 1966, is in fair condition.

kitchen

cabinets

Provide complete replacement of finishes and casework. Provide for the replacement of kitchen equipment due to age of equipment. Provide Art Program kiln.

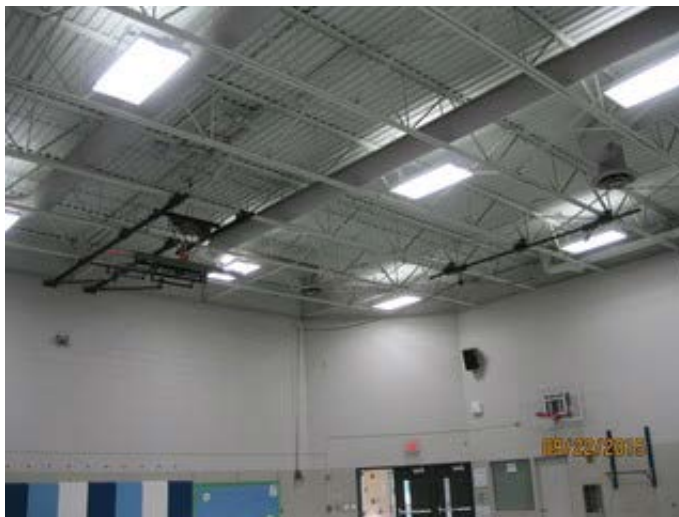
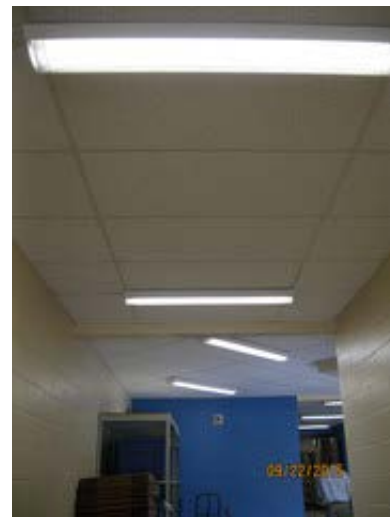
The typical Classrooms in the overall facility are equipped with T-8 1x4 indirect suspended fluorescent fixtures with multi-level switching. Classroom fixtures are in good condition, providing an average illumination of 59 FC, thus complying with the 50 FC recommended by the OSDM. The typical Corridors in the overall facility are equipped with T-8 1x4 surface mount fluorescent fixtures with single level switching. Corridor fixtures are in good condition, providing an average illumination of 25 FC, thus complying with the 20 FC recommended by the OSDM. The Primary Gymnasium spaces are equipped with pendant T-8 2x4 fluorescent fixture type lighting, in good condition, providing an average illumination of 58 FC, thus complying with the 50 ES FC recommended by the OSDM. The Media Center is equipped with 1x4 indirect suspended T-8 fluorescent fixture type lighting in good condition, providing an average illumination of 53 FC, thus complying with the 50 FC recommended by the OSDM. The Student Dining spaces are equipped with lay-in 2x4 T-8 fluorescent fixture type lighting with single level switching. Student Dining fixtures are in good condition, providing an average illumination of 66 FC, thus complying with the 50 FC recommended by the OSDM. The Kitchen spaces are equipped with 2x4 surface mount T-8 fluorescent fixture type lighting with multi-level switching. Kitchen fixtures are in good condition, providing an average illumination of 51 FC, which is less than the 75-80 FC recommended by the OSDM. The Service Areas in the overall facility are equipped with 1x4 surface mount T-8 fluorescent fixture type lighting in good condition. The typical Administrative spaces in the overall facility are equipped with lay-in 2x4 T-8 fluorescent fixture type lighting in good condition, providing adequate illumination based on OSDM requirements. The overall lighting systems of the facility are not fully compliant with Ohio School Design Manual requirements due to inadequate lighting levels and lack of multi-level switching.

Gym Lighting

Corridor Lighting

Provide complete replacement of lighting system due to lighting levels, lack of multi-level switching, and installation of systems outlined in Item U.

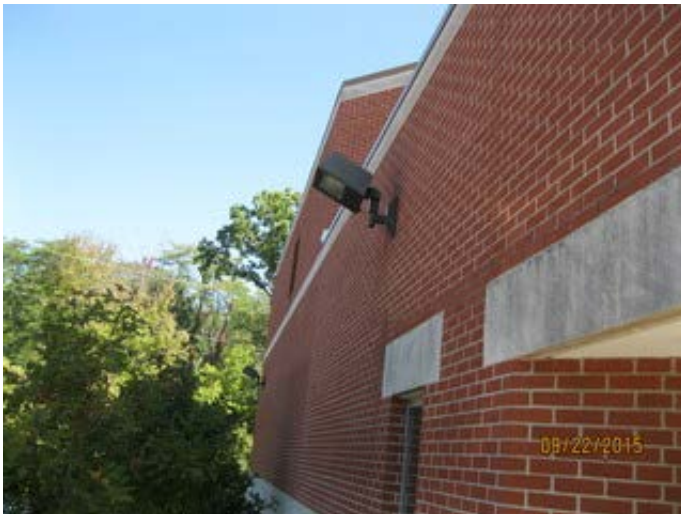
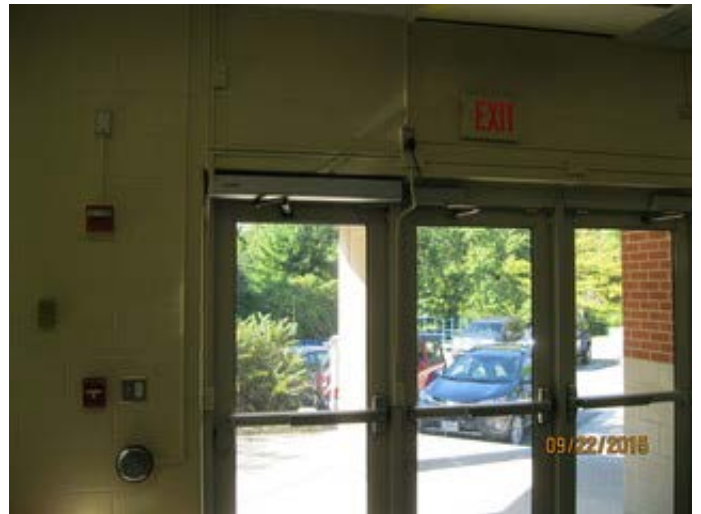
**Description:** The overall facility contains a Security Command intrusion, door contact type security system in good condition. Motion detectors are not adequately provided in main entries, central gathering areas, offices, main Corridors, and spaces where 6 or more computers are located. Exterior doors are equipped with door contacts. An automatic visitor control system is provided. Compliant color CCTV cameras are not provided at parking lots, central gathering areas, and main Corridors. CCTV is monitored in Administrative Area with the use of a TV. A compliant computer controlled access control system integrating alarms and video signals, with appropriate UPS backup, is not provided. The system is equipped with card readers. The security system is not adequately provided throughout, and the system is not compliant with Ohio School Design Manual guidelines. The exterior site lighting system is equipped with surface mounted HID entry lights in good condition. Pedestrian walkways are illuminated with high pressure sodium fixtures in good condition. Parking and bus pick-up / drop off areas are not illuminated. The exterior site lighting system provides inadequate illumination due to insufficient fixture capacity and sparse placement of fixtures.

**Rating:** 3 Needs Replacement

Parking Lot Lighting

Door Contacts/Exit Signs/FA Devices

**Recommendations:** Provide new security system and exterior lighting to meet Ohio School Design Manual guidelines. Add exterior site lighting to provide adequate illumination.

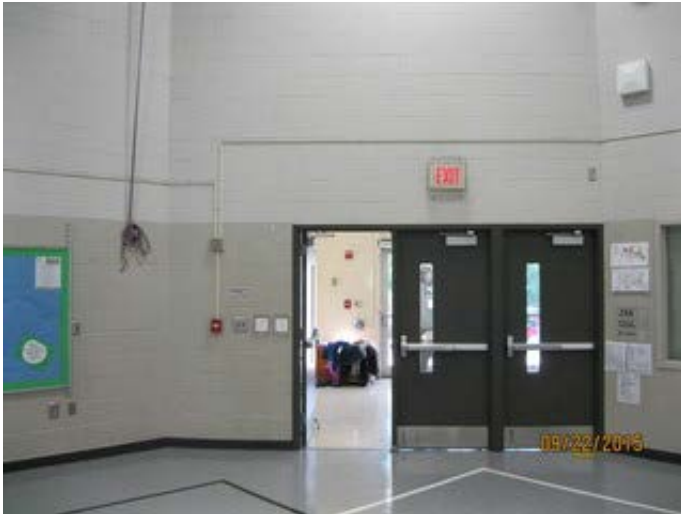
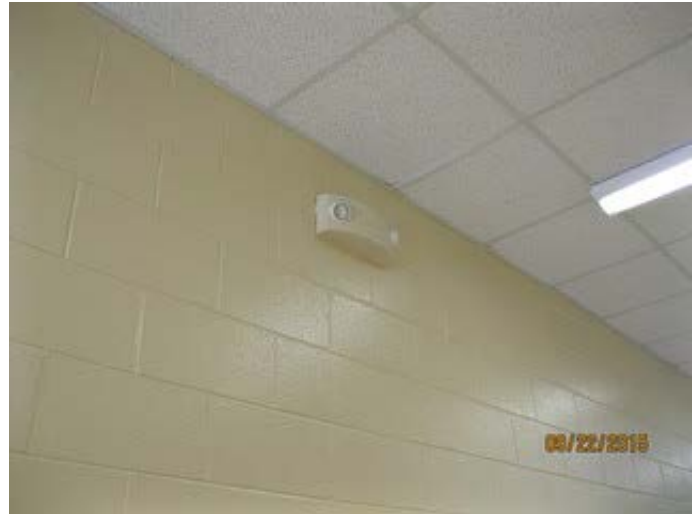
**Description:** The overall facility is equipped with an emergency egress lighting system consisting of non-compliant incandescent, plastic construction exit signs, as well as OSDM compliant red lettered, LED illuminated exit signs, and the system is in good condition. The facility is equipped with emergency egress floodlighting, and the system is in good condition. The system is provided with appropriate battery backup. The system is adequately provided throughout, and does not meet Ohio School Design Manual and Ohio Building Code requirements.

**Rating:** 3 Needs Replacement

Exit Sign

Battery Pack

**Recommendations:** Provide new emergency / egress lighting system to meet Ohio School Design Manual and Ohio Building Code guidelines and in conjunction with work in Item U.

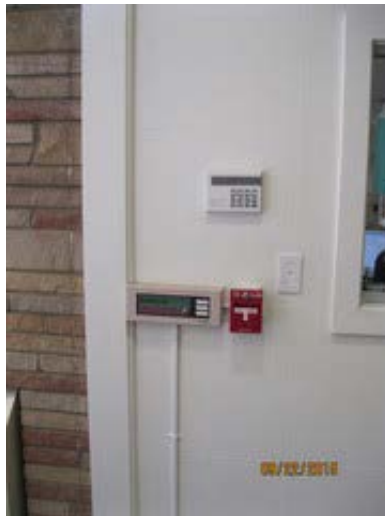
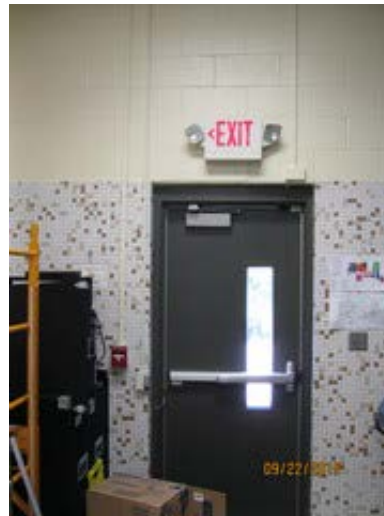
**Description:** The overall facility is equipped with a Simplex type fire alarm system in good condition, consisting of manual pull stations, bells, and horn and strobe indicating devices. The system is automatic and is monitored by a third party. The system is equipped with sufficient audible horns and strobe indicating devices. The system is not equipped with sufficient smoke detectors or heat sensors. The system is not equipped with any flow switches or tamper switches. The system thus will not support future fire suppression systems. The system is adequately provided throughout, and does not have additional zone capabilities. The system is not compliant with Ohio Building Code, NFPA, and Ohio School Design Manual requirements.

**Rating:** 3 Needs Replacement

FA Remote Annunciator/Pull Station

FA Pull Station/Exit Sign/Door Contact

**Recommendations:** Provide new fire alarm system to meet OBC, NFPA, and Ohio School Design Manual guidelines.

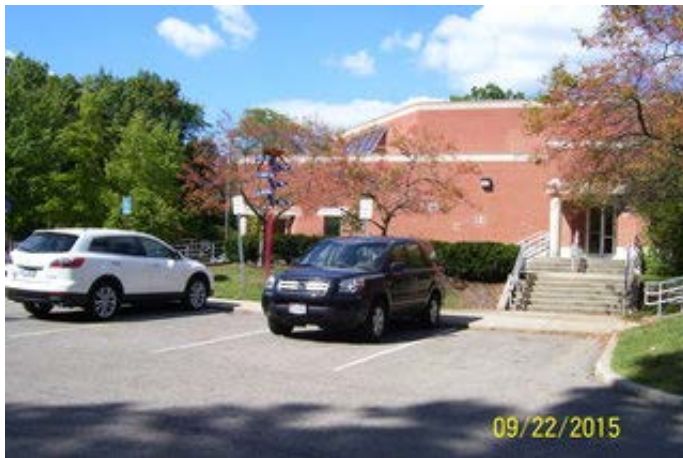
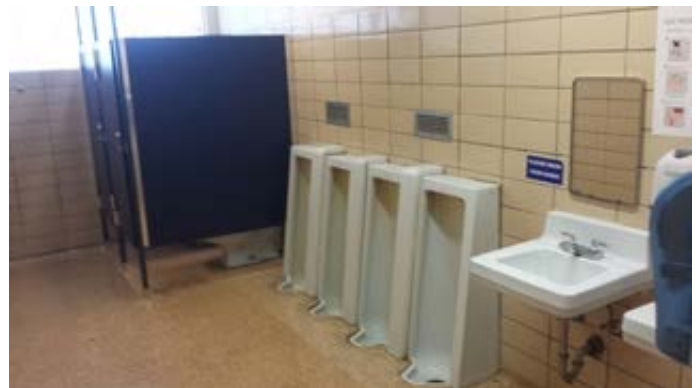
**Description:** On the interior of the building, space allowances and reach ranges are not compliant. There is not an accessible route through the building, which does include protruding objects. Ground and floor surfaces are not compliant due to elevation of ramps. Ramps and stairs do not meet all ADA requirements, and are insufficient due to incline. Elevation changes within the overall facility are facilitated by 2 non-compliant ramps in poor condition. Special provisions for floor level changes in this 1 story structure are insufficient due to ramps' incline being too great. Access to the Stage is not facilitated by a chair lift /ramp / other. The facility is provided with a power assisted ADA door opener in good condition in the Gymnasium addition. Interior doors are not recessed, are not provided adequate clearances, and are provided with ADA-compliant hardware. 11 ADA-compliant toilets are required, and 0 are currently provided. 11 ADA-compliant Restroom lavatories are required, and 0 are currently provided. 2 ADA-compliant urinals are required, and 10 are currently provided. 6 ADA-compliant electric water coolers are required, and 2 are currently provided. Toilet partitions are plastic, and do not provide appropriate ADA clearances. ADA-compliant accessories are not adequately provided and mounted. Mirrors do not meet ADA requirements for mounting heights. Due to existing grade configuration, no Science Classroom considerations require evaluation. Health Clinic and Special Education Restrooms are not compliant with ADA requirements due to size of space. ADA signage is not provided on both the interior and the exterior of the building.

**Rating:** 3 Needs Replacement

Inaccessible Entrance

Boy's Restroom - Central Flush Urinals

**Recommendations:** Provide ADA-compliant signage, ramps, chair lifts, electric water coolers, toilets, sinks, remounted restroom mirrors, toilet partitions, toilet accessories in the overall facility to facilitate the school's meeting of ADA requirements.

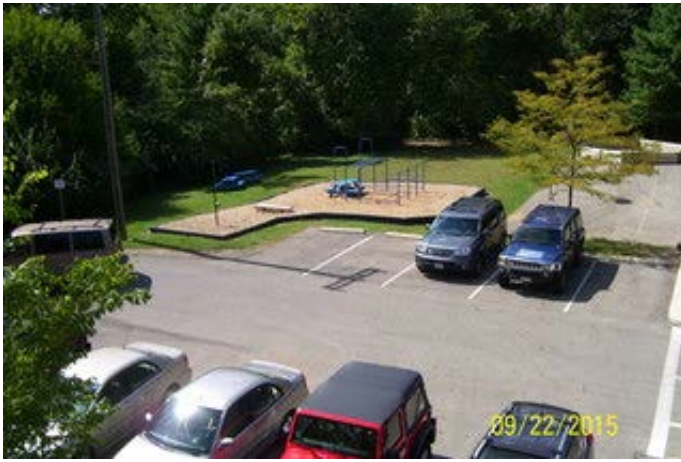
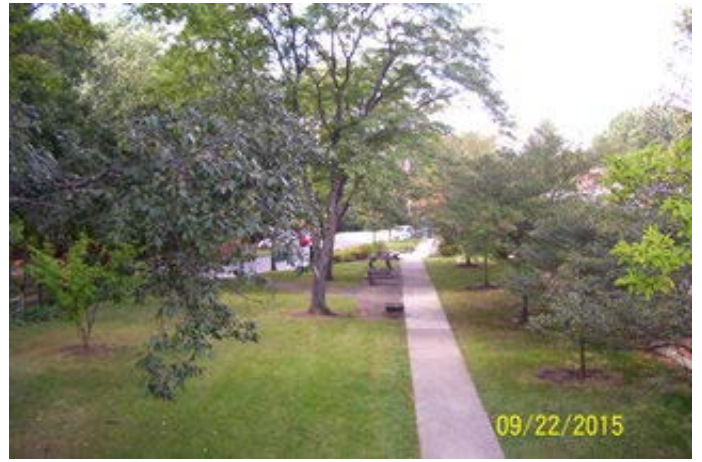
Parking & Play Area

Typical Site Landscape

Provide on-site bus loop. Provide erosion stabilization work adjacent to ravine. Provide new chain link fencing where grade is steep adjacent to ravine. Provide new heavy duty concrete dumpster pad. Repaint exterior handrails where required. Provide new playground equipment. Provide new asphalt wearing course as required for areas in poor condition.

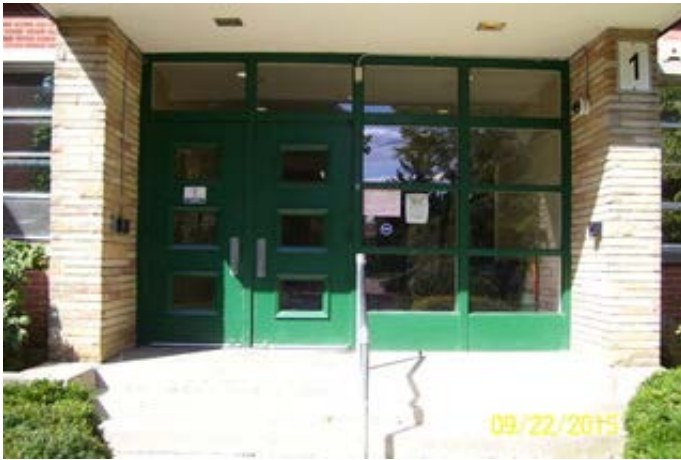
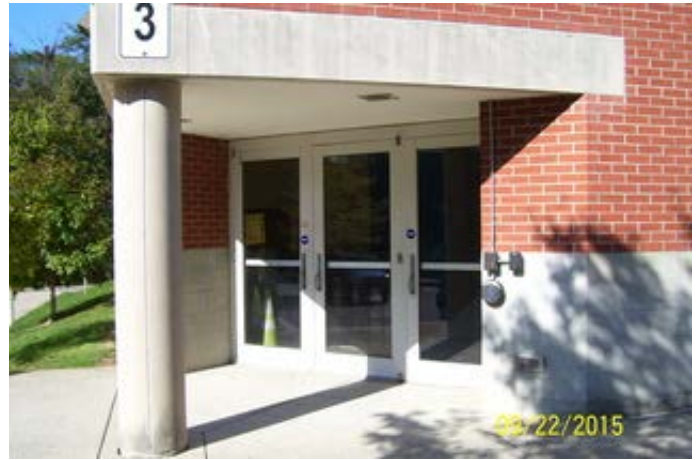
**Description:** Typical exterior doors in the 1955 Original Construction and in the 1957 Addition are wood type construction, installed on wood frames, and in poor condition. Typical exterior doors feature single glazed unprotected vision panels, and inappropriate hardware. Typical exterior doors in the 1966 Addition are wood type construction, installed on hollow metal frames, and in fair condition. Typical exterior doors feature single glazed unprotected vision panels, and appropriate hardware. There are no exterior doors associated with the 1979 Addition. Typical exterior doors in the 1987 Addition are metal doors installed on hollow metal frames, and in good condition. Typical exterior doors feature single glazed tempered glass vision panels, and appropriate hardware. Entrance doors in the 1955 Original Construction and in the 1957, 1966, 1979 Additions are wood type construction, installed on wood frames, and in fair condition. Entrance doors feature single glazed unprotected vision panels, transoms, sidelights, and appropriate hardware. Entrance doors in the 1987 Addition are aluminum type construction, installed on aluminum frames, and in good condition. Entrance doors feature double glazed tempered glass vision panels, transoms, sidelights, and appropriate hardware. The facility is not equipped with any roof access doors. There are no overhead doors in the facility.

**Rating:** 3 Needs Replacement

Original Building Wood Entrance Doors

1987 Entrance Doors to Remain

**Recommendations:** Replace all exterior and entrance doors in the Original Building, 1957 Addition, and 1966 Additions to comply with Ohio Building Code, ADA, and Ohio School Design Manual guidelines.

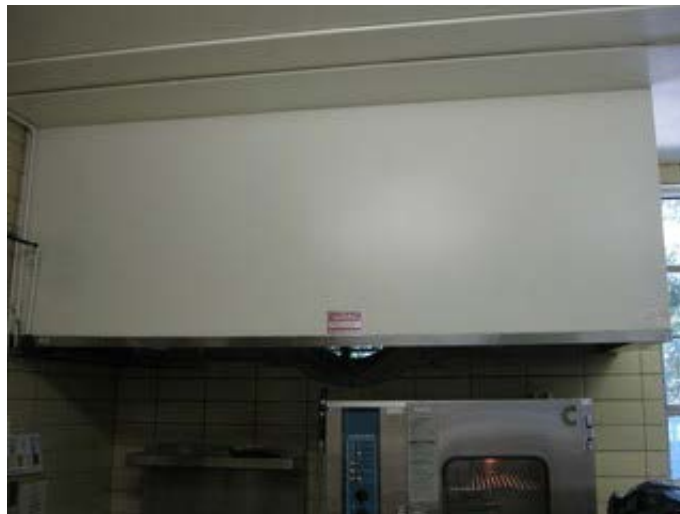
**Rating:** 3 Needs Replacement

Kitchen Hood

**Recommendations:** Provide new automated fire suppression system to meet Ohio School Design Manual guidelines. Provide increased water service of a capacity sufficient to support the fire suppression system, funding included in fire suppression funding. Provide new emergency generator, with funding provided via complete replacement of electrical system in Item D. Provide interlock to de-energize cooking equipment upon discharge of the Kitchen hood fire suppression system.

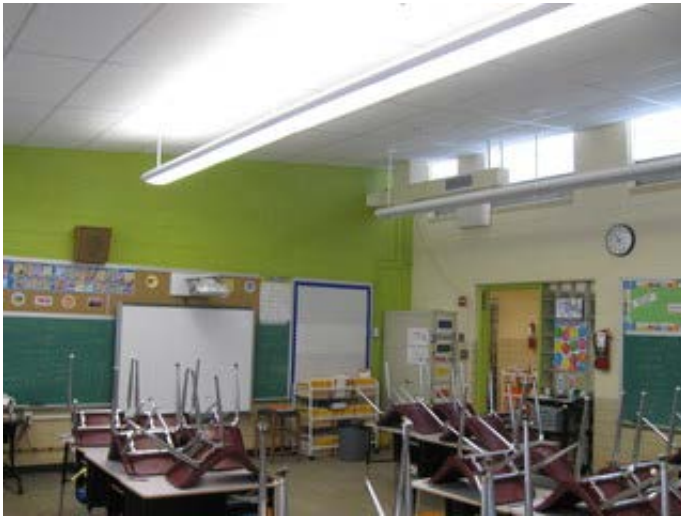
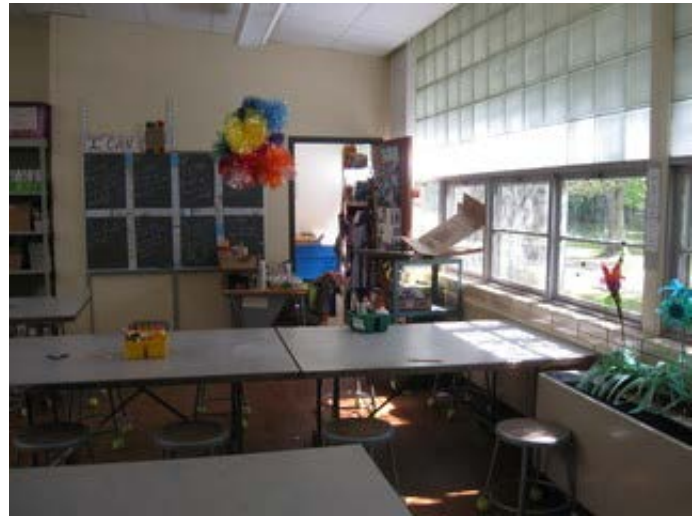
**Rating:** 3 Needs Replacement

Classroom

**Recommendations:** Provide for replacement of outdated or inadequate furnishings.

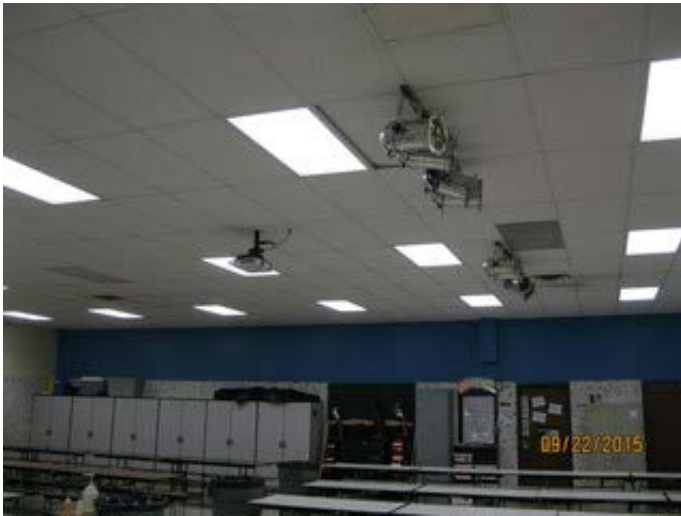
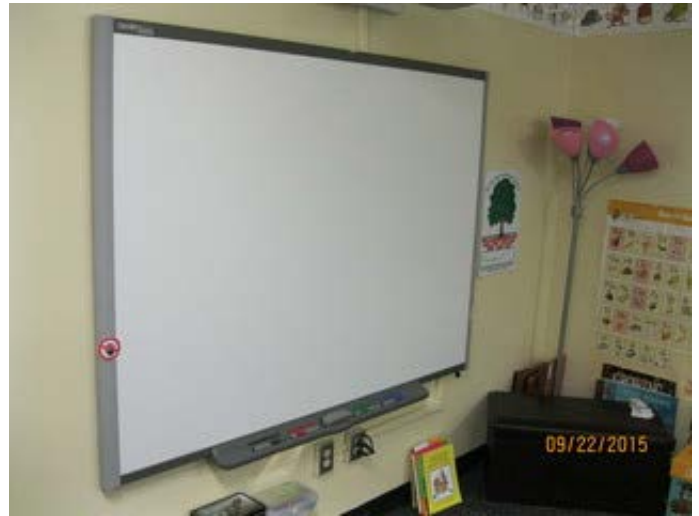
**Rating:** 3 Needs Replacement

Projector

Smartboard

**Recommendations:** Provide complete replacement of technology systems to meet Ohio School Design Manual requirements, and to sustain the capacity to keep pace with technological development.
