Building Information - Worthington City (45138) - Evening Street Elementary

Building Construction Information - Worthington City (45138) - Evening Street Elementary (10868)

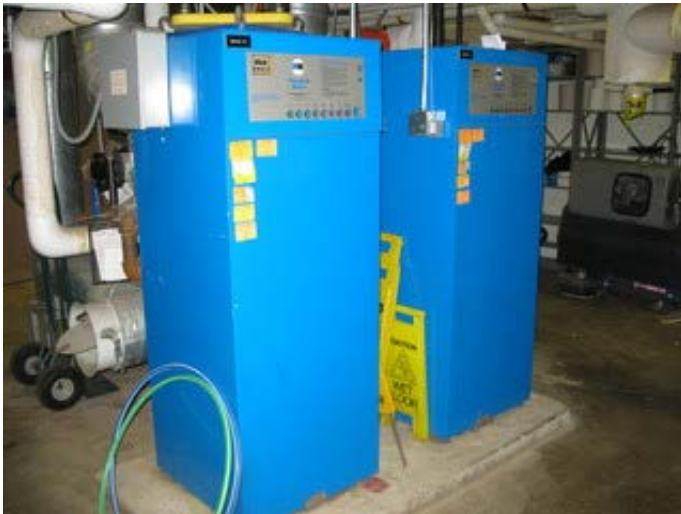
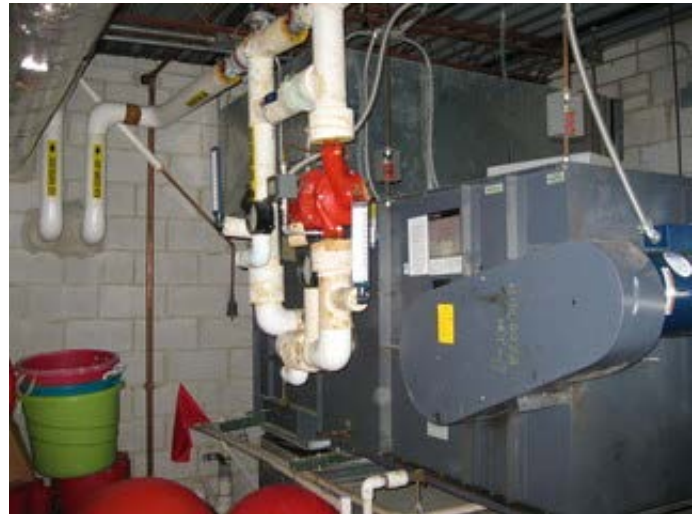
Description: The existing system for the overall facility is a gas fired heating hot water system, installed in 1963, and is in fair condition. The heating and chilled water system in the overall facility is a 2-pipe system, without a capacity for simultaneous heating and cooling operation, which is not compliant with the OSDM requirements for basic system type. The 3 gas fired boilers, manufactured by PK and Thermal Solutions, were installed in 1999 and 2015 and are in good condition. Heating water is distributed to terminal units consisting of unit ventilators, cabinet heaters, unit heaters, fin tubes, and air handlers. The terminal equipment was installed in 1963 and 1999 and is in fair condition. The system does not comply with the 15 CFM per person fresh air requirements of the Ohio Building Code mechanical code and Ohio School Design Manual. The DDC type system temperature controls were installed in 1999 and are in fair condition. The system does feature individual temperature controls in all spaces required by the OSDM. The overall system does not feature any central energy recovery systems. The facility is not equipped with louvered interior doors to facilitate Corridor utilization as return air plenums. The existing system is ducted in the Gymnasium and Cafeteria, but the ductwork cannot be integrated into a possible future system due to arrangement, air volume, and routing of existing ductwork. The existing system is not ducted, and floor to structural deck heights will not accommodate the installation of properly sized ductwork for a future Ohio School Design Manual approved system. The overall heating system is evaluated as being in safe but inefficient working order, and long term life expectancy of the existing system is not anticipated. The structure is equipped with central air conditioning. The site does not contain underground fuel tanks.

Rating: 3 Needs Replacement

Gas Fired Boilers

Air Handler

Recommendations: Provide new overall heating, ventilating, and air conditioning system to achieve compliance with Ohio Building Code and Ohio School Design Manual standards. Convert to ducted system to facilitate efficient exchange of conditioned air. Provide architectural soffits to accommodate the installation of ductwork in the Classrooms.

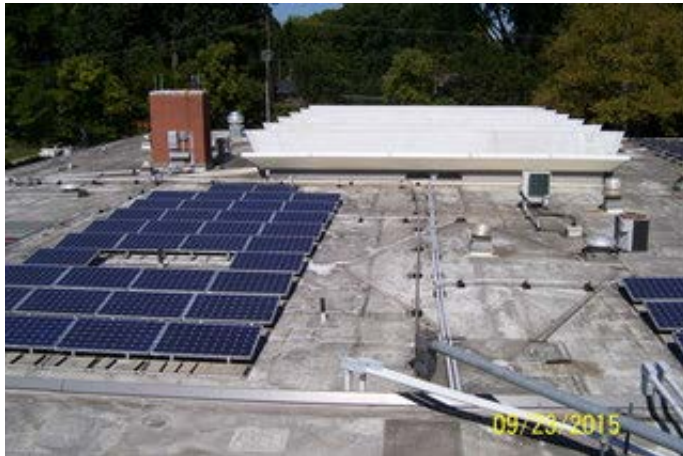
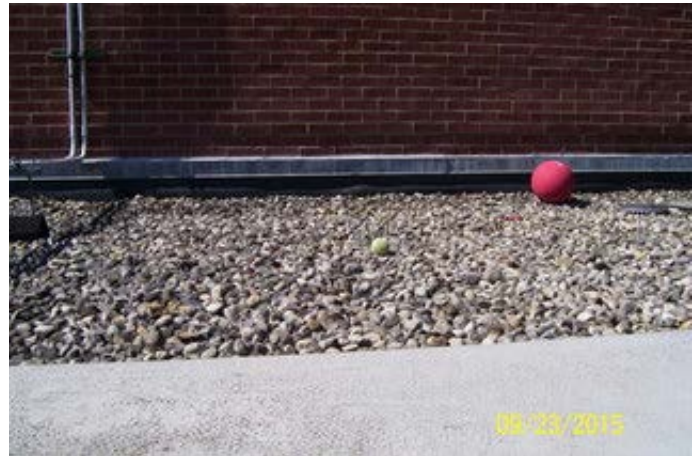
The roof over the Original Building is a mechanically attached heat welded membrane roof system that was installed in 2008 and is in fair condition. The 1988 Addition is a ballasted EPDM roof system that is original to the addition and is in poor condition. There are no District reports of current leaking. No signs of past leaking were observed during the physical assessment. Access to the main roof was gained by an access hatch and an access door that are in fair condition. Access to the gymnasium roof was gained by an access hatch in fair condition. Fall safety protection cages are not required, are not provided. There were observations of standing water on the roof. Metal cap flashings and stone copings are in good condition. Roof storm drainage is addressed through a system of gutters and downspouts and roof drains, which are properly located, and in fair condition. The roof is not equipped with overflow roof drains. No problems requiring attention were observed with any roof penetrations. There are not any covered walkways attached to this structure. A 2011 summary of a report provided by the school district states: "The roof on Evening Street Elementary consists of two different roof systems. A ballasted EPDM roof system, and a mechanically attached heat welded roof system are installed on this facility. The roof was recently renovated and is in good serviceable condition. The roof area is typical of a school facility and rooftop equipment and projections are moderate. The roof area drains to internal roof drains. The mechanically attached heat welded roof system is in good condition and should afford another 8 to 12 years of satisfactory service life. The ballasted EPDM roofing system is at the end of its useful service life and should be budgeted for replacement in the year 2011. Field seams were observed to be failing at the time of inspection, in addition to failed field seams failed flashings were observed throughout the roofing system. Recently a photovoltaic electrical generating station was installed on the ballasted EPDM roof area. This photovoltaic system will have to be removed prior to roof renovation and then reinstalled after roof renovation in a separate contract. Roof Management's budget does not include removal and reinstallation of the photovoltaic system."

3 Needs Replacement

Typical EPDM Roof

Typical Ballasted EPDM

The roof over the 1988 Addition requires replacement to meet Ohio School Design Manual guidelines due to condition and age of system and projected lifecycle. The photovoltaic system on this roof will need to be removed and reinstalled in conjunction with the roof replacement.

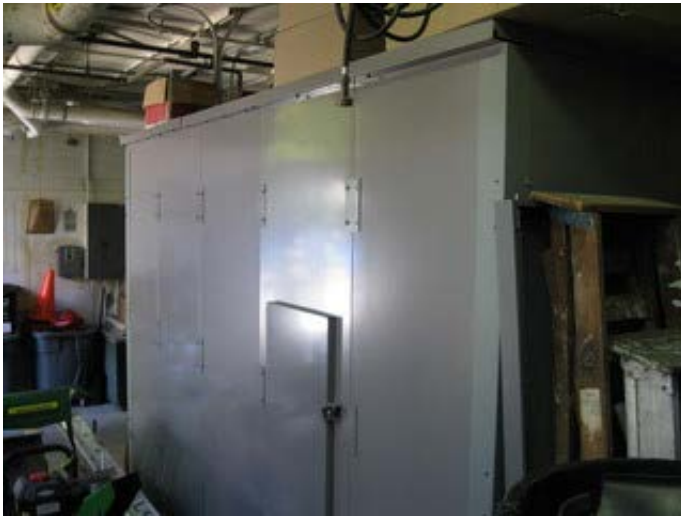
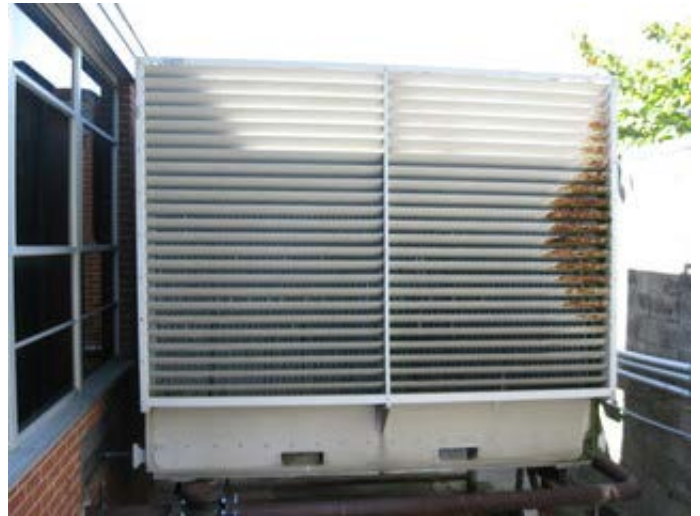
Description: The overall facility is equipped with a chilled water type central air conditioning system, which is in fair condition. A chiller provides chilled water and pumps are utilized to distribute chilled water to the terminal units. The ventilation system in the overall facility consists of unit ventilators, installed in 1999 and in fair condition, providing fresh air to Classrooms, and air handlers, installed in 1963 and in poor condition, providing fresh air to other miscellaneous spaces such as Gymnasiums and Student Dining. Relief air venting is provided by transfer grilles to corridors. The ventilation system does not meet the Ohio Building Code 15 CFM per occupant fresh air requirement. The overall system is not compliant with Ohio Building Code and Ohio School Design Manual requirements. Dust collection systems are not required in this facility. The Art program is equipped with a kiln, and existing kiln ventilation is inadequate. General building exhaust systems for Restrooms and Storage Rooms are adequately placed, and in fair condition.

Rating: 2 Needs Repair

Chiller

Cooling Tower

Recommendations: Provide an air conditioning system to meet with Ohio Building Code and Ohio School Design Manual requirements. Replace general building exhaust systems located in Restrooms, Storage Rooms, and Custodial Closets. Pricing included in Item A. Provide a kiln exhaust system.

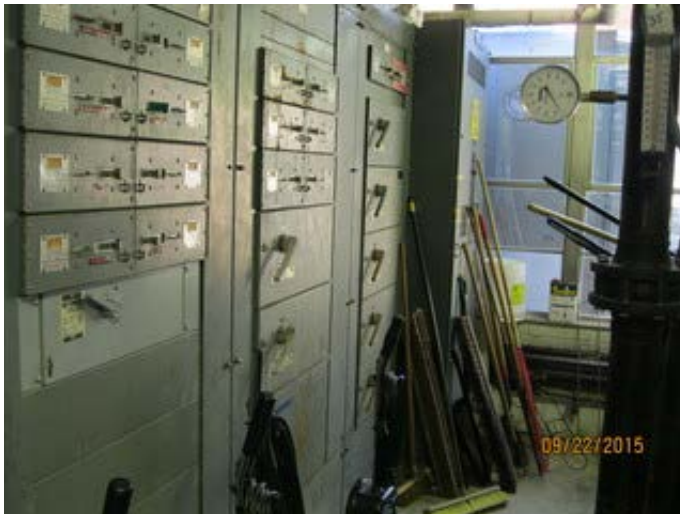
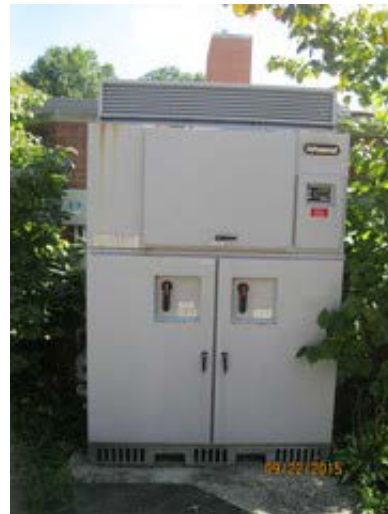
Description: The electrical system provided to the overall facility is a 120/208-volt, 3-phase, 4-wire, 1,200-amp system installed in 1963, and is in poor condition. Main switch is missing. Shunt trip button system is also tied into solar panel equipment. Power is provided to the school by a multiple utility owned, pole-mounted transformer located in exterior parking garage, and in good condition. The panel system, installed in 1963, is in poor condition, and cannot be expanded to add additional capacity. The Classrooms are not equipped with adequate electrical outlets. The typical Classroom contains 26 general purpose outlets, 2 dedicated outlets for each Classroom computer, and 2 dedicated outlets for each Classroom television. Some Classrooms are equipped with as many as 28 general purpose outlets, while others are equipped with as few as 24 general purpose outlets. There are not any spaces that have no electrical outlets. The Corridors are not equipped with adequate electrical outlets for servicing. Adequate GFI protected exterior outlets are not provided around the perimeter of the building. The facility is not equipped with an emergency generator. Inadequate lightning protection safeguards are provided. The existing facility is not equipped with a Stage. The overall electrical system does not meet Ohio School Design Manual requirements in supporting the current needs of the school, and will be inadequate to meet the facility's future needs.

Rating: 3 Needs Replacement

Main Switchgear

Solar Power Inverter/Switchgear

Recommendations: The entire electrical system requires replacement to meet Ohio School Design Manual guidelines for overall capacity, Classroom capacity, due to condition and age, lack of OSDM-required features, and to facilitate the scope of work outlined in Item U.

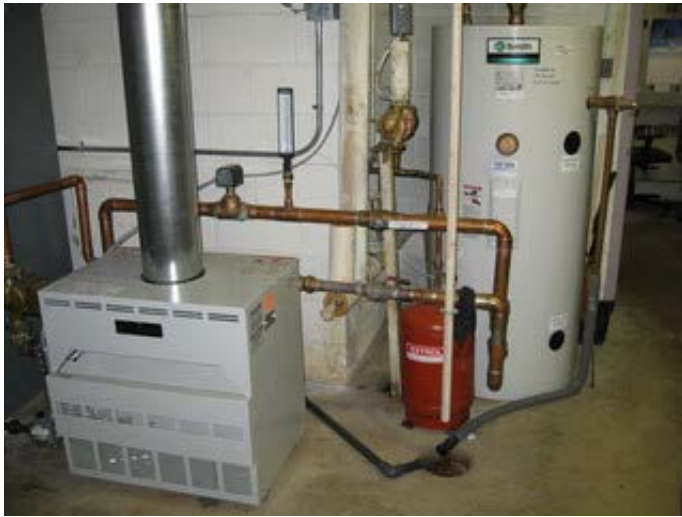
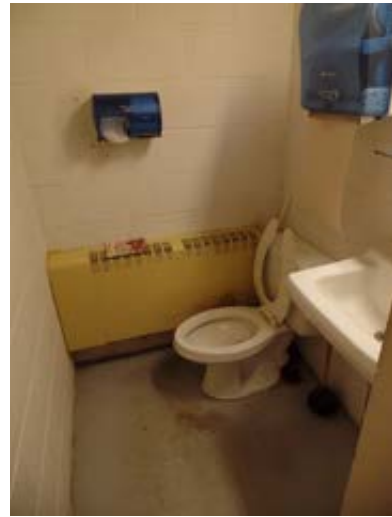
Description: The service entrance is not equipped with a reduced pressure backflow preventer. A water treatment system is not provided. The domestic water supply piping in the overall facility is copper, was installed in 1963, is original to each addition, and is in fair condition. The waste piping in the overall facility is PVC and galvanized, was installed in 1963, and is in fair condition. The facility is equipped with a gas water heater in good condition, with a separate 119-gallon storage tank in good condition. The school contains 2 Large Group Restrooms for boys, 2 Large Group Restrooms for girls, 1 Single Restroom for boys, 1 Single Restroom for girls, 3 Restrooms associated with specialty Classrooms, and 4 Restrooms for staff. Boys' Large Group Restrooms contain 0 ADA and 4 non-ADA wall mounted flush valve toilets, 3 ADA and 5 non-ADA wall mounted flush valve urinals, as well as 0 ADA and 6 non-ADA wall mounted lavatories. Girls' Large Group Restrooms contain 0 ADA and 7 non-ADA wall mounted flush valve toilets, as well as 0 ADA and 8 non-ADA wall mounted lavatories. Staff Restrooms contain 0 ADA and 8 non-ADA wall mounted flush valve toilets, 0 ADA and 1 non-ADA wall mounted urinals, as well as 0 ADA and 7 non-ADA wall mounted lavatories. Condition of fixtures is fair. The facility is equipped with 0 ADA and 0 non-ADA drinking fountains, as well as 2 ADA and 4 non-ADA electric water coolers, in fair condition. The 20 Elementary Classrooms are equipped with 20 ADA and 0 non-ADA sink mounted type drinking fountains, in poor condition. The Special Education Classroom is not equipped with the required Restroom. The Kitchen is equipped with the required Restroom, and fixtures are in poor condition. The Health Clinic is equipped with the required Restroom, and fixtures are in poor condition. The Kindergarten is equipped with Restroom facilities, and fixtures are in poor condition. Kitchen fixtures consist of 1 hand sink, 1 double-compartment sink, and 1 triple-compartment sink, which are in fair condition. The Kitchen is not equipped with a satisfactory grease interceptor. The Kitchen is provided the required 140 degree hot water supply via a mixing valve, which is in good condition. The school does not meet the OBC requirements for fixtures. Relative to LEED requirements, the school is not equipped with low flow type fixtures. Per OBC and OSDM requirements this facility should be equipped with 23 toilets, 10 urinals, 31 lavatories, 20 Classroom sink mounted drinking fountains, and 15 electric water coolers. Observations revealed that the school is currently equipped with 22 toilets, 10 urinals, 22 lavatories, 20 Classroom sink mounted drinking fountains, and 6 electric water coolers. ADA requirements are not met for fixtures and drinking fountains (see Item O). Custodial Closets are properly located and are adequately provided with required service sinks or floor drain sinks, which are in poor condition. A Science Classroom, Lab utility sinks, gas connections, compressed air connections, and safety shower / eyewash are not provided, but are not required due to existing grade configuration. Due to existing grade configuration, no Biology or Chemistry Classroom acid waste systems are required. Adequate exterior wall hydrants are provided.

Rating: 3 Needs Replacement

Domestic Water Heater

Single-Occupant Restroom

Recommendations: To facilitate the school's compliance with OBC and OSFC fixture requirements, provide 11 new toilets, 9 new lavatories, 0 new urinals, 9 new electric water coolers / new lavatory mounted type drinking fountains. Due to age, condition, LEED, and OSFC requirements, provide 33 new toilets, 31 new lavatories, 10 new urinals, 15 new electric water coolers / new lavatory mounted type drinking fountains. Replace sanitary waste piping in the original construction. Provide reduced pressure backflow preventer. Provide a grease interceptor.

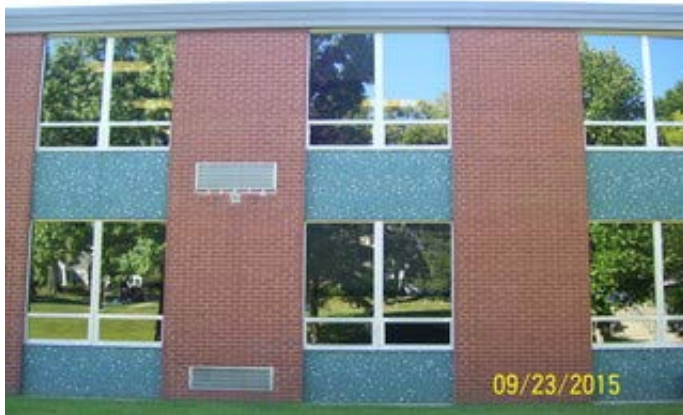
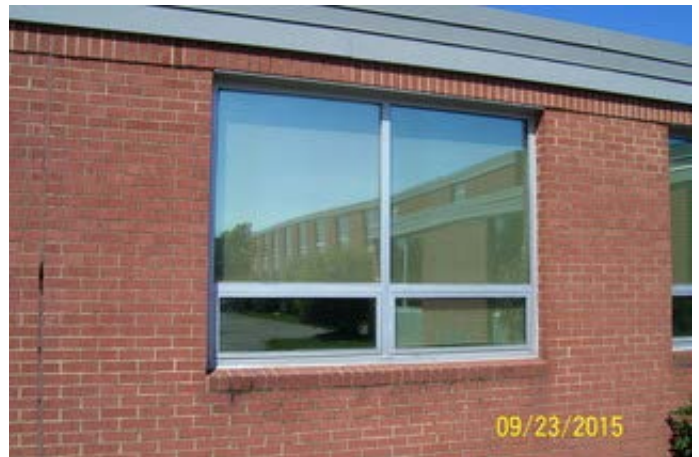
The Original Building is equipped with aluminum frame windows with single glazed type window system, which was installed in 1963 and is in poor condition. The window system features operable windows throughout the building, and operable windows are equipped with opening limiters in poor condition and insect screens in poor condition. Window system seals are in poor condition, with moderate air and water infiltration being experienced. Window system hardware is in fair condition. The window system features surface mounted blinds, which are in fair condition. The 1963 Original Construction is equipped with an aluminum frame curtain wall system, installed in at an unknown date, and is in fair condition. The 1988 Addition is equipped with aluminum frame windows with double glazed, tempered type window system, which was installed in 1988 and is in good condition. The window system features inoperable windows throughout the addition. Window system seals are in fair condition, with minimal air and water infiltration being experienced. The windows in this addition do not include blinds. This overall facility does not feature any glass block windows. The exterior doors in the Original Building are equipped with hollow metal frame sidelights and transoms with single pane glazing, provided with internal wire mesh, in fair condition. Exterior door vision panels are provided single pane glazing, provided with internal wire mesh, in fair condition. The exterior doors in the 1988 Addition are not equipped with sidelights or transoms. The school does not contain skylights. The school does not contain any clerestories. Interior glass is wired glass safety glazing. Window security grilles are not provided for ground floor windows. There is not a Greenhouse associated with this school.

3 Needs Replacement

Typical Fenestration

Typical Window

Provide a new insulated window system with integral blinds to meet with Ohio School Design Manual requirements in the Original Building. Exterior door replacement is addressed in Item S.

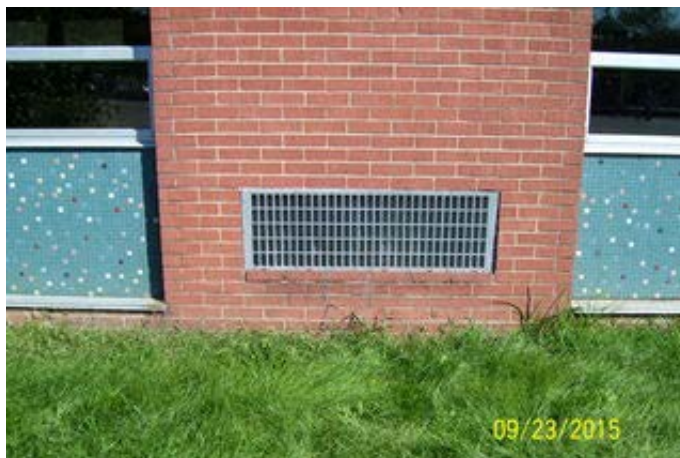
The Original Building and 1988 Addition have a brick veneer on load bearing masonry wall system, which displayed minor locations of deterioration, and is in fair condition. The exterior masonry throughout appears to have appropriately spaced and inadequately caulked control joints in poor condition. Control joints are provided at lintel locations, at doors and windows, building corners, and wall offsets and are in poor condition. The Original Building does have sufficient expansion joints, and they are in poor condition. Cracking was observed in several areas on the exterior masonry. The 1988 Addition does have sufficient expansion joints, and they are in fair condition, and no cracking was observed on the exterior masonry. Exterior walls in the Original Building are inadequately insulated. Brick veneer masonry walls are not cavity walls. Exterior walls in the 1988 Addition are adequately insulated. Brick veneer masonry wall are cavity walls. On the Original Building, weep holes and vents are not provided or required. On the Gym Addition, weep holes are provided in sufficient quantity (at 24"-48" on center) at the base of masonry cavity walls, and are in fair condition. Weep holes are not rope type weeps. Vents are not provided. The exterior masonry has not been cleaned and sealed in recent years, and shows evidence of efflorescence and mold in several locations. Architectural exterior accent materials consist of stone, which is in good condition, and mosaic tile, which is in poor condition. Exterior building fenestration in the Original Building represents 25% of the exterior surfaces, and fenestration in the 1988 Addition represents 3% of the exterior surfaces. Interior Corridor and demising walls are brick, concrete masonry units, and glazed block, project full height from floor to bottom of deck, and are in fair condition. Interior masonry appears to have adequately spaced and caulked control joints in fair condition. Interior soffits are of stud and gypsum board type construction, and in fair condition. The window sills are brick and aluminum, and are in fair condition. The exterior lintels are precast steel, and are rusting. Chimneys are in fair condition with minor cracking observed. Exterior soffits are of suspended exterior drywall type construction, and in poor condition. The school is provided with an uncovered, concrete conventional loading dock to facilitate the receipt of product, supplies, and foodstuffs, 245 square feet in size. The dock itself is in fair condition, and is equipped with bumper pads in fair condition.

2 Needs Repair

Brick to be Tuckpointed

Provide tuckpointing in all areas of mortar deterioration as required in the Original Building. Provide masonry cleaning and sealing as required through the overall facility. Recaulk existing control joints at the Original Building. Prep and paint exposed steel lintels through the overall facility. Repair exterior soffits, stone accents, and mosaic tile where damage has occurred. Additional wall insulation is addressed in Item J.

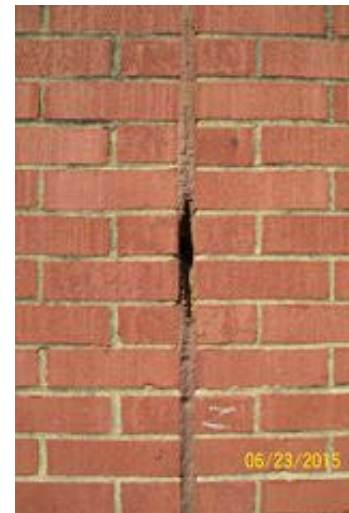
Control Joint to be Caulked

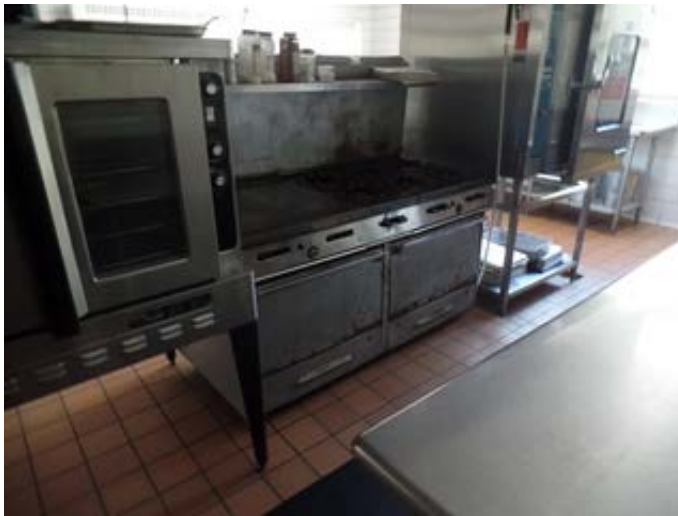
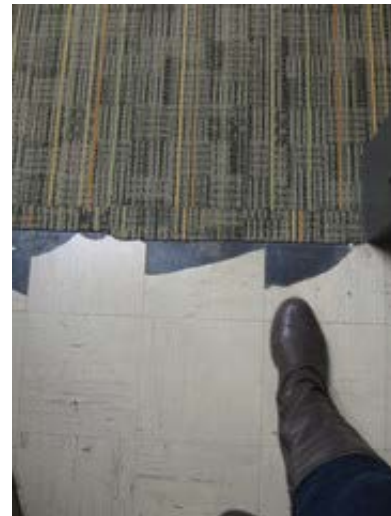
Description: The overall facility features conventionally partitioned Classrooms with carpet tile and vinyl type flooring, 2x4 ACT type ceilings, as well as painted CMU type wall finishes, and they are in good condition. The overall facility has Corridors with terrazzo, vinyl, and carpet tile type flooring, 2x4 ACT type ceilings, as well as brick and painted CMU type wall finishes, and they are in good condition. The overall facility has Restrooms with terrazzo type flooring, 2x4 ACT type ceilings, as well as painted CMU type wall finishes, and they are in fair condition. Toilet partitions are plastic, and are in good condition. The 1988 Addition has Corridors with terrazzo, vinyl, and carpet tile type flooring, 2x4 ACT type ceilings, as well as brick and painted CMU type wall finishes, and they are in good condition. Classroom casework in the overall facility is wood type construction with plastic laminate tops, is adequately provided, and in fair condition. The typical Classroom contains 8' lineal feet of casework. Classrooms are provided adequate chalkboards, markerboards, tackboards which are in good condition. The Classroom storage cubbies, located in the Classrooms, are adequately provided, and in fair condition. The Art program is not equipped with a kiln. The facility is equipped with wood non-louvered interior doors that are partially recessed with proper ADA hardware and clearances, and in good condition. The Gymnasium space(s) have VCT type flooring, open type ceilings, as well as painted CMU type wall finishes, and they are in good condition. Gymnasium basketball backboards are electrically operated type, and are in good condition. The Media Center, has carpet tile type flooring, 2x4 ACT type ceilings, as well as painted CMU type wall finishes, and they are in good condition. Student Dining, has VCT type flooring, metal panel type ceilings, as well as painted CMU type wall finishes, and they are in fair condition. No stage is provided. Existing Gymnasium, Student Dining, Media Center, and Music spaces are inadequately provided with appropriate sound attenuation acoustical surface treatments. The existing Kitchen is full service, is undersized based on current enrollment, and the existing Kitchen equipment, installed in 1987-2005, is in fair/poor condition.

Rating: 3 Needs Replacement

Kitchen

Hallway with Damaged Tile

Recommendations: Provide complete replacement of finishes and casework due to condition and installation of systems outlined in Items (A / C / D / E / I / K / L / M / N / T / U / W). Provide for the replacement of kitchen equipment due to age. Provide additional wall insulation per Item H.

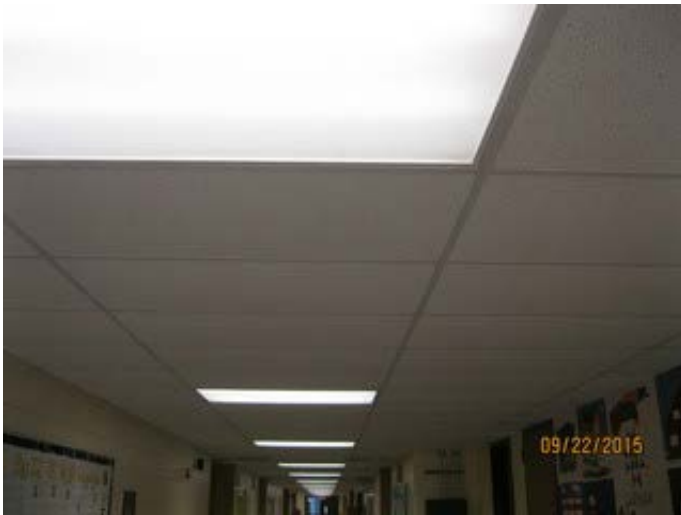
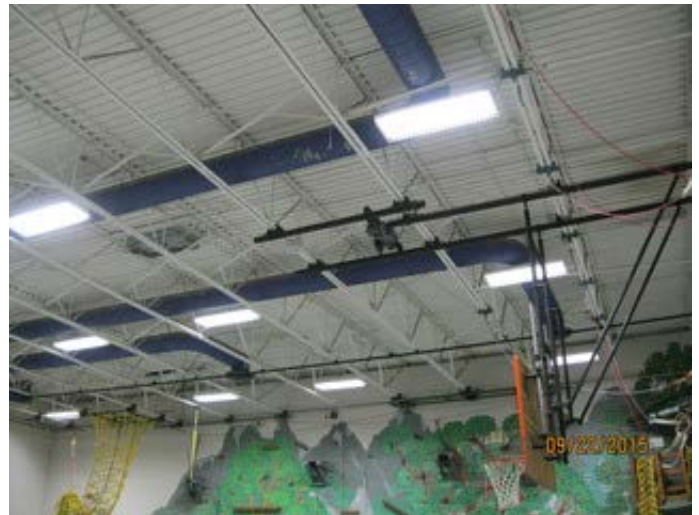
The typical Classrooms in the overall facility are equipped with T-8 lay-in 2x4 fluorescent fixtures with multi-level switching. Classroom fixtures are in good condition, providing an average illumination of 66 FC, thus complying with the 50 FC recommended by the OSDM. The typical Corridors in the overall facility are equipped with T-8 lay-in 2x4 fluorescent fixtures with dual level switching. Corridor fixtures are in good condition, providing an average illumination of 22 FC, thus complying with the 20 FC recommended by the OSDM. The Primary Gymnasium spaces are equipped with pendant T-8 2x4 mount fluorescent fixture type lighting, in good condition, providing an average illumination of 50 FC, thus complying with the 50 ES FC recommended by the OSDM. The Media Center is equipped with lay-in 2x4 T-8 fluorescent fixture type lighting in good condition, providing an average illumination of 75 FC, thus complying with the 50 FC recommended by the OSDM. The Student Dining spaces are equipped with 1x4 surface mount T-8 fluorescent fixture type lighting with multi-level switching. Student Dining fixtures are in poor condition, providing an average illumination of 30 FC, which is less than the 50 FC recommended by the OSDM. The Kitchen spaces are equipped with 1x4 surface mount T-8 fluorescent fixture type lighting with single level switching. Kitchen fixtures are in good condition, providing an average illumination of 56 FC, which is less than the 75-80 FC recommended by the OSDM. The Service Areas in the overall facility are equipped with 1x4 suspended T-8 fluorescent fixture type lighting in good condition. The typical Administrative spaces in the overall facility are equipped with lay-in 2x4 T-8 fluorescent fixture type lighting in good condition, providing adequate illumination based on OSDM requirements. The overall lighting systems of the facility are not fully compliant with Ohio School Design Manual requirements due to inadequate lighting levels and lack of multi-level switching.

3 Needs Replacement

Corridor Lighting

Gym Lighting

Provide complete replacement of lighting system due to lighting levels, lack of multi-level switching, installation of systems outlined in Item U.

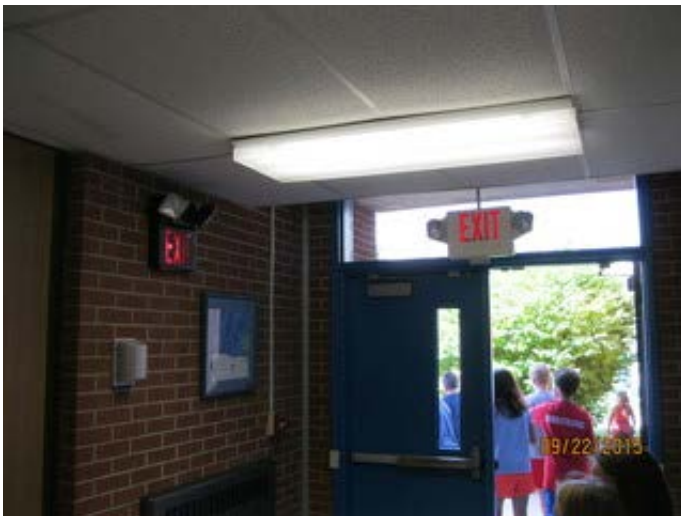
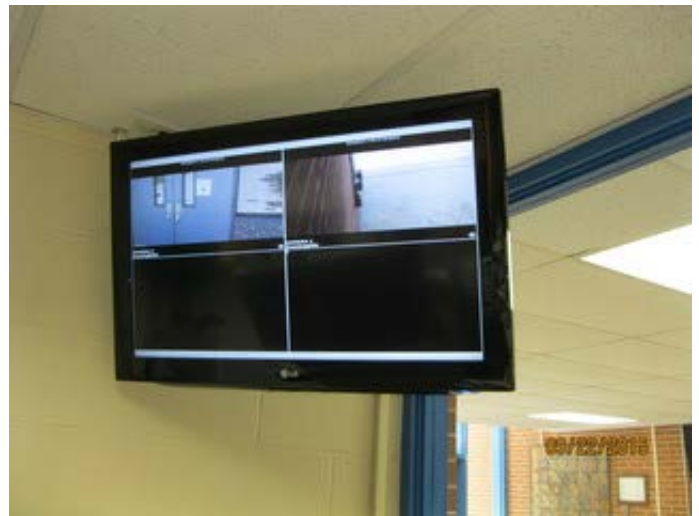
Description: The overall facility contains a Security Command motion detector, CCTV, intrusion, and door contact type security system in good condition. Motion detectors are not adequately provided in main entries, central gathering areas, offices, main Corridors, and spaces where 6 or more computers are located. Exterior doors are equipped with door contacts. An automatic visitor control system is provided. Compliant color CCTV cameras are not provided at parking lots, central gathering areas, and main Corridors. CCTV is monitored in Administrative Area with the use of a TV. A compliant computer controlled access control system integrating alarms and video signals, with appropriate UPS backup, is not provided. The system is equipped with card readers. The security system is not adequately provided throughout, and the system is not compliant with Ohio School Design Manual guidelines. The exterior site lighting system is equipped with surface mounted high pressure sodium entry lights in fair condition. Pedestrian walkways are illuminated with high pressure sodium fixtures in fair condition. Parking and bus pick-up / drop off areas are illuminated by pole mounted high pressure sodium fixtures in fair condition. The exterior site lighting system provides inadequate illumination due to sparse placement of fixtures.

Rating: 3 Needs Replacement

Door Security Contacts/Exit Signs/FA Pull Stations

Camera Monitor

Recommendations: Provide new security system to meet Ohio School Design Manual guidelines.

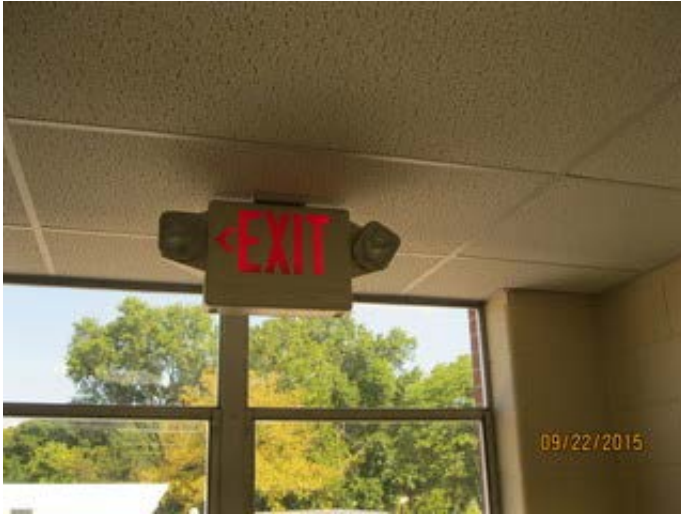
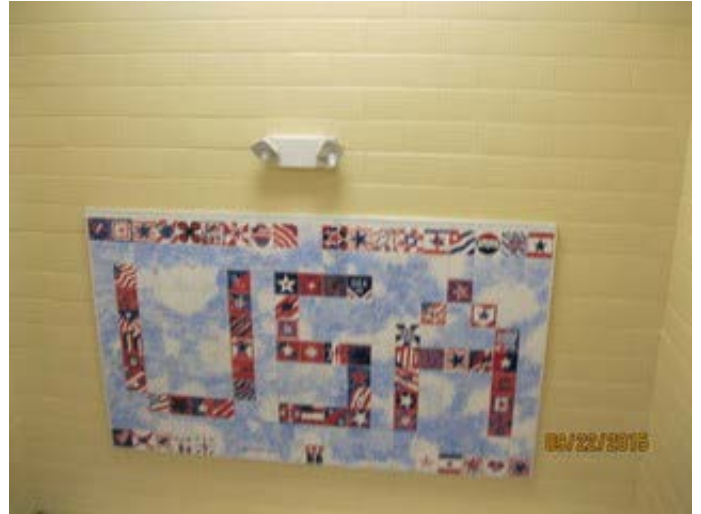
Description: The overall facility is equipped with an emergency egress lighting system consisting of non-compliant plastic construction exit signs, as well as OSDM compliant red lettered, LED illuminated exit signs, and the system is in good condition. The facility is equipped with emergency egress floodlighting, and the system is in good condition. The system is provided with appropriate battery backup. The system is adequately provided throughout, and does not meet Ohio School Design Manual and Ohio Building Code requirements.

Rating: 3 Needs Replacement

Exit Sign With Remote Heads

Battery Pack

Recommendations: Provide new emergency / egress lighting system to meet Ohio School Design Manual and Ohio Building Code guidelines and in conjunction with work in Item U.

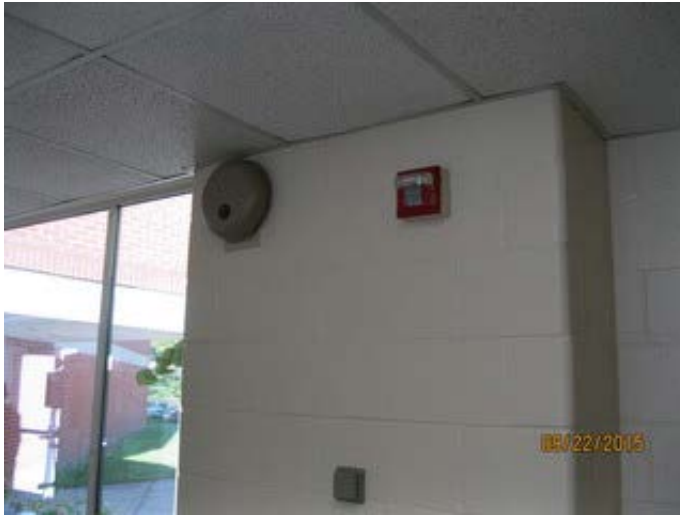
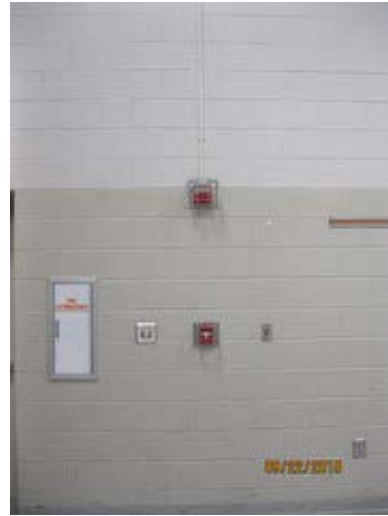
Description: The overall facility is equipped with a Simplex type fire alarm system, and is in good condition, consisting of manual pull stations, bells, and horn and strobe indicating devices. The system is automatic and is monitored by a third party. The system is equipped with sufficient audible horns and strobe indicating devices. The system is not equipped with sufficient smoke detectors or heat sensors. The system is not equipped with any flow switches or tamper switches. The system thus will not support future fire suppression systems. The system is adequately provided throughout, and does not have additional zone capabilities. The system is not fully compliant with Ohio Building Code, NFPA, and Ohio School Design Manual requirements.

Rating: 3 Needs Replacement

Fire Alarm Horn Strobe

Gym Fire Alarm Equipment

Recommendations: Provide new fire alarm system to meet OBC, NFPA, and Ohio School Design Manual guidelines.

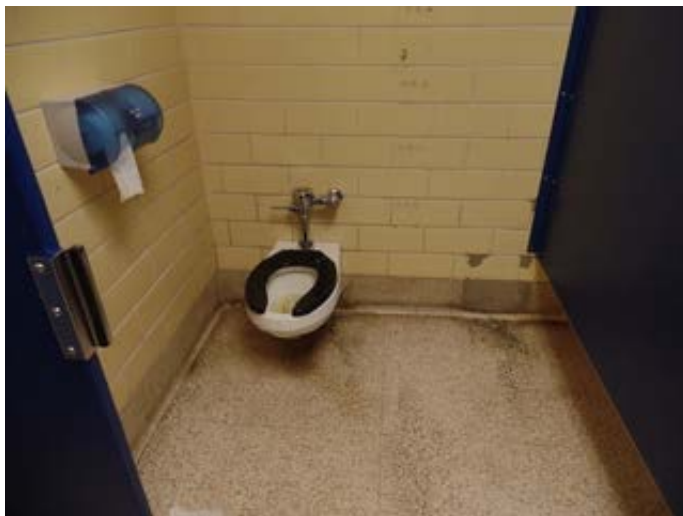
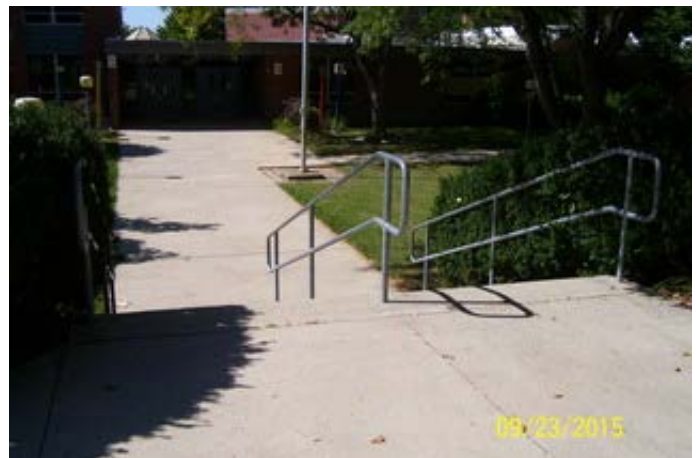
3 Needs Replacement

ADA-restroom

Steps at Front Sidewalk

Provide ADA-compliant signage, power assist door opener, ramps, electric water coolers, toilets, sinks, urinals, toilet partitions, toilet accessories in the overall facility to facilitate the school's meeting of ADA requirements. Parking issues are corrected in Item P.

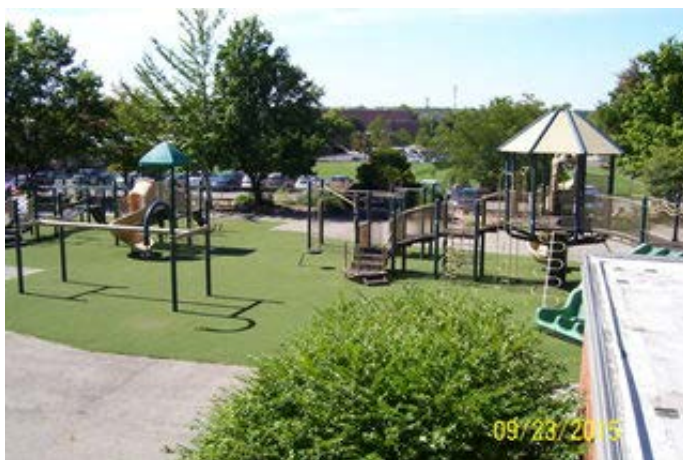
3 Needs Replacement

Typical Playground

Provide bus loop for student loading and unloading. Replace wood retaining wall at the west parking lot location due to structural deterioration. Provide a concrete pad for dumpsters. It is recommended to replace playground equipment to more ADA-compliant play structures.

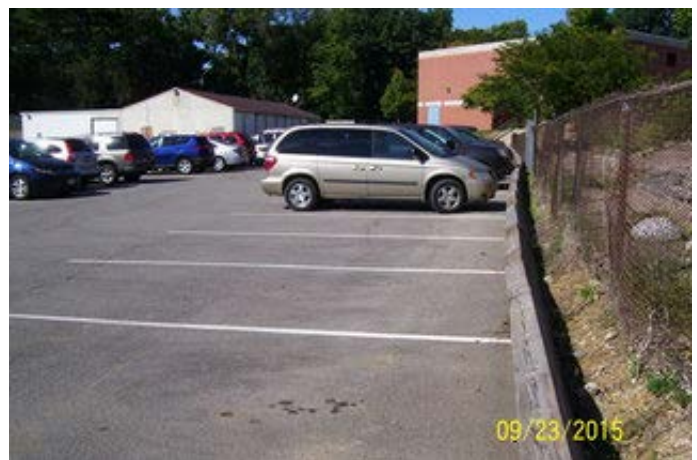
Retaining Wall to be Replaced

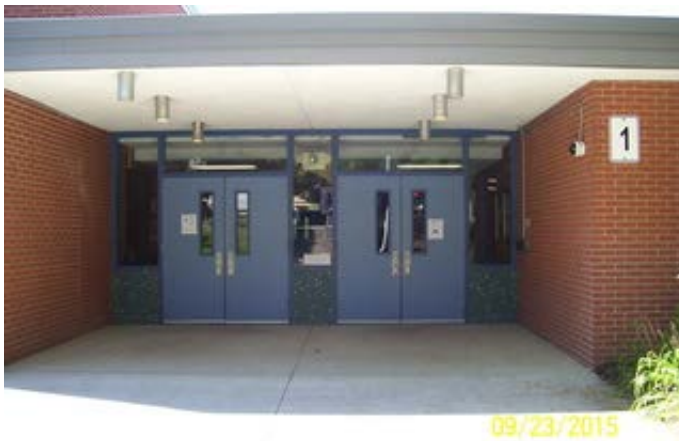
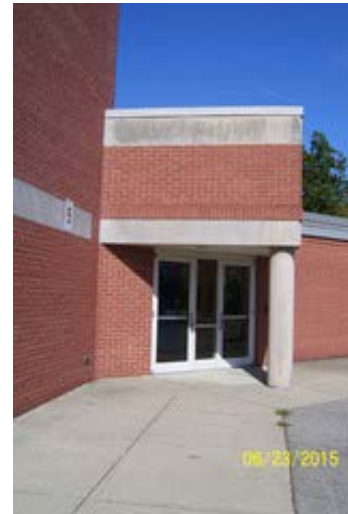
Description: Typical exterior doors in the 1963 Original Construction are hollow metal type construction, installed on hollow metal frames, and in fair condition. Typical exterior doors feature single wired glass vision panels, and appropriate hardware. Typical exterior doors in the 1988 Gym Addition are aluminum type construction, installed on aluminum frames, and in good condition. Typical exterior doors feature no vision panels, and appropriate hardware. Entrance doors in the 1963 Original Facility are hollow metal type construction, installed on aluminum frames, and in fair condition and feature single glazed wired glass vision panels, transoms, and appropriate hardware. Entrance doors in the 1988 Gym Addition are aluminum type construction, installed on aluminum frames, and in good condition and feature double glazed tempered glass, transoms, side-lights and appropriate hardware. The facility is equipped with one roof access door, which is in fair condition. There are no overhead doors in the facility.

Rating: 3 Needs Replacement

Original Building Entrance Doors

1988 Addition Entrance Doors

Recommendations: Replace all exterior and entrance doors in the Original Building to comply with Ohio Building Code, ADA, and Ohio School Design Manual guidelines.

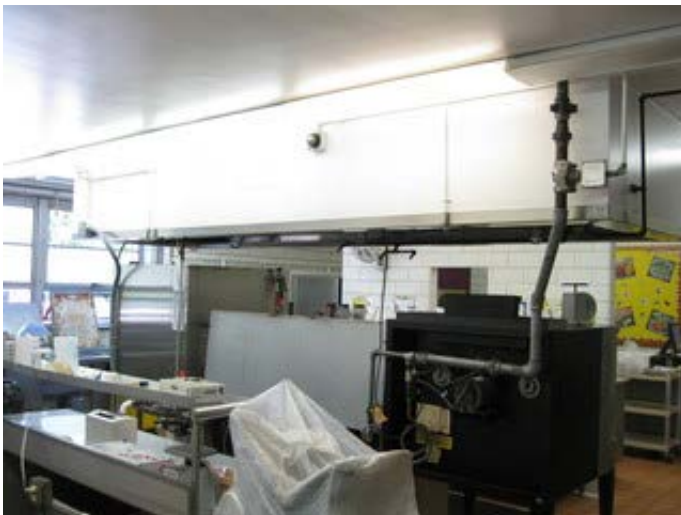
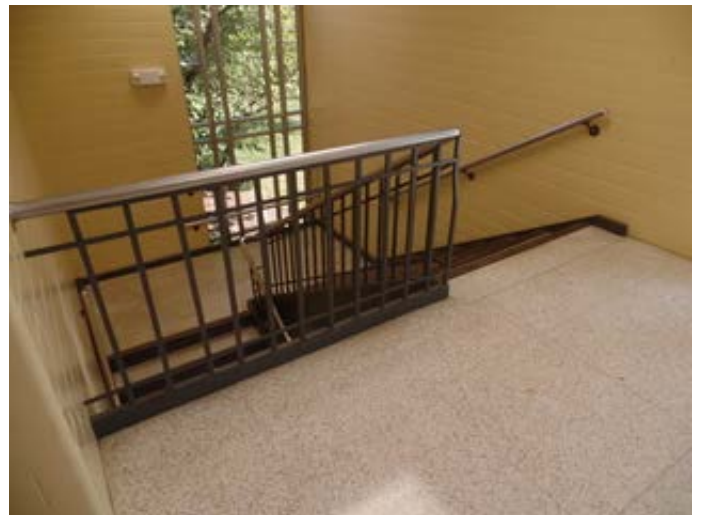
Description: The overall facility is not equipped with an automated fire suppression system. Exit Corridors are situated such that dead-end Corridors are not present. The facility features 2 interior stair towers, which are not protected by a compliant two hour fire enclosure. The facility features 0 exterior stairways providing egress from intermediate floors. Guardrails do not meet the 4" ball test and do not extend past the top and bottom stair risers as required by the Ohio Building Code. The 1988 Addition is equipped with a compliant automated fire suppression system in fair condition. The Kitchen hood is in poor condition, and is equipped with the required UL 300 compliant wet chemical fire suppression system. The cooking equipment is interlocked to shut down in the event of discharge of the fire suppression system. The facility is not equipped with an emergency generator. The existing water supply is provided by a tie-in to the city system, and is insufficient to meet the future fire suppression needs of the school. Rooms with a capacity greater than 50 occupants are equipped with adequate egress.

Rating: 3 Needs Replacement

Kitchen Hood

stairs

Recommendations: Provide new automated fire suppression system to meet Ohio School Design Manual guidelines. Provide increased water service of a capacity sufficient to support the fire suppression system, funding included in fire suppression funding. Provide new emergency generator, with funding provided via complete replacement of electrical system in Item D. Provide new Kitchen hood with a UL 300 compliant wet chemical fire suppression system. Provide new handrails to meet the requirements of the Ohio Building Code.

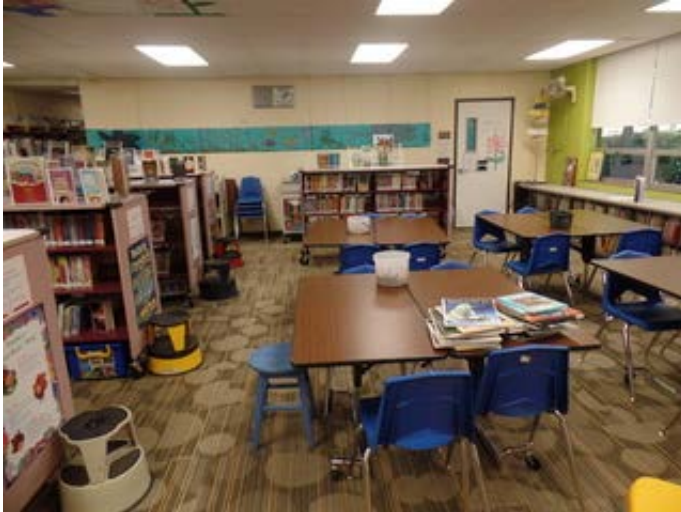
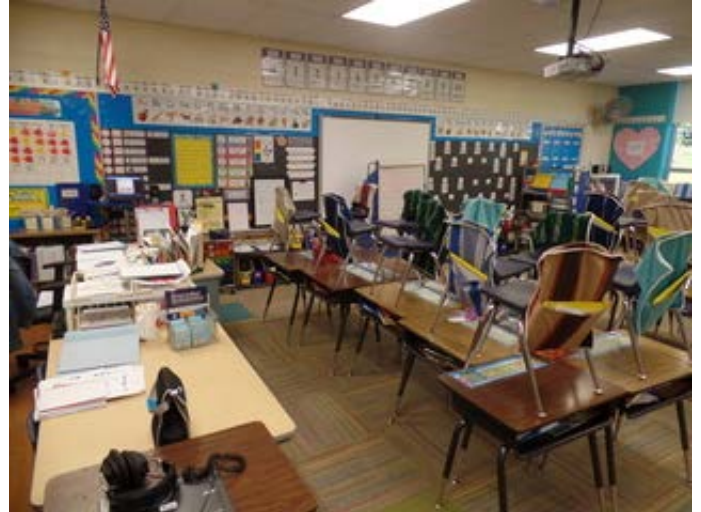
Description: The typical Classroom furniture is mismatched, and in generally fair condition, consisting of student desks & chairs, teacher desks & chairs, desk height file cabinets, reading tables, computer workstations, bookcases, wastebaskets, and other. The facility's furniture and loose equipment were evaluated in item 6.17 in the CEFPI section of this report, and on a scale of 1 to 10 the overall facility received a rating of 4 due to observed conditions, and due to the fact that it lacks some of the Design Manual required elements.

Rating: 3 Needs Replacement

library

classroom

Recommendations: Provide for replacement of outdated or inadequate furnishings.

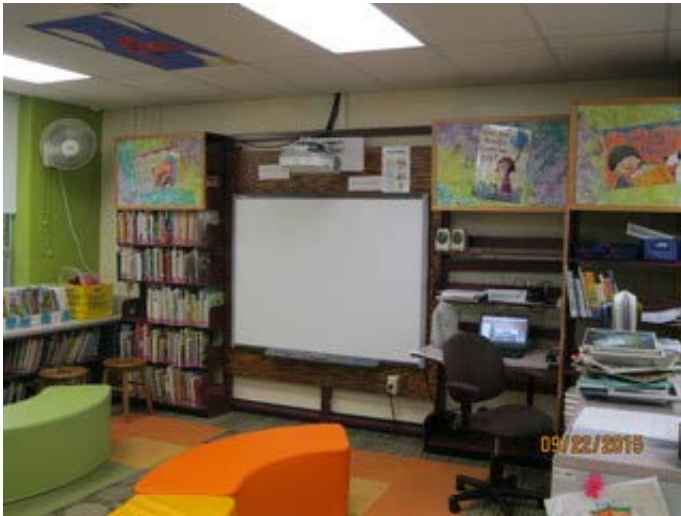
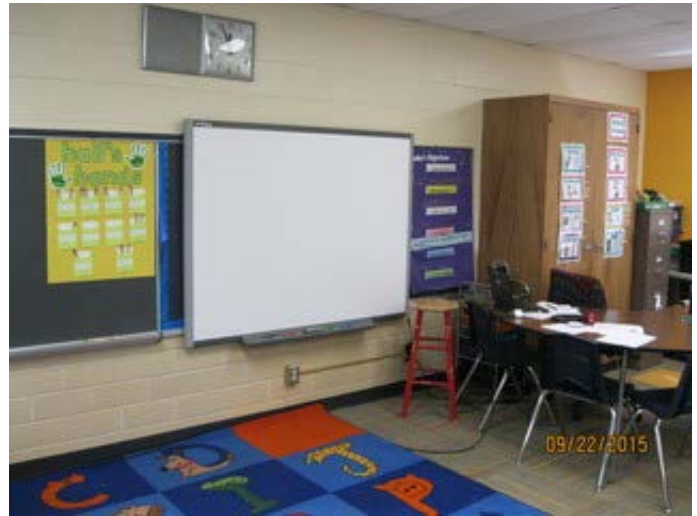
Rating: 3 Needs Replacement

Smartboard/Projector

Smartboard

Recommendations: Provide complete replacement of technology systems to meet Ohio School Design Manual requirements, and to sustain the capacity to keep pace with technological development.
