**Building Information - Worthington City (45138) - Kilbourne Middle School**

**85,536** Total Existing Square Footage  
**1939,1939,1965,1995** Building Dates  
**7-8** Grades  
**376** Current Enrollment  
**20** Teaching Stations  
**2.70** Site Acreage

Kilbourne Middle School, which is not on the National Register of Historic Buildings, and originally constructed in 1939, is a two story, 85,536 square foot brick school building is located in a suburban residential setting. The existing facility features a conventionally partitioned design, and does not utilize modular buildings. The structure of the original building contains brick type exterior wall construction, with plaster on CMU type wall construction in the interior. The floor system consists of metal form deck on steel joist. The roof structure is wood joist. The roofing system is a shingle tile, installed in 1939. The structure of the 1991 addition contains brick type exterior wall construction, with CMU type wall construction in the interior. The floor system consists of metal form deck on steel joist. The roof structure is metal form deck on steel joist. The roofing system is ballasted EPDM, installed in 2015. The c

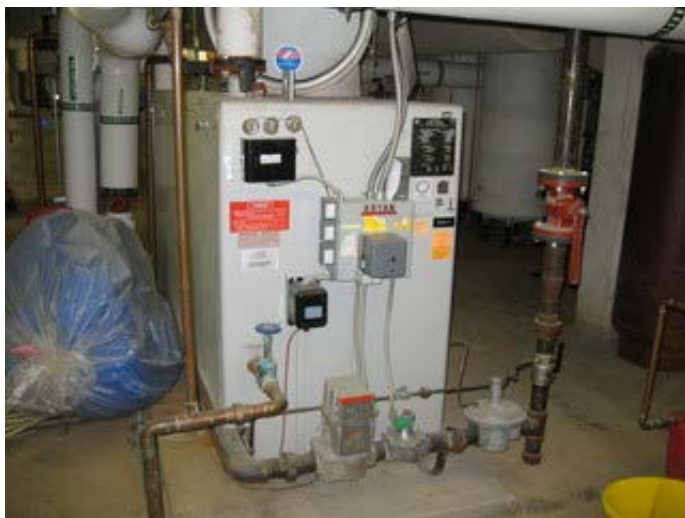
The existing system for the Original Construction is a gas fired heating hot water system, installed in 1968, and is in poor condition. The existing system for the Auditorium, Music Room, Library, and interior Classrooms is a gas fired forced air system, installed in 1995 and in poor-to-fair condition. The heating and chilled water system in the overall facility is a 2-pipe system, without a capacity for simultaneous heating and cooling operation, which is not compliant with the OSDM requirements for basic system type. The 2 gas fired boilers, manufactured by Bryan Boilers, were installed in 1995 and are in fair condition. Heating water is distributed to terminal units consisting of unit ventilators, cabinet heaters, unit heaters, and air handlers. The terminal equipment was installed in 1995 and is in fair condition. The system does not comply with the 15 CFM per person fresh air requirements of the Ohio Building Code mechanical code and Ohio School Design Manual. The DDC type system temperature controls were installed in 1999 and are in good condition. The system does feature individual temperature controls in all spaces required by the OSDM. The overall system does not feature any central energy recovery systems. The facility is not equipped with interior doors to facilitate Corridor utilization as return air plenums. The existing system is not ducted in the perimeter Classrooms, Dining, Offices, and Kitchen, and floor to structural deck heights will not accommodate the installation of properly sized ductwork for a future Ohio School Design Manual approved system. The existing system is ducted in the Gymnasium, Library, Band Room, and Auditorium, though lack of need for HVAC system replacement at this time negates any need to evaluate the potential integration of existing ductwork into a new system. The overall heating system is evaluated as being in safe but inefficient working order, and long term life expectancy of the existing system is not anticipated. The structure is equipped with central air conditioning. The site does not contain underground fuel tanks.

3 Needs Replacement

Gas Fired Boiler

Provide new overall heating, ventilating, and air conditioning system to achieve compliance with Ohio Building Code and Ohio School Design Manual standards. Convert to ducted system in the perimeter Classrooms, Dining, Offices, and Kitchen to facilitate efficient exchange of conditioned air.

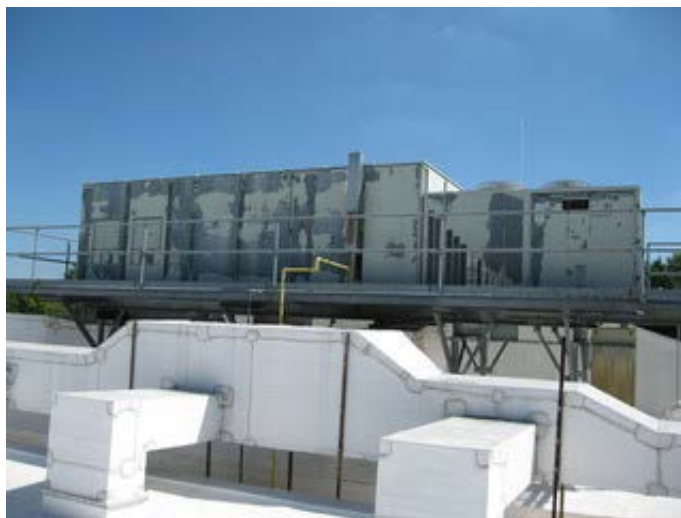
Gas Fired Rooftop Unit

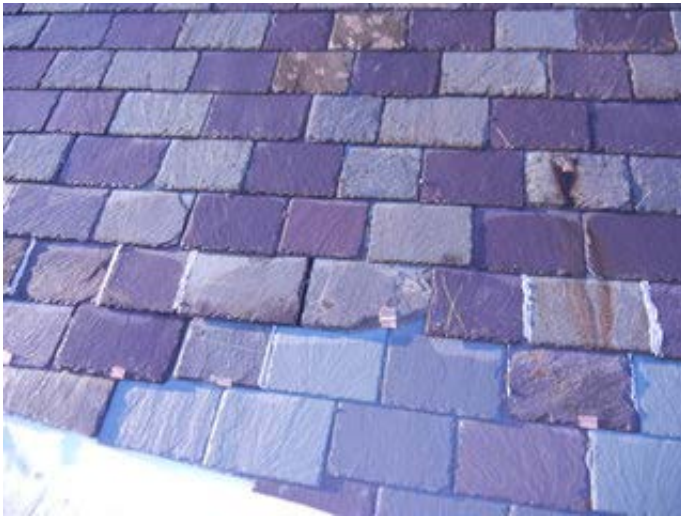
**Description:** The roof over the original 1939 building is a shingle tile system that was installed in 1939, and is in fair condition. The roof over both the 1965 and 1995 addition is an EPDM system that was installed in 2015, and is in good condition. There are no District reports of current leaking. No signs of past leaking were observed during the physical assessment. Access to the roof was gained by an access door and access hatch, both which are in fair condition. Fall safety protection cages are not required and have not been provided. There were no observations of standing water on the roof. Metal cap flashing are in good condition. Roof storm drainage is addressed through a system of roof drains, through-wall scuppers, and gutters and downspouts, which are properly located, and in good condition. The roof is not equipped with overflow roof drains. No problems requiring attention were encountered with any roof penetrations. There are not any covered walkways attached to this structure.

**Rating:** 3 Needs Replacement

Original shingle tile

**Recommendations:** Replace existing tile roof over the original 1939 building and auditorium. Replace gutters and downspouts. Replace roof hatch.

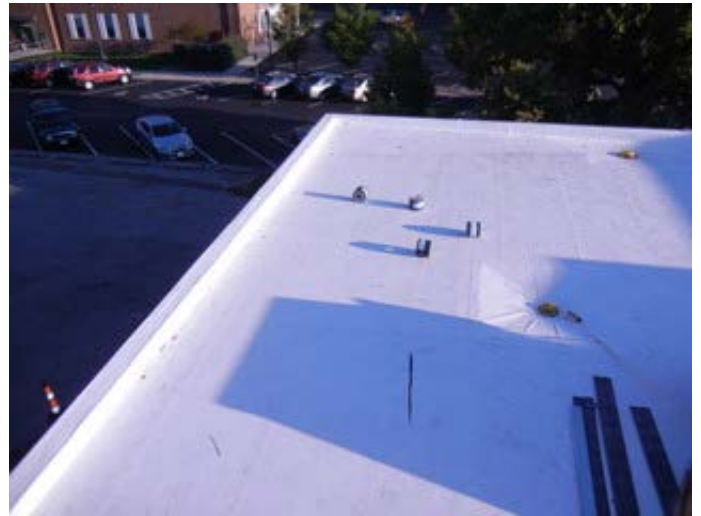
New Roof

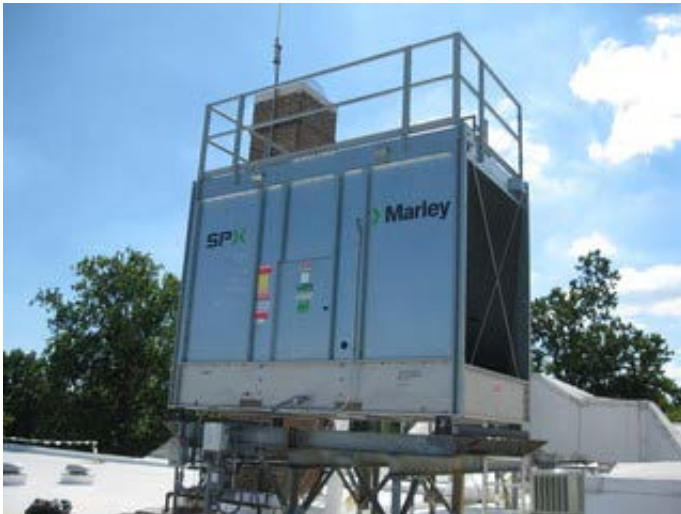
**Description:** The overall facility is equipped with a chilled water and a DX forced air central air conditioning system, which is in good-to-poor condition. The existing system for the Auditorium, Band Room, and Library utilizes rooftop units that condition the space with forced air, which is in poor condition. The existing system for the perimeter Classrooms, Main Office, Cafeteria, and Kitchen utilizes a cooling tower and chiller. The cooling tower supplies water to the chiller to make chilled water for the building, and pumps deliver the chilled water to the terminal units. The air conditioning system equipment was installed in 1995 and 2013 and is in good-to-fair condition. The ventilation system in the overall facility consists of unit ventilators and rooftop units, installed in 1995 and in fair condition, providing fresh air to Classrooms, and unit ventilators, air handlers, and rooftop units, installed in 1995 and in fair-to-poor condition, providing fresh air to other miscellaneous spaces such as Gymnasiums, Student Dining, and Media Center. Relief air venting is provided by transfer grilles to corridors. The ventilation system does not meet the Ohio Building Code 15 CFM per occupant fresh air requirement. The overall system is not compliant with Ohio Building Code and Ohio School Design Manual requirements. Dust collection systems are not required in this facility. The Art program is equipped with a kiln, and existing kiln ventilation is inadequate, and in poor condition. General building exhaust systems for Restrooms and Storage Rooms are adequately placed, and in fair condition.

Cooling Tower

**Recommendations:** Provide an air conditioning system to meet with Ohio Building Code and Ohio School Design Manual requirements. Replace general building exhaust systems located in Restrooms, Storage Rooms, and Custodial Closets. Pricing included in Item A. Replace the kiln exhaust system due to existing condition.

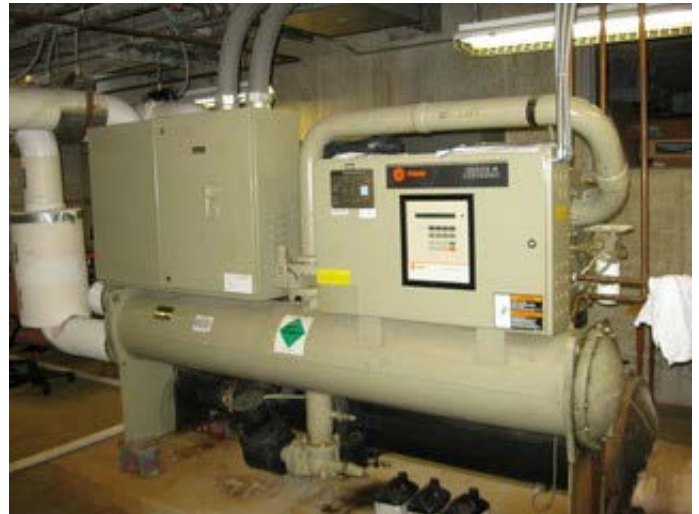
Water Cooled Chiller

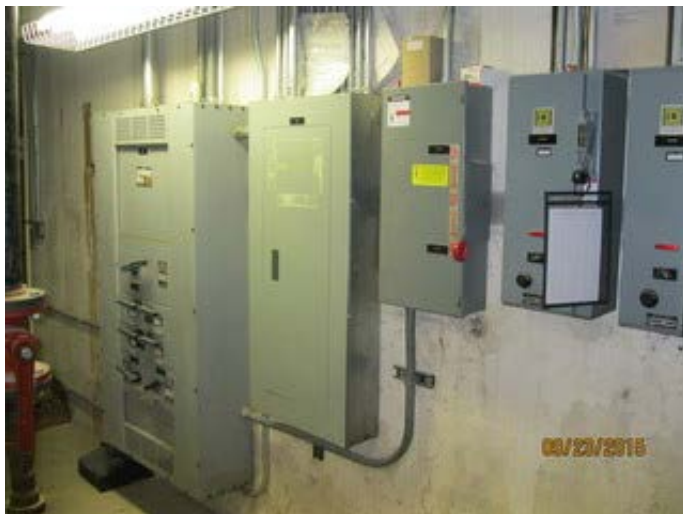
**Description:** The electrical system provided to the overall facility is a 120/208-volt, 3-phase, 4-wire, 3,000-amp system installed in exterior courtyard, and is in poor condition. Power is provided to the school by a single utility owned, pad-mounted transformer, located in exterior parking lot, and in good condition. The panel system is in good condition, and cannot be expanded to add additional capacity. The Classrooms are not equipped with adequate electrical outlets. The typical Classroom contains 16 general purpose outlets, 2 dedicated outlets for each Classroom computer, and 2 dedicated outlets for each Classroom television. Some Classrooms are equipped with as many as 18 general purpose outlets, while others are equipped with as few as 10 general purpose outlets. There are not any spaces that have no electrical outlets. The Corridors are not equipped with adequate electrical outlets for servicing. Adequate GFI protected exterior outlets are not provided around the perimeter of the building. The facility is not equipped with a suitable emergency generator. Adequate lightning protection safeguards are provided. Stage lighting power system, including control panel, breakers, and dimmers is adequately provided, in good condition, and does meet OSDM requirements. The overall electrical system does not meet Ohio School Design Manual requirements in supporting the current needs of the school, and will be adequate to meet the facility's future needs.

**Rating:** 3 Needs Replacement

Electrical Panels in Boiler Room

**Recommendations:** The entire electrical system requires work to meet Ohio School Design Manual guidelines for Classroom capacity, lack of OSDM-required features, and to facilitate the scope of work outlined in Item U. Provide additional panels, circuits and outlets, to increase capacity for Classrooms and Corridors. Provide emergency generator.

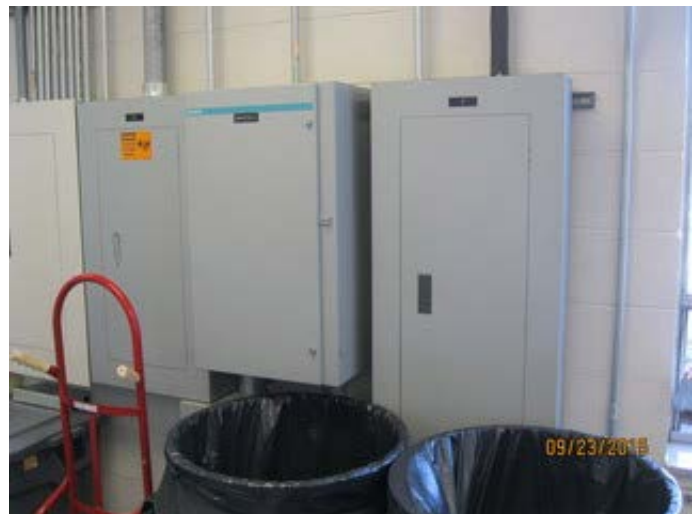
Electrical Distribution Panels

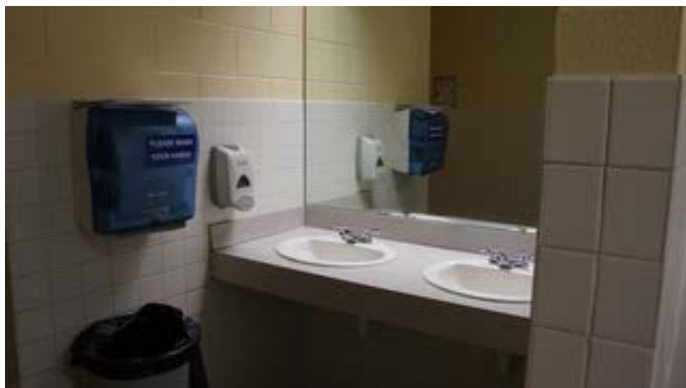
Typical Undersized Bathroom

Replace galvanized water supply piping in the original construction with copper piping. Replace sanitary waste piping in the original construction due to existing condition. Provide a new domestic hot water system. Provide a new hot water system to provide 140-degree hot water supply to the kitchen. Provide a new grease interceptor for the kitchen. To facilitate the school's compliance with OBC and OSFC fixture requirements, provide 55 new toilets / 39 new lavatories / 22 new electric water coolers / 1 new lavatory mounted type drinking fountains. See Item O for replacement of fixtures related to ADA requirements. Provide required sink mounted type drinking fountains in Special Education Classroom spaces. Provide 2 additional custodial closets and fixtures for janitorial spaces.

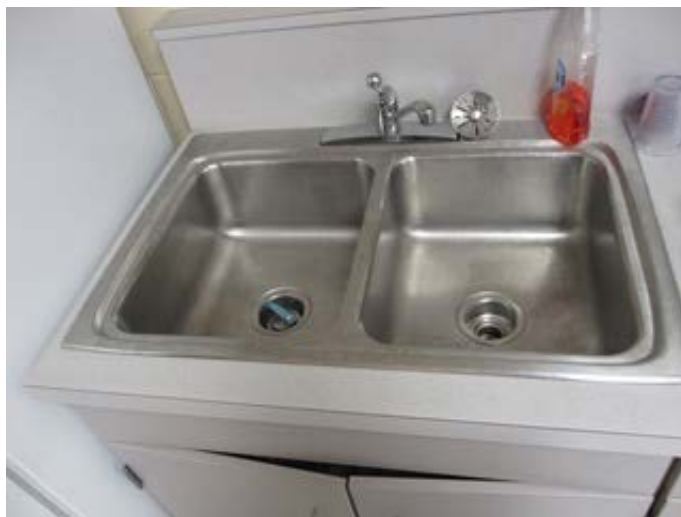
Spec. Ed. Room - Sink Without Drinking Fountain

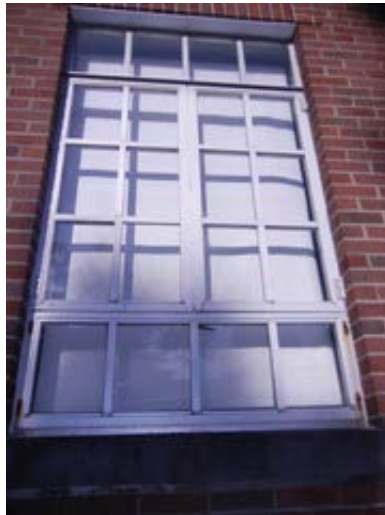
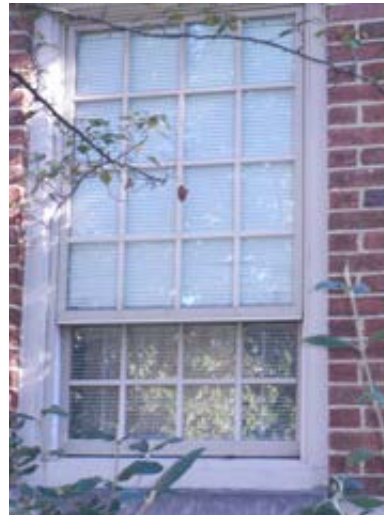
The original building is equipped with thermally broken aluminum and wood frame windows with single and double glazed type window systems, which were installed in 1991, and is in fair condition. The window system features operable windows throughout the building, operable windows are equipped with opening limiters in fair condition. Window system seals are in fair condition, with no air and water infiltration being experienced. Window system hardware is in fair condition. The windows system features some windows with integral blinds and other windows with surface mounted blinds, which are in fair condition. The 1965 addition is equipped with thermally broken aluminum frame windows with single glazed type window systems, which were installed in 1991, and is in fair condition. The window system features operable windows throughout the building, operable windows are equipped with opening limiters in fair condition. Window system seals are in fair condition, with no air and water infiltration being experienced. Window system hardware is in fair condition. The windows system features surface mounted blinds, which are in fair condition. This facility is not equipped with any curtain wall systems. There are glass block windows in the 1965 addition, in good condition. The exterior doors in the original 1939 building are equipped with wood sidelights and transoms with single pane, in fair condition. Exterior door vision panels are single pane. The exterior doors in the 1965 addition are equipped with aluminum sidelights and transoms with single pane, in fair condition. Exterior door vision panels are single pane. The building does contain one aluminum skylight in good condition. The school does contain two clerestories, and clerestory windows are in good condition. Interior glass is OSDM compliant and in good condition. Window security grilles are not provided for ground floor windows. There is not a greenhouse associated with this school.

North Facade Window

South Facade Window

Provide new insulated window system with integral blinds to meet with Ohio School Design Manual requirements.

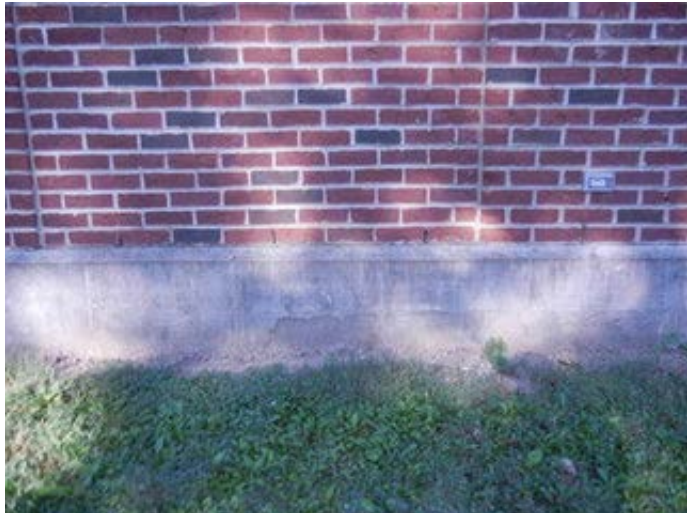
**Description:** The overall facility is equipped with concrete masonry unit foundation walls on concrete footings, which displayed no locations of significant differential settlement, cracking, or leaking, and is in good condition. No significant issues related to foundation cracking or spalling were encountered. The district reports that there has been no past leaking. No grading or site drainage deficiencies were noted around the perimeter of the structure that are contributing or could contribute to foundation / wall structural deterioration.

Base Of Wall

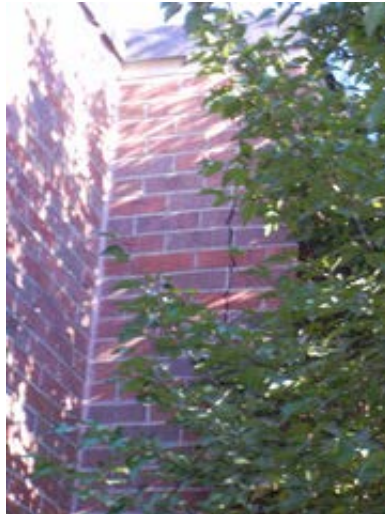
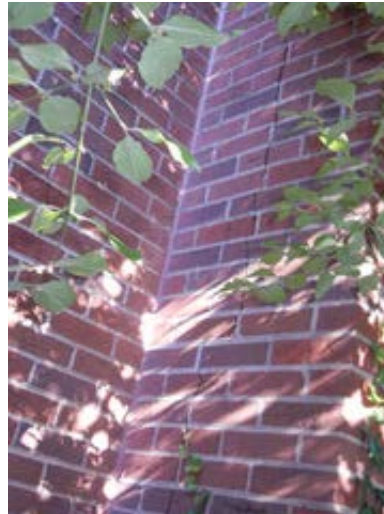
**Description:** The original 1939 building has a brick veneer on load bearing masonry wall systems, which display no locations of deterioration, and is in good condition. The 1965 addition has a brick veneer on load bearing masonry wall systems, which display no locations of deterioration, and is in good condition. The exterior masonry appears to have inappropriately spaced and adequately caulked control joints, which are in fair to poor condition. Control joints are not provided at all lintel locations, doors and windows, building corners, and wall offsets. The school does have expansion joints, and they are in fair condition. Exterior walls in the overall facility are adequately insulated. Brick veneer masonry walls are cavity walls. Weep holes are provided but not in sufficient quantity at 24"-48", at lintels, below sills, and the base of masonry cavity walls, and are in good to fair condition. Weep holes are not rope type weeps. The exterior masonry has not been cleaned or sealed in recent years and has locations of efflorescence. Interior corridors and demising walls are CMU, glazed blocks, and plaster, project full height from floor to bottom of deck, and are in good to fair condition. Interior masonry appears to have inadequately spaced control joints. The control joints that are provided are in good condition. Window sills are stone, and are in good condition. The exterior lintels are steel, there are a few that are sagging and rusting, are in good to fair condition. Chimney is in good condition. There are canopies over entrances and are steel type construction and are in fair condition. There are no exterior soffits.

Crack in Wall

**Recommendations:** Provide tuckpointing in all areas of mortar deterioration are required through the overall facility. Provided masonry cleaning, sealing, caulking as required through the overall facility. Recaulk existing control joints. Prep and paint exposed steel lintels that are sagging and rusting.

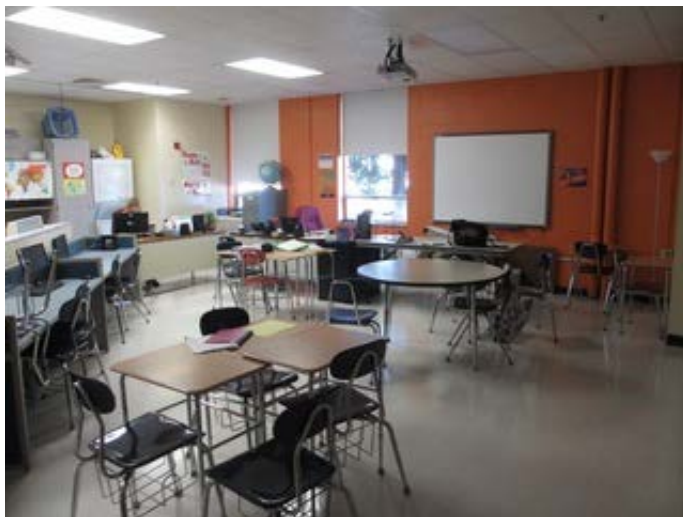
The Original Building features conventionally partitioned Classrooms with VCT or carpet tile type flooring, 2x4 ACT type ceilings, as well as painted CMU and gypsum board type wall finishes, and they are in good condition. Corridors have terrazzo type flooring, 2x4 ACT type ceilings, as well as painted CMU, gypsum board and plaster type wall finishes, and they are in good condition. Restrooms feature ceramic tile type flooring, gypsum board type ceilings, and ceramic tile type wall finishes, and they are in good condition. Toilet partitions are metal, and are in fair condition. Classroom casework in the overall facility is wood type construction with plastic laminate tops, is inadequately provided, and in fair to poor condition. The typical Classroom contains 11 lineal feet of casework, and Classroom casework provided ranges from 5 to 18 feet. Classrooms are provided adequate chalkboards, markerboards, and tackboards which are in good condition. The lockers, located in the Corridors, are adequately provided, and in good condition. The Art program is equipped with a kiln in good condition, and existing kiln ventilation is adequate. The facility is equipped with wood louvered and non-louvered interior doors that are both flush mounted and recessed, mostly with proper ADA hardware and clearances, and in poor condition. The Gymnasium space has athletic wood type flooring, open type ceilings, as well as painted CMU type wall finishes, and they are in good condition. Wood Gymnasium flooring has been well maintained, will accommodate a few more future sandings and refinishings, and is rated at a median stage of its product lifecycle. Gymnasium telescoping stands are plastic type construction in good condition. Gymnasium basketball backboards are electrically operated type, and are in good condition. The Media Center, located in the 1965 Addition, has carpet tile type flooring, open exposed with tectum tile type ceilings, as well as painted brick and gypsum board type wall finishes, and they are in good to fair condition, as the paint will need touching up in the near future. Student Dining, located in the 1965 Addition, has VCT type flooring, 2x4 ACT type ceilings, as well as painted CMU type wall finishes, and they are in good condition. OSDM-required fixed equipment for Stage is adequately provided, and in good condition. Existing Gymnasium, Student Dining, Media Center and Music spaces are inadequately provided with appropriate sound attenuation acoustical surface treatments. The existing Kitchen is full service, is undersized based on current enrollment, and the existing Kitchen equipment, installed in 1989, is in fair condition. The Kitchen hood is in fair condition, and the required 6" overhang on all three exposed sides of the cooking equipment is provided by the hood. Walk-in freezers and coolers are located within the Kitchen spaces and are in fair condition.

Typical Classroom Finishes

Provide for the complete replacement of finishes and casework as well as kitchen equipment.

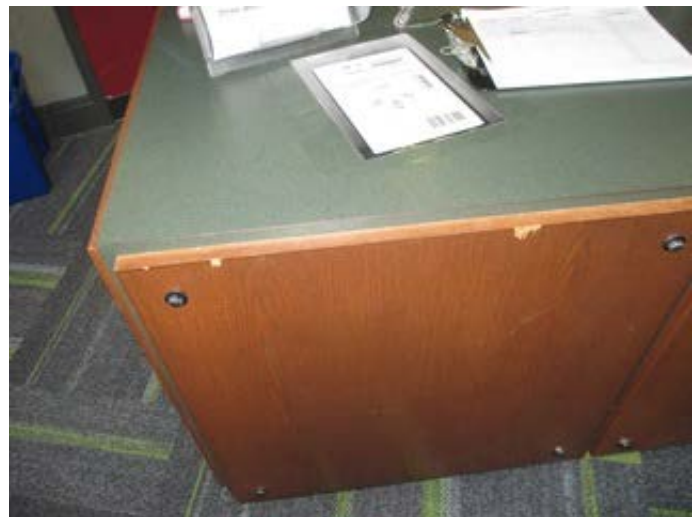
Chips In Casework Finishes

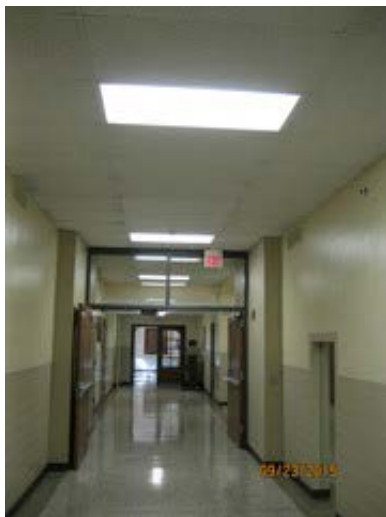
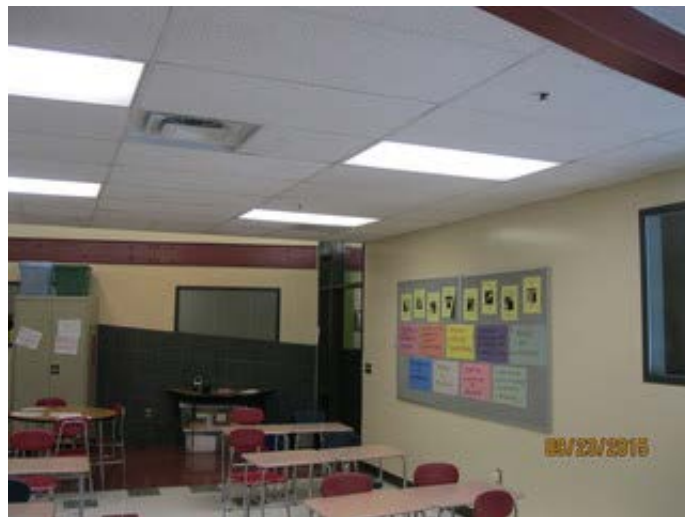
The typical Classrooms in the overall facility are equipped with T-8 lay-in 2x4 fluorescent fixtures with dual level switching. Classroom fixtures are in good condition, providing an average illumination of 60 FC, thus complying with the 50 FC recommended by the OSDM. The typical Corridors in the overall facility are equipped with T-8 lay-in 2x4 fluorescent fixtures with single level switching. Corridor fixtures are in good condition, providing an average illumination of 14 FC, which is less than the 20 FC recommended by the OSDM. The Primary Gymnasium spaces are equipped with pendant T-8 2x4 mount fluorescent fixture type lighting, in good condition, providing an average illumination of 86 FC, thus complying with the 50 MS FC recommended by the OSDM. The Media Center is equipped with indirect fluorescent fixture type lighting in good condition, providing an average illumination of 148 FC, thus complying with the 50 FC recommended by the OSDM. The Student Dining spaces are equipped with lay-in 2x4 T-8 fluorescent fixture type lighting with multi-level switching. Student Dining fixtures are in good condition, providing an average illumination of 104 FC, thus complying with the 50 FC recommended by the OSDM. The Kitchen spaces are equipped with 2x4 surface mount T-8 fluorescent fixture type lighting with single level switching. Kitchen fixtures are in good condition, providing an average illumination of 78 FC, thus complying with the 75-80 FC recommended by the OSDM. The Service Areas in the overall facility are equipped with 1x4 suspended and surface mount T-8 fluorescent fixture type lighting in good condition. The typical Administrative spaces in the overall facility are equipped with lay-in 2x4 T-8 fluorescent fixture type lighting in good condition, providing adequate illumination based on OSDM requirements. The overall lighting systems of the facility are not compliant with Ohio School Design Manual requirements due to age and condition, inadequate lighting levels, and lack of multi-level switching.

Corridor Lighting

Classroom Lighting

Provide complete replacement of lighting system due to lighting levels, lack of multi-level switching, and installation of systems outlined in Item U.

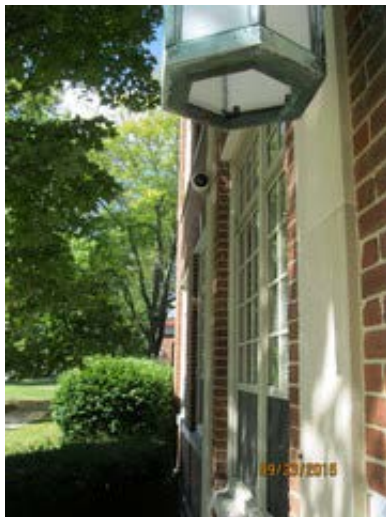
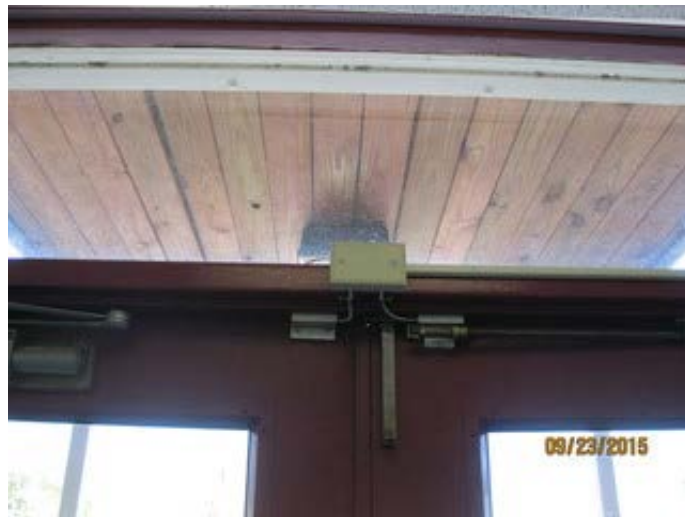
**Description:** The overall facility contains a Security Command motion detector, intrusion, and door contact type security system in good condition. Motion detectors are adequately provided in main entries, central gathering areas, offices, main Corridors, and spaces where 6 or more computers are located. Exterior doors are equipped with door contacts. An automatic visitor control system is not provided. Compliant color CCTV cameras are not provided at main entry areas, parking lots, central gathering areas, and main Corridors. CCTV is not monitored in Administrative Area. A compliant computer controlled access control system integrating alarms and video signals, with appropriate UPS backup, is not provided. The system is equipped with card readers. The security system is not adequately provided throughout, and the system is not compliant with Ohio School Design Manual guidelines. The exterior site lighting system is equipped with surface mounted HID entry lights in good condition. Pedestrian walkways are illuminated with wall mounted fixtures in good condition. Parking and bus pick-up / drop off areas are not illuminated. The exterior site lighting system provides inadequate illumination due to insufficient fixture capacity and sparse placement of fixtures.

Access Control Camera at Main Door

Door Contacts for Security System

**Recommendations:** Provide new security system and exterior site lighting to meet Ohio School Design Manual guidelines.

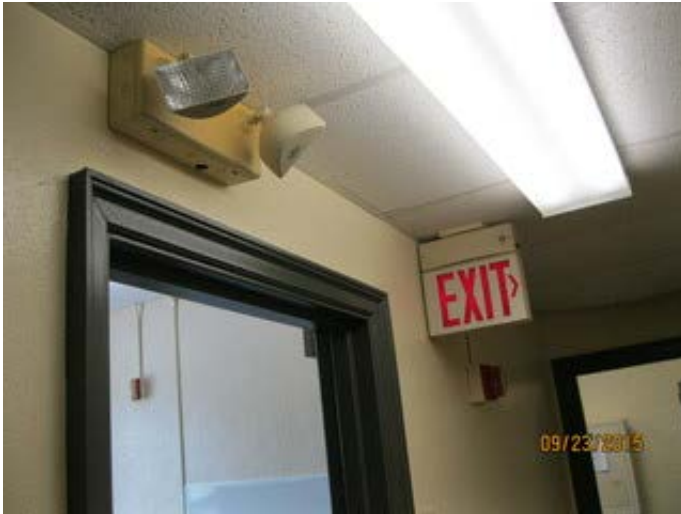
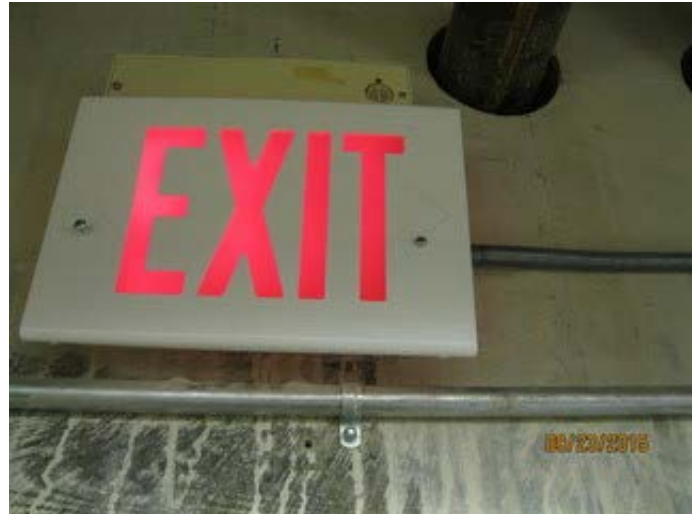
**Description:** The overall facility is equipped with an emergency egress lighting system consisting of non-compliant plastic construction, as well as OSDM compliant red lettered, LED illuminated exit signs, and the system is in good condition. The facility is equipped with emergency egress floodlighting, and the system is in good condition. The system is provided with appropriate battery backup. The system is adequately provided throughout, and does not meet Ohio School Design Manual and Ohio Building Code requirements.

Battery Pack / Exit Sign

Exit Sign in Boiler Room

**Recommendations:** Provide complete replacement of emergency / egress lighting system to meet Ohio School Design Manual and Ohio Building Code guidelines in conjunction with work in Item U.

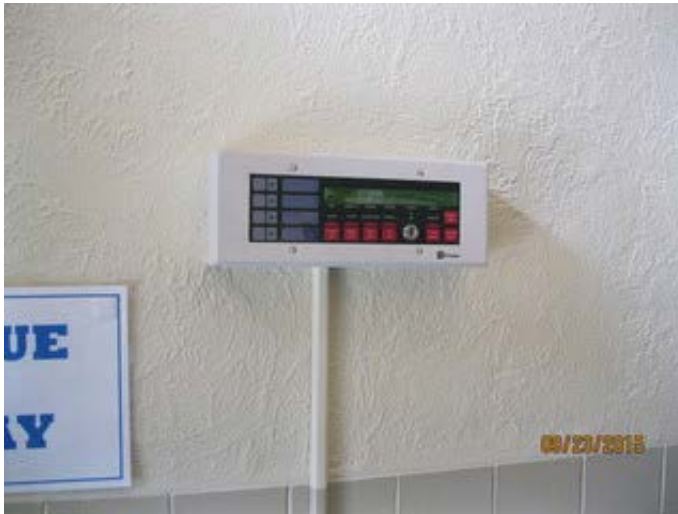
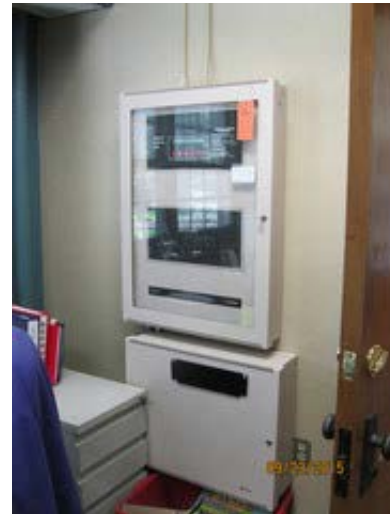
**Description:** The overall facility is equipped with a Simplex type fire alarm system in good condition, consisting of manual pull stations, bells, and horn and strobe indicating devices. The system is automatic and is monitored by a third party. The system is equipped with sufficient audible horns, strobe indicating devices, flow switches, and tamper switches. The system is not equipped with sufficient smoke detectors or heat sensors. The system thus will support future fire suppression systems. The system is adequately provided throughout, and does not have additional zone capabilities. The system is not fully compliant with Ohio Building Code, NFPA, and Ohio School Design Manual requirements.

Fire Alarm Remote Annunciator

Fire Alarm Control Panel

**Recommendations:** Provide complete replacement of the fire alarm system to meet OBC, NFPA, and Ohio School Design Manual guidelines.

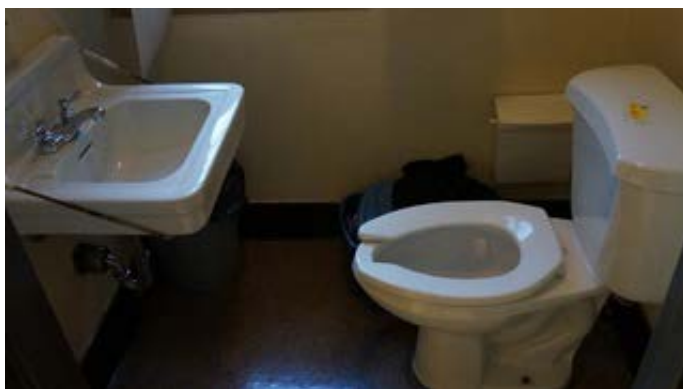
Non-ADA Health Clinic Bathroom

Provide ADA-compliant signage. Provide ADA-compliant showers. Re-mount mirrors that are not ADA-compliant. See section P for additional fixtures required. Replace any remaining non-compliant door hardware in the original facility and in the 1965 addition to facilitate the school's meeting of ADA requirements. Parking issues are corrected in Item P. An additional power assist door could be added to the front entrance in addition to a renovated ramp for more convenient accessible access direct to the main office.

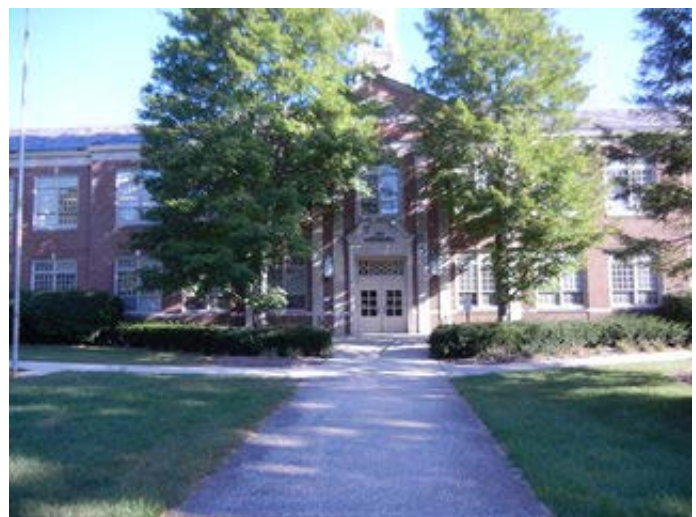
Main Entrance - Non-ADA Ramp, No Door Assist

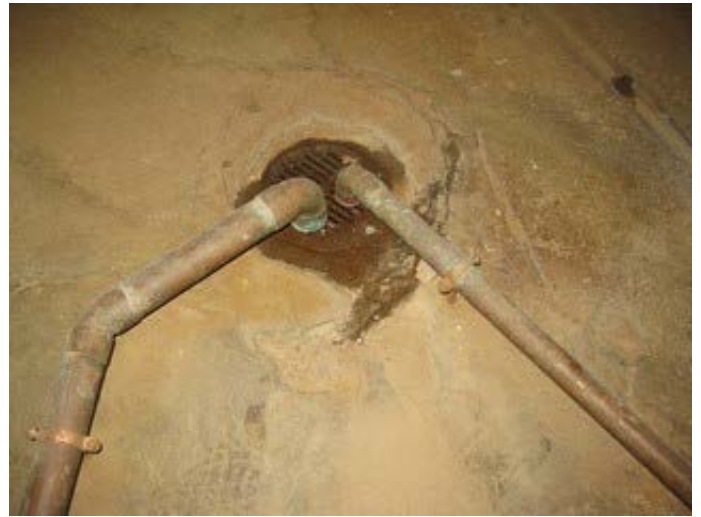
Exposed Waste in Boiler Room

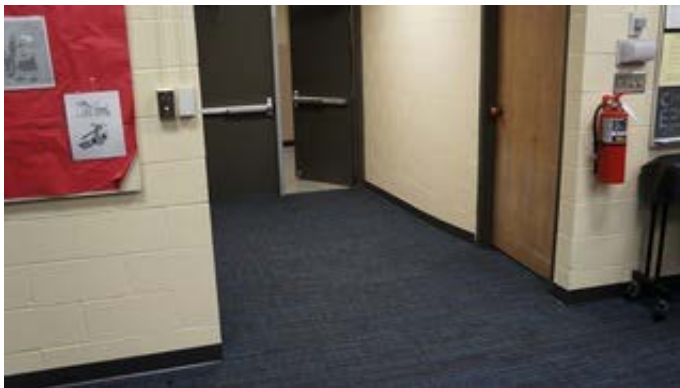
Carpet Over Potential Hazardous Flooring

**Recommendations:** Remove all hazardous materials, inclusive of asbestos-containing materials in the 1939 Original Construction and the 1965 Addition, as noted in the attached AHERA Three Year Reinspection Report. Provide for disposal of fluorescent lighting.

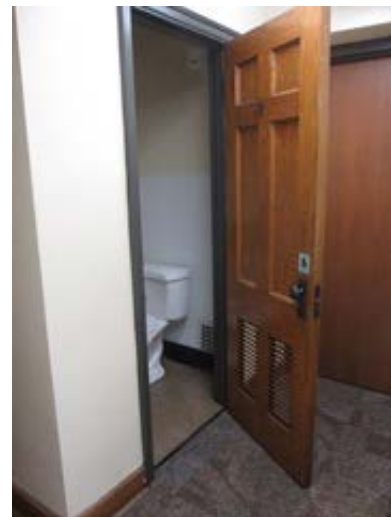
Hazardous Tile Material

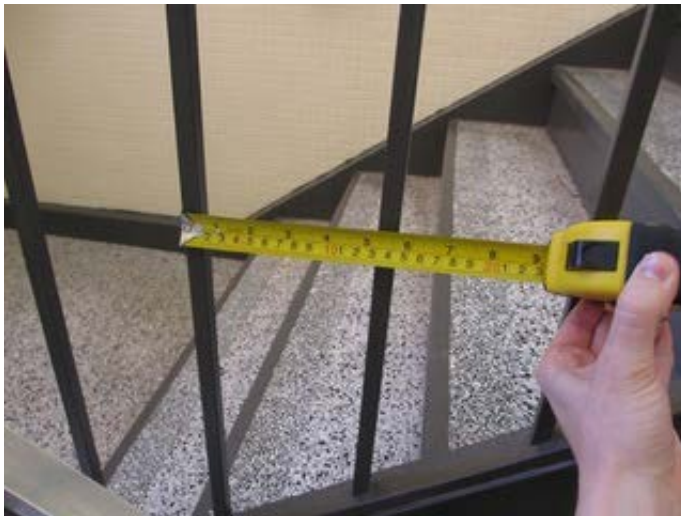
Guard rails do not meet the 4 inch ball test

Provide new emergency generator, with funding provided via complete replacement of electrical system in Item D. Provide new handrails to meet the requirements of the Ohio Building Code. Rework existing non-compliant stair towers. Provide fire-rated enclosure around existing stair tower.

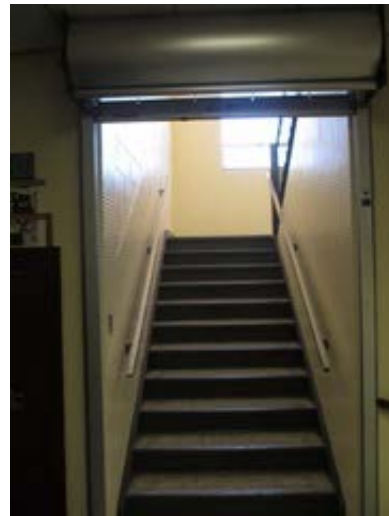
Stairwells are not protected by a fire-rated enclosure

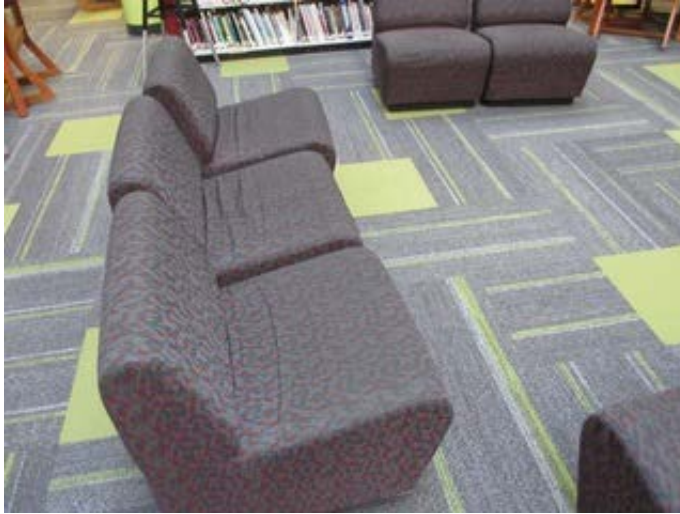
Soft seating near the end of product life

**Recommendations:** Provide for replacement of outdated or inadequate furnishings.

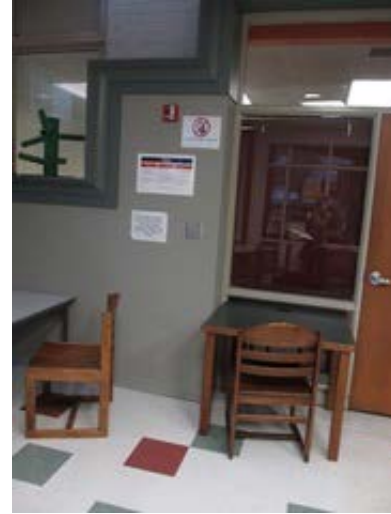
Outdated and mismatched furnishings
