**Building Information - Worthington City (45138) - Linworth Campus Alternative Program**

Program Type	Assessment Only
Setting	Suburban
Assessment Name	Linwoth Alternative Program (DRAFT)
Assessment Date (on-site; non-EEA)	2015-11-19
Kitchen Type	No Kitchen
Cost Set:	2015
Building Name	Linworth Campus Alternative Program
Building IRN	
Building Address	2075 W. Dublin-Granville Road
Building City	Worthington
Building Zipcode	43085
Building Phone	(614)450-6900
Acreage	4.46
Current Grades:	9-12
Teaching Stations	11
Number of Floors	2
Student Capacity	192
Current Enrollment	177
Enrollment Date	2015-10-05
Enrollment Date is the date in which the current enrollment was taken.	
Number of Classrooms	8
Historical Register	<b>NO</b>
Building's Principal	Chris Hasebrook
Building Type	High

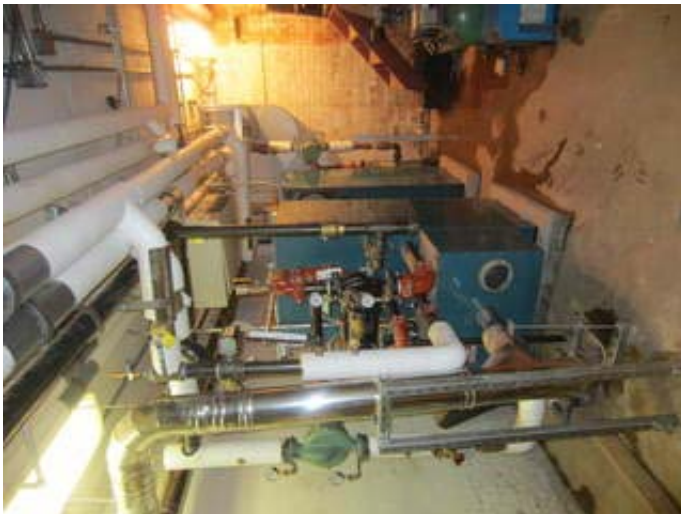
The existing system for the 1918 Original Construction is a natural gas fired heated water boiler type system, installed in 1918 with recent upgrades, and is in fair condition. The system in the 1994 Addition is an extension of that found in the 1918 Original Construction. The heating and chilled water system in the overall facility is a 4-pipe system, with a capacity for simultaneous heating and cooling operation, which is compliant with the OSDM requirements for basic system type. The two water boilers, manufactured by Thermal Solutions, were installed in 2015 and are in good condition. Heating water is distributed to terminal units consisting of unit ventilators, cabinet heaters, unit heaters, and air handlers. The terminal equipment is original to each addition and is in fair condition. The system does not appear to fully comply with the 15 CFM per person fresh air requirements of the Ohio Building Code mechanical code and Ohio School Design Manual. The Automated Logic DDC type system temperature controls were installed in 2009 and are in good to fair condition. The system does feature individual temperature controls in all spaces required by the OSDM. The overall system does not feature any central energy recovery systems. The facility is not equipped with louvered interior doors to facilitate Corridor utilization as return air plenums. The existing system is ducted, except for the Classroom and Corridors of the overall facility, but the ductwork cannot be integrated into a possible future system due to arrangement, air volume, and routing of existing ductwork. The existing system in the remainder of the overall facility is not ducted, and floor to structural deck heights will accommodate the installation of properly sized ductwork for a future Ohio School Design Manual approved system. The overall heating system is evaluated as not being in safe and efficient working order, and long term life expectancy of the existing system is not anticipated. The structure is equipped with central air conditioning. The site does not contain underground fuel tanks.

Natural Gas Fired Heated Water Boiler

Provide new overall heating, ventilating, and air conditioning system to achieve compliance with Ohio Building Code and Ohio School Design Manual standards. Convert the Classrooms and Corridors of the overall facility to ducted system to facilitate efficient exchange of conditioned air. Replace existing ductwork in the remainder of the overall facility to facilitate efficient exchange of conditioned air.

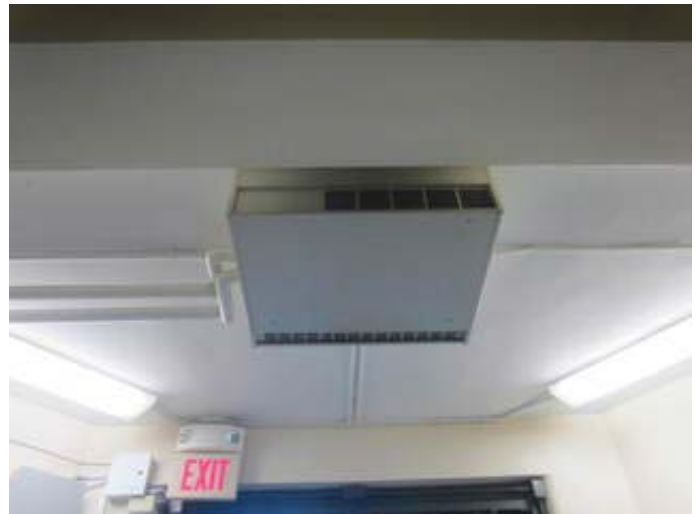
Heating Water Cabinet Heater

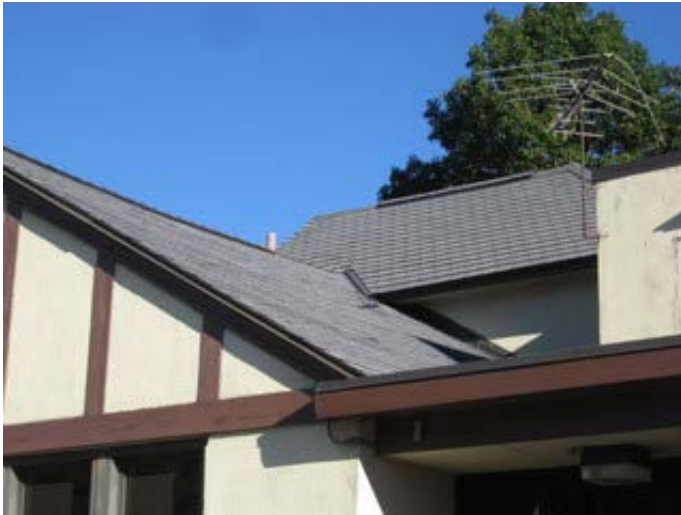
**Description:** The roof over the 1918 Original Construction has a shingle system that was installed in 2001, and is in fair condition and a membrane system that was installed in 1997, in fair condition. The roof over the 1994 Addition is a membrane system that was installed at the time of construction, and is in fair condition. There are no District reports of current leaking. No Signs of past leaking were observed during the physical assessment. Access to the roof was not available. Provide roof access hatches / ladders as appropriate to facilitate access to all levels of low slope roof surfaces. Fall safety protection cages are required, are not provided. There were no observations of standing water on the roof. Metal cap flashings are in fair condition. Roof storm drainage is addressed through a system of gutters and downspouts, through-wall scuppers which are properly located, and in fair condition. The roof is not equipped with overflow roof drains though they are not required. No problems requiring attention were encountered with any roof penetrations. There are not any covered walkways attached to this structure.

Shingle Roof

**Recommendations:** The flashing and / or coping on the overall facility require replacement due to condition. Funding for flashing and coping replacement is provided for in the complete replacement of roof. Due to existing conditions gutters and downspouts require replacement. Remove and replace existing shingle roofing due to age and condition. Remove and replace existing membrane roofing due to age and condition. Provide roof access hatch and fall protection cage as required.

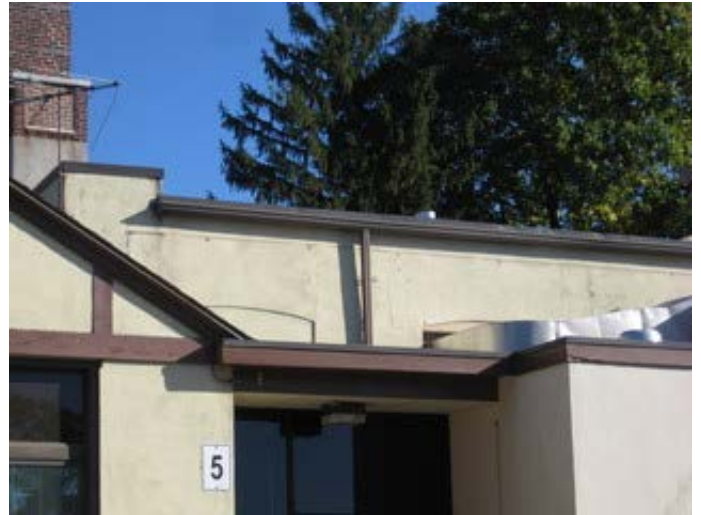
Flashing at Low Slope Membrane Roof

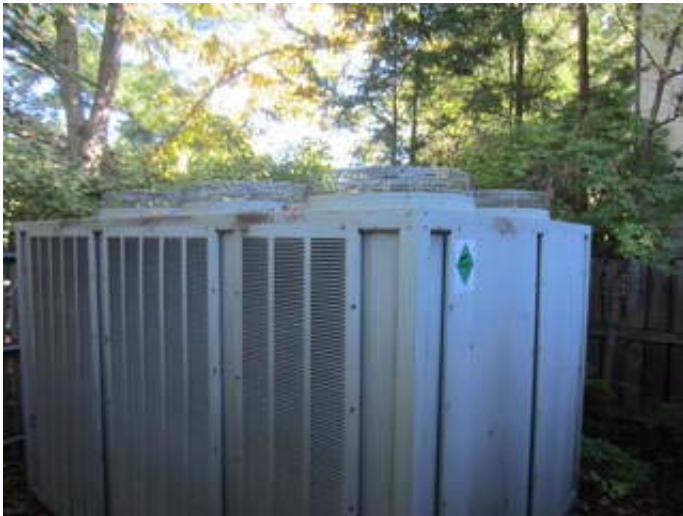
**Description:** The overall facility is equipped with a chilled water type central air conditioning system, which is in fair to poor condition. The system consists of a single pad mounted Trane air cooled liquid chiller unit, in fair condition, with multiple pumps located in the Mechanical Room. The facility is not equipped with any window units. An isolated room systems consisting of Mitsubishi ductless split system is provided in the Computer Lab location. An isolated room systems consisting of ducted split system, with the condensing unit pad mounted outside the facility, is provided in the provided in Administrative Offices location. The ventilation system in the overall facility consists of unit ventilators, original to each addition and in fair condition, providing fresh air to Classrooms, and air handlers, original to each addition and in fair condition, providing fresh air to other miscellaneous spaces such as Gymnasiums, Student Dining, and Media Center. Relief air venting is provided by ceiling plenums, central relief fans, fresh air exchangers, and air handlers. The ventilation system does not appear to fully meet the Ohio Building Code 15 CFM per occupant fresh air requirement. The overall system is not compliant with Ohio Building Code and Ohio School Design Manual requirements. Dust collection systems are not required in this facility. The Art program is not equipped with a kiln. General building exhaust systems for Restrooms, Storage Rooms, Art Rooms, and Custodial Closets are inadequately placed, and in fair condition.

Air Cooled Chiller

**Recommendations:** Provide an air conditioning system to meet with Ohio Building Code and Ohio School Design Manual requirements. Replace general building exhaust systems located in Restrooms, Storage Rooms, and Custodial Closets. Pricing included in Item A. Provide a new kiln ventilation/exhaust system.

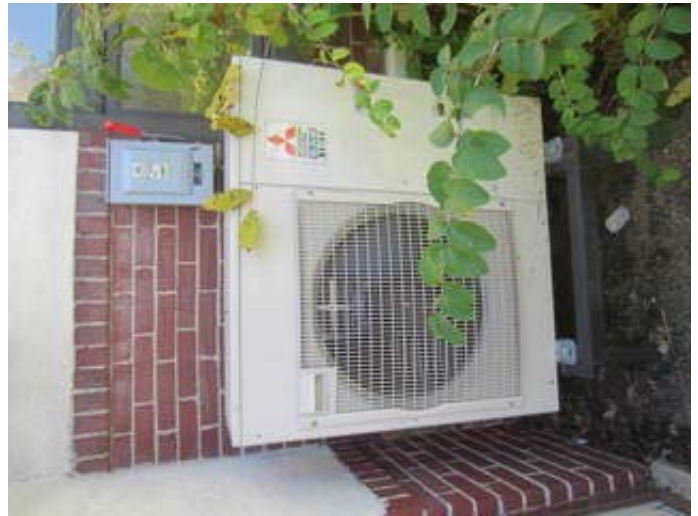
Mini-Split AC Unit

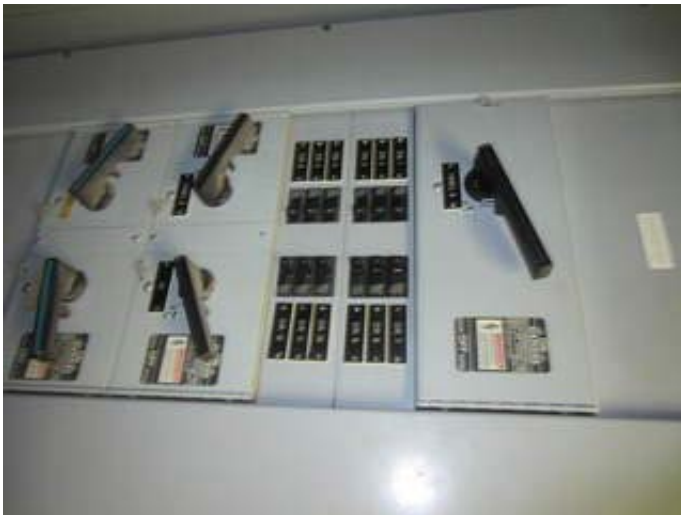
**Description:** The electrical system provided to the 1918 Original Construction is a 120/240 volts, 400 amp, 1 phase and 3 wire system installed in 1918 with upgrades in 1994, and is in fair condition. The system in the 1994 Addition is an extension of that found in the 1918 Original Construction. Power is provided to the school by a single utility owned, pad-mounted transformer located near the street, and in fair condition. The Siemens panel systems, original to each addition, are in fair condition, and for the most part cannot be expanded to add additional capacity. The Classrooms are equipped with adequate electrical outlets. The typical Classroom contains five (5) general purpose outlets, zero (0) dedicated outlets for each Classroom computer, and one (1) dedicated outlet for each Classroom television. Some Classrooms are equipped with as many as six (6) general purpose outlets, while others are equipped with as few as three (3) general purpose outlets. There are not any spaces that have no electrical outlets. The Corridors are not equipped with adequate electrical outlets for servicing. Adequate GFI protected exterior outlets are not provided around the perimeter of the building. The facility is not equipped with an emergency generator. Adequate lightning protection safeguards do not appear to be provided. The existing facility is not equipped with a Stage. The overall electrical system does not fully meet Ohio School Design Manual requirements in supporting the current needs of the school, and will be inadequate to meet the facility's future needs.

Main Electrical Distribution Panel

**Recommendations:** The entire electrical system requires replacement to meet Ohio School Design Manual guidelines for overall capacity and due to age, condition, lack of OSDM-required features, and to accommodate the addition of an air conditioning system. Provide an emergency generator, with funding included in the electrical system replacement. Provide adequate lightning protection safeguards in the overall facility, including associated grounding system, with funding included in the electrical system replacement.

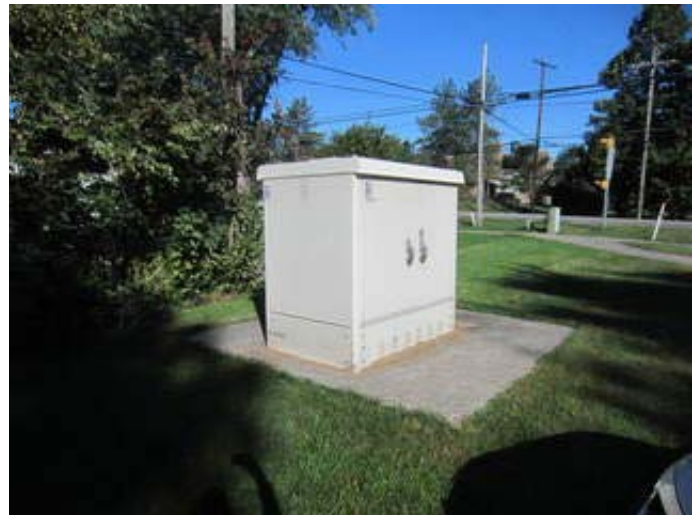
Pad Mounted Transformer

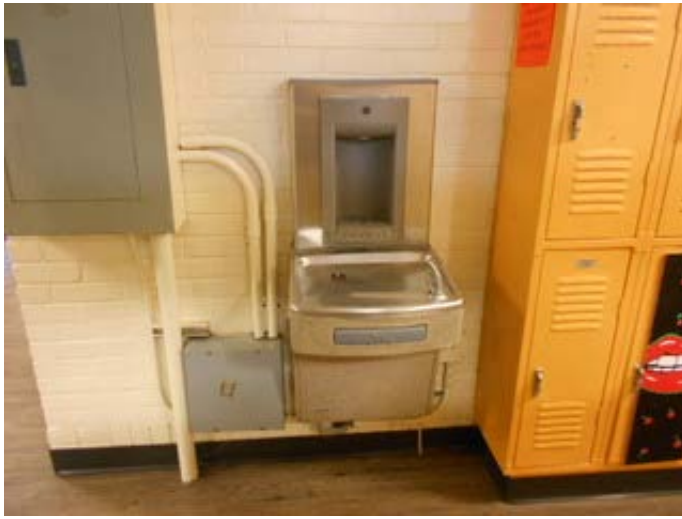
The service entrance is not equipped with a reduced pressure back flow preventer. A water treatment system is not provided, though none is needed. The domestic water supply piping in the overall facility is copper, was installed in 1994, and is in good condition. The waste piping in the overall facility is cast iron and PVC, is original to each addition, and is in fair condition for the cast iron and good condition for the PVC. The facility is equipped with a 75 gallon gas water heater in good condition. The school contains 1 Large Group Restroom for boys, 1 Large Group Restroom for girls, 0 Locker Room Restrooms for boys, 0 Locker Room Restrooms for girls, 0 Restrooms associated with Specialty Classrooms, and 0 Restrooms for staff. Boys' Large Group Restroom contains 1 ADA and 1 non-ADA wall mounted flush valve toilets, 0 ADA and 1 non-ADA wall mounted flush valve urinal, as well as 1 ADA and 1 non-ADA wall mounted lavatories. Girls' Large Group Restroom contains 1 ADA and 2 non-ADA wall mounted flush valve toilets, as well as 1 ADA and 1 non-ADA wall mounted lavatories. Staff utilize same Restrooms as students. Condition of fixtures is good. The facility is equipped with 0 ADA and 0 non-ADA drinking fountains, as well as 2 ADA and 0 non-ADA electric water coolers, in good to fair condition. No designated Special Education Classrooms are present on site; no Classroom sinks with deck mounted bubblers are required. No designated Special Education Classroom, Kitchen, or Clinic is present on site. Due to existing grade configuration, Kindergarten / Pre-K Classroom Restroom considerations are not relevant. The school does meet the OBC requirements for fixtures with the exception of one urinal. Relative to LEED requirements, the school is not equipped with low flow type fixtures. Per OBC and OSDM requirements this facility should be equipped with 4 toilets, 2 urinals, 4 lavatories, 0 Classroom sink mounted drinking fountains, and 1 electric water cooler. Observations revealed that the school is currently equipped with 5 toilets, 1 urinal, 4 lavatories, 0 Classroom sink mounted drinking fountains, and 2 electric water coolers. ADA requirements are not met for fixtures and drinking fountains (see Item O). Science Classroom is equipped with required utility sinks, gas connections, and hood, but is not equipped with an emergency shower/eyewash and compressed air connections. Existing fixtures and hood are in good condition. Science Classroom is not equipped with an acid waste system and neutralization tank. Custodial Closets are properly located and are adequately provided with required service sinks or floor drain sinks, which are in good condition. Adequate exterior wall hydrants are not provided.

Electric Water Cooler

Replace remaining cast iron waste piping through the overall facility. Provide a reduced pressure back flow preventer. To facilitate the school's compliance with OBC and OSFC fixture requirements, provide 1 new urinal in Boys Restroom. Due to age and condition, replace 1 wall mounted electric water cooler. Provide Science Classroom with 8 compressed air connections and 1 emergency shower/eyewash station. Provide 1 point of use under-counter 5 gallon acid neutralization tank at the Teacher's Prep sink. Due to age, condition, LEED, OBC, and OSFC, replace 19 faucets and valves throughout the overall facility. All fixtures, whether new or replaced, to be mounted at ADA compliant heights. Provide 2 additional exterior wall hydrants throughout the overall facility. See Item O for replacement of fixtures related to ADA requirements.

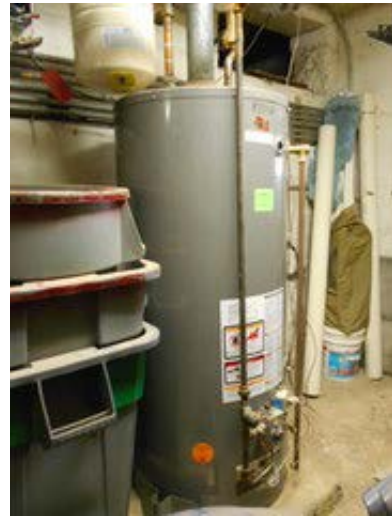
Water Heater

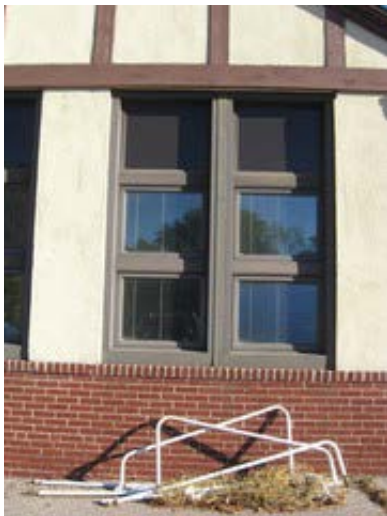
**Description:** The overall facility is equipped with thermally broken aluminum clad wood frame windows with double glazed insulated glazing type window system, which was installed on an unknown date but likely during a major renovation in 1999, and are in fair condition. The window system features operable windows throughout the building, and operable windows are not equipped with opening limiters and are equipped with insect screens in good condition. Window system seals are in good condition, with no air and water infiltration being experienced. Window system hardware is in good condition. The window system features integral and surface mounted blinds, which are in good condition. This facility is not equipped with any curtain wall systems. This facility does not feature any glass block windows. The exterior doors in the 1994 Addition are equipped with thermally broken aluminum frame sidelights and transoms with tempered double glazed insulated glazing in fair condition. Exterior door vision panels are tempered single pane. The school does not contain skylights. The school does contain 4 aluminum-clad wood frame clerestories, and clerestory windows are in fair condition. Interior glass is OSDM compliant. Window security grilles are not provided for ground floor windows. There is not a Greenhouse associated with this school.

Wood Clad Windows

**Recommendations:** Provide a new insulated window system with integral blinds to meet with Ohio School Design Manual requirements. Replacement of storefront aluminum door frames and glazing is provide in Item S.

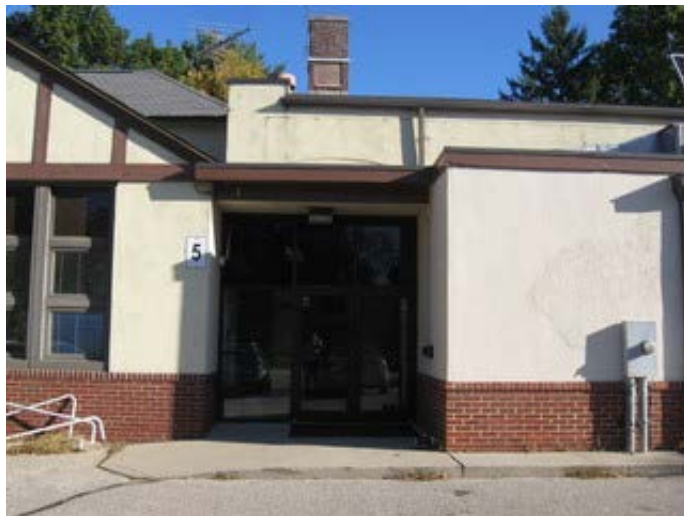
Aluminum Storefront

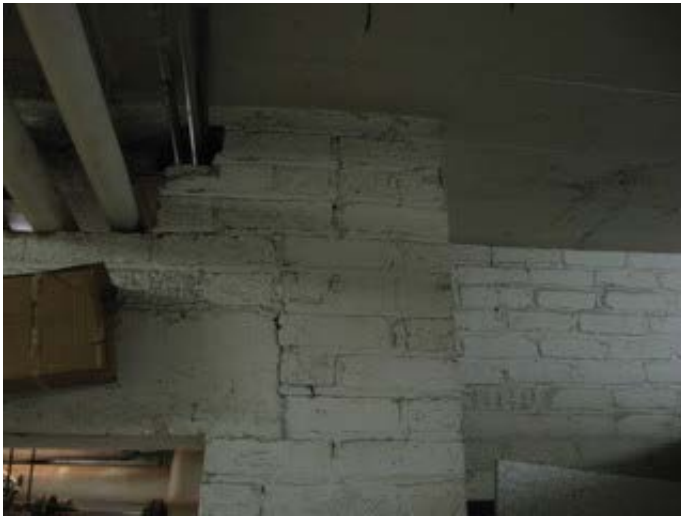
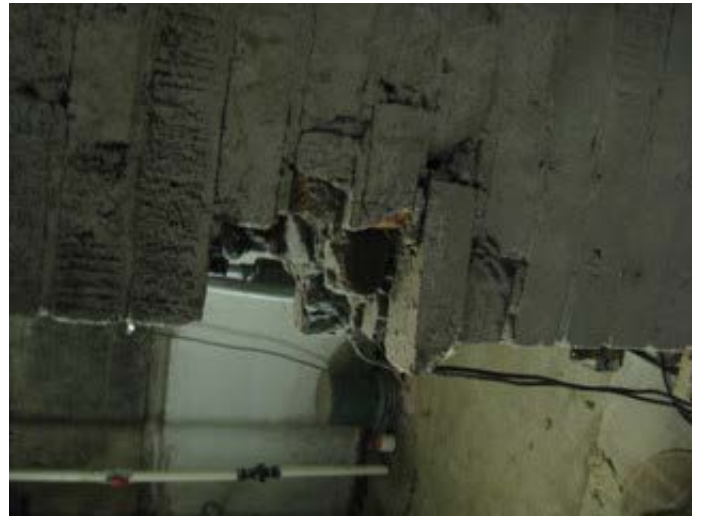
**Description:** The 1918 Original Construction is equipped with brick foundation walls on concrete footings, which displayed locations of significant differential settlement, cracking, or leaking, and are in poor condition. The 1994 Addition is equipped with concrete masonry unit foundation walls on concrete footings, which displayed no locations of significant differential settlement, cracking, or leaking, and are in good condition. Areas of minor cracking and spalling were observed through the 1918 Original Construction. The District reports that there has been past leaking in the basement and was observed during physical assessment. No grading or site drainage deficiencies were noted around the perimeter of the structure that are contributing or could contribute to foundation / wall structural deterioration.

1918 Brick Foundation

**Recommendations:** Provide sprayed on waterproofing system in the 1918 Original Construction. Provide drainage tile system at perimeter of the 1918 Original Construction due to leaking. Repair areas of cracking and spalling through the 1918 Original Construction.

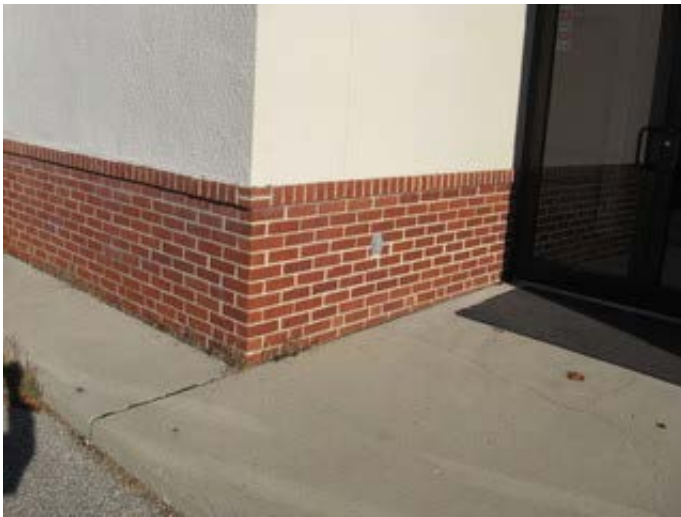
**Description:** The overall facility has a brick veneer wainscot with stucco on wood frame which displayed no locations of deterioration, and is in good condition. The exterior masonry appears to have appropriately spaced and adequately caulked control joints in fair condition. Control joints are not provided at lintel locations, at doors and windows, building corners, and wall offsets though are not needed. The school does not contain expansion joints and none are needed, as there is no indication of exterior masonry cracking or separation. Exterior walls in the overall facility are adequately insulated. Weep holes and vents are not provided or required. The exterior masonry has been cleaned and sealed in recent years, showing no evidence of mortar deterioration. Architectural exterior accent materials consist of metal and wood trim, in good condition. Exterior building fenestration in the overall facility represents 24% of the exterior surfaces. Interior Corridor and demising walls are wood framed partitions with plaster, project full height from floor to bottom of deck, and are in fair condition. Interior masonry appears to have adequately spaced and caulked control joints in fair condition. Interior soffits are of plaster type construction, and in fair condition. The window sills are brick and stucco and are in good condition. The exterior lintels are wood, and are covered by stucco. Chimney is in fair condition. Exterior soffits are of lay-in tile type construction, and in good condition. The school is not equipped with a loading dock.

Brick Wainscot and Stucco Wall

**Recommendations:** Provide tuckpointing, cleaning, and sealing on masonry chimney.

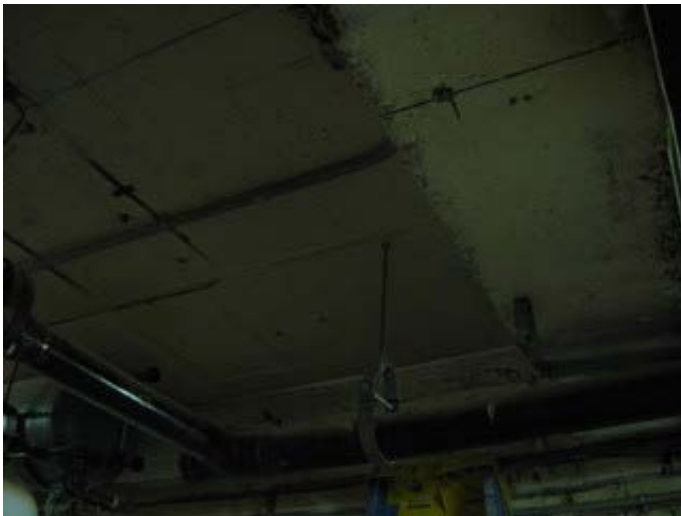
**Description:** The floor construction of the base floor of the 1918 Original Construction is cast-in-place concrete and brick floor type construction, and is in fair condition. Crawl space is located under the Classroom section of the facility. The floor construction of the base floor of the 1994 Addition is concrete slab on grade type construction, and is in fair condition. There is no crawl space. The floor construction of the first floor of the 1918 Original Construction is cast-in-place concrete type construction, and is in fair condition. The floor construction of the second floor of the 1918 Original Construction is wood frame type construction, and is in fair condition. There are no intermediate floors in the 1994 Addition. This is a single story structure. Ceiling to structural deck spaces are sufficient to accommodate HVAC, electrical, and plumbing scopes of work in required renovations. The roof construction of the 1918 Original Construction is wood frame type construction, and is in fair condition. The roof construction of the 1994 Addition is metal deck on steel joist type construction, and is in fair condition.

Cast-in-Place Floor Framing

**Recommendations:** Provide fire separation assembly at roof framing. Refer to Item A for funding of architectural soffits to accommodate HVAC, electrical, and plumbing scopes of work.

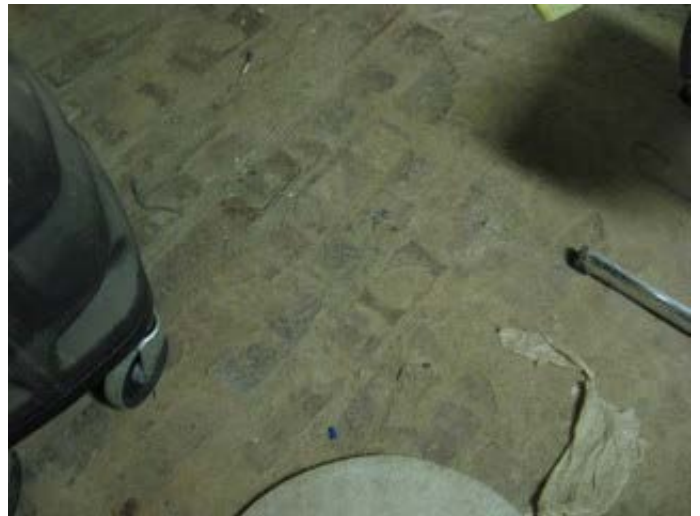
Brick Floor

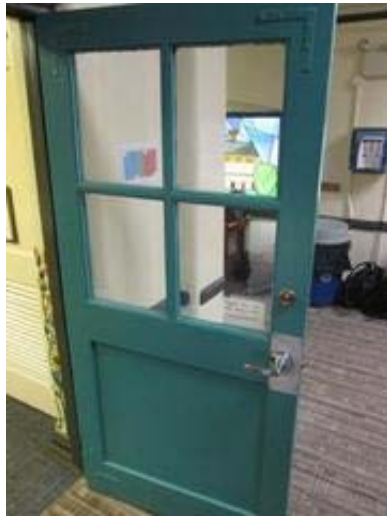
Typical Classroom Door

Provide for replacement of casework due to condition. Provide for the replacement of toilet accessories. Provide for the replacement of interior doors due to age and condition. Provide for the replacement of acoustical ceiling tile due to condition. Provide for plaster refinishing. Provide for the replacement of lockers due to condition. Provide for the replacement of markerboards and chalkboards due to condition. Provide for replacement Art program kilns, with funding for the exhaust systems provided in Item C. Provide for appropriate acoustical sound attenuation surface treatments in the Multipurpose Room. Provide funding for replacement of resilient flooring in the 1918 Original Construction. Funding for removal of flooring is provided for in Item T. Provide an allowance to repair the plaster, dry wall and/or tin ceiling located in the 1918 Original Construction following the installation of the new HVAC and lighting systems.

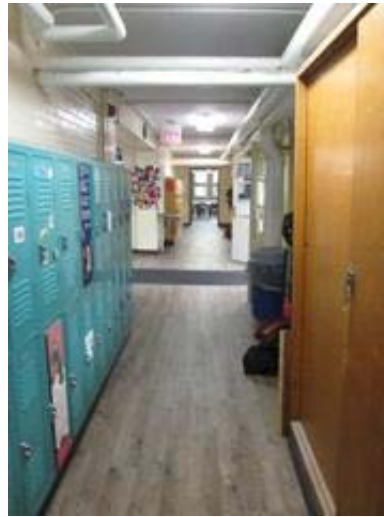
The 1918 Original Construction features conventionally partitioned Classrooms with carpet type flooring, painted plaster or painted tin type ceilings, as well as painted brick and painted plaster type wall finishes, and they are in good to fair condition. The 1918 Original Construction has Corridors with carpet or LVT type flooring, painted gypsum type ceilings, as well as painted brick or gypsum type wall finishes, and they are in good to fair condition. The 1918 Original Construction does not have Restrooms. The 1994 Addition has Restrooms with VCT type flooring, acoustical tile type ceilings, as well as painted block type wall finishes, and they are in good to fair condition. Toilet partitions are plastic, and are in good condition. Classroom casework in the overall facility is built into walls with wood type construction, is inadequately provided, and in fair condition. The typical Classroom contains 10 lineal feet of casework, and Classroom casework provided ranges from 10 to 20 feet. Classrooms are provided adequate chalkboards, markerboards, and tackboards which are in good to fair condition. The lockers and coat hooks, located in the Corridors, are adequately provided, and in fair condition. There is no dedicated Art space and no Art kiln. The facility is equipped with wood non-louvered interior doors that are flush mounted with proper ADA hardware and clearances, and in fair condition. The Multipurpose space has carpet type flooring, painted gypsum type ceilings, as well as painted gypsum with wood wainscoting type wall finishes, and they are in good to fair condition. There are no stands or basketball backboards. There is no Media Center associated with the facility. Student Dining shares the Multipurpose space. OSDM-required fixed equipment for Stage is adequately provided, and in good to fair condition. Existing Multipurpose space is not provided with appropriate sound attenuation acoustical surface treatments. There is no Kitchen associated with this facility. Students typically bring a lunch, and use vending machines located in the Corridors and Multipurpose space. There is a microwave and standard residential refrigerator/freezer in the Multipurpose space.

Typical Corridor Finishes

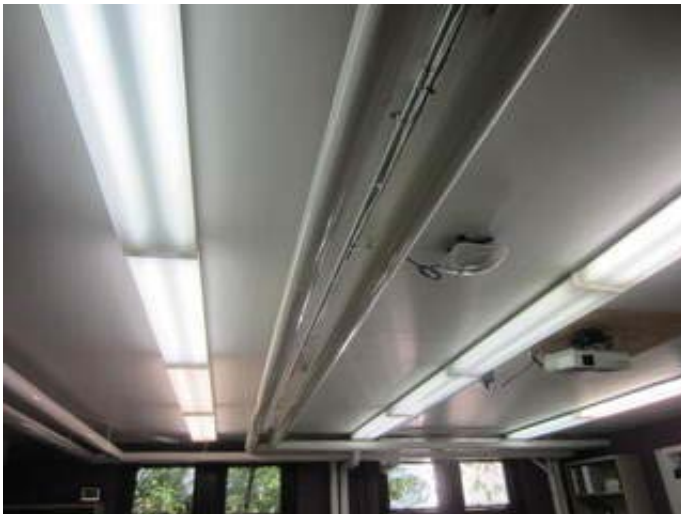
The typical Classrooms in the overall facility are equipped with 2-lamp T-8 1x4 surface mount continuous strip fluorescent fixtures with dual level switching. Classroom fixtures are in fair condition, providing an average illumination of 65 FC, thus complying with the 50 FC recommended by the OSDM. The typical Corridors in the overall facility are equipped with some incandescent fixture and 2-lamp T-8 2x4 surface mount fluorescent fixtures with single level switching. Corridor fixtures are in fair condition, providing an average illumination of 30 FC, thus complying with the 20 FC recommended by the OSDM. The Multi-Purpose (Gymnasium and Student Dining) spaces are equipped with 6-lamp T-5 2x8 surface mount fluorescent fixtures type lighting, in good to fair condition, providing an average illumination of 30 FC, which is less than the 50 FC recommended by the OSDM. The Media Center is equipped with 4-lamp T-8 surface mount fluorescent fixture type lighting in good to fair condition, providing an average illumination of 55 FC, thus complying with the 50 FC recommended by the OSDM. There are no Kitchen spaces provided in this facility. The Service Areas in the overall facility are equipped with incandescent fixture and 2-lamp T-8 1x4 suspended fluorescent fixture type lighting in fair condition, providing inadequate illumination based on OSDM requirements. The typical Administrative spaces in the overall facility are equipped with 3-lamp T-8 2x4 lay-in direct fluorescent fixture type lighting in fair condition, providing adequate illumination based on OSDM requirements. The overall lighting systems of the facility are not fully compliant with Ohio School Design Manual requirements due to age, condition, inadequate lighting levels, and lack of multi-level switching.

Classroom Fluorescent Light Fixtures

Provide complete replacement of lighting system due to age, condition, lighting levels, utilization of incandescent fixtures, lack of multilevel switching, and installation of systems outlined in Items A, C, J, and U.

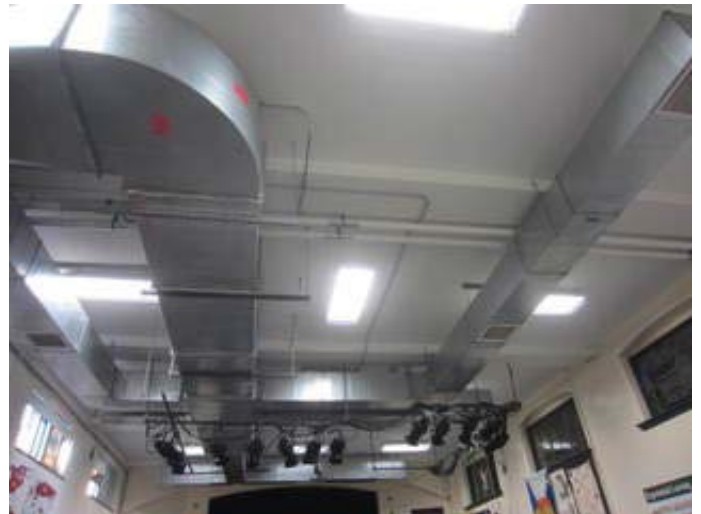
Gymnasium Fluorescent Light Fixtures

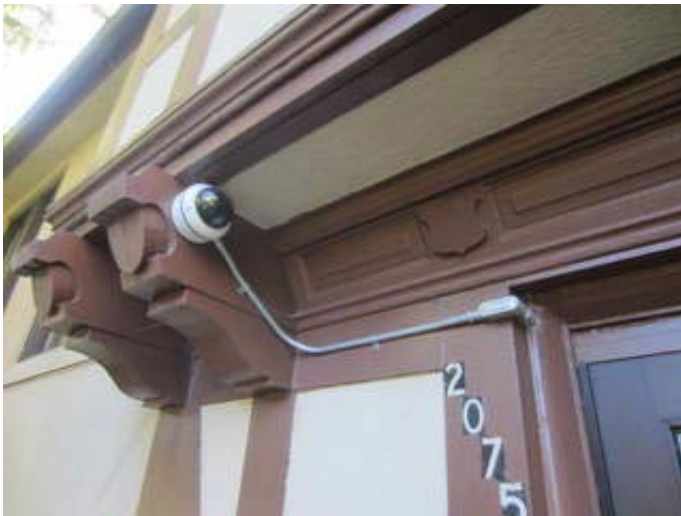
**Description:** The overall facility contains a door contact, motion sensor, and CCTV type security system in fair condition. Motion detectors are inadequately provided in main entries, central gathering areas, offices, main Corridors, and spaces where 6 or more computers are located. Exterior doors are equipped with door contacts. An automatic visitor control system is provided. Compliant color CCTV cameras are not adequately provided at main entry areas, parking lots, central gathering areas, and main Corridors. CCTV is monitored in Administrative Area with the use of a LCD monitor. A compliant computer controlled access control system integrating alarms and video signals, with appropriate UPS backup, is not provided. The system is equipped with card / biometric readers. The security system is not adequately provided throughout, and the system is not fully compliant with Ohio School Design Manual guidelines. Due to existing grade configuration there are no playground fencing issues requiring attention. The exterior site lighting system is equipped with surface mounted HID high pressure sodium entry lights in fair condition. Pedestrian walkways are illuminated with surface and pole mounted HID high pressure sodium fixtures in fair condition. Parking and bus pick-up / drop off areas are illuminated by pole mounted HID high pressure sodium fixtures in fair condition. The exterior site lighting system provides inadequate illumination due to insufficient fixture capacity and sparse placement of fixtures.

Security System CCTV Camera

**Recommendations:** Provide complete replacement of security system to meet Ohio School Design Manual guidelines. Provide complete replacement of exterior site lighting system to meet Ohio School Design Manual guidelines.

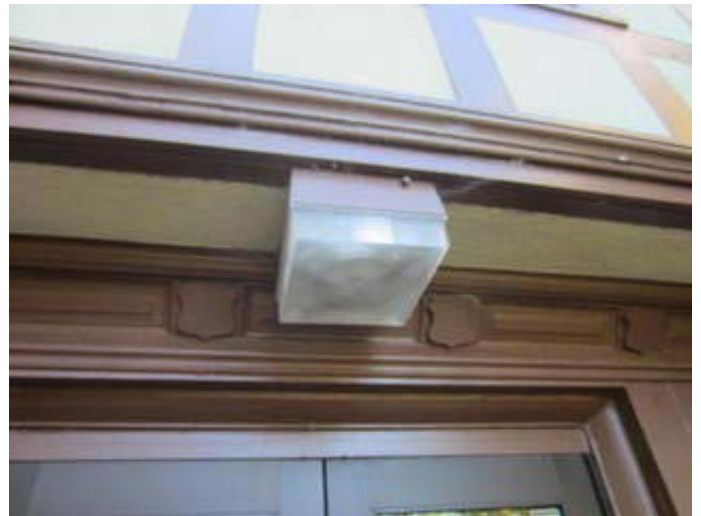
Exterior Entry Light Fixture

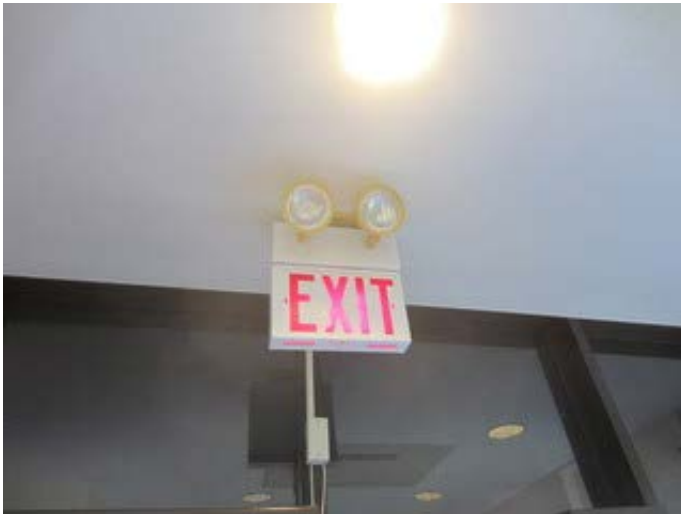
Exit Sign with Emergency Egress Lighting

**Recommendations:** Provide complete replacement of emergency / egress lighting system to meet Ohio School Design Manual and Ohio Building Code guidelines.

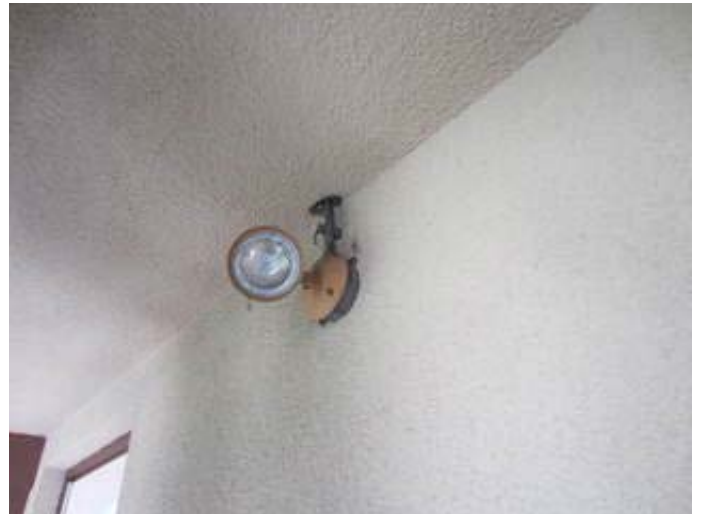
Emergency Egress Light Fixture

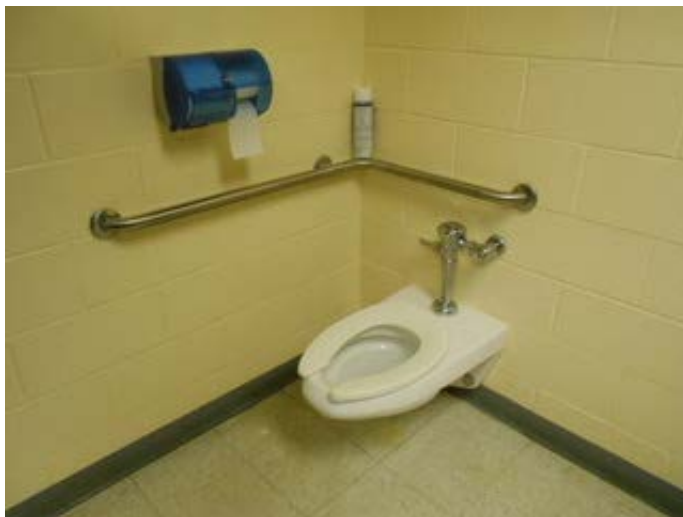
ADA Compliant Toilet-1994 Addition

Provide ADA-compliant signage throughout the site both on the interior and exterior spaces. Provide 1 ADA-compliant power assist door at the Main Entrance. Provide ADA-compliant ramp to facilitate access to the Stage. Due to layout and age of 1918 Original Construction, an elevator is not recommended. Provide 1 chair lift at the main stairwell to facilitate compliance with ADA accessibility. Provide two sets of ADA compliant door hardware. All fixtures (whether new or replaced) to be mounted at the correct ADA compliant heights. Provide 4 ADA compliant pipe wrap throughout overall facility. Funding provided in Item E for Electric Water Cooler replacement. Funding for the provision of an ADA compliant urinal is provided for in Item E with the installation of an additional urinal. Funding for replacement of handrails and guardrails is provided for in Item U.

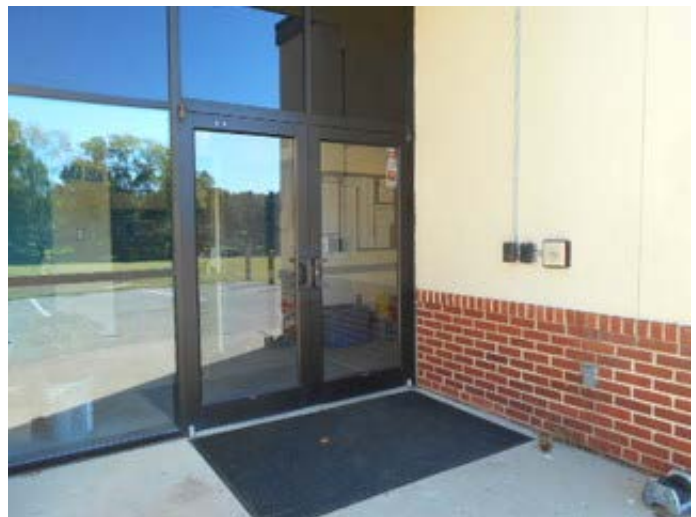
ADA Compliant Power Assisted Door-1994 Addition

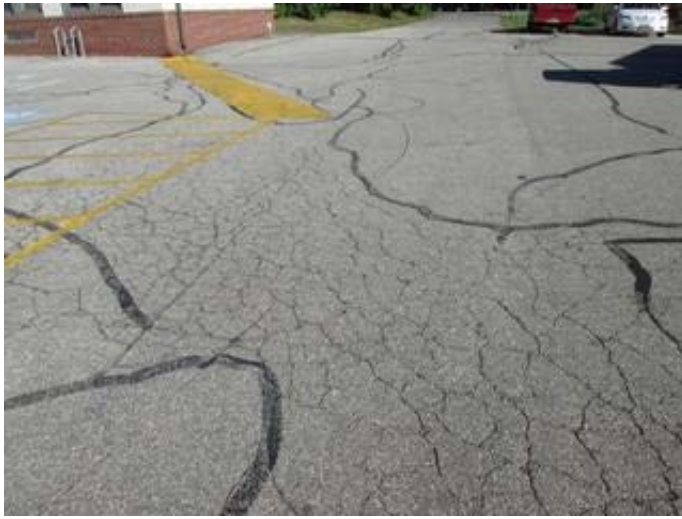
Typical Asphalt Condition

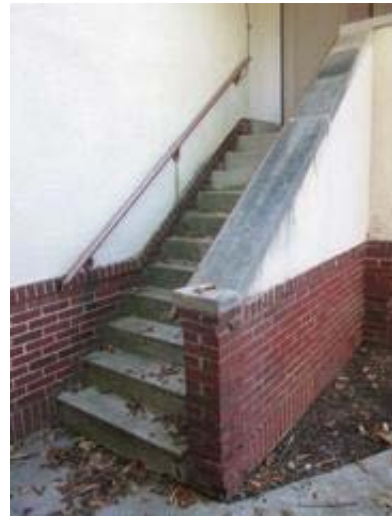
Exterior Stairs and Handrail

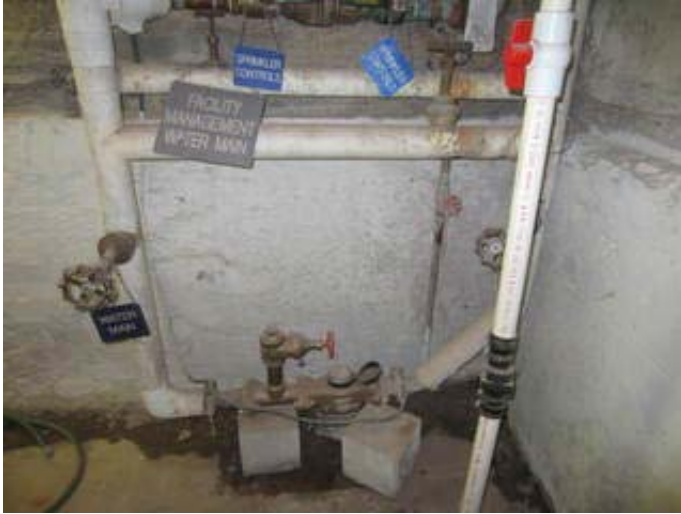
Incoming Domestic Water Service Line

**Recommendations:** Provide a new city water supply line of adequate capacity to support the existing needs of the facility, as well as a future automated fire suppression system. Funding provided in Item U.

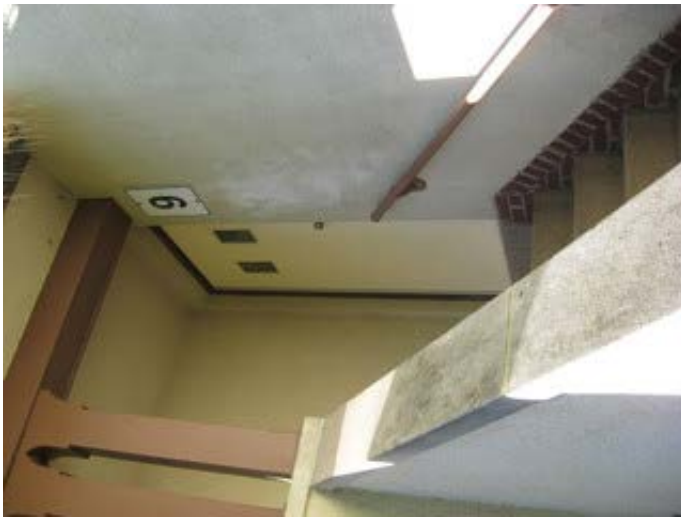
Exterior Door

**Recommendations:** Replace all exterior doors to comply with Ohio Building Code, ADA, and Ohio School Design Manual guidelines. Aluminum entrance door frames and glazing are covered under Item F. Provide funding for replacement of 1 interior fire door in the Boiler Room located in the 1918 Original Construction. Funding for removal of door due to hazardous materials is provided in Item T.

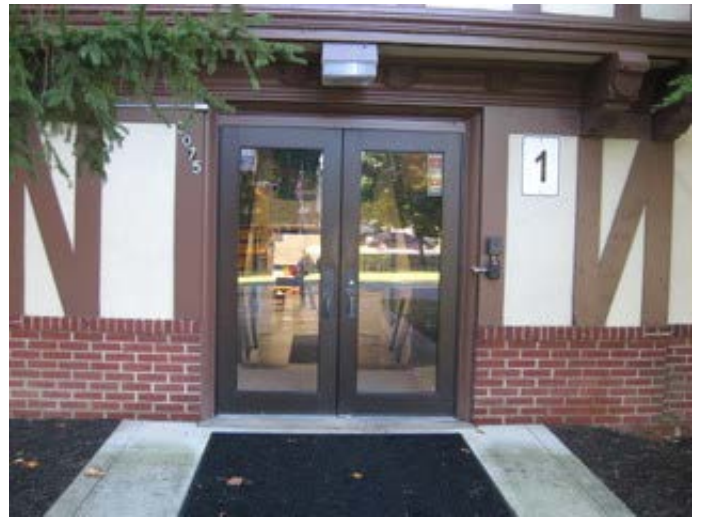
Entrance Door

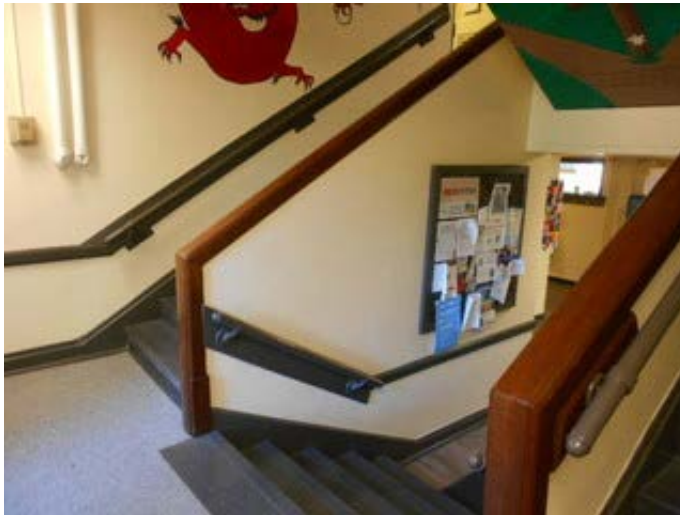
Non Compliant Stair Tower-1918 Original Construction

**Recommendations:** Provide new automated fire suppression system to meet Ohio School Design Manual guidelines. Provide increased water service of a capacity sufficient to support the fire suppression system, funding included in fire suppression funding. Provide new emergency generator, with funding provided via complete replacement of electrical system in Item D. Provide new handrails to meet the requirements of the Ohio Building Code. Provide fire-rated enclosure around existing stair tower. Funding for replacement of exterior concrete stairways is provided for in Item P. Funding for provision of fire separation assembly for wood roof structure in the 1918 Original Construction is provided for in Item I.

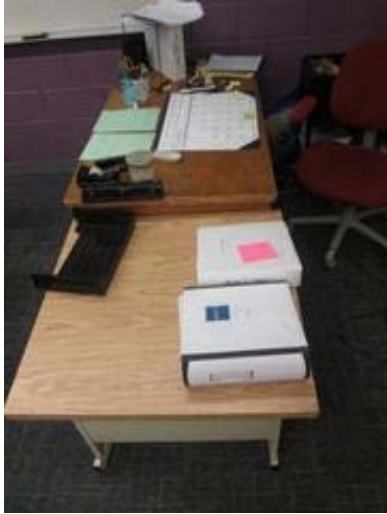
Teacher Desk and Chair

**Recommendations:** Provide for replacement of outdated or inadequate furnishings.

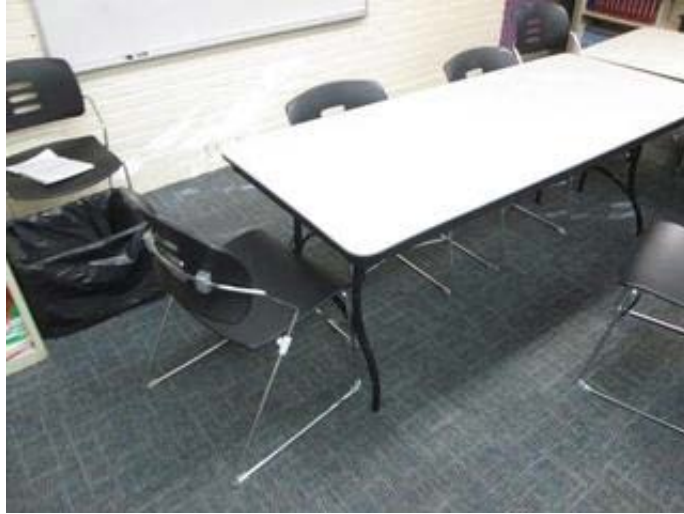
Typical Student Desk and Chairs

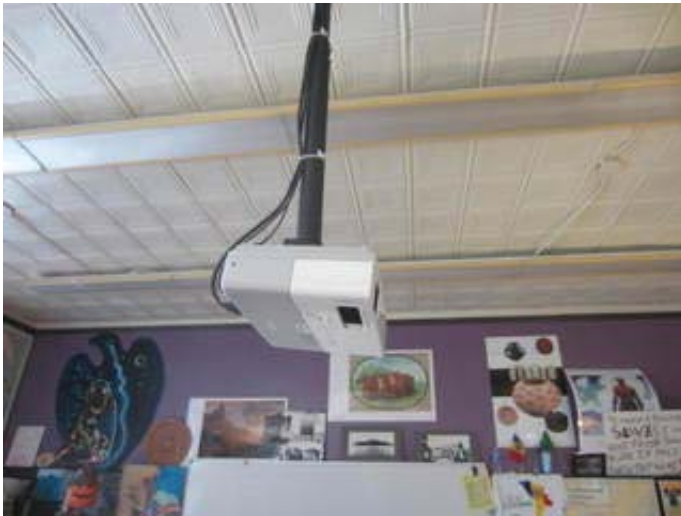
Classroom Projector

**Recommendations:** Provide complete replacement of technology systems to meet Ohio School Design Manual requirements.

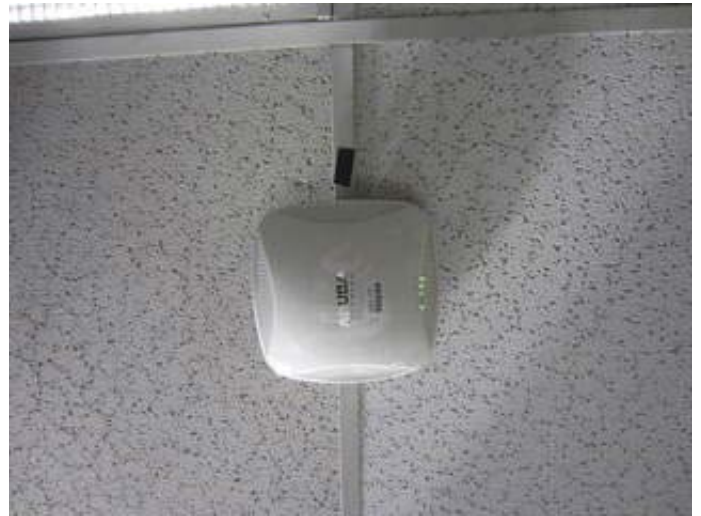
Wireless Access Point
