Building Information - Worthington City (45138) - Thomas Worthington High

Program Type	Assessment Only
Setting	Suburban
Assessment Name	Thomas Worthington High School (042283)
Assessment Date (on-site; non-EEA)	2015-09-28
Kitchen Type	Full Kitchen
Cost Set:	2015
Building Name	Thomas Worthington High
Building IRN	42283
Building Address	300 W. Granville Road
Building City	Worthington
Building Zipcode	43085
Building Phone	(614)450-6200
Acreage	84.88
Current Grades:	9-12
Teaching Stations	92
Number of Floors	2
Student Capacity	1944
Current Enrollment	1550
Enrollment Date	2015-10-14
Enrollment Date is the date in which the current enrollment was taken.	
Number of Classrooms	85
Historical Register	NO
Building's Principal	Mr. Jim Gaskill
Building Type	High

Thomas Worthington High School, which is not on the National Register of Historic Buildings, and originally constructed in 1951, is a two story, 293,479 square foot brick and stone school building located in a suburban residential setting. The existing facility features a conventionally partitioned design, and does not utilize modular buildings. The structure of the 1951 Original Construction, 1952, 1957, 1974, 1985, 1990, 2002, and 2

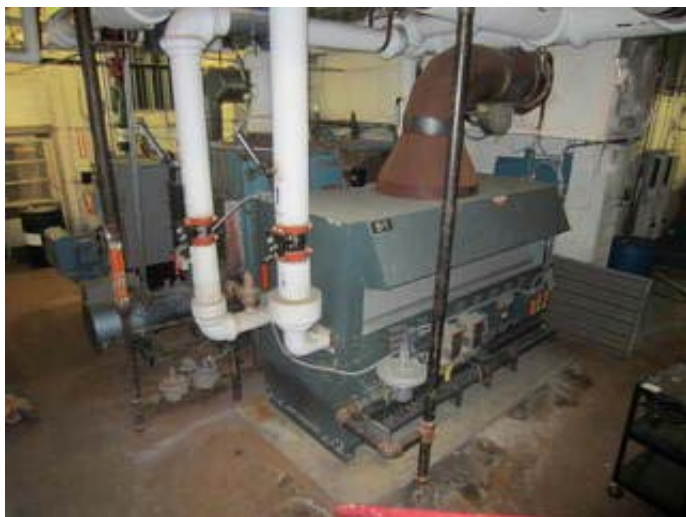
The overall facility is equipped with multiple heating systems. The existing system for the 1974 Addition is a natural gas fired heated water boiler type system, installed in 1974, with upgrades in 2001, and is in fair condition. The systems in the 1951 Original Construction, 1974 Auditorium Fixed Seating Area, and 1952, 1957, 1985, and 1992 Additions are an extension of that found in the 1974 Addition. The existing system for the 1990 Original Construction is a natural gas fired heated water boiler type system, installed in 1990, and is in fair condition. The system in the 2015 Addition is an extension of that found in the 1990 Addition. The 2002 Addition is a separate ducted packaged roof top HVAC unit type system, installed in 2002, and in fair condition. The system features two (2) Trane roof top HVAC units, installed in 1990, and in fair condition, with heating air distributed to terminal units consisting of CAV/VAV boxes. For the most part, the heating and chilled water system in the overall facility is a 4-pipe system, with a capacity for simultaneous heating and cooling operation, which is compliant with the OSDM requirements for basic system type. The 1974 Addition is equipped with three (3) boilers. The first, manufactured by Raypack, was installed in 1993, and is in fair condition. The second, manufactured by Burnham, was installed in 1987, and is inoperable. The third, manufactured by Bryan Boilers, was installed in 2001, and is in fair condition. The 1990 Addition is equipped with two (2) boilers, both manufactured by Bryan Boilers, installed in 1990, and in fair condition. Heating water is distributed to terminal units consisting of unit ventilators, cabinet heaters, fin tubes, and air handlers. The terminal equipment is original to each addition and is in fair condition. The system does not appear to fully comply with the 15 CFM per person fresh air requirements of the Ohio Building Code mechanical code and Ohio School Design Manual. The Automated Logic DDC type system temperature controls were installed in 2012 and are in good condition. The system does feature individual temperature controls in all spaces required by the OSDM. The overall system does not feature any central energy recovery systems. The facility is mainly equipped with a non-louvered interior doors, but some areas like the 1957 Addition are equipped with louvered interior doors, which are used to facilitate Corridor utilization as return air plenums. The existing systems in the Classrooms of the overall facility are not ducted, but floor to structural deck heights will accommodate the installation of properly sized ductwork for a future Ohio School Design Manual approved system. The existing systems are ducted in the remainder of the overall facility, but the ductwork cannot be integrated into a possible future system due to arrangement, air volume, and routing of existing ductwork. The overall heating system is evaluated as not fully being in safe and efficient working order, and long term life expectancy of the existing system is not anticipated. The structure is equipped with central air conditioning in the majority of spaces. The site does not contain an underground fuel tank.

3 Needs Replacement

Natural Gas Fired Heated Water Boilers

Provide new overall heating, ventilating, and air conditioning system to achieve compliance with Ohio Building Code and Ohio School Design Manual standards. Convert the Classrooms in the overall facility to a ducted system to facilitate efficient exchange of conditioned air. Replace existing ductwork in the remainder of the overall facility to facilitate efficient exchange of conditioned air.

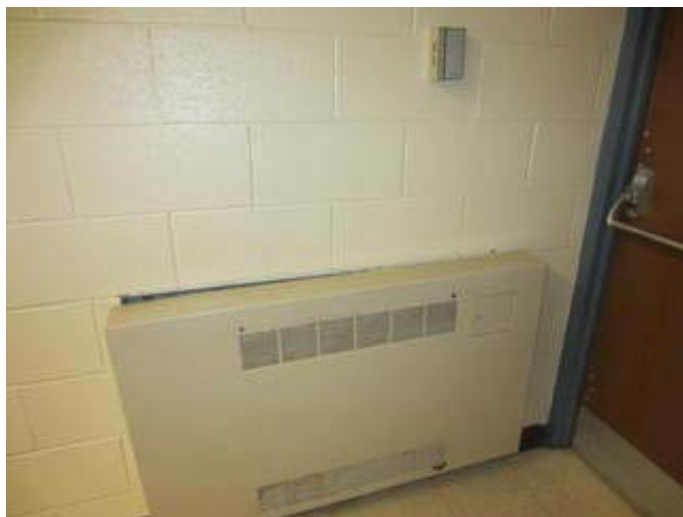
Heating Water Cabinet Heater

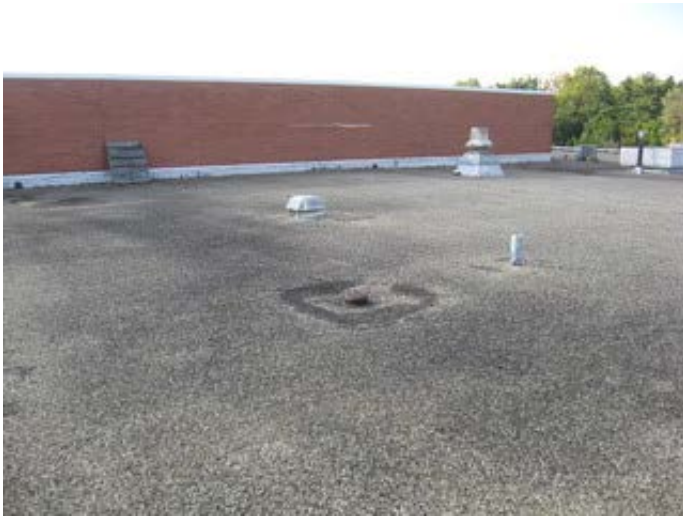
2 Needs Repair

Ballasted Roof

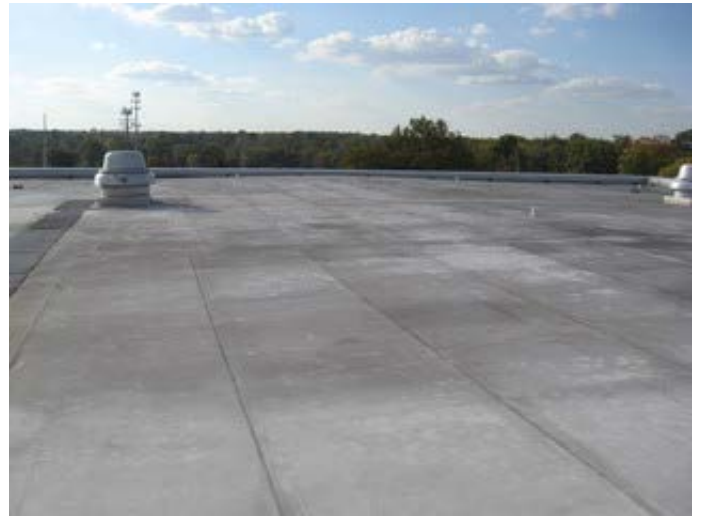
Membrane Roof

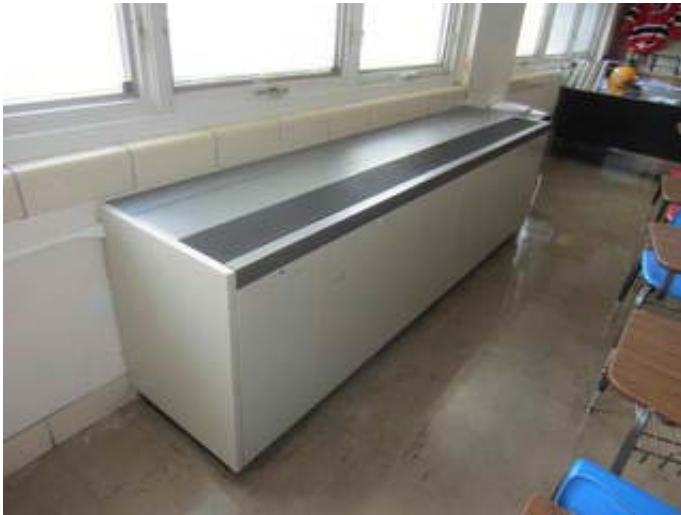
3 Needs Replacement

Unit Ventilator

Provide an air conditioning system to meet with Ohio Building Code and Ohio School Design Manual requirements. Replace general building exhaust systems located in Restrooms, Storage Rooms, Art Rooms, and Custodial Closets. Pricing included in Item A. Provide new kiln ventilation/exhaust systems for kilns.

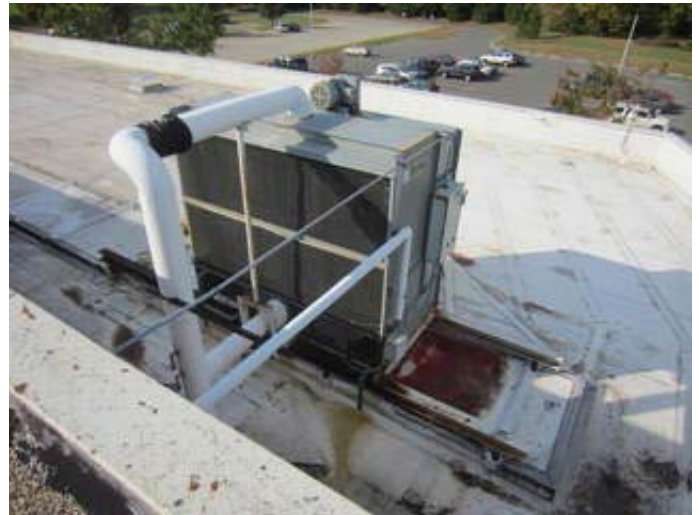
Cooling Tower

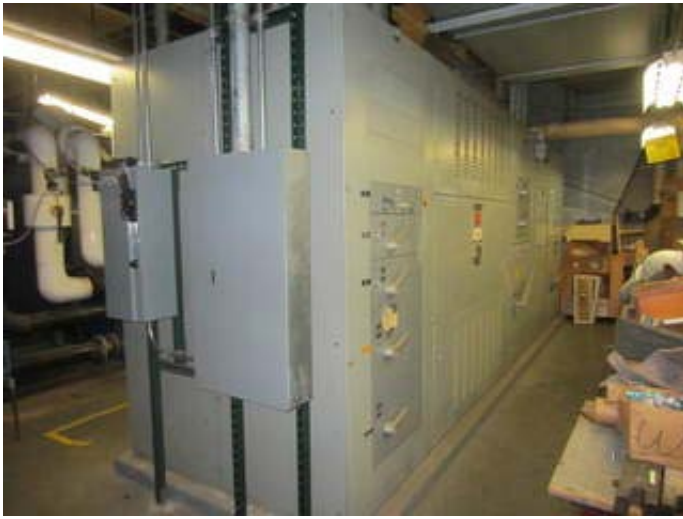
Rating: 3 Needs Replacement

Main Electrical Distribution Panel

Recommendations: The entire electrical system requires replacement to meet Ohio School Design Manual guidelines for overall capacity and due to condition and age, lack of OSDM-required features, to accommodate the addition of an air conditioning system. Provide an emergency generator, with funding included in the electrical system replacement. Provide adequate lightning protection safeguards in the overall facility, including associated grounding system, with funding included in the electrical system replacement. Provide control panel, dimmers, and breakers to support the Stage lighting system, with funding included in the electrical system replacement.

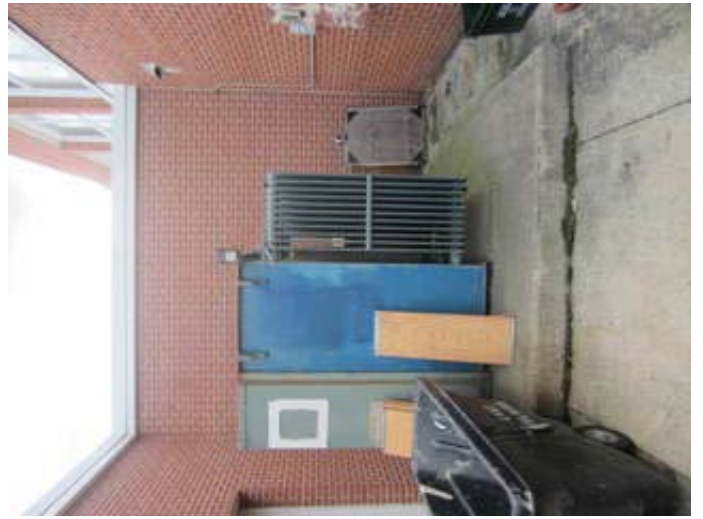
Pad Mounted Transformer

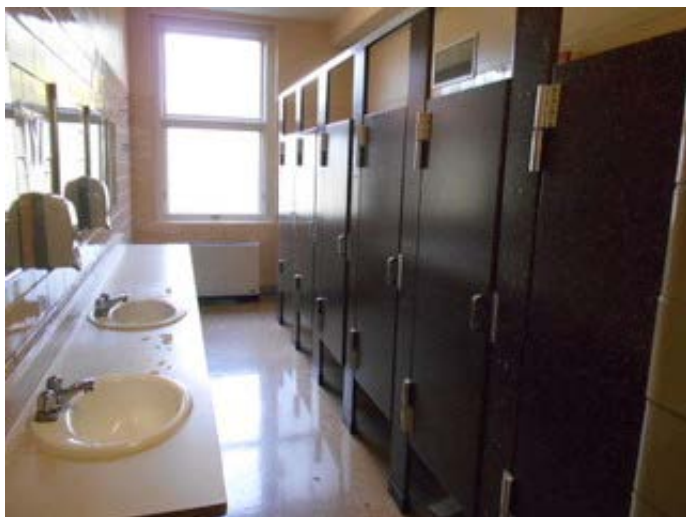
Large Group Restroom Girls-1951 Original Construction

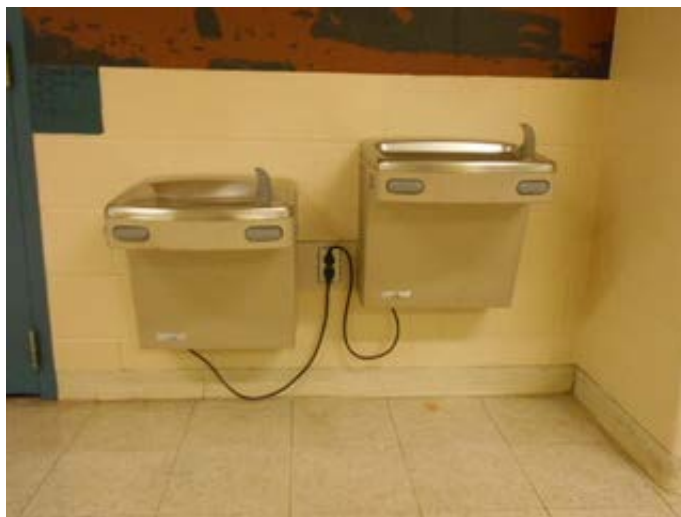
Electric Water Coolers-1992 Addition

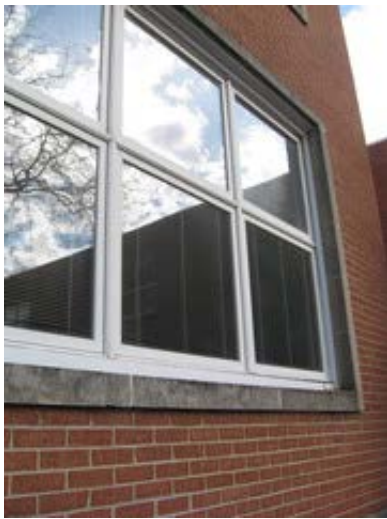
Aluminum Clad Wood Windows

Provide a new insulated window system with integral blinds, in place of wood clad windows and fixed aluminum windows to meet with Ohio School Design Manual requirements throughout the overall facility, but not including the 2015 Addition, as this portion of the building was just recently constructed. Provide for the replacement of the existing Greenhouse. Replace curtain wall system in the 1957, 1974, and 1990 Additions. Replace window transoms and sidelights at exterior doors of the 1957 and 1974 Additions. Square footage of window transoms and sidelights are included in the total insulated glass/panel areas. Clerestory replacement is included in the Insulated Glass/Panels totals.

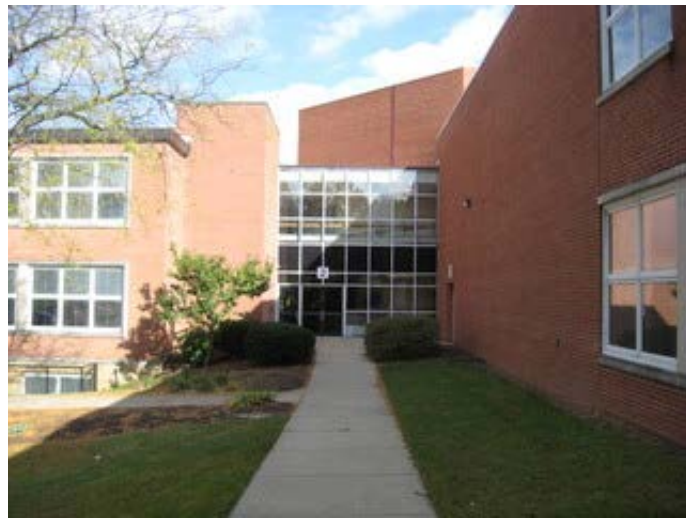
Aluminum Frame Curtain Wall

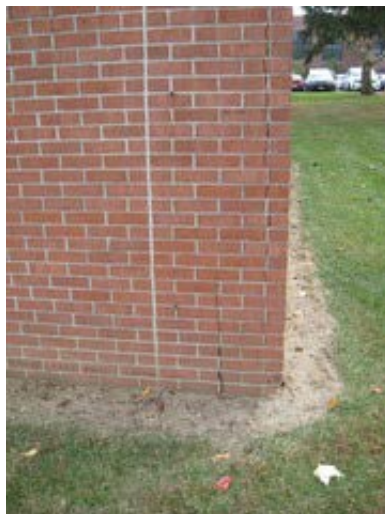
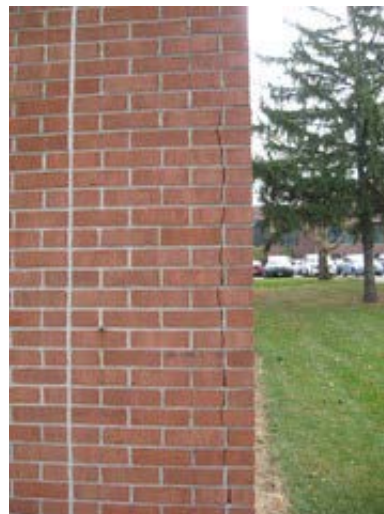
Veneer Cracks / Foundation Settlement

Recommendations: Repair areas of cracking and settlement at the exterior corners of the 1974 Addition, located at two classrooms at the southeast corner of the facility.

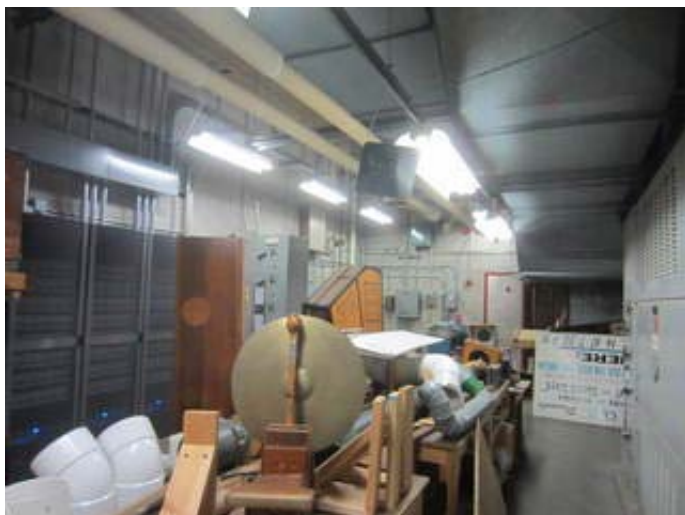
Service Area Fluorescent Lighting

Provide complete replacement of lighting system due to age, condition, lighting levels, lack of multilevel switching, and installation of systems outlined in Items A, C, J, and U.

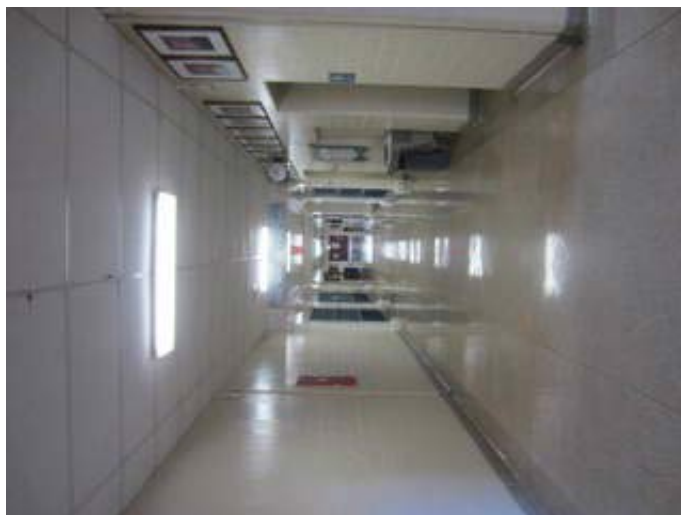
Corridor Fluorecent Lighting

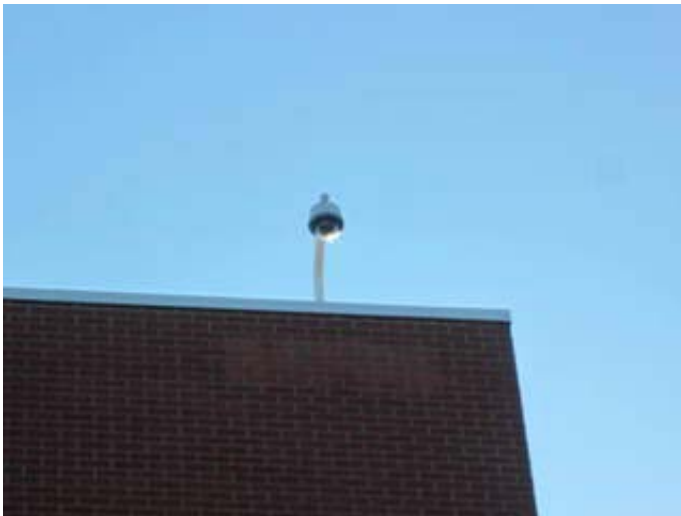
Security System CCTV Camera

Provide complete replacement of security system to meet Ohio School Design Manual guidelines. Provide complete replacement of exterior site lighting system to meet Ohio School Design Manual guidelines. Provide playground fencing as required to meet OSDM guidelines, with funding included in the security system replacement.

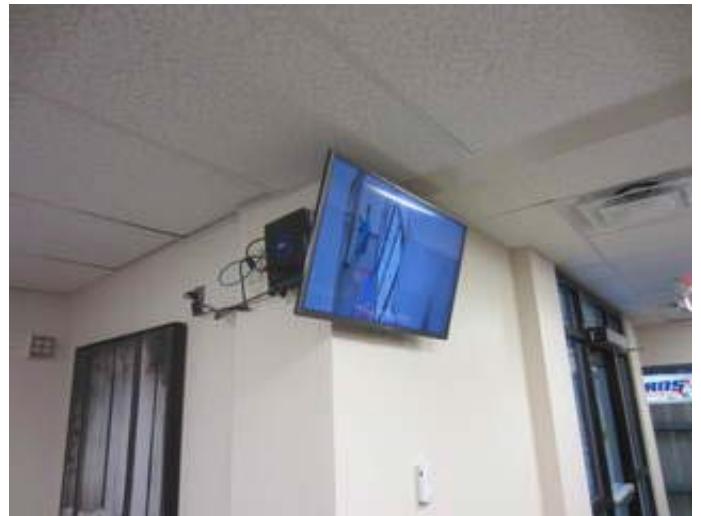
Security System CCTV Monitor

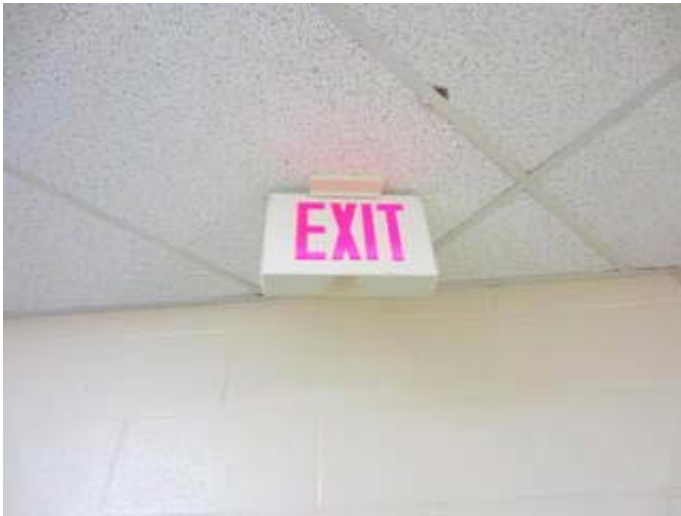
Exit Sign

Recommendations: Provide complete replacement of emergency / egress lighting system to meet Ohio School Design Manual and Ohio Building Code guidelines.

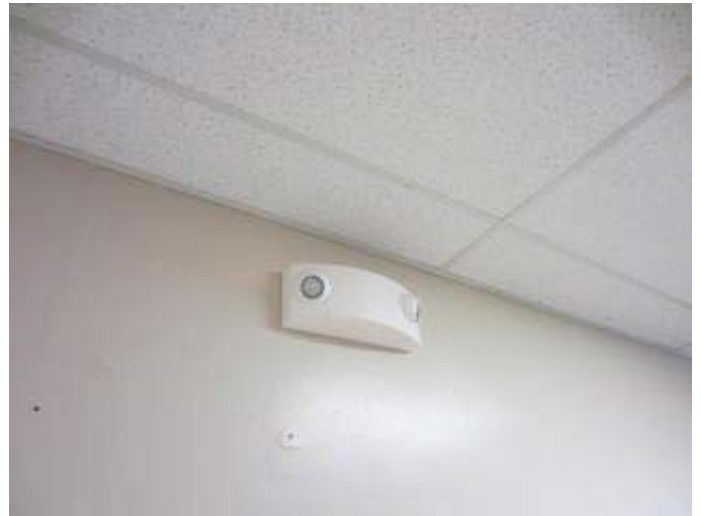
Emergency Egress Light Fixture

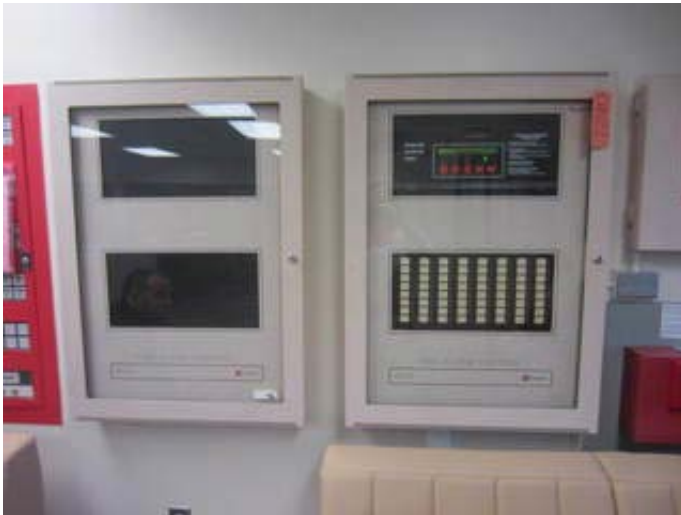
Fire Alarm System Control Panels

Recommendations: Provide complete replacement of fire alarm system to meet OBC, NFPA, and Ohio School Design Manual guidelines.

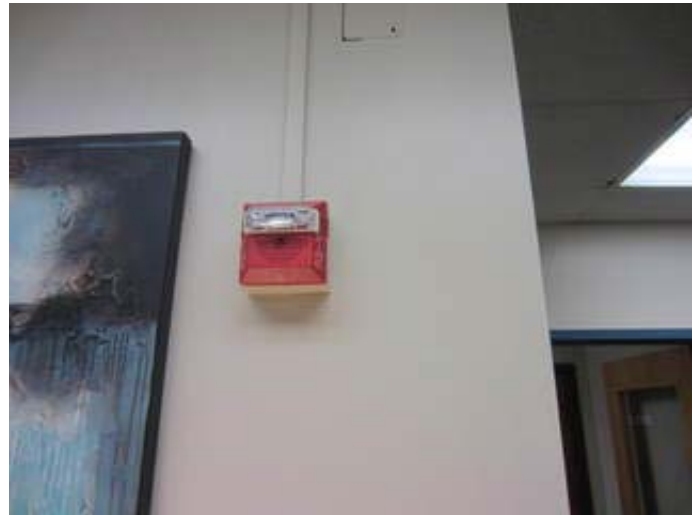
Fire Alarm System Audible Horn and Strobe Indicating Device

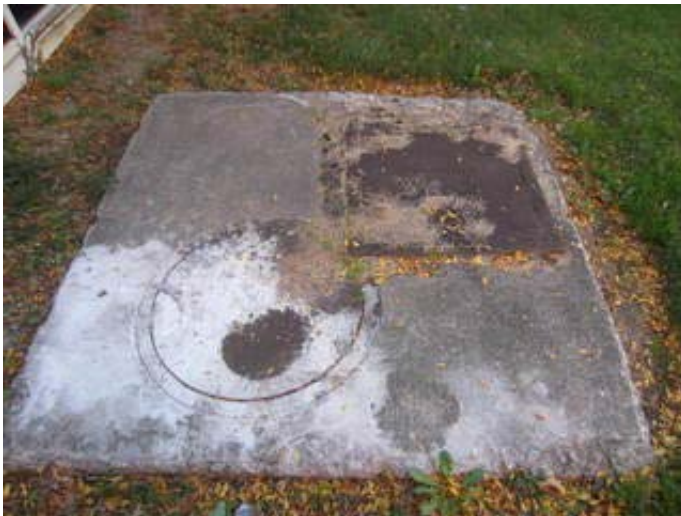
Incoming Domestic Water Service Meter Pit

Recommendations: Provide a new city water supply line of adequate capacity to support the existing needs of the facility, as well as a future automated fire suppression system. Funding provided in Item U.

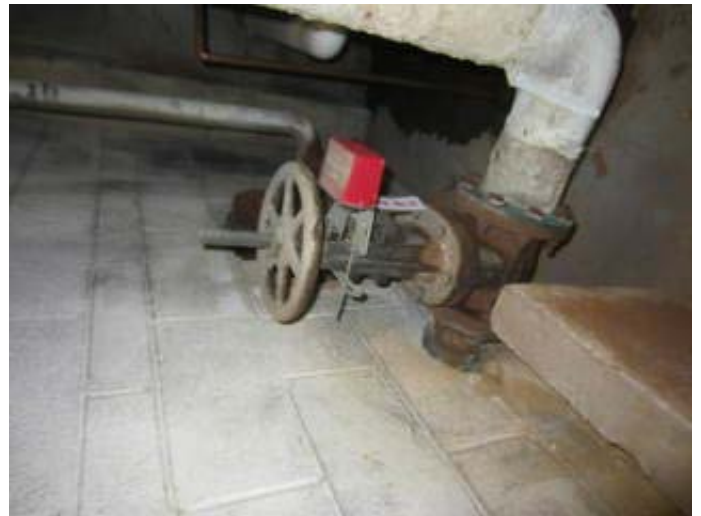
Incoming Domestic Water Service Line
