Building Information - Worthington City (45138) - Worthington Kilbourne High

Program Type	Assessment Only
Setting	Suburban
Assessment Name	Worthington Kilbourne High School
Assessment Date (on-site; non-EEA)	2015-09-28
Kitchen Type	Full Kitchen
Cost Set:	2015
Building Name	Worthington Kilbourne High
Building IRN	112094
Building Address	1499 Hard Road
Building City	Columbus
Building Zipcode	43235
Building Phone	(614)450-6400
Acreage	54.40
Current Grades:	9-12
Teaching Stations	85
Number of Floors	2
Student Capacity	1776
Current Enrollment	1113
Enrollment Date	2015-10-15
Enrollment Date is the date in which the current enrollment was taken.	
Number of Classrooms	77
Historical Register	NO
Building's Principal	Ms. Angie Adrean
Building Type	High

Worthington Kilborne High School, which is not on the National Register of Historic Buildings, and originally constructed in 1990, is a two story, 282,036 square foot brick and stone school building located in a suburban residential setting. The existing facility features a conventionally partitioned and demountable partitioned design, and does not utilize modular buildings. The structure of the 1990 Original Construction contains brick venee

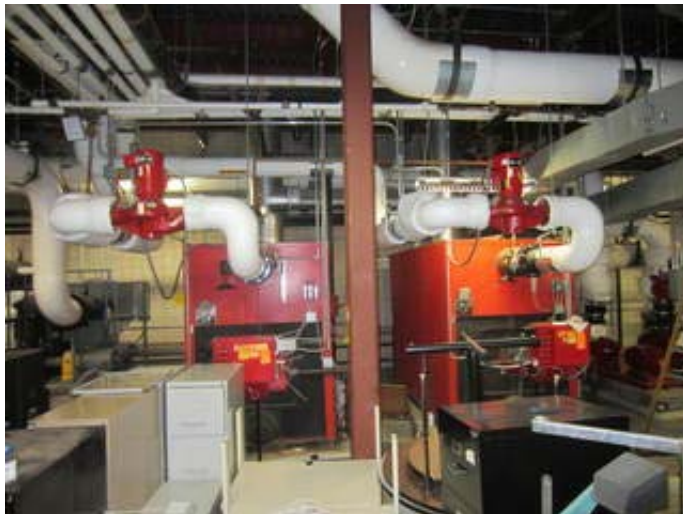
The existing system for the 1990 Original Construction is a natural gas fired heated water boiler type system, installed in 1990, and is in fair condition. The system in the 1998 Addition is an extension of that found in the 1990 Original Construction. The heating and chilled water system in the overall facility is a 4-pipe system, with a capacity for simultaneous heating and cooling operation, which is compliant with the OSDM requirements for basic system type. The 1990 Original Construction is equipped with two (2) flexible water tube boilers, manufactured by Hartford Boilers, installed in 1990, and in fair condition. Heating water is distributed to terminal units throughout the overall facility consisting of unit heaters, cabinet heaters, and air handlers. The terminal equipment is original to each addition and is in fair condition. The system appears to comply with the 15 CFM per person fresh air requirements of the Ohio Building Code mechanical code and Ohio School Design Manual. The Automated Logic DDC type system temperature controls were installed in 2009, with upgrades in 2015, and are in good to fair condition. The system does feature individual temperature controls in all spaces required by the OSDM. The overall system does not feature any central energy recovery systems. The facility is not equipped with louvered interior doors to facilitate Corridor utilization as return air plenums. The existing systems in the overall facility are ducted, but the ductwork cannot be integrated into a possible future system due to arrangement, air volume, and routing of existing ductwork. The overall heating system is evaluated as being in safe and efficient working order, though long term life expectancy of the existing system is not anticipated. The structure is equipped with central air conditioning. The site does not contain an underground fuel tank.

Natural Gas Fired Heated Water Boilers

Provide new overall heating, ventilating, and air conditioning system due to age and condition and to achieve compliance with Ohio Building Code and Ohio School Design Manual standards. Replace the ductwork in the overall facility to facilitate efficient exchange of conditioned air.

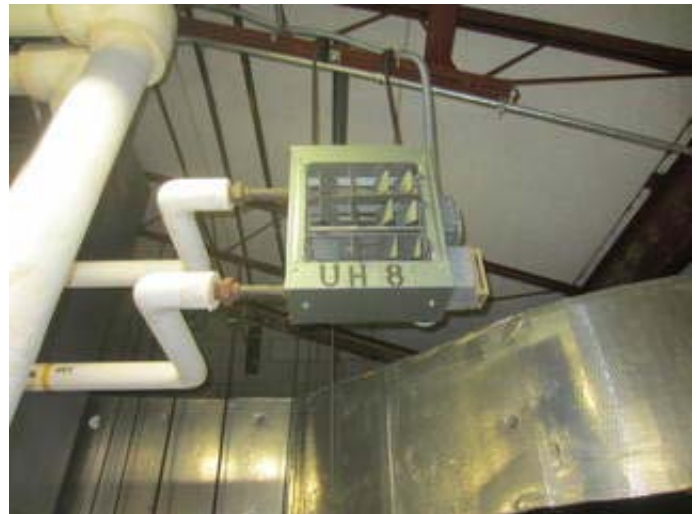
Heating Water Unit Heater

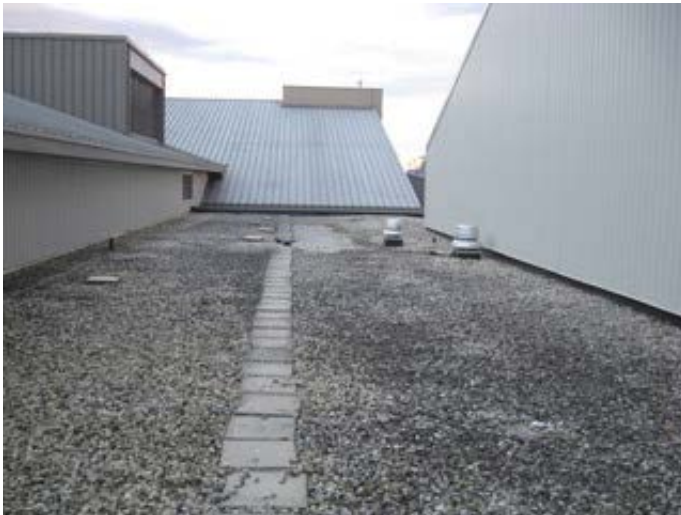
Description: The roof over the overall facility is a combination of standing seam metal roof, membrane, and ballasted membrane systems that was installed in 1990, and is in fair condition. There are District reports of current leaking. Leaking is occurring at a section of ballasted membrane roof located near the main gymnasium. No signs of past leaking were observed during the physical assessment. Access to the roof was gained by access ladder and access door that are in good condition. Fall safety protection cages are not required. There were no observations of standing water on the roof. Metal cap flashings and stone copings are in good condition. Roof storm drainage is addressed through a system of gutters and downspouts, roof drains, and through-wall scuppers which are properly located, and in good condition. The roof is equipped with overflow roof drains in sufficient quantity and in good condition. No problems requiring attention were encountered with any roof penetrations. There are covered walkways that are integral to the structure and consist of open first floor areas with second floor occupied space above.

Ballasted Roof

Recommendations: Replace membrane roofing due to age and end of life cycle. Remove stone ballast. Funding for stone ballast removal is provided for in complete roof replacement cost. Use fully adhered membrane roofing system in replacement of ballasted roofing. Standing seam metal roofing does not require replacement. The flashing and / or coping at the 1990 Original Construction and the 1998 Addition require replacement due to condition and roof replacement. Funding for flashing and coping replacement is provided for in the complete replacement of roof. Provide new / additional roof insulation due to roof replacement.

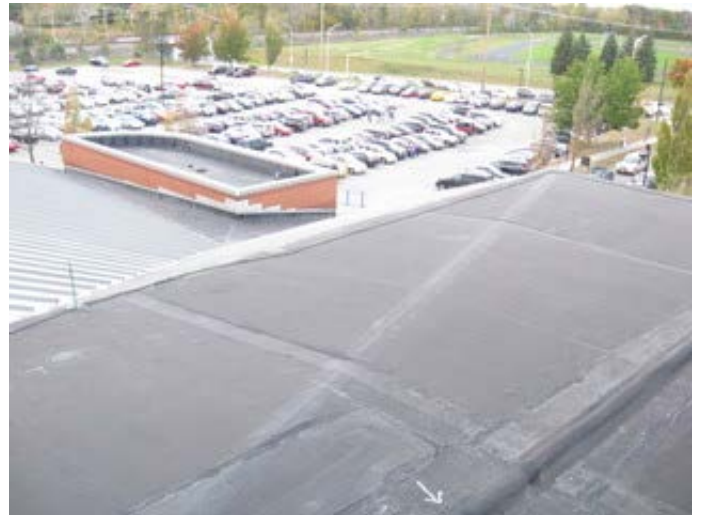
Standing Seam and Membrane Roofing

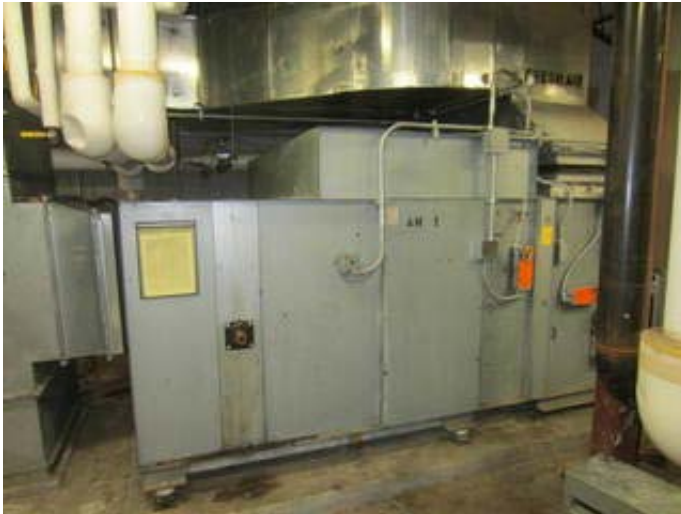
Description: The overall facility is equipped with a chilled water type central air conditioning system, which is in fair condition. The system consists of two (2) Trane roof top air cooled helical-rotary liquid chillers, in good to fair condition, and a packaged EnviroSep pump system, in good to fair condition, providing chilled water to terminal units consisting of air handlers. The overall facility is not equipped with any window units or isolated room systems. The ventilation system in the overall facility consists of air handlers, original to each addition and in fair condition, providing fresh air to Classrooms and other miscellaneous spaces such as Gymnasium, Student Dining, and Media Center. Relief air venting is provided by ceiling plenums, central relief fans, and air handlers. The ventilation system appears to meet the Ohio Building Code 15 CFM per occupant fresh air requirement. The overall system is not fully compliant with Ohio Building Code and Ohio School Design Manual requirements. Dust collection systems are not required in this facility. The Art program is equipped with two (2) kilns, and existing kiln ventilation systems are inadequate, and in fair condition. General building exhaust systems for Restrooms, Storage Rooms, Art Rooms, and Custodial Closets appear to be adequately placed, and in fair condition.

Air Handling Unit

Recommendations: Provide an air conditioning system due to age and condition and to meet with Ohio Building Code and Ohio School Design Manual requirements. Replace general building exhaust systems located in Restrooms, Storage Rooms, Art Rooms, and Custodial Closets. Pricing included in Item A. Replace the existing Art Program kiln ventilation systems.

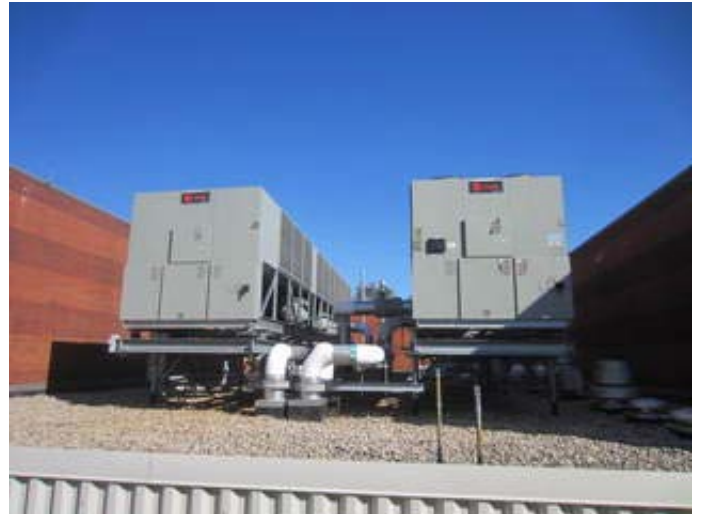
Air Cooled Helical-Rotary Liquid Chillers

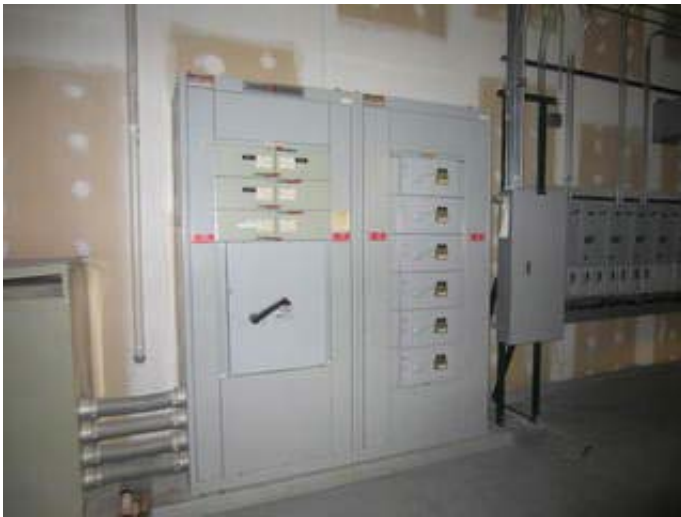
Description: The electrical system provided to the 1990 Original Construction is a 480/277 volts, 1,200 amp, 3 phase and 4 wire system installed in 1990, and is in fair condition. The system in the 1998 Addition is an extension of that found in the 1990 Original Construction. Power is provided to the school by a single utility owned, pad-mounted transformer located outside the Mechanical Room, and is in fair condition. The panel systems, original to each addition, are in fair condition, and for the most part can be expanded to add additional capacity. The Classrooms are not equipped with adequate electrical outlets. The typical Classroom contains four (4) general purpose outlets, one (1) dedicated outlet for each Classroom computer, and one (1) dedicated outlet for each Classroom television. Some Classrooms are equipped with as many as five (5) general purpose outlets, while others are equipped with as few as three (3) general purpose outlets. There are not any spaces that have no electrical outlets. The Corridors are equipped with adequate electrical outlets for servicing. GFI protected exterior outlets are adequately provided around the perimeter of the building. The facility is equipped with an unsuitable diesel emergency generator, in fair to poor condition. Adequate lightning protection safeguards do not appear to be provided. Stage lighting power system including control panel, breakers, and dimmers is inadequately provided, in fair condition and does not appear to meet OSDM requirements. The overall electrical system does not meet Ohio School Design Manual requirements in supporting the current needs of the school, and will be inadequate to meet the facility's future needs.

Main Electrical Distribution Panel

Recommendations: The entire electrical system requires replacement to meet Ohio School Design Manual guidelines for overall capacity and due to condition and age and lack of OSDM-required features. Provide an emergency generator, with funding included in the electrical system replacement. Provide adequate lightning protection safeguards in the overall facility, including associated grounding system, with funding included in the electrical system replacement. Provide control panel, dimmers, and breakers to support the Stage lighting system.

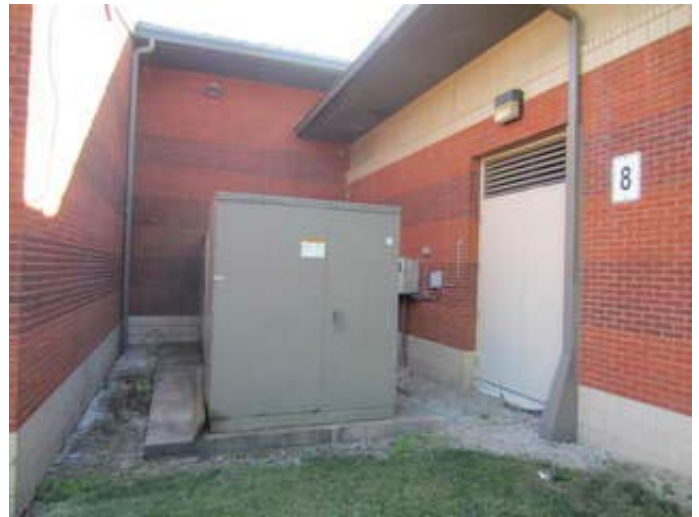
Pad Mounted Transformer

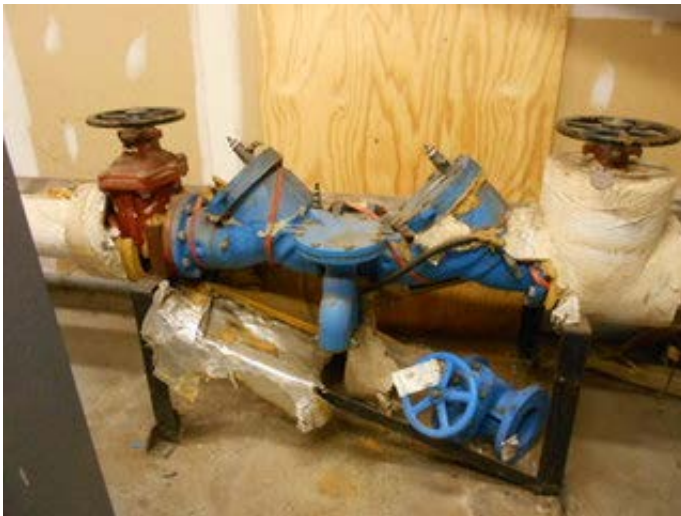
Reduced Pressure Backflow Preventer

Rating:	3 Needs Replacement
Recommendations:	<p>In the overall facility, replace the remaining galvanized steel domestic water piping and the remaining cast iron waste piping due to age and condition. To facilitate the school's compliance with OBC and OSFC fixture requirements throughout the overall facility: Due to age, condition, LEED, OBC, and OSFC, replace 200 faucets and valves throughout the overall facility. Due to age and condition, replace 3 utility sinks in Scene Shop. Provide a total of 5 solids interceptors on sinks, 2 for the Art Rooms and 3 on the replaced utility sinks in the Scene Shop. Provide emergency shower in Restroom located in the Special Needs/Education wing for full compliance of criteria. In Science Classrooms and Prep Rooms, provide 35 compressed air connections, 2 emergency shower/eyewash combinations, 1 single emergency shower, 6 Single 4 station lab/work stations (which include a lab sink with 2 faucet/gas/compressed air combinations), 10 ADA compliant lab/work stations (1 per Science Classroom), 1 single gas connection, 36 (2) faucet/gas/compressed air combination units and 1 Instructor demonstration/prep station with sink and faucet/gas/compressed air combination. All fixtures, whether new or replaced, to be mounted at ADA compliant heights. See Item O for replacement of fixtures related to ADA requirements as well as toilet rooms for 2 Staff Restrooms and 8 Coach's Restrooms. Funding for fixtures and equipment replacement in Kitchen is provided for in Item J.</p>

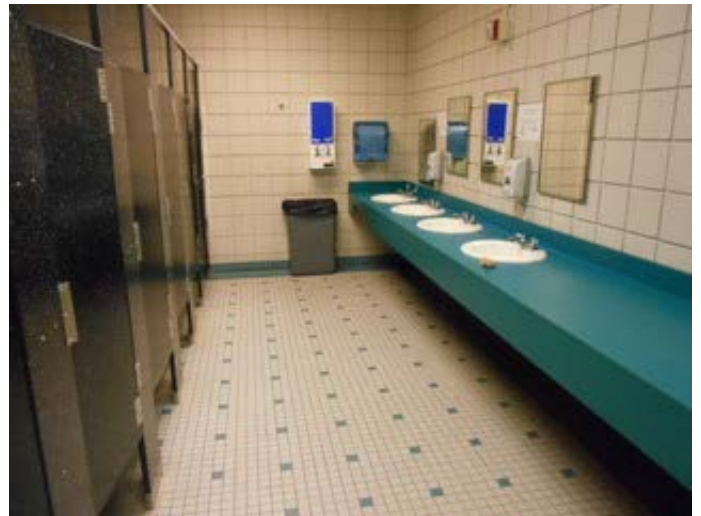
Large Group Restroom Girls 1990 Original Construction

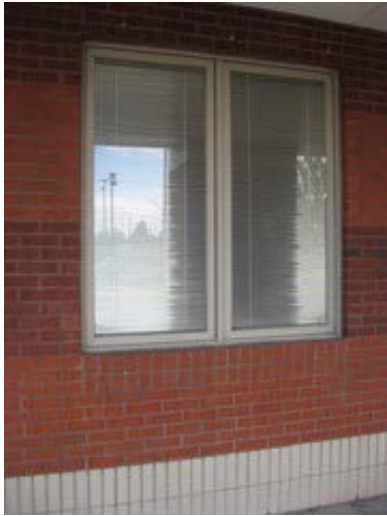
Description: The overall facility is equipped with thermally broken aluminum frame windows with single double glazed insulated glazing type window system, which was installed in 1990, and is in good condition. The window system features operable windows throughout most of the building, and operable windows are equipped with opening limiters in good condition and insect screens in good condition. Window system seals are in good condition, with no air and water infiltration being experienced. Window system hardware is in good condition. The window system features integral blinds, which are in good condition. This facility is not equipped with any curtain wall systems. There are glass block windows in the original construction, in good condition. The exterior doors in the overall facility are equipped with thermally broken aluminum frame sidelights and transoms with tempered double glazed insulated glazing, in good condition. Exterior door vision panels are double glazed insulated glazing. The school does contain 1 aluminum frame skylight in good condition. The school does not contain clerestories. Interior glass is OSDM-compliant. There is a 365 SF Greenhouse associated with this school, and it is in good condition.

Aluminum Frame Windows

Recommendations: Existing windows are in good condition, however they require replacement due to age and end of life cycle. Provide for the replacement of existing windows system.

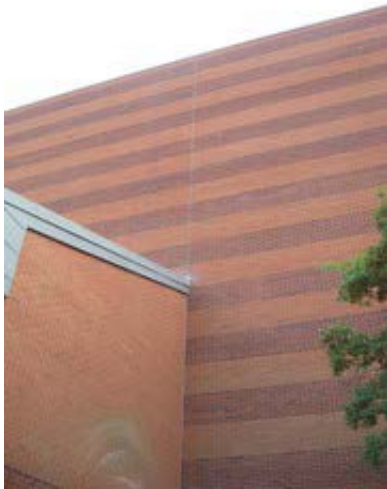
Description: The overall facility has a brick veneer and split-face block on a load bearing masonry wall system with steel framing, which displayed no locations of deterioration, and is in good condition. The exterior masonry appears to have appropriately spaced and adequately caulked control joints in good condition. Control joints are provided at lintel locations, at doors and windows, building corners, and wall offsets and are in good condition. The school does have sufficient expansion joints, and they are in good condition. Exterior walls in the overall facility are adequately insulated. Brick veneer masonry walls are cavity walls. Weep holes are provided in sufficient quantity, at 24"-48" on center, at lintels, below sills, and the base of masonry cavity walls, and are in good condition. Weep holes are rope type weeps. Vents are provided in sufficient quantity at 24"-48" on center. The exterior masonry has not yet needed to be cleaned and sealed, showing no evidence of mortar deterioration. Architectural exterior accent materials consist of split-faced block and stucco which is in good condition. Exterior building fenestration in the overall facility represents 15% of the exterior surfaces. Interior Corridor and demising walls are concrete masonry units and demountable partitions, the masonry walls project full height from floor to bottom of deck, and are in good condition. Interior masonry appears to have adequately spaced and caulked control joints in good condition. Interior soffits are of painted gypsum board type construction, and in good condition. The window sills are brick, and are in good condition. The exterior lintels are steel, and are in good condition. There are no chimneys. Canopies over entrances are elements of the roof construction, and are in good condition. Exterior soffits are of painted gypsum board type construction, and in good condition. The school is provided with an uncovered concrete conventional loading dock to facilitate the receipt of product, supplies, and foodstuffs, 445 square feet in size and featuring coiling type overhead doors. The dock itself is in good condition, and is equipped with bumper pads in good condition.

Brick Veneer and Control Joint

Recommendations: Remove and replace rope type weeps. Provide masonry cleaning and sealing as required through the overall facility.

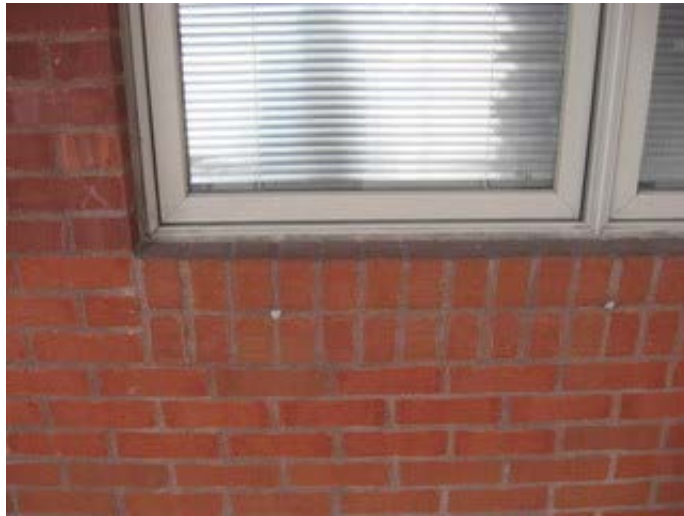
Rope Weep

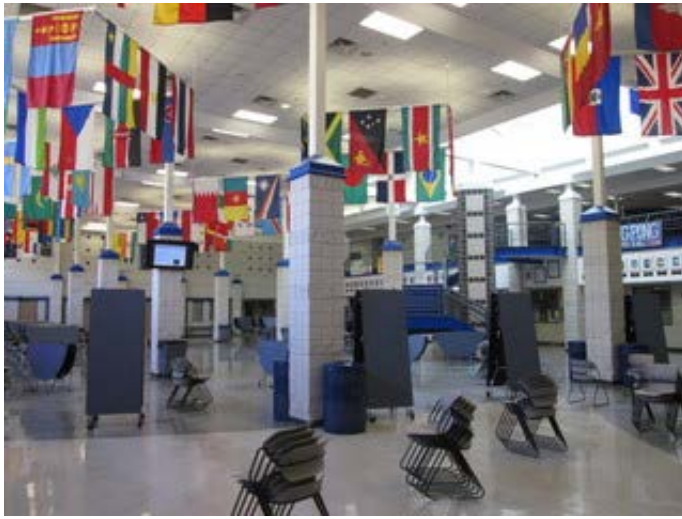
Finishes in Student Dining

Provide for sanding and refinishing of wood interior doors due to age and condition. Provide for the replacement of demountable partitions with new OSDM compliant partitions. Provide for the replacement of Kitchen equipment due to age. Provide for a new Kitchen Hood due to age. Provide for new walk-in cooler and freezer due to age. Funding for the walk-in cooler and freezer is provided for in the cost of the total Kitchen equipment replacement. Provide for the replacement of two Art Program kilns, with funding for kiln ventilation provided in Item C. Provide for appropriate acoustical sound attenuation surface treatments in the Gymnasiums, Media Center, and Student Dining. Provide for the replacement of Toilet Accessories. Provide for casework in the Classrooms. Provide for the replacement of the acoustic ceiling in the 1990 Original Construction due to installation of new HVAC and sprinkler systems. The Auditorium Fixed Seating Addition does not have ACT ceiling tiles and the Weight Room Addition has an exposed ceiling with no ACT ceiling tiles.

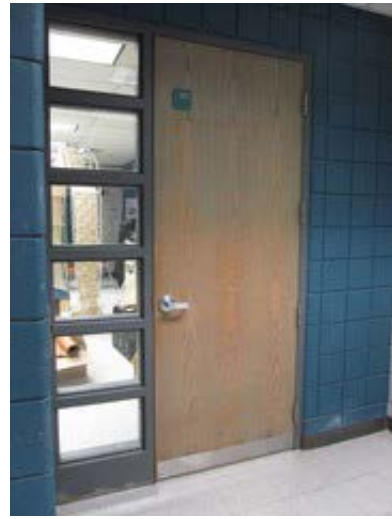
Typical Interior Wood Door

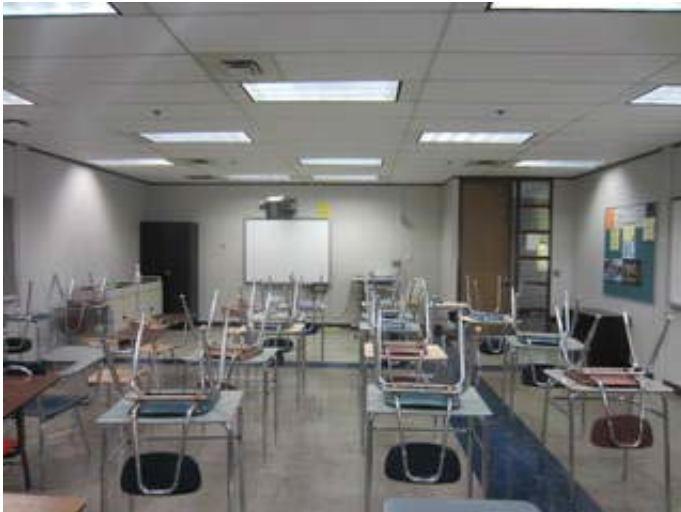
The Classrooms are equipped with 2-lamp T-8 2x4 lay-in direct parabolic fluorescent fixtures with dual level switching. Classroom fixtures are in fair condition, providing an average illumination of 60 FC, thus complying with the 40 FC recommended by the OSDM. The Corridors are equipped with some incandescent can fixtures, along with 2-lamp T-8 2x4 lay-in direct parabolic fluorescent fixtures with single level switching. Corridor fixtures are in fair condition, providing an average illumination of 12 FC, which is less than the 15 FC recommended by the OSDM. The Primary Gymnasium spaces are equipped with 6-lamp T-8 2x4 suspended fluorescent fixtures type lighting, in good to fair condition, providing an average illumination of 54 FC, thus complying the 50 FC recommended by the OSDM. The Auxiliary Gymnasium spaces are equipped with 6-lamp T-8 2x4 suspended fluorescent fixtures type lighting, in good to fair condition, providing an average illumination of 49 FC, which is less than the 50 FC recommended by the OSDM. The Student Dining spaces are equipped with incandescent can fixtures and 3-lamp T-8 2x4 lay-in direct parabolic fluorescent fixtures type lighting, in good to fair condition, providing an average illumination of 45 FC, thus complying with the 40 FC recommended by the OSDM. The Media Center is equipped with incandescent can fixtures, T-8 1x4 suspended strip fluorescent fixtures (with indirect up-lighting), and 3-lamp T-8 2x4 lay-in direct parabolic fluorescent fixtures type lighting in fair condition, providing an average illumination of 45 FC, thus complying with the 30 FC recommended by the OSDM. The Kitchen spaces are equipped with 3-lamp T-8 2x4 lay-in direct parabolic fluorescent fixtures type lighting with dual level switching. Kitchen fixtures are in fair condition, providing an average illumination of 40 FC, which is less than the 50 FC recommended by the OSDM. The Service Areas in the overall facility are equipped with T-8 1x4 surface mount and suspended fluorescent fixture type lighting in fair condition, providing inadequate illumination based on OSDM requirements. The typical Administrative spaces in the overall facility are equipped with T-8 2x4 lay-in direct parabolic fluorescent fixture type lighting fixtures. Administrative fixtures are in fair condition, providing an average illumination of 53 FC, thus complying with the 40 FC recommended by the OSDM. The overall lighting systems of the facility are not fully compliant with Ohio School Design Manual requirements due to age, condition, utilization of incandescent fixtures, inadequate lighting levels, and lack of multi-level switching.

Classroom Fluorescent Light Fixtures

Provide complete replacement of lighting system due to age, condition, lighting levels, lack of multilevel switching, utilization of incandescent fixtures, and installation of systems outlined in Items A, C, J, and U.

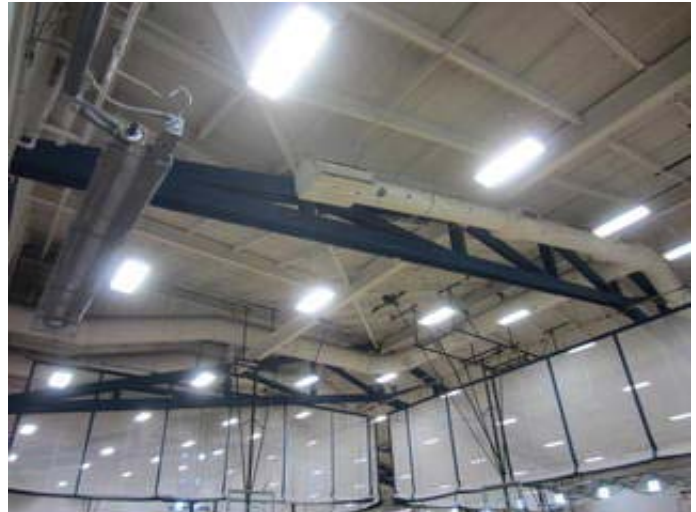
Gymnasium Fluorescent Light Fixtures

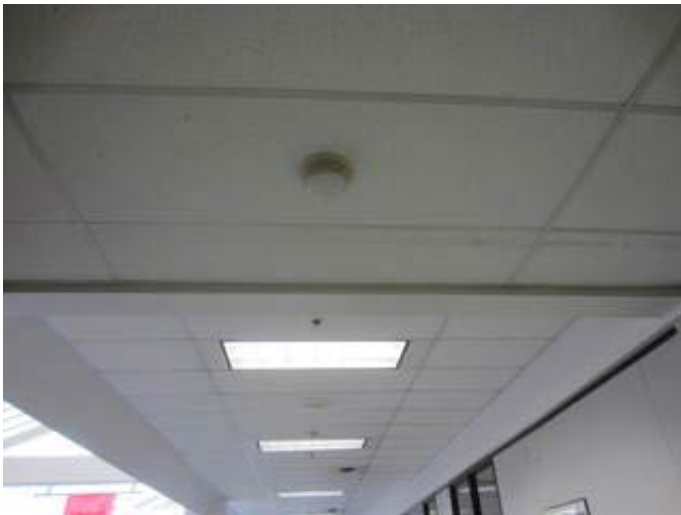
Description: The overall facility contains a motion sensor, door contact, and CCTV camera type security system in fair condition. Motion detectors are not adequately provided in main entries, central gathering areas, offices, main Corridors, and spaces where 6 or more computers are located. Exterior doors are equipped with door contacts. An automatic visitor control system is provided. Compliant color CCTV cameras are inadequately provided at the main entry area, parking lots, central gathering areas, and main Corridors. CCTV is monitored in Administrative Area with the use of staff lap tops / computers. A compliant computer controlled access control system integrating alarms and video signals, with appropriate UPS backup, is not provided. The system is equipped with card / biometric readers. The security system is not adequately provided throughout, and the system is not fully compliant with Ohio School Design Manual guidelines. Due to existing grade configuration there are no playground fencing issues requiring attention. The exterior site lighting system is equipped with recessed and surface mounted incandescent and HID high pressure sodium entry lights in fair condition. Pedestrian walkways are illuminated with surface and pole mounted HID high pressure sodium light fixtures in fair condition. Parking and bus pick-up / drop off areas are illuminated by pole mounted HID high pressure sodium light fixtures in fair condition. The exterior site lighting system provides inadequate illumination due to insufficient fixture capacity, sparse placement of fixtures, age, and condition.

Security System Motion Sensor

Recommendations: Provide complete replacement of security system to meet Ohio School Design Manual guidelines. Provide complete replacement of exterior site lighting system to meet Ohio School Design Manual guidelines.

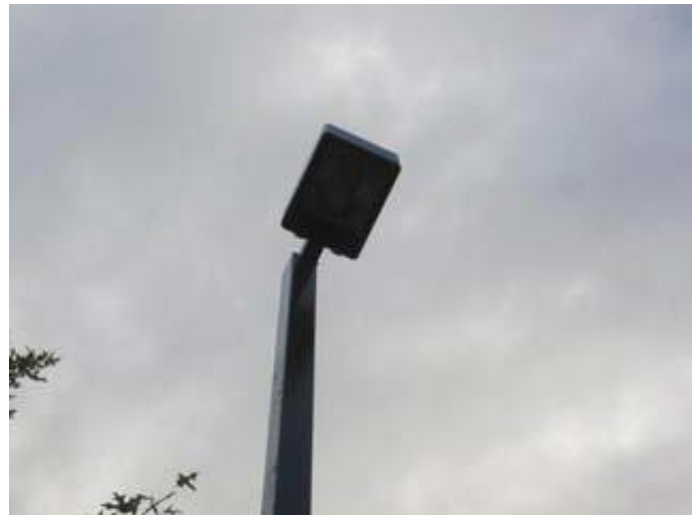
Pole Mounted HID High Pressure Sodium Light Fixture

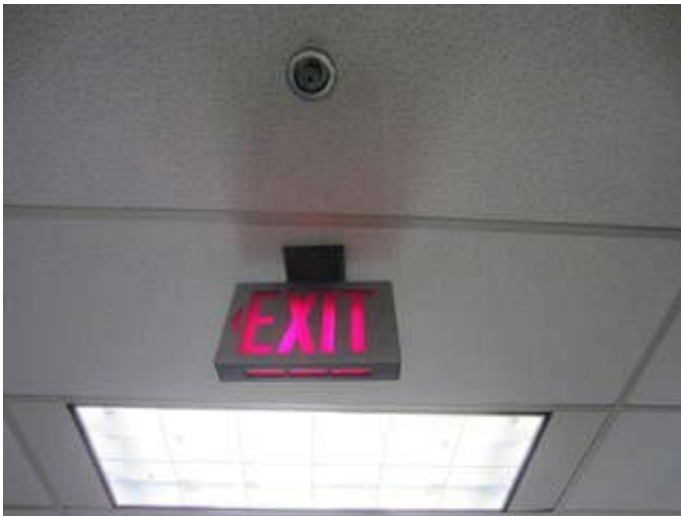
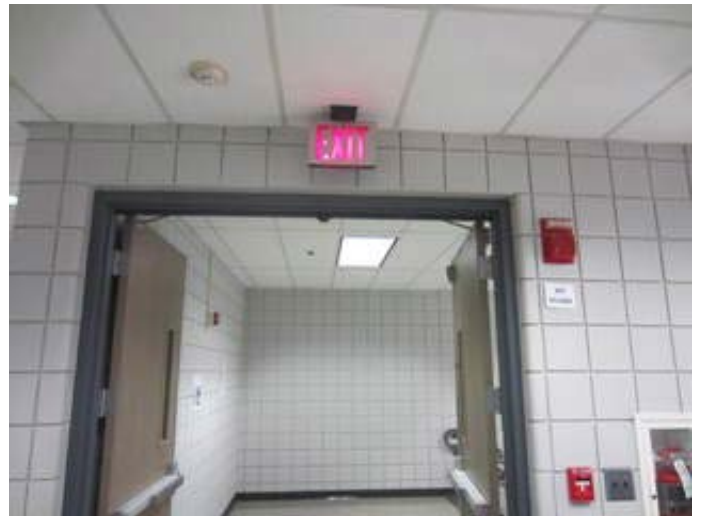
Description: The overall facility is equipped with an emergency egress lighting system consisting of non compliant plastic construction exit signs, as well as OSDM compliant red lettered and LED illuminated exit signs, and the system is in fair condition. The facility is inadequately equipped with emergency egress floodlighting and recessed fluorescent lighting used as emergency egress lighting, and the system is in fair condition. The system is provided with inadequate battery backup and diesel powered emergency generator on separate circuits and the system is in fair to poor condition. The system is not adequately provided throughout, and does not fully meet Ohio School Design Manual and Ohio Building Code requirements.

Exit Sign

Recommendations: Provide complete replacement of emergency / egress lighting system to meet Ohio School Design Manual and Ohio Building Code guidelines.

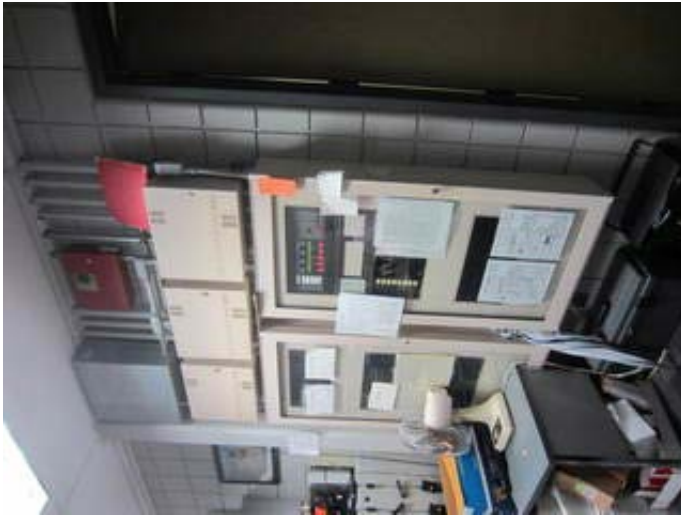
Fire Alarm System Control Panel

Recommendations: Provide complete replacement of fire alarm system to meet OBC, NFPA, and Ohio School Design Manual guidelines.

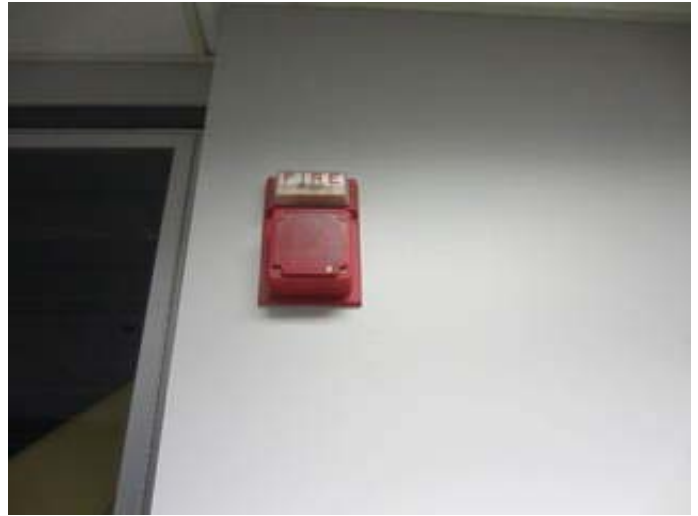
Fire Alarm System Audible Horn and Strobe Indicating Device

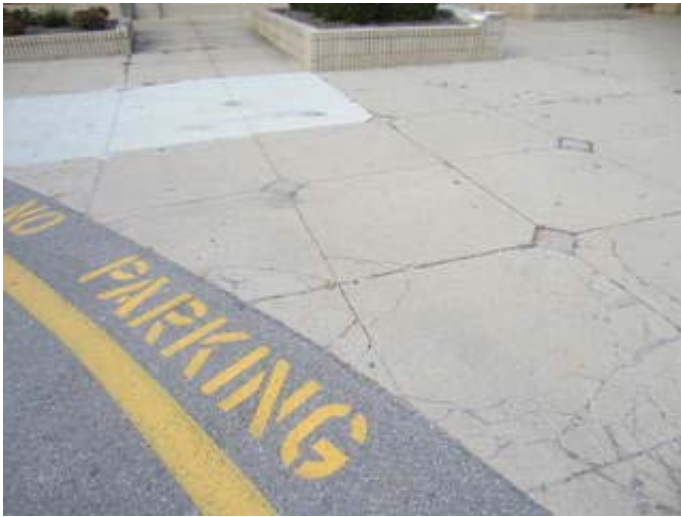
Condition of Concrete Sidewalk

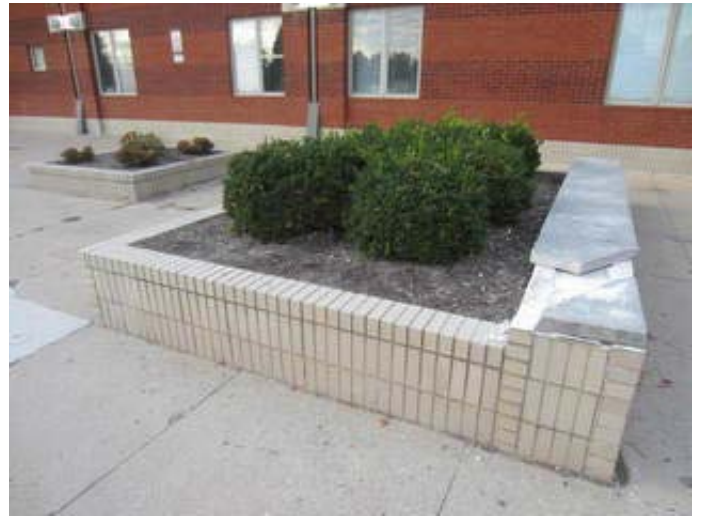
Raised Masonry Planting Bed

Other: Repair Raised Masonry Planting Beds	\$25.00	sq.ft. (Qty)			116 Required	4 Required	\$3,000.00	Repair Raised Masonry Planting Beds
Other: Replace Exterior Basketball Backboards	\$500.00	each			3 Required	1 Required	\$2,000.00	Provide for the replacement of exterior basketball backboards due to condition.
Sum:			\$1,749,573.00	\$0.00	\$1,715,778.30	\$33,794.70
