Building Information - Worthington City (45138) - Wilson Hill Elementary

Program Type	Assessment Only
Setting	Suburban
Assessment Name	Wilson Hill Elementary (041624) DRAFT
Assessment Date (on-site; non-EEA)	2015-09-28
Kitchen Type	Full Kitchen
Cost Set:	2015
Building Name	Wilson Hill Elementary
Building IRN	41624
Building Address	6500 Northland Road
Building City	Worthington
Building Zipcode	43085
Building Phone	(614) 450-4800
Acreage	11.97
Current Grades:	K-6
Teaching Stations	34
Number of Floors	1
Student Capacity	718
Current Enrollment	494
Enrollment Date	2015-09-28
Enrollment Date is the date in which the current enrollment was taken.	
Number of Classrooms	32
Historical Register	NO
Building's Principal	Mr. Dan Girard
Building Type	Elementary

Wilson Hill Elementary School, which is not on the National Register of Historic Buildings, and originally constructed in 1962, is a one story, 60,880 square foot brick school building located in a suburban residential setting. The existing facility features a conventionally partitioned design, and does not utilize modular buildings. The structure of the 1962 Original Construction and 1968 Addition contains steel frame with concrete maso

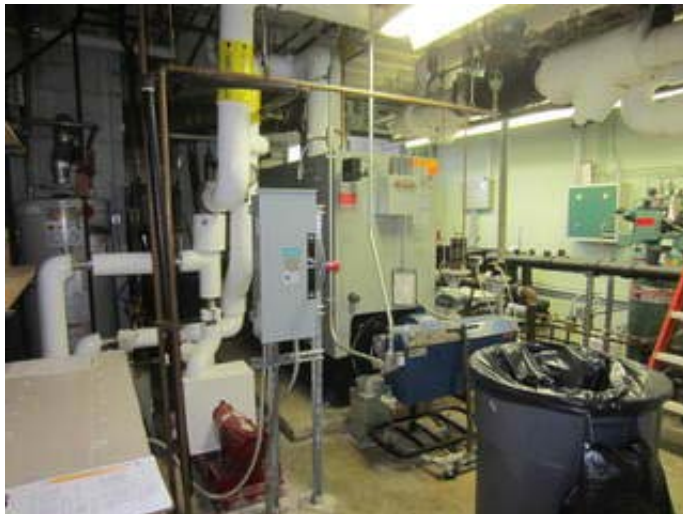
The existing system for the 1962 Original Construction is a natural gas fired heated water boiler type system, installed in 1962, with upgrades in 2009, and is in fair condition. The system in the 1988 Addition is an extension of that found in the 1962 Original Construction. The existing system for the 1968 Addition is a separate natural gas fired heated water boiler type system, installed in 1968, with upgrades in 2009, and is in fair condition. 2-pipe vs. 4-pipe designations are not applicable in the 1962 Original Construction and 1988 Addition, as no central air conditioning is provided. 2-pipe vs. 4-pipe designations are not applicable in the 1968 Addition, as the central air conditioning provided is a liquid refrigerant type system. The 1962 Original Construction is equipped with two (2) boilers, manufactured by Bryan Boilers, were installed in 2009, and are in good to fair condition. The 1968 Addition is equipped with a single boiler, manufactured by Bryan Boilers, installed in 2009, and in good to fair condition. Heating water is distributed to terminal units throughout the overall facility consisting of unit ventilators, cabinet heaters, fin tubes, fan coil units, and air handlers. The terminal equipment is original to each addition and is in fair condition. The system does not appear to fully comply with the 15 CFM per person fresh air requirements of the Ohio Building Code mechanical code and Ohio School Design Manual. The Limbach Controls and Automated Logic DDC type system temperature controls were installed in 2009 and are in good to fair condition. The system does feature individual temperature controls in all spaces required by the OSDM. The overall system does not feature any central energy recovery systems. The facility is not equipped with louvered interior doors to facilitate Corridor utilization as return air plenums. The existing systems for all spaces but the Classrooms and Corridors are ducted, but the ductwork cannot be integrated into a possible future system due to arrangement, air volume, and routing of existing ductwork. The existing systems for the Classrooms and Corridors are not ducted, but floor to structural deck heights will accommodate the installation of properly sized ductwork for a future Ohio School Design Manual approved system. The overall heating system is evaluated as not being in safe and efficient working order, and long term life expectancy of the existing system is not anticipated. The 1968 Addition is equipped with central air conditioning. The remainder of the structure is not equipped with central air conditioning, although multiple isolated room systems are provided. The site does not contain an underground fuel tank.

Natural Gas Fired Heated Water Boiler

Provide new overall heating, ventilating, and air conditioning system to achieve compliance with Ohio Building Code and Ohio School Design Manual standards. Convert the Classrooms and Corridors of the overall facility to a ducted system to facilitate efficient exchange of conditioned air. Replace the remainder of the overall facility ductwork to facilitate efficient exchange of conditioned air.

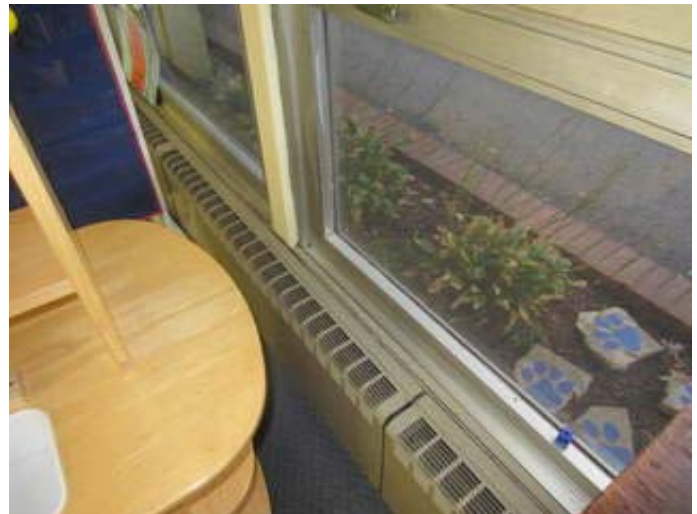
Heating Water Fin Tube

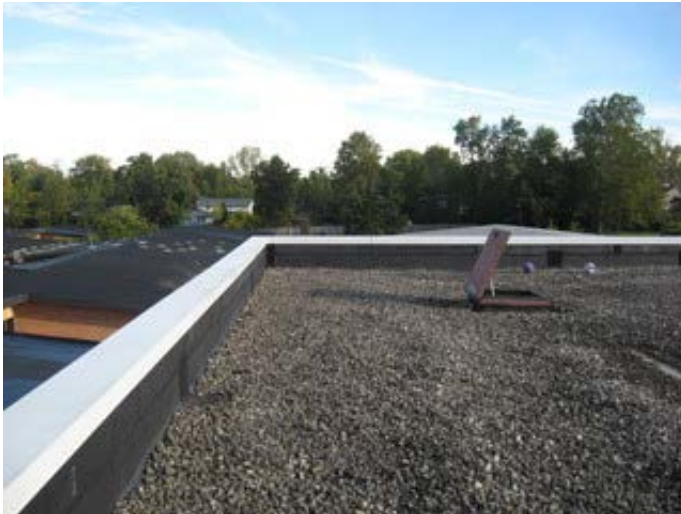
Description: The roof over the 1962 Original Construction is a ballasted membrane system that is currently being repaired at the time of assessment. The roof over the 1968 Addition is a membrane system that was installed at an unknown date and is currently in fair condition. The 1968 Addition is a EPDM system, installed at an unknown date, and is in fair condition. The roof over the 1988 Addition is a ballasted membrane system that was installed at an unknown date and is good condition. There are no District reports of current leaking. No signs of past leaking were observed during the physical assessment. Access to the roof of the 1988 Addition was gained by access hatch that is in good condition. Due to the slope of the roof, access to the roof areas of the 1962 Original Construction and 1968 Addition was not available. Fall safety protection cages in the 1988 Addition are not required. There were no observations of standing water on the roof. Metal cap flashings are in good to fair condition. Roof storm drainage in the 1962 Original Construction and the 1968 Addition is addressed through a system of gutters and downspouts, which are properly located, and in good condition. Roof storm drainage in the 1988 Addition is addressed through a system of roof drains, which are properly located, and in good condition. The roof is not equipped with overflow roof drains though they are needed on this building. No problems requiring attention were encountered with any roof penetrations. There are not any covered walkways attached to this structure.

Ballasted Roof at 1988 Addition

Recommendations: The roof over the 1968 Addition requires replacement to meet Ohio School Design Manual guidelines due to apparent age of system and projected lifecycle. And the flashing and / or coping will require replacement due to condition. Provide new / additional insulation as required due to roof replacement. Overflow drain will need to be added to the 1988 Addition.

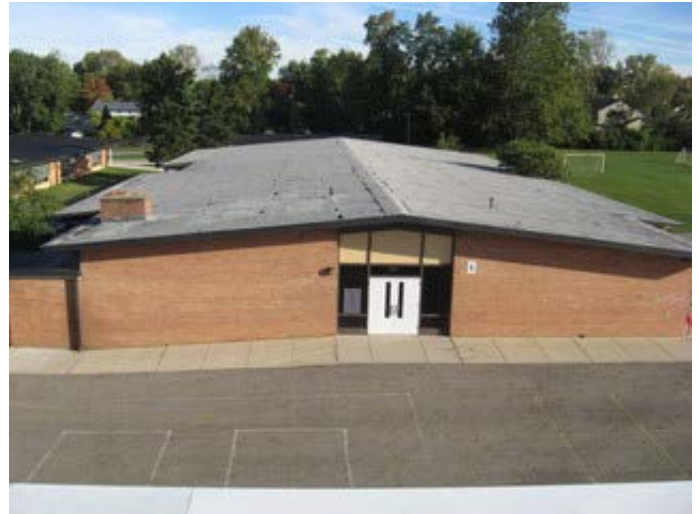
Rating: 3 Needs Replacement

Membrane Roof at 1968 Addition

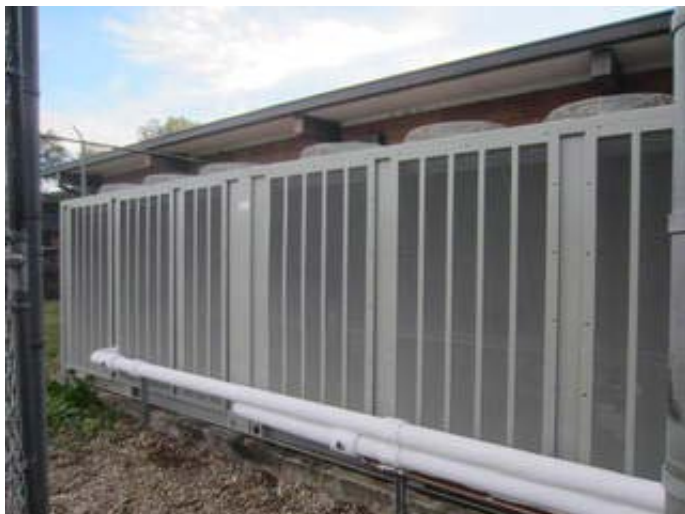
Description: The 1962 Original Construction and 1988 Addition are not equipped with a central air conditioning system. The 1968 Addition is equipped with a chilled water type central air conditioning system, which is in good to fair condition. The system consists of pad mounted Trane split system condensing units / remote chillers (located outside the Mechanical Room), in good to fair condition and multiple, with multiple pumps located inside the Mechanical Room. Window units are not present in the overall facility. The 1962 Original Construction is equipped with isolated room systems consisting of ducted split HVAC units (with multiple condensing units pad mounted in the Courtyard), provided in Administrative Offices locations. Isolated room systems consisting of unit ventilators with built-in AC condensing units are also provided in the 1962 Original Construction Classroom locations. The ventilation system in the overall facility consists of unit ventilators, original to each addition and in fair condition, providing fresh air to Classrooms, and air handlers, original to each addition and in fair condition, providing fresh air to other miscellaneous spaces such as Gymnasiums, Student Dining, and Media Center. Relief air venting is provided by ceiling plenums, central relief fans, and air handlers. The ventilation system does not appear to fully meet the Ohio Building Code 15 CFM per occupant fresh air requirement. The overall system is not compliant with Ohio Building Code and Ohio School Design Manual requirements. Dust collection systems are not required in this facility. The Art program is equipped with a kiln, and existing kiln ventilation is inadequate, and in fair condition. General building exhaust systems for Restrooms, Storage Rooms, Art Rooms, and Custodial Closets are inadequately placed, and in fair condition.

Air Cooled Condensing Unit

Recommendations: Provide an air conditioning system to meet with Ohio Building Code and Ohio School Design Manual requirements. Replace general building exhaust systems located in Restrooms, Storage Rooms, Art Rooms, and Custodial Closets. Pricing included in Item A. Replace the existing Art Program kiln ventilation system.

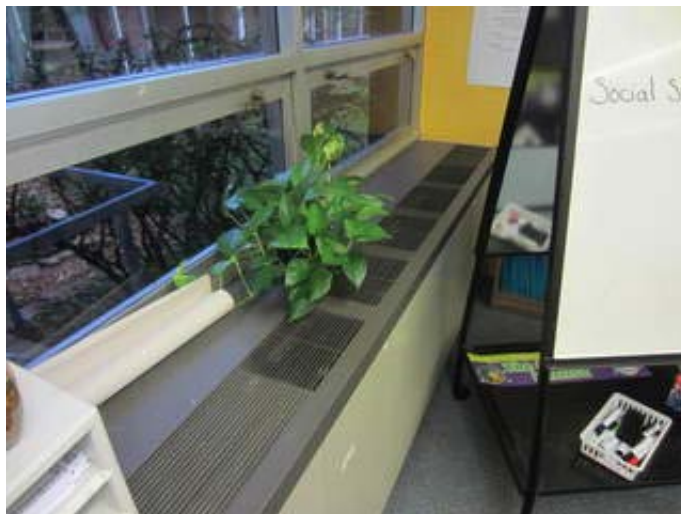
Unit Ventilator

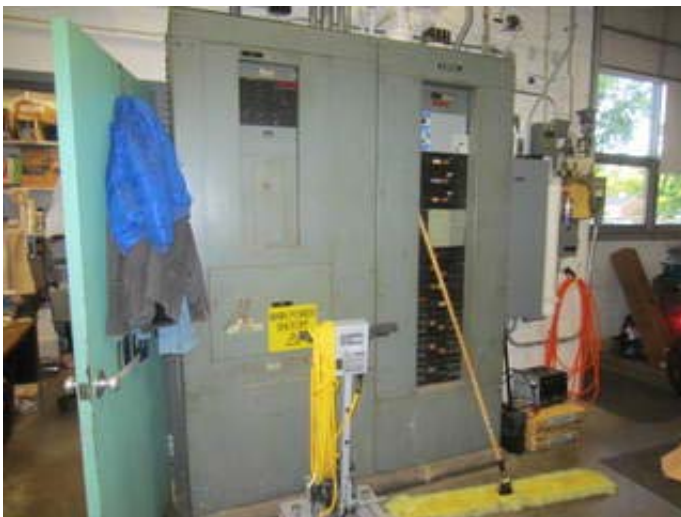
Description: The facility is equipped with two electrical systems. The first is the electrical system provided to the 1962 Original Construction, which is a 120/208 volts, 600 amp, 3 phase and 4 wire system installed in 1962, and is in fair condition. The system in the 1988 Addition is an extension of that found in the 1962 Original Construction. The second is the electrical system provided to the 1968 Addition, which is a 120/208 volts, 400 amp, 3 phase and 4 wire system installed in 1968, and is in fair condition. Power is provided to the school's two electrical systems by two utility owned, pad-mounted transformers, one located outside each Mechanical Room, and are in good to fair condition. The panel systems, original to each addition, are in fair condition, and for the most part cannot be expanded to add additional capacity. The Classrooms are not equipped with adequate electrical outlets. The typical Classroom contains five (5) general purpose outlets, one (1) dedicated outlet for each Classroom computer, and zero (0) dedicated outlets for each Classroom television. Some Classrooms are equipped with as many as six (6) general purpose outlets, while others are equipped with as few as three (3) general purpose outlets. There are not any spaces that have no electrical outlets. The Corridors are equipped with adequate electrical outlets for servicing. GFI protected exterior outlets are adequately provided around the perimeter of the building. The facility is not equipped with an emergency generator. Adequate lightning protection safeguards do not appear to be provided. The facility is not equipped with a Stage. The overall electrical system does not meet Ohio School Design Manual requirements in supporting the current needs of the school, and will be inadequate to meet the facility's future needs.

Rating: 3 Needs Replacement

Main Electrical Distribution Panel

Recommendations: The entire electrical system requires replacement to meet Ohio School Design Manual guidelines for overall capacity and due to condition and age, lack of OSDM-required features, to accommodate the addition of an air conditioning system. Provide an emergency generator, with funding included in the electrical system replacement. Provide adequate lightning protection safeguards in the overall facility, including associated grounding system, with funding included in the electrical system replacement.

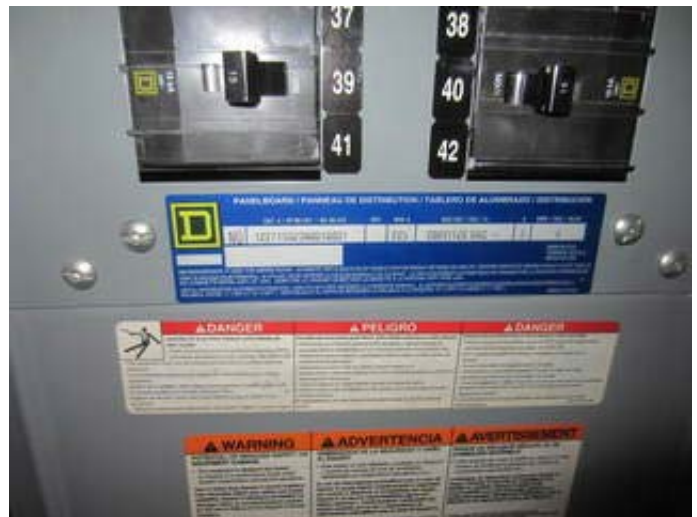
Electrical Distribution Subpanel

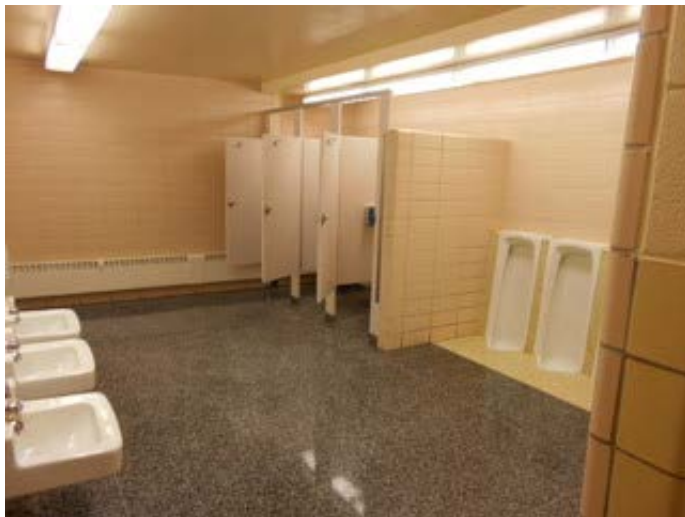
Large Group Restroom Boys 1962 Original Construction

Replace the remaining galvanized in the 1962 Original Construction and 1968 Addition with copper piping. In the overall facility, replace the remaining cast iron waste piping with PVC. Provide a reduced pressure backflow preventer. Due to waste pipe replacement, replace 15 floor mounted urinals with wall mounted ADA compliant fixtures. To facilitate the school's compliance with OBC and OSFC fixture requirements throughout the overall facility, provide 5 new Classroom sinks with deck mounted drinking fountains and replace 25 Classroom sinks with deck mounted drinking fountains due to age and condition. Due to age and condition, replace 24 toilets and 9 lavatories throughout the overall facility. Due to age, condition, LEED, OBC and OSFC, replace 71 faucets and valves throughout the overall facility. Replace grease interceptor in the Kitchen. Replace 1 single electric water cooler with an ADA compliant unit and provide 3 additional single electric water coolers. All fixtures, whether new or replaced, to be mounted at ADA compliant heights. Provide 5 additional exterior wall hydrants. See Item O for replacement, remounting of fixtures related to ADA requirements as well as toilet rooms for 1 Kitchen, 1 Clinic, 1 Coach's Office and 3 Staff Restrooms. Funding for replacement of Kitchen equipment and fixtures is provided for in Item J.

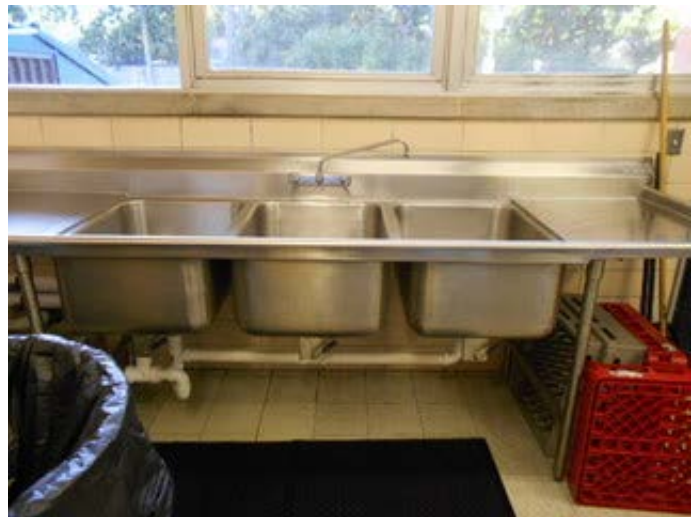
Three Compartment Sink Kitchen-1962 Original Construction

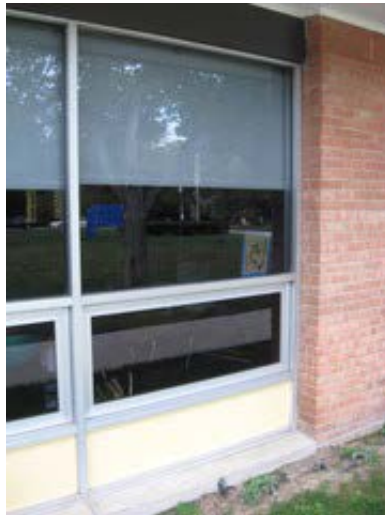
Description: The overall facility is equipped with thermally broken aluminum frame windows with single glazed type window system, which was installed at an unknown date, and is in fair condition. The window system features operable windows in most of the building, and operable windows are equipped with opening limiters in fair condition and insect screens in fair condition. Window system seals are in fair condition, with no air and water infiltration being experienced. Window system hardware is in fair condition. The window system features surface mounted blinds, which are in fair condition. This facility is not equipped with any curtain wall systems. This facility does not feature any glass block windows. The exterior doors in the overall facility are equipped with hollow metal frame sidelights and transoms with single pane glazing, in fair condition. Exterior door vision panels are single pane glazing. The school does not contain skylights. The school does not contain clerestories. Interior glass is not OSDM-compliant. Window security grilles are not provided for ground floor windows. There is not a Greenhouse associated with this school.

Rating: 3 Needs Replacement

Aluminum Frame Windows

Recommendations: Provide a new insulated window system with integral blinds to meet with Ohio School Design Manual requirements. Replace window transoms and sidelights at exterior doors of the overall facility. Funding included in the total insulated glass/panel areas. Provide for replacement of exterior door vision panels.

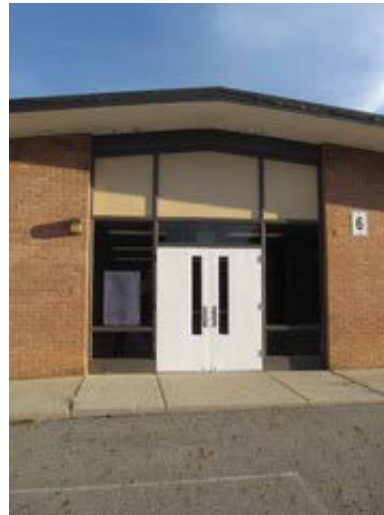
Hollow Metal Door with Transom and Sidelight

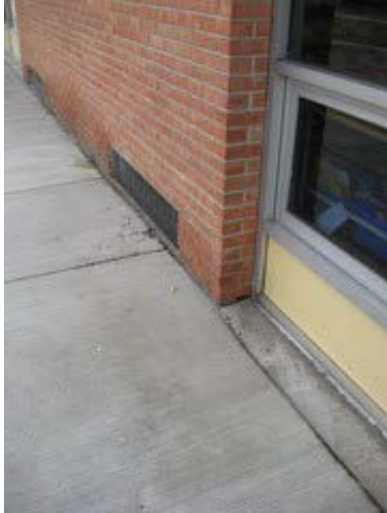
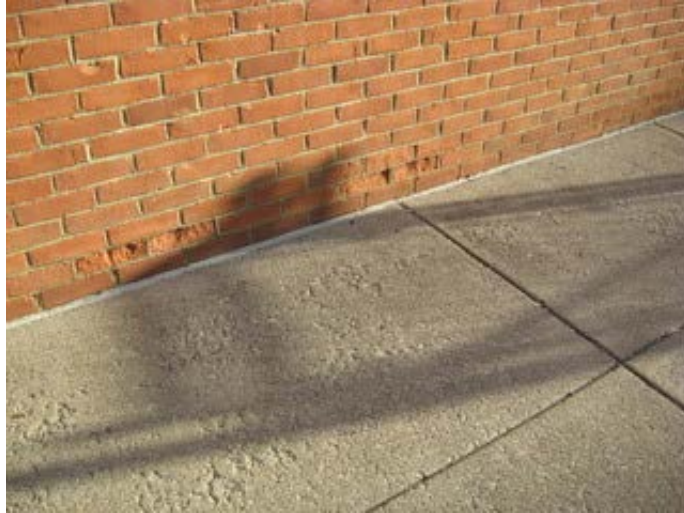
Description: The overall facility is equipped with concrete foundation walls on concrete footings, which displayed no locations of significant differential settlement, cracking, or leaking, and are in good condition. No significant issues related to foundation cracking or spalling were encountered. The District reports that there has been no past leaking. No grading or site drainage deficiencies were noted around the perimeter of the structure that are contributing or could contribute to foundation / wall structural deterioration.

Exterior Wall at Foundation

Recommendations: Existing conditions require no renovation or replacement at the present time.

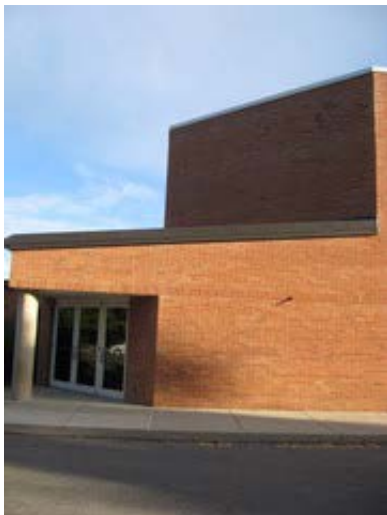
Description: The 1962 Original Construction and the 1968 Addition has a steel frame with concrete masonry unit and brick veneer, which displayed locations of deterioration, and is in fair condition. The 1988 Addition has a brick veneer on load bearing masonry wall system, which displayed locations of deterioration, and is in fair condition. The exterior masonry appears to have appropriately spaced and adequately caulked control joints in fair condition. Control joints are provided at lintel locations, at doors and windows, building corners, and wall offsets and are in fair condition. The school does have sufficient expansion joints, and they are in fair condition. Exterior walls in the overall facility are inadequately insulated. Brick veneer masonry walls are not cavity walls. Weep holes and vents are not provided or required. The exterior masonry has not been cleaned and sealed in recent years, and shows evidence of mortar deterioration. Architectural exterior accent materials consist of metal, which is in fair condition. Exterior building fenestration in the overall facility represents 28% of the exterior surfaces. Installation of new HVAC systems will result in removal of existing unit ventilators, necessitating the exterior masonry infill of associated exterior wall voids. Interior Corridor and demising walls are concrete masonry units and glazed block, project full height from floor to bottom of deck, and are in good condition. Interior masonry appears to have adequately spaced and caulked control joints in good condition. Interior soffits are of plaster or gypsum board type construction, and in good condition. The window sills are an element of the aluminum window system, and are in poor condition. The exterior lintels are steel, and are rusting. Chimneys are in fair condition requiring tuckpointing and new flashing. Canopies over entrances are steel frame and metal type construction, and are in good condition. Exterior soffits are of a plaster or metal panel type construction, and in fair condition. The school is not equipped with a loading dock.

Brick Veneer

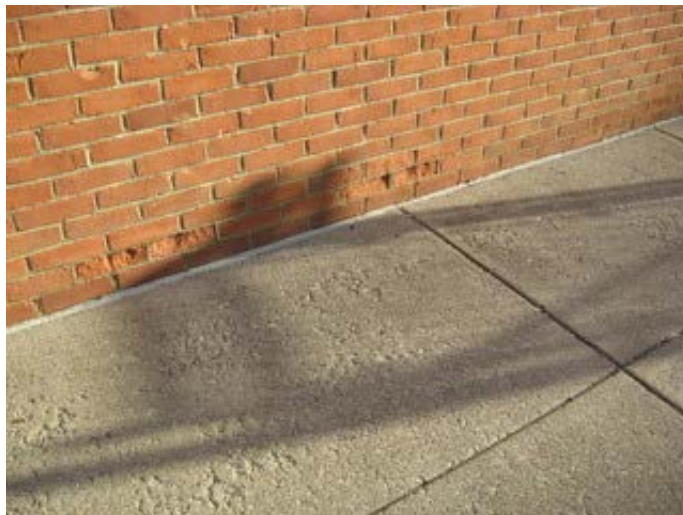
Rating: 2 Needs Repair

Brick Veneer Requiring Repair

Recommendations: Provide tuckpointing in all areas of mortar deterioration as required through the overall facility. Provide masonry cleaning and sealing as required through the overall facility. Recaulk existing control joints. Prep and paint exposed steel lintels through the overall facility. Exterior wall insulation deficiencies are addressed in Item J. Provide masonry infill at voids left by removal of exterior unit ventilator louvers in the 1962 Original Construction. Prep and paint exterior metal soffits.

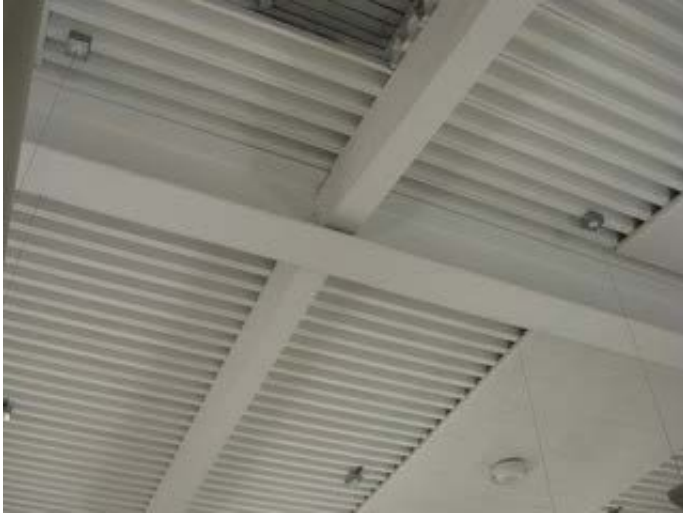
Description: The floor construction of the base floor of the overall facility is concrete slab on grade type construction, and is in good condition. There are no intermediate floors in this single story structure. Ceiling to structural deck spaces are sufficient to accommodate HVAC, electrical, and plumbing scopes of work in required renovations. The roof construction of the 1962 Original Construction and the 1967 Addition is structural composite metal deck on steel frame type construction, and is in good condition. The roof construction of the 1988 Addition is metal form deck on steel joist type construction, and is in good condition.

Structural Composite Metal Deck

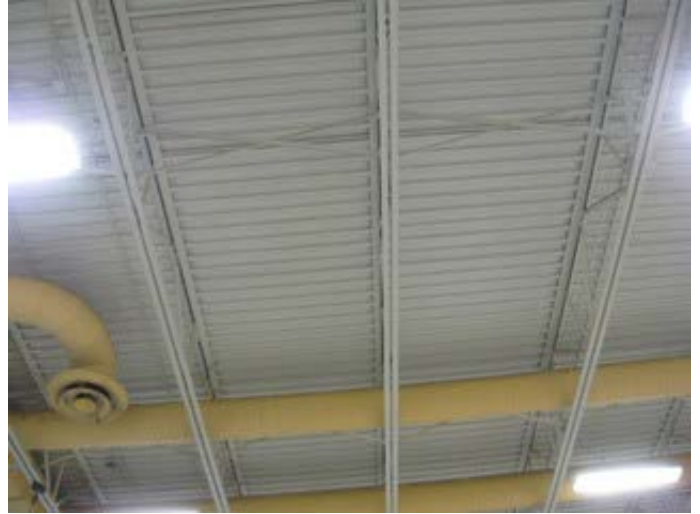
Steel Joist Structure

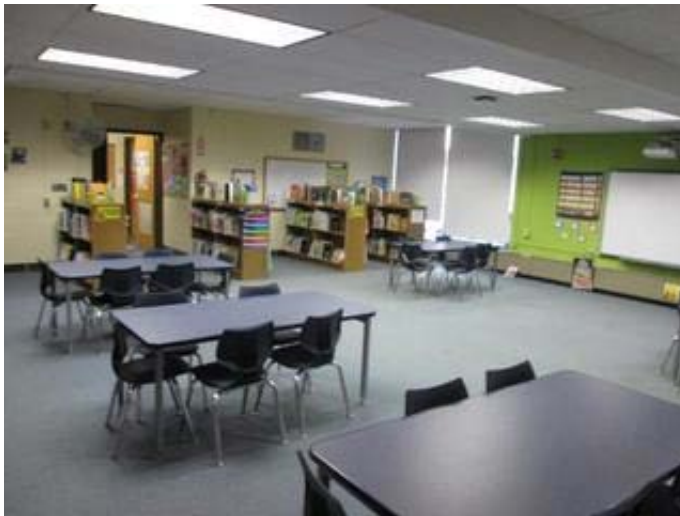
Description:	<p>The overall facility features conventionally partitioned Classrooms with VCT and carpet type flooring, exposed type ceilings, as well as painted block and glazed block type wall finishes, and they are in fair condition. The overall facility has Corridors with terrazzo type flooring, acoustical tile or painted gypsum type ceilings, as well as painted block, glazed block, brick, and laminate wood panel type wall finishes, and they are in fair condition. The overall facility has Restrooms with terrazzo or ceramic tile type flooring, painted gypsum type ceilings, as well as glazed block and painted block type wall finishes, and they are in fair condition. Toilet partitions are plastic, and are in good to fair condition. Flexible partition walls have been provided in four Classrooms between the two Courtyards. Classroom casework in the overall facility is wood or metal type construction with plastic laminate or metal tops, is adequately provided, and in fair to poor condition. The typical Classroom contains 12 lineal feet of casework, and Classroom casework provided ranges from 10 to 15 feet. Classrooms are provided adequate chalkboards, markerboards, tackboards which are in fair condition. The storage cubbies, located in the Classrooms, are adequately provided, and in fair condition. The Art program is equipped with a kiln in fair to poor condition, and existing kiln ventilation is inadequate. A staff member has indicated that a new kiln with a new ventilation system is scheduled to be installed at some time during the same day of the assessment. The facility is equipped with wood non-louvered interior doors that are recessed without proper ADA hardware and clearances, and in fair condition. Typical Classroom doors are equipped with sidelights containing louvered panels and interior glass, and is not OSDM-compliant. The Gymnasium space has VCT type flooring, exposed type ceilings, as well as painted block type wall finishes, and they are in fair condition. There are no Gymnasium stands. Gymnasium basketball backboards are an electrically operated type, and are in fair condition. The Media Center, located in the 1962 Original Construction, has carpet type flooring, acoustical tile type ceilings, as well as painted block type wall finishes, and they are in fair condition. Student Dining, located in the 1962 Original Construction, has VAT type flooring, exposed type ceilings, as well as painted block and glazed block type wall finishes, and they are in fair condition. There is no Stage in the overall facility. Stage related equipment is demountable and was located in a storage room adjacent to the Gymnasium during the assessment. Existing Student Dining space is adequately provided with appropriate sound attenuation acoustical surface treatments. Existing Gymnasium, Music Room, and Media Center is not provided with appropriate sound attenuation acoustical surface treatments. The existing Kitchen is full service, is undersized based on current enrollment, and the existing Kitchen equipment, installed over 20 years ago, is in fair to poor condition. The Kitchen hood is in fair condition, and is equipped with the required UL 300 compliant wet chemical fire suppression system. The required 6" overhang on all three exposed sides of the cooking equipment is provided by the hood. Kitchen hood exhaust ductwork is of proper construction, material, insulation, and installed as required by the OSDM and OBCMC. A walk-in cooler is located within the Kitchen spaces, and is in fair condition.</p>

Media Center Finishes

Rating:	2 Needs Repair
Recommendations:	<p>Provide for the complete replacement of finishes and casework due to condition and installation of systems outlined in Items A, C, D, E, K, L, M, N, T, U, and W. Provide for the replacement of interior doors of interior doors due to age and condition Provide for the replacement of glass sidelights and louvered panels adjacent to interior Classroom doors. Louvered panels within interior glazing frames are to be replaced with OSDM-compliant glass. Provide for the repair of terrazzo flooring due to condition. Provide for an Art Program kiln, with funding for the exhaust system provided in Item C. Provide for the replacement of toilet accessories. Provide for Gymnasium Stands. Provide for two Gymnasium Basketball Backboards. Provide for appropriate acoustical sound attenuation surface treatments in the Music spaces, Gymnasium, and Media Center. Provide for the replacement of a walk-in cooler due to age and condition. Funding for the walk-in cooler and freezer is provided for in the cost of the total Kitchen equipment replacement. Provide for the replacement of the Kitchen Hood due to age and condition. Provide for the replacement of Kitchen equipment due to age and condition. Provide for additional wall insulation. Provide for replacement of cement board and gypsum board due to work in Item T.</p>

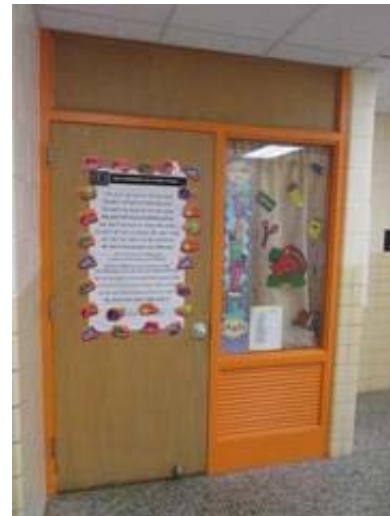
Typical Classroom Door

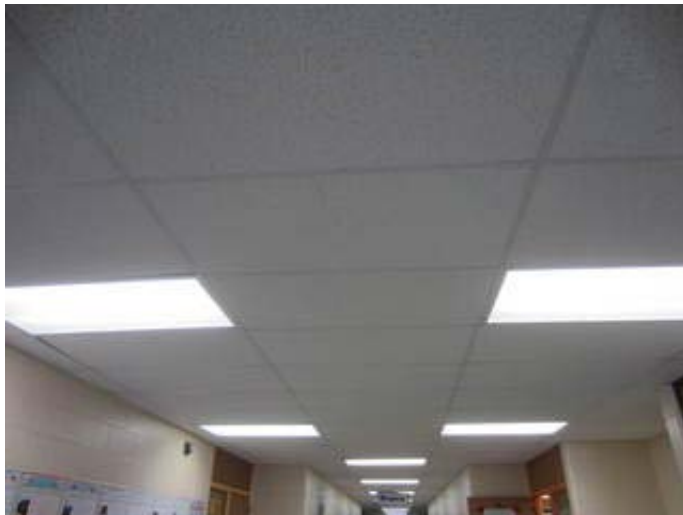
The typical Classrooms in the overall facility are equipped with 2-lamp T-8 1x4 suspended continuous strip direct (with indirect up-lighting) fluorescent fixtures with dual level switching. Classroom fixtures are in fair condition, providing an average illumination of 30 FC, which is less than the 40 FC recommended by the OSDM. The typical Corridors in the overall facility are equipped with 4-lamp T-8 2x4 lay-in direct fluorescent fixtures with single level switching. Corridor fixtures are in fair condition, providing an average illumination of 26 FC, thus complying with the 15 FC recommended by the OSDM. The Gymnasium spaces are equipped with 3-lamp T-5 suspended fluorescent fixtures type lighting, in good to fair condition, providing an average illumination of 28 FC, which is less than the 30 FC recommended by the OSDM. The Student Dining spaces are equipped with T-8 1x4 suspended continuous strip direct (with indirect up-lighting) fluorescent fixtures type lighting, in fair condition, providing an average illumination of 90 FC, thus complying with the 40 FC recommended by the OSDM. The Media Center is equipped with T-8 2x4 la-in direct fluorescent fixture type lighting in good to fair condition, providing an average illumination of 35 FC, thus complying with the 30 FC recommended by the OSDM. The Kitchen spaces are equipped with 2-lamp T-12 1x4 continuous strip surface mount fluorescent fixture type lighting with dual level switching. Kitchen fixtures are in fair condition, providing an average illumination of 45 FC, which is less than the 50 FC recommended by the OSDM. The Service Areas in the overall facility are equipped with 2-lamp T-12 1x4 suspended fluorescent fixture type lighting in fair condition, providing inadequate illumination based on OSDM requirements. The typical Administrative spaces in the overall facility are equipped with 3-lamp T-8 2x4 lay-in direct fluorescent fixture type lighting fixtures. Administrative fixtures are in fair condition, providing an average illumination of 35 FC, which is less than the 40 FC recommended by the OSDM. The overall lighting systems of the facility are not fully compliant with Ohio School Design Manual requirements due to age, condition, inadequate lighting levels, utilization of T-12 fixtures, and lack of multi-level switching.

Corridor Fluorescent Light Fixtures

Provide complete replacement of lighting system due to age, condition, lighting levels, lack of multilevel switching, utilization of T-12 fixtures, and installation of systems outlined in Items A, C, J, and U.

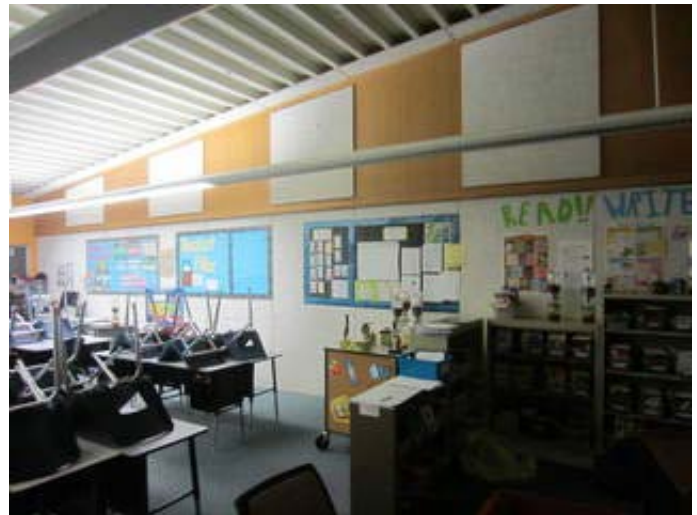
Classroom Fluorescent Light Fixtures

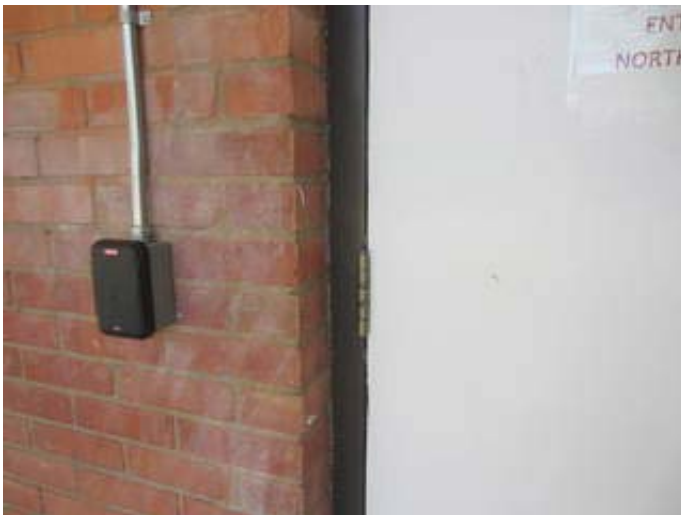
Description: The overall facility contains a Habitec motion sensor, door contact, and CCTV camera type security system in good to fair condition. Motion detectors are not adequately provided in main entries, central gathering areas, offices, main Corridors, and spaces where 6 or more computers are located. Exterior doors are equipped with door contacts. An automatic visitor control system is provided. Compliant color CCTV cameras are provided at the main entry area only and is not provided at parking lots, central gathering areas, and main Corridors. CCTV is monitored in Administrative Area with the use of a LCD TV / monitor. A compliant computer controlled access control system integrating alarms and video signals, with appropriate UPS backup, is not provided. The system is equipped with card / biometric readers. The security system is not adequately provided throughout, and the system is not fully compliant with Ohio School Design Manual guidelines. There are playground fencing issues requiring attention, as the site and playground areas are not fully fenced to meet OSDM guidelines. The exterior site lighting system is equipped with surface mounted HID high pressure sodium entry lights in fair condition. Pedestrian walkways are illuminated with surface and pole mounted HID high pressure sodium light fixtures in fair condition. Parking and bus pick-up / drop off areas are illuminated by pole mounted HID high pressure sodium light fixtures in fair condition. The exterior site lighting system provides inadequate illumination due to insufficient fixture capacity, sparse placement of fixtures, age, and condition.

Security System Card Reader

Recommendations: Provide complete replacement of security system to meet Ohio School Design Manual guidelines. Provide complete replacement of exterior site lighting system to meet Ohio School Design Manual guidelines. Provide playground fencing as required to meet OSDM guidelines, with funding included in the security system replacement.

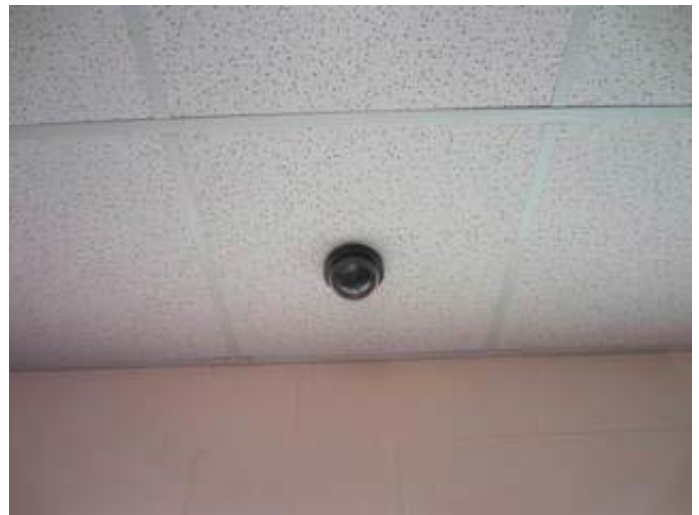
Security System CCTV Camera

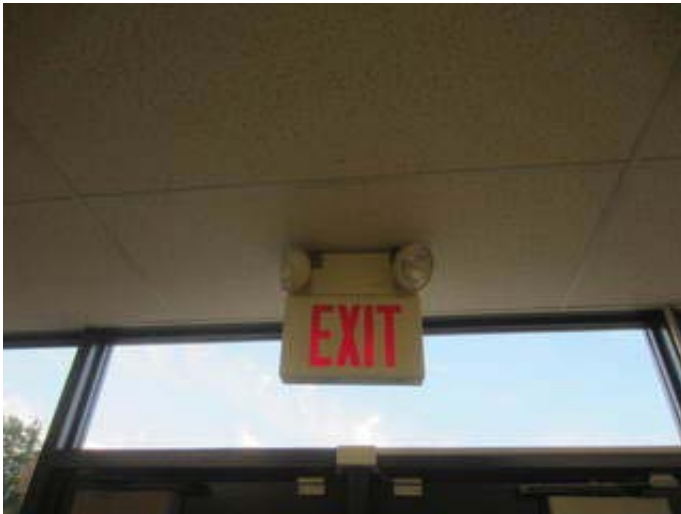
Description: The overall facility is equipped with an emergency egress lighting system consisting of non compliant plastic construction exit signs, as well as OSDM compliant red lettered and LED illuminated exit signs, and the system is in fair condition. The facility is inadequately equipped with emergency egress floodlighting and recessed fluorescent lighting used as emergency egress lighting, and the system is in fair condition. The system is not provided with appropriate battery backup or emergency generator on separate circuits. The system is not adequately provided throughout, and does not meet Ohio School Design Manual and Ohio Building Code requirements.

Exit Sign with Emergency Egress Lighting

Recommendations: Provide complete replacement of emergency / egress lighting system to meet Ohio School Design Manual and Ohio Building Code guidelines.

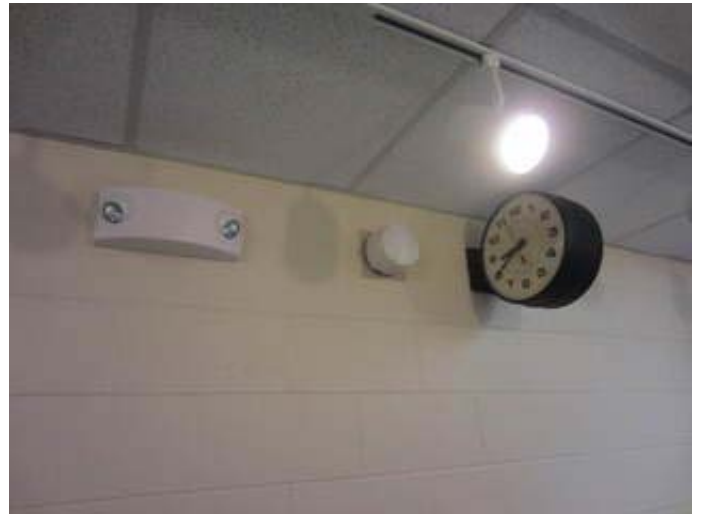
Emergency Egress Light Fixture

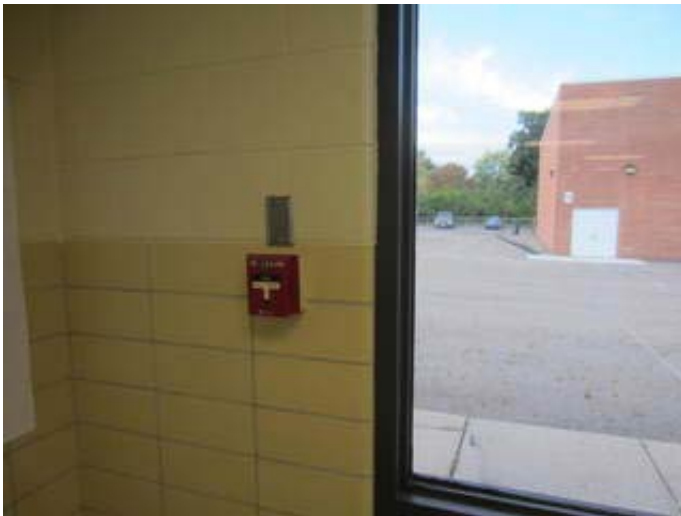
Fire Alarm System Manual Pull Station

Recommendations: Provide complete replacement of fire alarm system to meet OBC, NFPA, and Ohio School Design Manual guidelines.

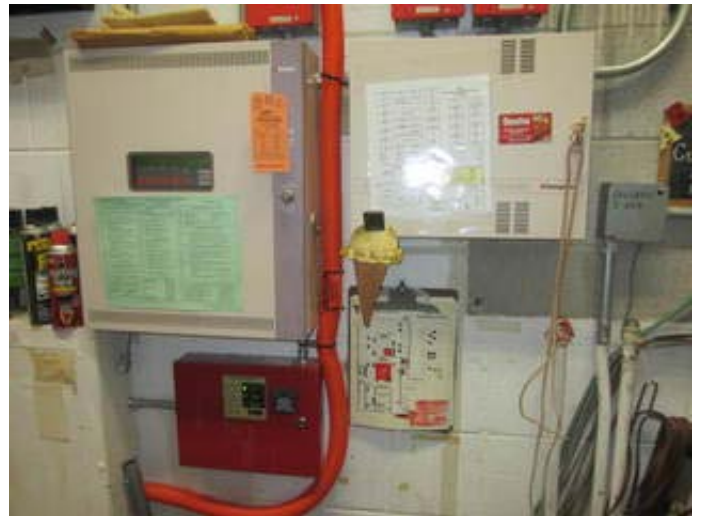
Fire Alarm System Control Panel

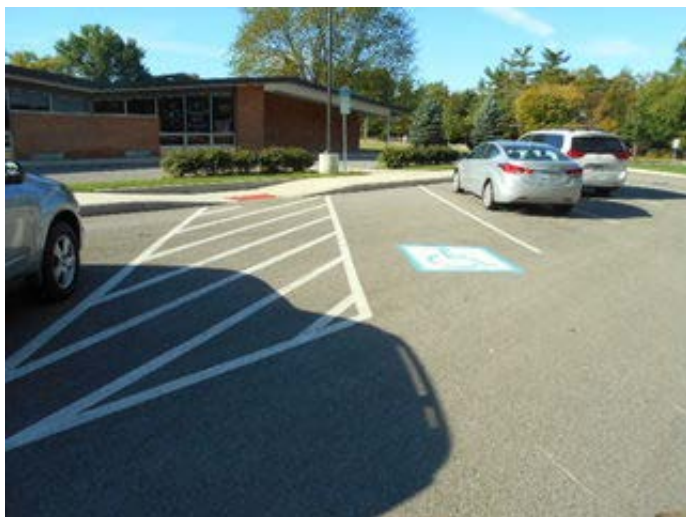
Compliant Parking Space with Access

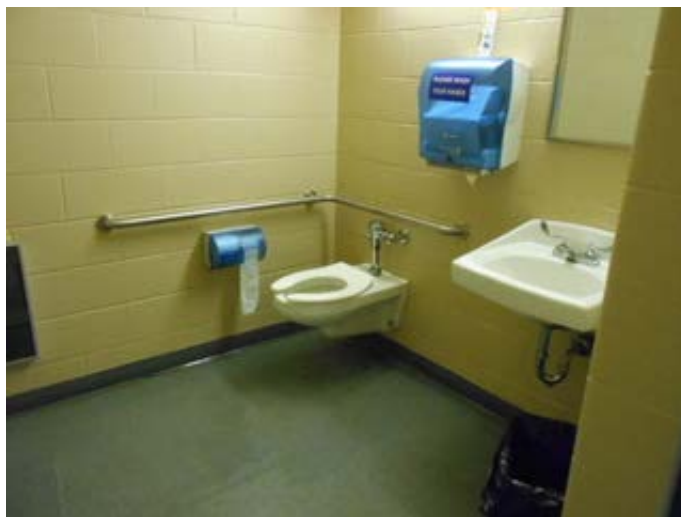
ADA Compliant Toilet Room-1988 Addition

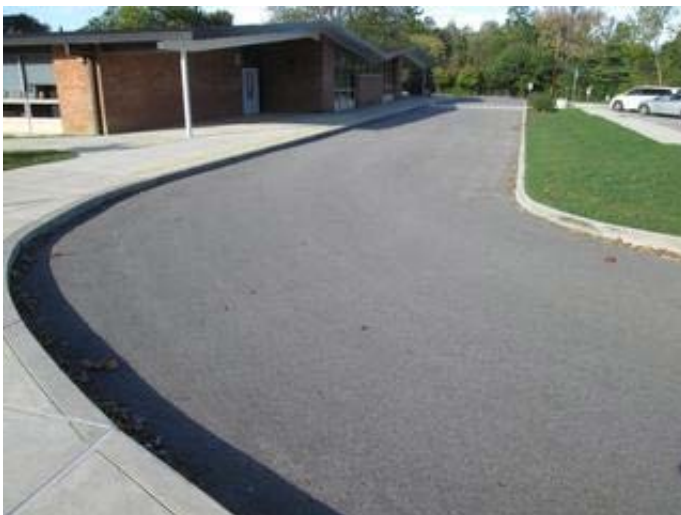
Asphalt Bus Loop and Concrete Curbs

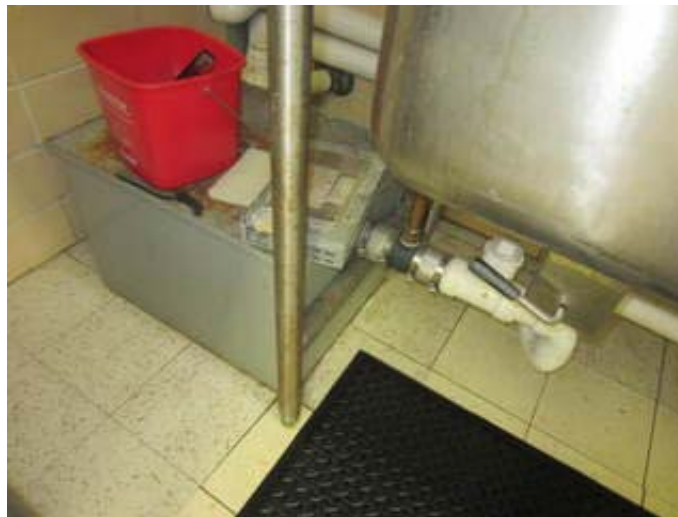
Kitchen Grease Trap Interceptor

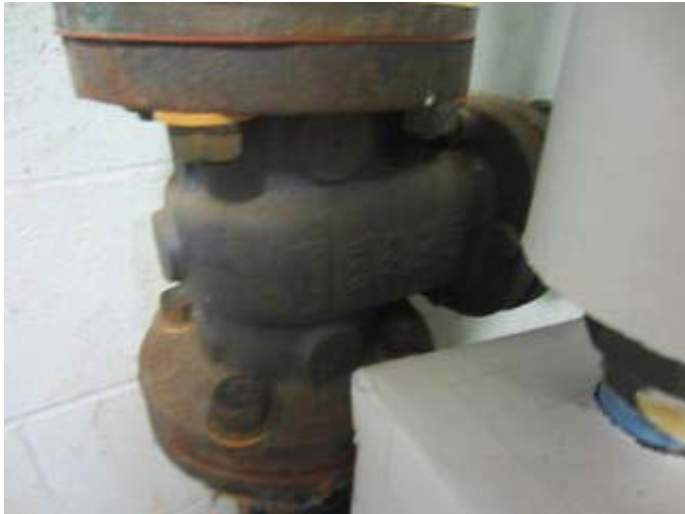
Incoming Domestic Water Service Line

Recommendations: Provide a new city water supply line of adequate capacity to support the existing needs of the facility, as well as a future automated fire suppression system. Funding provided in Item U.

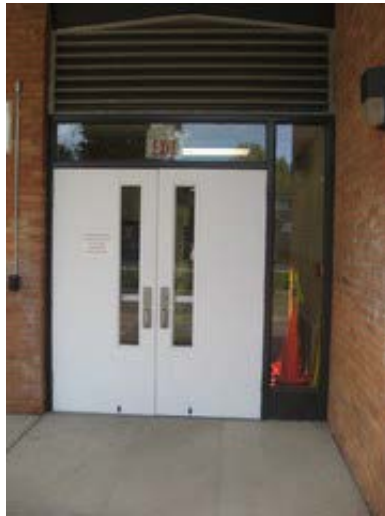
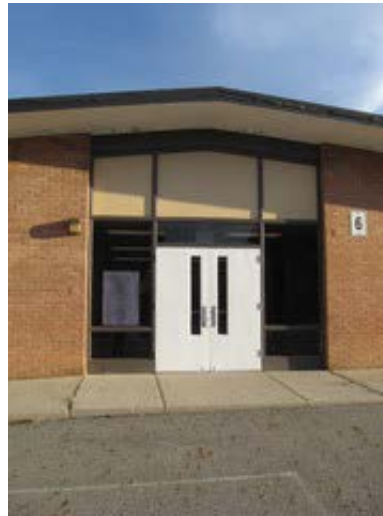
Hollow Metal Door with Transom and Sidelight

Recommendations: Replace all exterior and entrance doors to comply with Ohio Building Code, ADA, and Ohio School Design Manual guidelines. Replacement of single glazed door vision panels, transoms, and sidelights is addressed in Item F. Provide funding for replacement of 3 exterior fire doors in the 1962 Original Construction and 1 exterior fire door in the 1968 Classroom Addition. Funding for removal of doors due to hazardous materials is provided for in Item T.

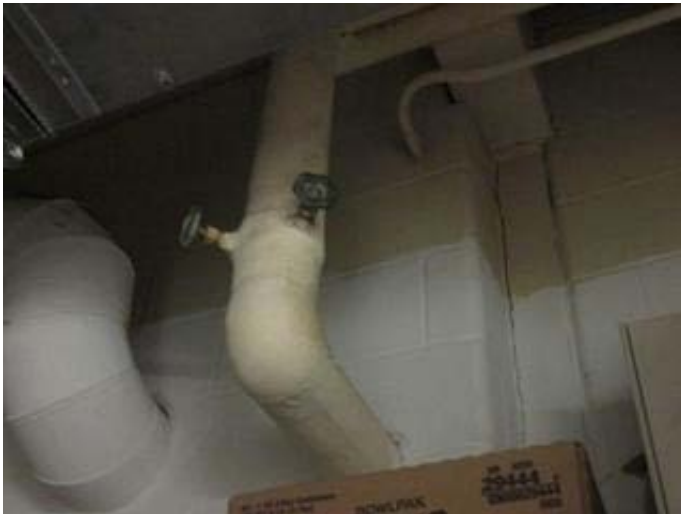
Pipe Fitting

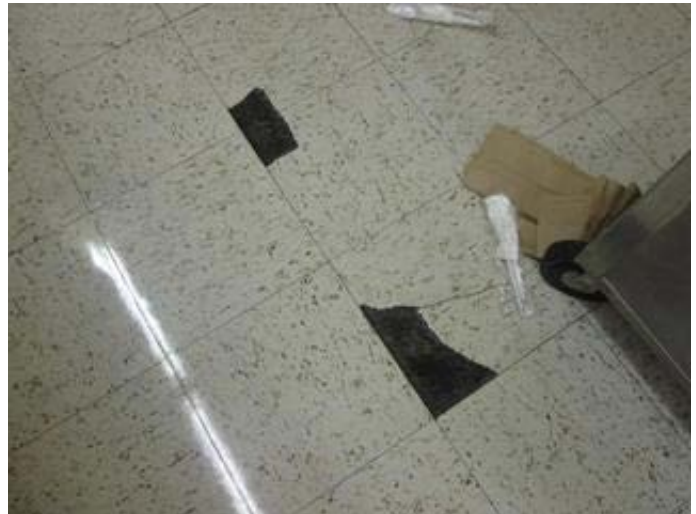
VAT Flooring

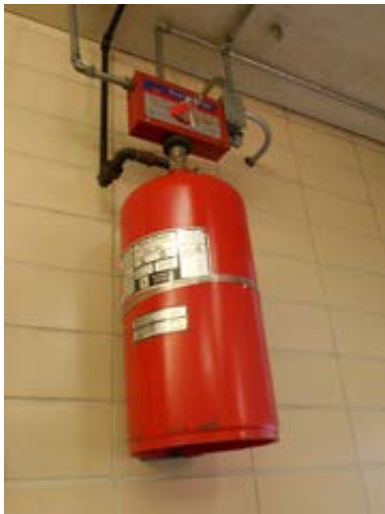
Compliant Wet Chemical Fire Suppression System

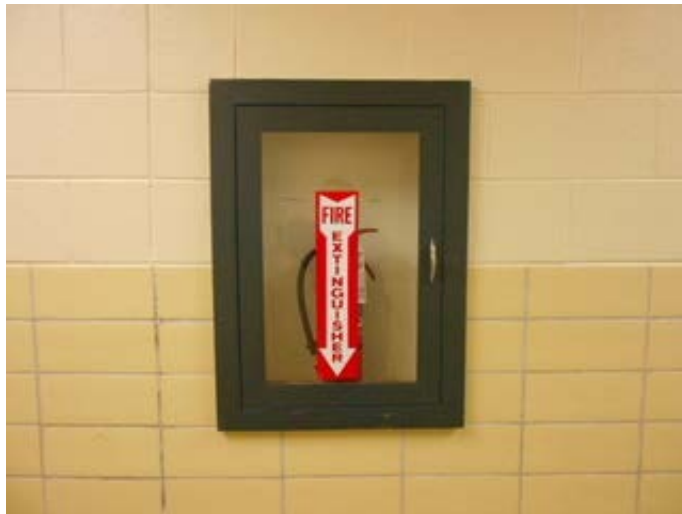
Compliant Fire Extinguisher

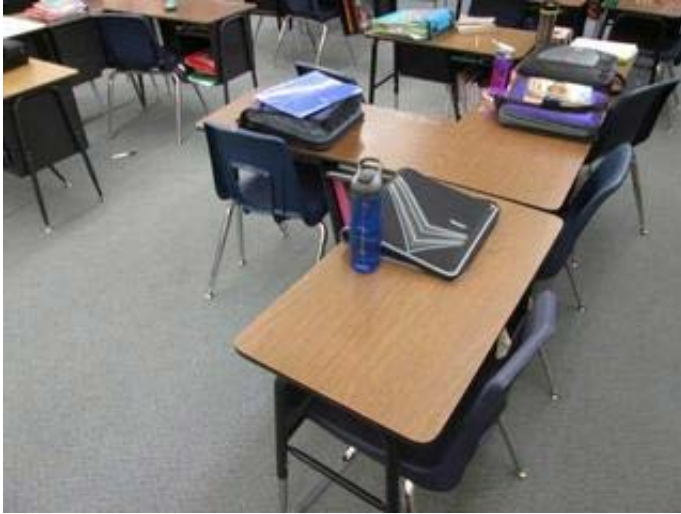
Typical Student Desk and Chair

Recommendations: Provide for replacement of outdated or inadequate furnishings.

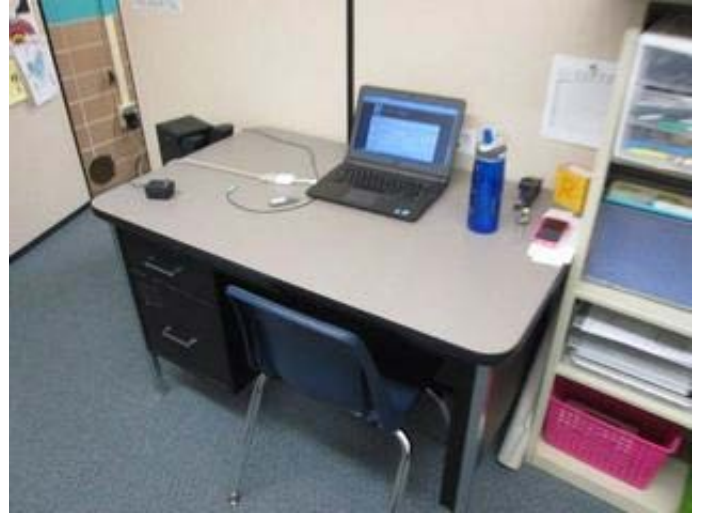
Typical Teacher Desk

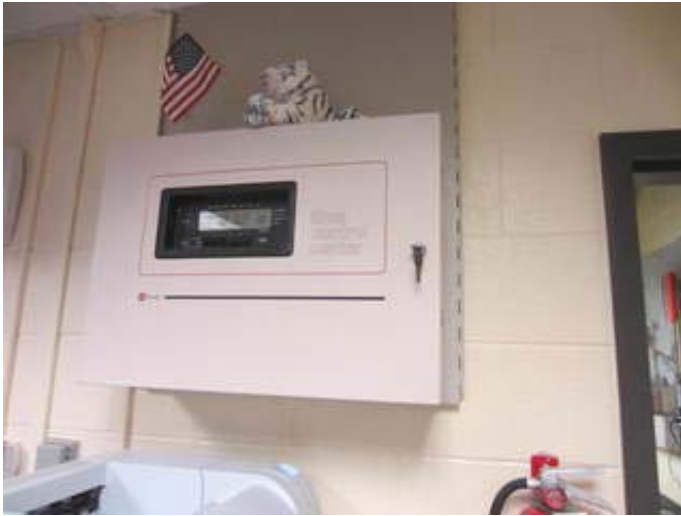
Centralized Clock System

Recommendations: Provide complete replacement of technology systems to meet Ohio School Design Manual requirements.

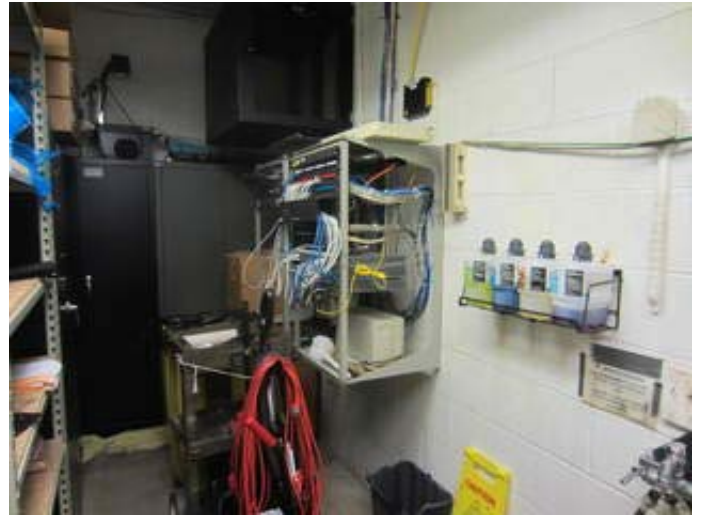
Data Rack
