Building Information - Worthington City (45138) - Worthington Estates Elementary

Program Type	Assessment Only
Setting	Suburban
Assessment Name	Worthington Estates Elementary (042275) DRAFT
Assessment Date (on-site; non-EEA)	2015-09-28
Kitchen Type	Full Kitchen
Cost Set:	2015
Building Name	Worthington Estates Elementary
Building IRN	42275
Building Address	6760 Rieber Street
Building City	Worthington
Building Zipcode	43085
Building Phone	(614) 450-4600
Acreage	24.01
Current Grades:	K-6
Teaching Stations	36
Number of Floors	1
Student Capacity	818
Current Enrollment	677
Enrollment Date	2015-09-28
Enrollment Date is the date in which the current enrollment was taken.	
Number of Classrooms	34
Historical Register	NO
Building's Principal	Mr. Rob Messenheimer
Building Type	Elementary

Building Construction Information - Worthington City (45138) - Worthington Estates Elementary (42275)

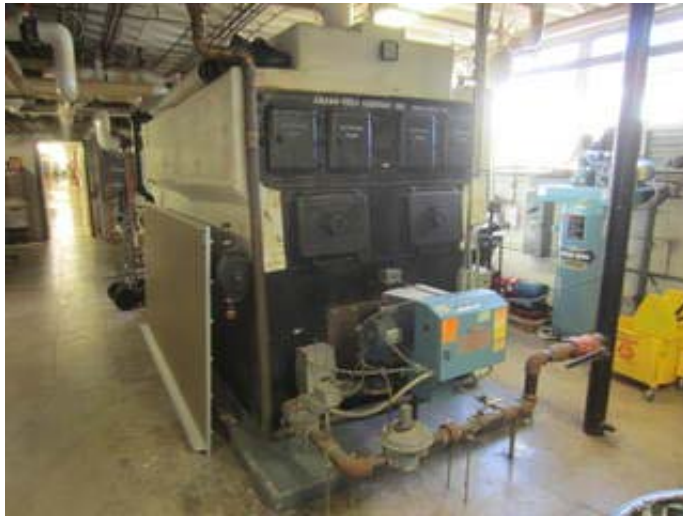
The existing system for the 1968 Original Construction is a natural gas fired heated water boiler type system, installed in 1968, with upgrades in 2005, and is in fair condition. The systems in the 1971 and 1988 Additions are an extension of that found in the 1968 Original Construction. The heating and chilled water system in the overall facility is a 4-pipe system, with a capacity for simultaneous heating and cooling operation, which is compliant with the OSDM requirements for basic system type. The 1968 Original Construction is equipped with two (2) boilers, one manufactured by Frank Prox Company, installed in 1968, and in fair to poor condition, the other manufactured by Bryan Boilers, installed in 2005, and in good to fair condition. Heating water is distributed to terminal units throughout the overall facility consisting of unit ventilators, cabinet heaters, fin tubes, and air handlers. The terminal equipment is original to each addition and is in fair condition. The system does not appear to fully comply with the 15 CFM per person fresh air requirements of the Ohio Building Code mechanical code and Ohio School Design Manual. The Automated Logic DDC type system temperature controls were installed in 2008 and are in good to fair condition. The system does feature individual temperature controls in all spaces required by the OSDM. The overall system does not feature any central energy recovery systems. The facility is not equipped with louvered interior doors to facilitate Corridor utilization as return air plenums. The existing systems in the 1971 and 1988 Additions are ducted, but the ductwork cannot be integrated into a possible future system due to arrangement, air volume, and routing of existing ductwork. The existing systems in the 1968 Original Construction are not ducted, but floor to structural deck heights will accommodate the installation of properly sized ductwork for a future Ohio School Design Manual approved system. The overall heating system is evaluated as not being in safe and efficient working order, and long term life expectancy of the existing system is not anticipated. The structure is equipped with central air conditioning. The site does not contain an underground fuel tank.

Natural Gas Fired Heated Water Boiler Type System

Provide new overall heating, ventilating, and air conditioning system to achieve compliance with Ohio Building Code and Ohio School Design Manual standards. Convert the 1968 Original Construction to a ducted system to facilitate efficient exchange of conditioned air. Replace the ductwork in the 1971 and 1988 Additions to facilitate efficient exchange of conditioned air.

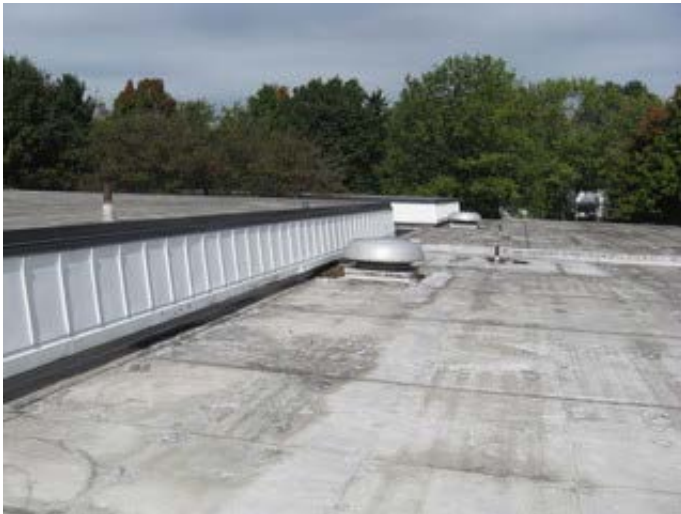
Description: The roof over the 1968 Original Construction and the 1971 Addition is a mechanically fastened, fully adhered membrane system and standing seam metal roof system, installed at an unknown date, and are in fair condition. The roof over the 1988 Addition is a ballasted membrane system that appears original to the addition and standing seam metal roof system, both are in good condition. There are no District reports of current leaking. No signs of past leaking were observed during the physical assessment. Access to the roof was gained by access hatch that is in good condition. Fall safety protection cages are not required. There were no observations of standing water on the roof. Metal flashings and copings are in good condition on the 1988 Addition and in fair condition over the rest of the facility. Roof storm drainage is addressed through a system of roof drains, which are properly located, and in fair condition. The roof is not equipped with overflow roof drains though they will be required in areas of roof replacement and they are needed on the 1988 Addition. No problems requiring attention were encountered with any roof penetrations. There are not any covered walkways attached to this structure.

Rating: 3 Needs Replacement

Membrane Roof and Standing Seam Metal

Recommendations: The roof over the 1968 Original Construction and 1971 Addition requires replacement due to age of system and projected lifecycle. Provide for the replacement of insulation due to roof replacement and OBC requirements. The flashing and / or coping at the 1968 Original Construction and the 1971 Addition require replacement due to condition and roof replacement. Funding for flashing and coping replacement is provided for in the complete replacement of roof. Add overflow roof drains to the 1988 Addition. Replace roof drains and add overflow roof drains to the 1968 Original Construction and the 1971 Addition.

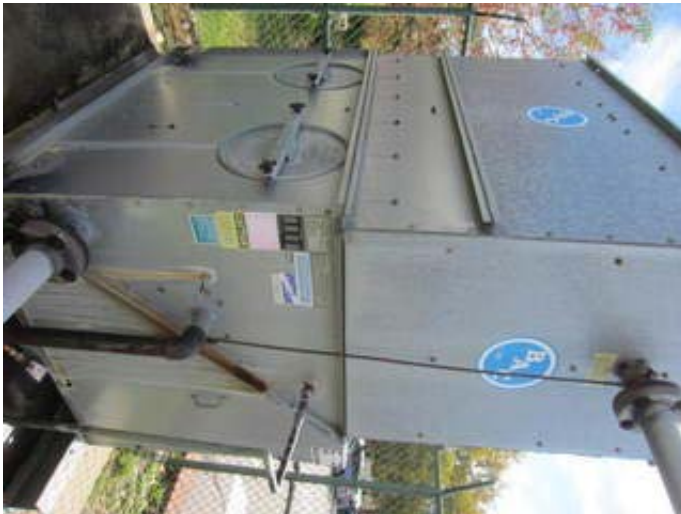
Description: The overall facility is equipped with a chilled water type central air conditioning system, which is in fair condition. The system consists of a single Baltimore Aircoil Company cooling tower, in fair to poor condition, and a single Carrier water cooled piston chiller, in good to fair condition, providing chilled water to terminal units consisting of unit ventilators and air handlers. The overall facility is not equipped with any window units. An isolated room system consisting of a ducted split HVAC system, with the Carrier Gemini condensing unit on a pad outside the Mechanical Room and the Trane air handler in the ceiling, is located in the 1968 Original Construction Administrative Offices area. The ventilation system in the overall facility consists of unit ventilators and air handlers, original to each addition and in fair condition, providing fresh air to Classrooms, and air handlers original to each addition and in fair condition, providing fresh air to other miscellaneous spaces such as Gymnasium, Student Dining, and Media Center. Relief air venting is provided by ceiling plenums, central relief fans, and air handlers. The ventilation system does not appear to meet the Ohio Building Code 15 CFM per occupant fresh air requirement. The overall system is not compliant with Ohio Building Code and Ohio School Design Manual requirements. Dust collection systems are not required in this facility. The Art program is equipped with a kiln, and existing kiln ventilation is inadequate, and in fair condition. General building exhaust systems for Restrooms, Storage Rooms, Art Rooms, and Custodial Closets are inadequately placed, and in fair condition.

Rating: 2 Needs Repair

BAC Cooling Tower

Recommendations: Provide an air conditioning system to meet with Ohio Building Code and Ohio School Design Manual requirements. Replace general building exhaust systems located in Restrooms, Storage Rooms, Art Rooms, and Custodial Closets. Pricing included in Item A. Provide new kiln ventilation/exhaust system for kilns recommended in Item J.

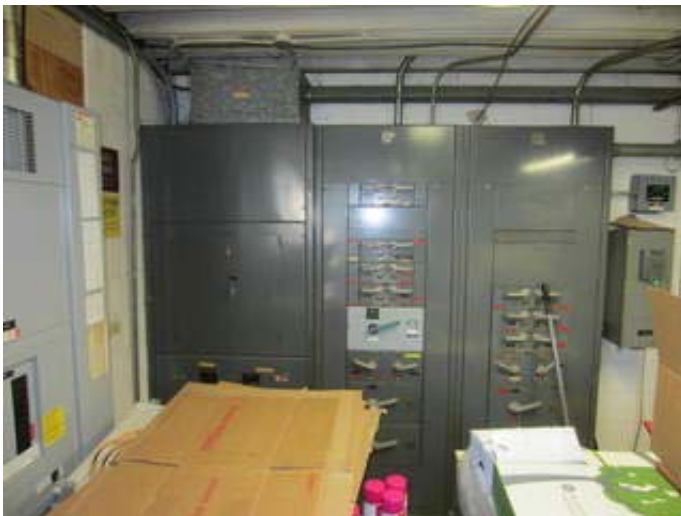
Description: The electrical system provided to the 1968 Original Construction is a 480/277 volts, 600 amp, 3 phase and 4 wire system installed in 1968 with upgrades in 1995, and is in fair condition. The systems in the 1971 and 1988 Additions are an extension of that found in the 1968 Original Construction. Power is provided to the school by multiple utility owned, pole-mounted transformers located outside the Mechanical Room, and are in fair condition. The panel systems, original to each addition, are in fair condition, and for the most part cannot be expanded to add additional capacity. The Classrooms are not equipped with adequate electrical outlets. The typical Classroom contains six (6) general purpose outlets, zero (0) dedicated outlets for each Classroom computer, and one (1) dedicated outlet for each Classroom television. Some Classrooms are equipped with as many as seven (7) general purpose outlets, while others are equipped with as few as five (5) general purpose outlets. There are not any spaces that have no electrical outlets. The Corridors are equipped with adequate electrical outlets for servicing. GFI protected exterior outlets are adequately provided around the perimeter of the building. The facility is not equipped with an emergency generator. Adequate lightning protection safeguards do not appear to be provided. The facility is not equipped with a Stage. The overall electrical system does not meet Ohio School Design Manual requirements in supporting the current needs of the school, and will be inadequate to meet the facility's future needs.

Rating: 3 Needs Replacement

Main Electrical Distribution Panel

Recommendations: The entire electrical system requires replacement to meet Ohio School Design Manual guidelines for overall capacity and due to condition and age, lack of OSDM-required features, to accommodate the addition of an air conditioning system. Provide an emergency generator, with funding included in the electrical system replacement. Provide adequate lightning protection safeguards in the overall facility, including associated grounding system, with funding included in the electrical system replacement.

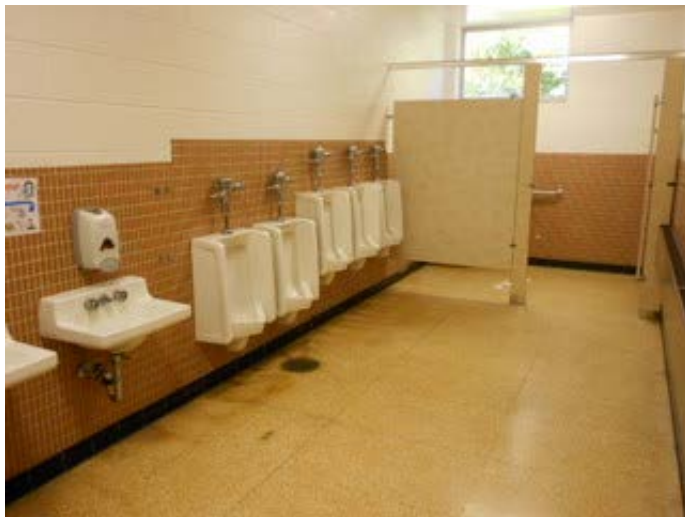
Large Group Restroom Boys 1968 Original Construction

In the overall facility, replace the remaining cast iron waste piping with PVC and the remaining galvanized domestic water supply with copper. To facilitate the school's compliance with OBC and OSFC fixture requirements throughout the overall facility, provide 5 new Classroom sinks with deck mounted bubblers and, due to age and condition, replace 28 Classroom sinks with deck mounted bubblers. Due to age and condition, replace 19 toilets, 14 urinals and 23 lavatories throughout the overall facility. Due to age, condition, LEED, OBC and OSFC, replace 57 faucets and valves throughout the overall facility. Provide a new grease interceptor/trap in the Kitchen. Provide solids interceptor on sink in Art Room. Provide 5 additional ADA compliant electric water coolers. All fixtures, whether new or replaced, to be mounted at ADA compliant heights. Provide 3 additional exterior wall hydrants. See Item O for replacement, remounting of fixtures related to ADA requirements as well as toilet rooms for 1 Kitchen, 1 Clinic, 1 Coach's Office, 1 Special Education Classroom, 1 Mechanical Room Restroom and 2 Staff Restrooms. Funding for replacement of Kitchen equipment and fixtures is provided for in Item J.

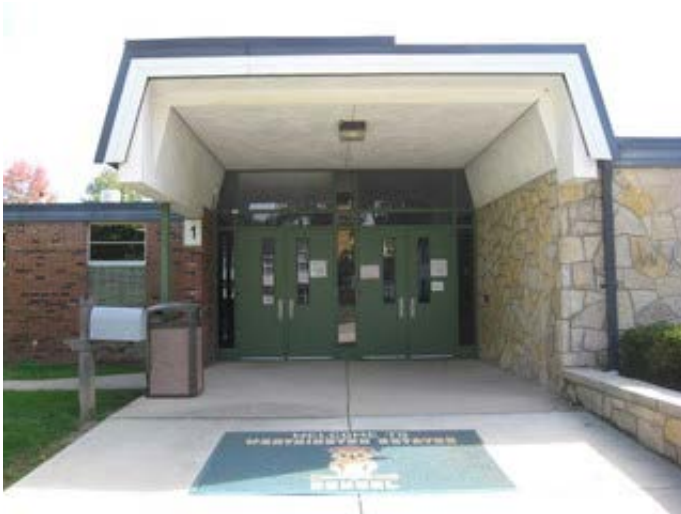
Transoms and Sidelights

Recommendations: Provide a new insulated window system with integral blinds to meet with Ohio School Design Manual requirements. Replace window transoms and sidelights at exterior doors of the overall facility. Finding to be included in the total replacement window area. Provide for the replacement of exterior door vision panels.

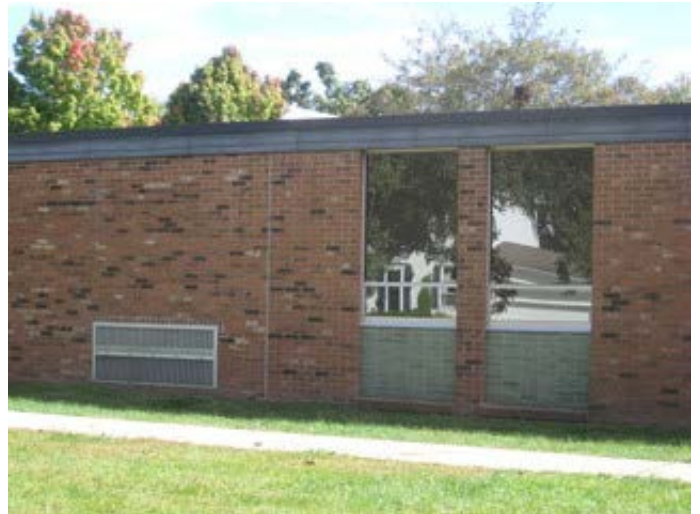
Description: The overall facility is equipped with thermally broken aluminum frame windows with single glazed type window system, which were installed at an unknown date, and is in fair condition. The window system features operable windows in most of the building, and operable windows are equipped with opening limiters in fair condition and insect screens in fair condition. Window system seals are in fair condition, with no air and water infiltration being experienced. Window system hardware is in fair condition. The window system features surface mounted blinds, which are in fair condition. This facility is not equipped with any curtain wall systems. This facility does not feature any glass block windows. The exterior doors in the overall facility are equipped with hollow metal frame sidelights and transoms with single pane glazing, in fair condition. Exterior door vision panels are single pane glazing. The school does not contain skylights. The school does not contain clerestories. Interior glass is not OSDM-compliant. Window security grilles are not provided for ground floor windows. There is not a Greenhouse associated with this school.

Rating: 3 Needs Replacement

Aluminum Frame Windows

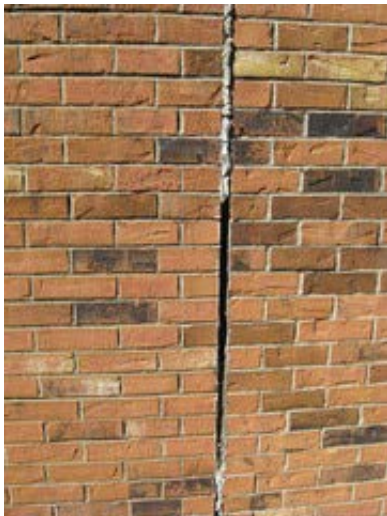
Description: The overall facility has a brick veneer on load bearing masonry wall system, which displayed no locations of deterioration, and is in good condition. The exterior masonry appears to have appropriately spaced and adequately caulked control joints in good condition. Control joints are not provided at lintel locations, at doors and windows, building corners, and wall offsets, though are not needed. The school does have sufficient expansion joints, and they are in poor condition. Exterior walls in the overall facility are inadequately insulated. Brick veneer masonry walls are not cavity walls. Weep holes and vents are not provided or required. The exterior masonry has not been cleaned and sealed in recent years, showing some evidence of mortar deterioration. Architectural exterior accent materials consist of stone and glazed brick, which are in good condition. Exterior building fenestration in the overall facility represents 12% of the exterior surfaces. Installation of new HVAC systems will result in removal of existing unit ventilators, necessitating the exterior masonry infill of associated exterior wall voids. Interior Corridor and demising walls are concrete masonry units and glazed block, project full height from floor to bottom of deck, and are in good condition. Interior masonry appears to have adequately spaced and caulked control joints in good condition. Interior soffits are of gypsum board type construction, and in good condition. The window sills are an element of the aluminum window system, and are in fair condition. The exterior lintels are steel are rusting, and in fair to poor condition. Chimneys are in fair condition. Canopies over entrances are steel frame with plaster type construction, and are in fair condition. Exterior soffits are of metal type construction, and in poor condition. The school is provided with a covered concrete conventional loading dock to facilitate the receipt of product, supplies, and foodstuffs, 100 square feet in size. The dock itself is in poor condition, and is equipped with bumper pads in poor condition.

Rating: 2 Needs Repair

Expansion Joint

Recommendations: Provide tuckpointing in all areas of mortar deterioration as required through the overall facility. Provide masonry cleaning and sealing as required through the overall facility. Recauk existing expansion joints in the 1968 Original Construction. Prep and paint exposed steel lintels through the overall facility. Exterior wall insulation deficiencies are addressed in Item J. Provide masonry infill at voids left by removal of exterior unit ventilator louvers in the 1968 Original Construction. Repair chimney as required. Replace exterior soffits due to condition. Repair concrete loading dock as required.

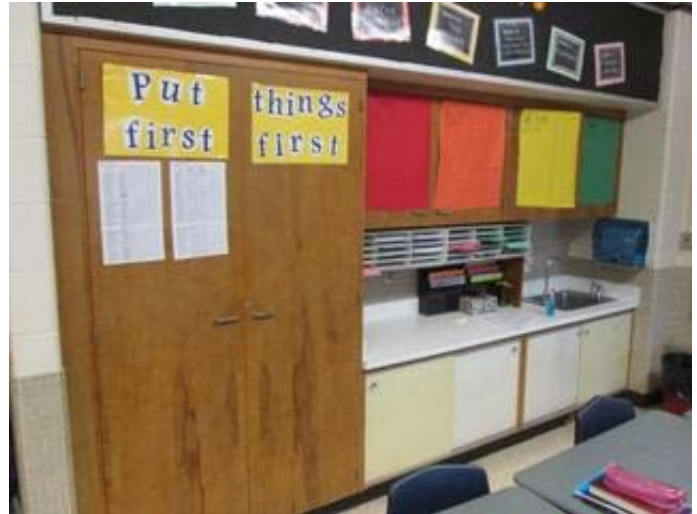
Rating:	2 Needs Repair
Recommendations:	<p>Provide complete replacement of finishes and casework due to condition and installation of systems outlined in Items A, C, D, E, K, L, M, N, T, U, W. Funding for the reworking of two door openings are provided in Item O. Provide for the repair of terrazzo flooring due to condition. Provide for two Art program kilns, with funding for the exhaust system provided in Item C. Remove Corridor transfer grilles, fill voids, and coordinate with adjacent finishes. Provide for the replacement of toilet accessories. Provide for Gymnasium Stands. Provide for four Gymnasium Basketball Backboards. Provide for appropriate acoustical sound attenuation surface treatments in the Music spaces, Gymnasium, Student Dining, and Media Center. Provide for the replacement of a walk-in cooler due to age and condition. Funding provided in the total Kitchen equipment replacement. Provide for the replacement of the Kitchen Hood due to age and condition. Funding provided in the total Kitchen equipment replacement. Provide for the replacement of Kitchen equipment due to age and condition. Provide for additional wall insulation.</p>

Typical Classroom Casework

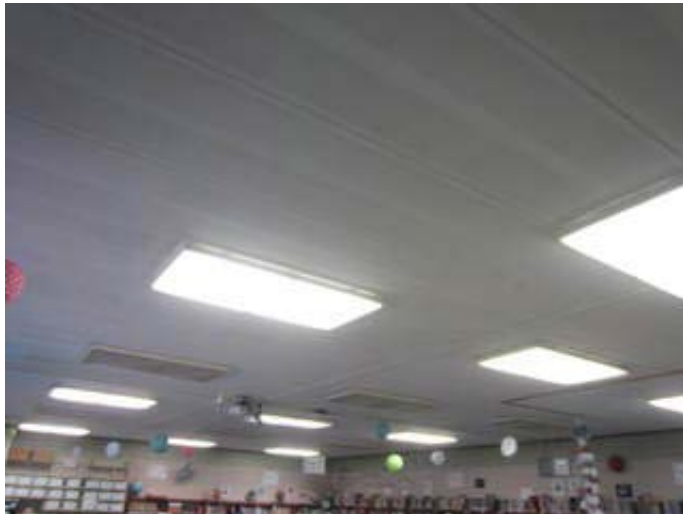
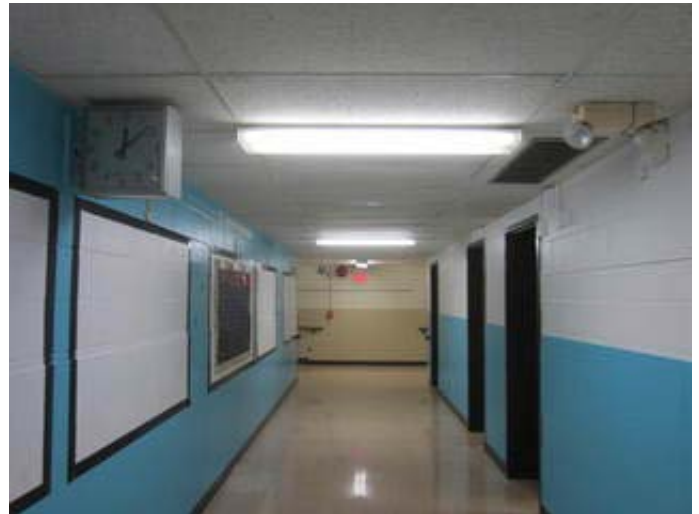
The 1968 Original Construction Classrooms are equipped with 2-lamp T-8 1x4 surface mount continuous strip fluorescent fixtures with dual level switching. Classroom fixtures are in fair condition, providing an average illumination of 65 FC, thus complying with the 40 FC recommended by the OSDM. The 1971 and 1988 Additions Classrooms are equipped with 4-lamp T-8 2x4 lay-in direct fluorescent fixtures with dual level switching. Classroom fixtures are in fair condition, providing an average illumination of 78 FC, thus complying with the 40 FC recommended by the OSDM. The 1968 Original Construction Corridors are equipped with some pendant incandescent fixtures, along with 2-lamp T-8 1x4 surface mount fluorescent fixtures with single level switching. Corridor fixtures are in fair condition, providing an average illumination of 8 FC, which is less than the 15 FC recommended by the OSDM. The 1971 and 1988 Additions Corridors are equipped with 2- and 4-lamp T-8 2x4 lay-in direct fluorescent fixtures with single level switching. Corridor fixtures are in fair condition, providing an average illumination of 20 FC, thus complying with the 15 FC recommended by the OSDM. The Gymnasium spaces are equipped with caged 6-lamp T-5 2x4 suspended fluorescent fixtures type lighting, in good to fair condition, providing an average illumination of 33 FC, thus complying the 30 FC recommended by the OSDM. The Student Dining spaces are equipped with caged 6-lamp T-5 2x4 suspended fluorescent fixtures type lighting, in good to fair condition, providing an average illumination of 45 FC, thus complying with the 40 FC recommended by the OSDM. The Media Center is equipped with 4-lamp T-8 2x4 surface mount fluorescent fixture type lighting in fair condition, providing an average illumination of 45 FC, thus complying with the 30 FC recommended by the OSDM. The Kitchen spaces are equipped with 2-lamp T-8 1x4 continuous strip surface mount fluorescent fixture type lighting with dual level switching. Kitchen fixtures are in fair condition, providing an average illumination of 45 FC, which is less than the 50 FC recommended by the OSDM. The Service Areas in the overall facility are equipped with T-8 and T-12 1x4 suspended fluorescent fixture type lighting in fair condition, providing inadequate illumination based on OSDM requirements. The typical Administrative spaces in the overall facility are equipped with T-8 2x4 lay-in direct fluorescent fixture type lighting fixtures. Administrative fixtures are in fair condition, providing an average illumination of 25 FC, which is less than the 40 FC recommended by the OSDM. The overall lighting systems of the facility are not fully compliant with Ohio School Design Manual requirements due to age, condition, inadequate lighting levels, utilization of incandescent fixtures, utilization of T-12 fixture, and lack of multi-level switching.

Media Center Fluorescent Light Fixtures

Corridor Fluorescent Light Fixtures

Provide complete replacement of lighting system due to age, condition, lighting levels, lack of multilevel switching, utilization of incandescent fixtures, utilization of T-12 fixture, and installation of systems outlined in Items A, C, J, and U.

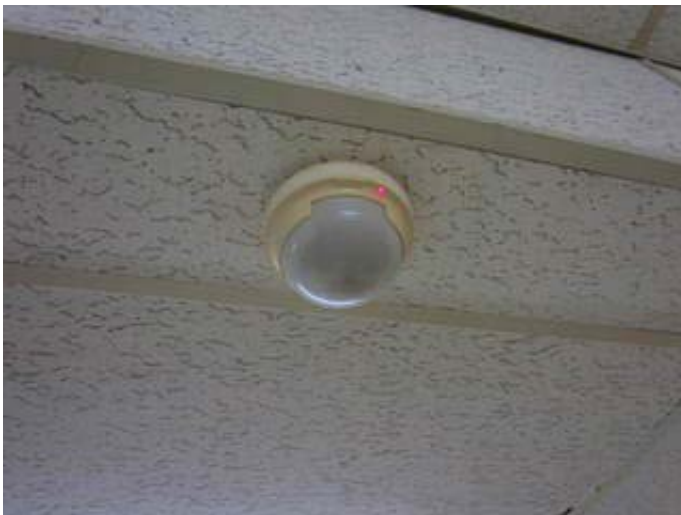
Description: The overall facility contains a motion sensor and CCTV camera type security system in fair condition. Motion detectors are not adequately provided in main entries, central gathering areas, Offices, main Corridors, and spaces where 6 or more computers are located. Exterior doors are equipped with door contacts. An automatic visitor control system is provided. Compliant color CCTV cameras are provided at the Main Entry area only and is not provided at parking lots, central gathering areas, and main Corridors. CCTV is monitored in Administrative Area with the use of a LCD TV / monitor. A compliant computer controlled access control system integrating alarms and video signals, with appropriate UPS backup, is not provided. The system is not equipped with card / biometric readers. The security system is not adequately provided throughout, and the system is not fully compliant with Ohio School Design Manual guidelines. There are playground fencing issues requiring attention, as the site and playground areas are not fenced to meet OSDM guidelines. The exterior site lighting system is equipped with recessed and surface mounted HID high pressure sodium entry lights in fair condition. Pedestrian walkways are illuminated with surface and pole mounted HID high pressure sodium light fixtures in fair condition. Parking and bus pick-up / drop off areas are illuminated by pole mounted HID high pressure sodium light fixtures in fair condition. The exterior site lighting system provides inadequate illumination due to insufficient fixture capacity, sparse placement of fixtures, age, and condition.

Rating: 3 Needs Replacement

Security System Motion Sensor

Recommendations: Provide complete replacement of security system to meet Ohio School Design Manual guidelines. Provide complete replacement of exterior site lighting system to meet Ohio School Design Manual guidelines. Provide playground fencing as required to meet OSDM guidelines, with funding included in the security system replacement.

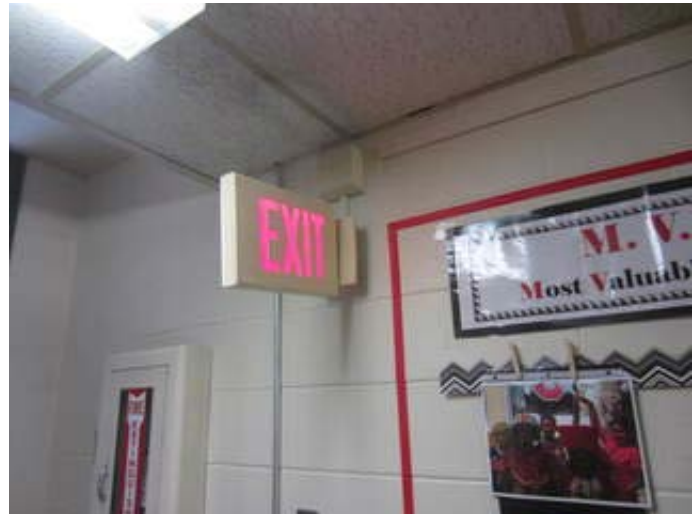
Description: The overall facility is equipped with an emergency egress lighting system consisting of non compliant plastic construction exit signs, as well as OSDM compliant red lettered and LED illuminated exit signs, and the system is in fair condition. The facility is inadequately equipped with emergency egress floodlighting and recessed fluorescent lighting used as emergency egress lighting, and the system is in fair condition. The system is not provided with appropriate battery backup or emergency generator on separate circuits. The system is not adequately provided throughout, and does not meet Ohio School Design Manual and Ohio Building Code requirements.

Rating: 3 Needs Replacement

Exit Sign

Recommendations: Provide complete replacement of emergency / egress lighting system to meet Ohio School Design Manual and Ohio Building Code guidelines.

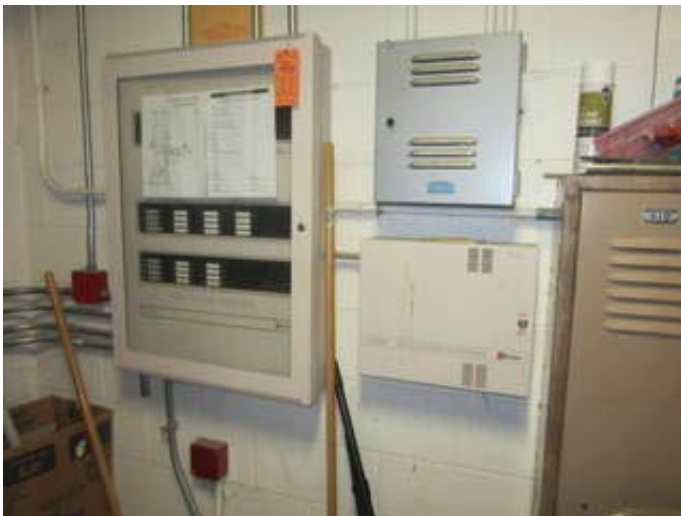
Description: The overall facility is equipped with an addressable Simplex 4002 type fire alarm system, installed in 1968 with recent upgrades, and in fair condition, consisting of bells, manual pull stations, and audible horn and strobe indicating devices. The system is automatic and is monitored by a third party. The system for the 1968 Original Construction and 1988 Addition appears to be equipped with sufficient audible horns and strobe indicating devices, however is not adequately equipped with smoke and duct detectors, and is not equipped with any flow switches, tamper switches, and heat sensors. The system for the 1971 Addition appears to be equipped with sufficient audible horns and strobe indicating devices, flow switches, tamper switches, and heat sensors, however is not adequately equipped with smoke and duct detectors. The overall facility system thus will not support future fire suppression systems. The system is not adequately provided throughout, and does not have additional zone capabilities. The system is not fully compliant with Ohio Building Code, NFPA, and Ohio School Design Manual requirements.

Rating: 3 Needs Replacement

Fire Alarm System Control Panel

Recommendations: Provide complete replacement of fire alarm system to meet OBC, NFPA, and Ohio School Design Manual guidelines.

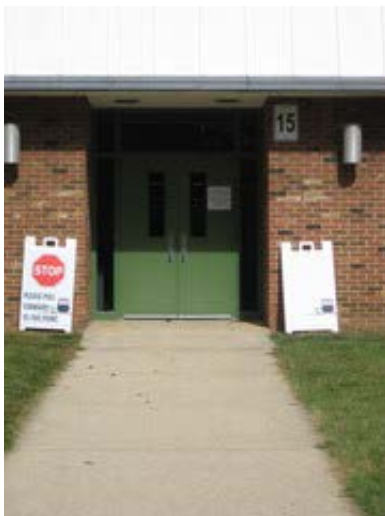
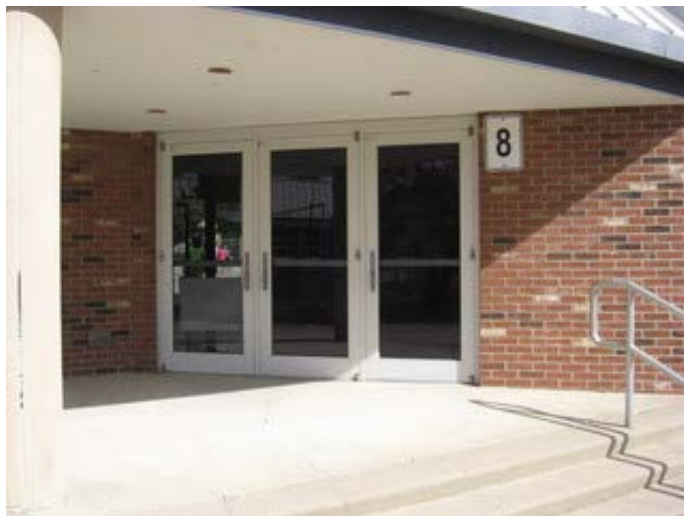
Hollow Metal Door with Transom and Sidelight

Aluminum Exterior Doors

Recommendations: Replace all exterior and entrance doors to comply with Ohio Building Code, ADA, and Ohio School Design Manual guidelines. Replacement of single glazed door vision panels, transoms, and sidelights is addressed in Item F.

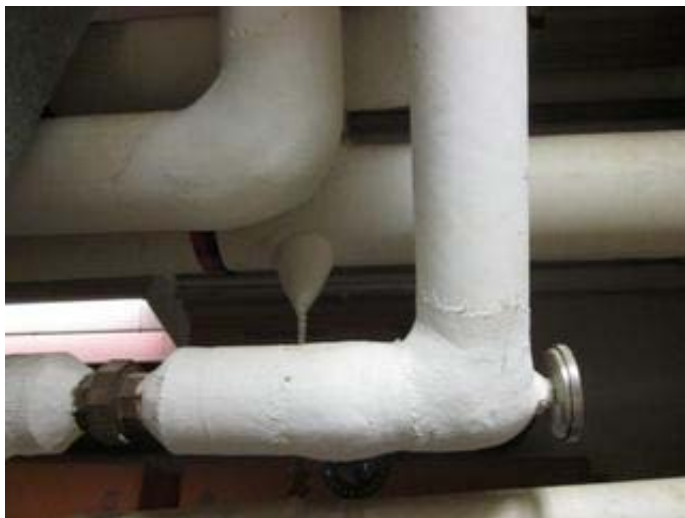
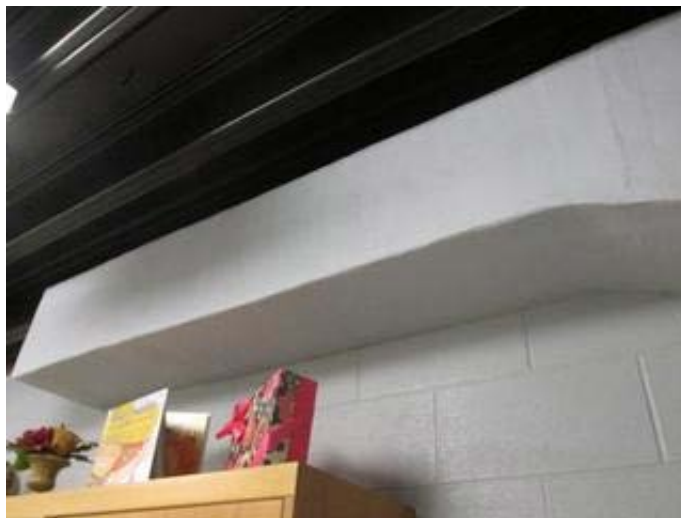
Mud Elbow Pipe Fittings

Duct Insulation

Recommendations: Remove all hazardous materials, inclusive of asbestos-containing materials in the overall facility, as noted in the attached Environmental Hazards Assessment. Provide for the testing of paint that has the potential of being lead-based. Provide for disposal of fluorescent lighting.
