Building Information - Worthington City (45138) - Worthington Park Elementary School

Building Construction Information - Worthington City (45138) - Worthington Park Elementary School (98087)

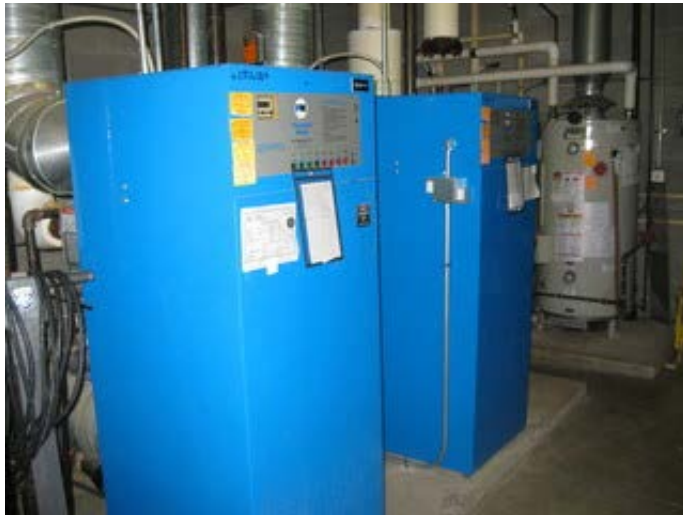
The existing system for the overall facility is a gas fired heating hot water system, installed in 1988, and is in fair condition. The heating and chilled water system in the overall facility is a 2-pipe system, without a capacity for simultaneous heating and cooling operation, which is not compliant with the OSDM requirements for basic system type. The 3 gas fired boilers, manufactured by PK and Thermal Solutions, were installed in 1988 and 2015 and are in fair-to good condition. Heating water is distributed to terminal units consisting of unit ventilators, cabinet heaters, unit heaters, and air handlers. The terminal equipment was installed in 1988 and is in fair condition. The system does not comply with the 15 CFM per person fresh air requirements of the Ohio Building Code mechanical code and Ohio School Design Manual. The DDC type system temperature controls were installed in 1999 and are in fair condition. The system does feature individual temperature controls in all spaces required by the OSDM. The overall system does not feature any central energy recovery systems. The facility is not equipped with interior doors. The existing system is ducted in the Library, Gymnasium, Cafeteria, and Main Office, but the ductwork cannot be integrated into a possible future system due to arrangement, air volume, and routing of existing ductwork. The existing system is not ducted in the Classrooms, and floor to structural deck heights will not accommodate the installation of properly sized ductwork for a future Ohio School Design Manual approved system. The overall heating system is evaluated as being in safe but inefficient working order, and long term life expectancy of the existing system is not anticipated. The structure is equipped with central air conditioning. The site does not contain underground fuel tanks.

Gas Fired Boilers

Provide new overall heating, ventilating, and air conditioning system to achieve compliance with Ohio Building Code and Ohio School Design Manual standards. Convert to ducted system in Classrooms to facilitate efficient exchange of conditioned air. Provide architectural soffits to accommodate the installation of ductwork.

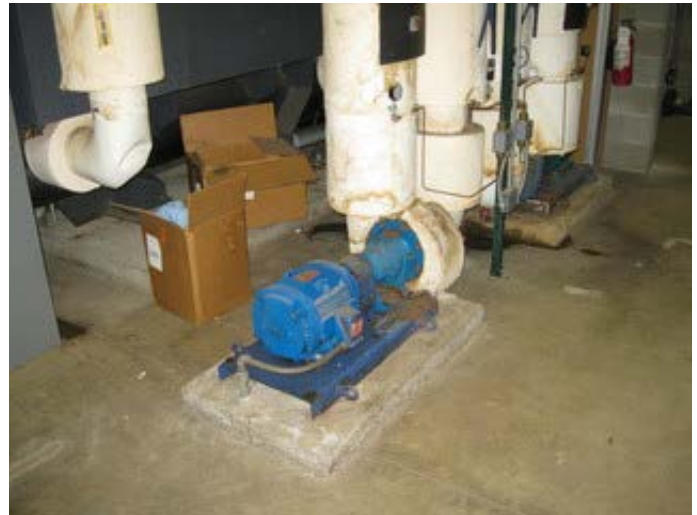
System Pumps

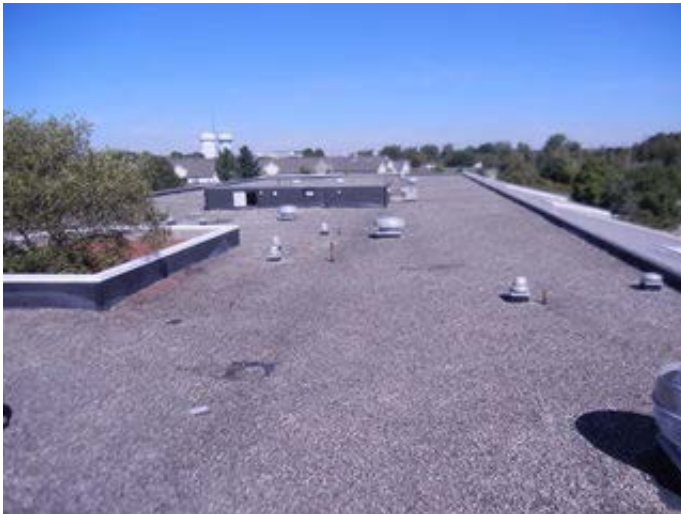
Description: The roof over the overall facility is a ballasted EPDM roof system and fiberglass shingle system that was installed in 1988 and is in poor condition. There are District reports of current leaking in the music room, classrooms, and library. Signs of past leaking were observed during the physical assessment. Access to the roof was gained by access door and ladder that are in fair condition. Fall safety protection cages are not required, and are not provided. There were no observations of standing water on the roof. Metal cap flashings and metal copings are in poor condition. Roof storm drainage is addressed through a system of gutters and downspouts, and roof drains, which are properly located, and in fair condition. The roof is not equipped with overflow roof drains though they will be required in areas of roof replacement. No problems requiring attention were encountered with any roof penetrations. There are not any covered walkways attached to this structure.

Rating: 3 Needs Replacement

Ballasted EPDM Roofing

Recommendations: The roof over the overall facility requires replacement to meet Ohio School Design Manual guidelines due to condition, age of system and projected lifecycle. The flashing and / or coping on the overall facility require replacement due to condition. Replace all downspouts due to condition.

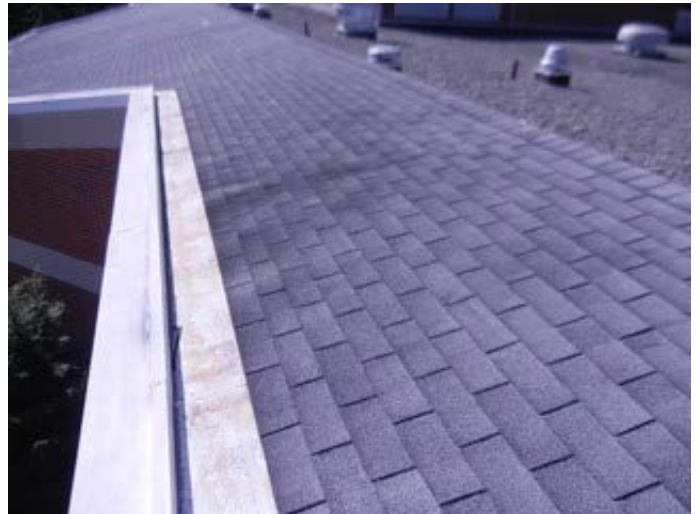
Fiberglass Shingle Roof

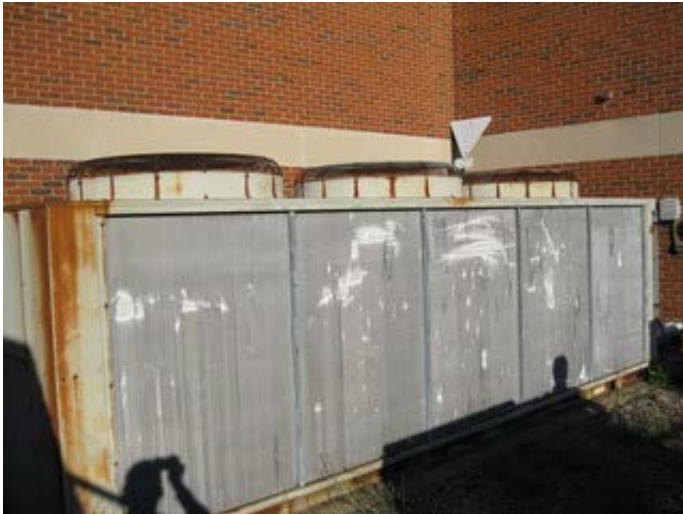
Description: The overall facility is equipped with a chilled water type central air conditioning system, which is in poor condition. An air cooled chiller creates chilled water and pumps distribute chilled water to the terminal units. The equipment is in poor condition. The ventilation system in the overall facility consists of unit ventilators, installed in 1988 and in fair condition, providing fresh air to Classrooms, and air handlers, installed in 1988 and in fair condition, providing fresh air to other miscellaneous spaces such as Gymnasiums, Student Dining, and Media Center. Relief air venting is provided by ceiling plenums. The ventilation system does not meet the Ohio Building Code 15 CFM per occupant fresh air requirement. The overall system is not compliant with Ohio Building Code and Ohio School Design Manual requirements. Dust collection systems are not required in this facility. The Art program is equipped with a kiln, and existing kiln ventilation is adequate, and in fair condition. General building exhaust systems for Restrooms, Storage Rooms, and Art Rooms are adequately placed, and in fair condition.

Air Cooled Chiller

Recommendations: Provide an air conditioning system to meet with Ohio Building Code and Ohio School Design Manual requirements. Replace general building exhaust systems located in Restrooms. Pricing included in Item A.

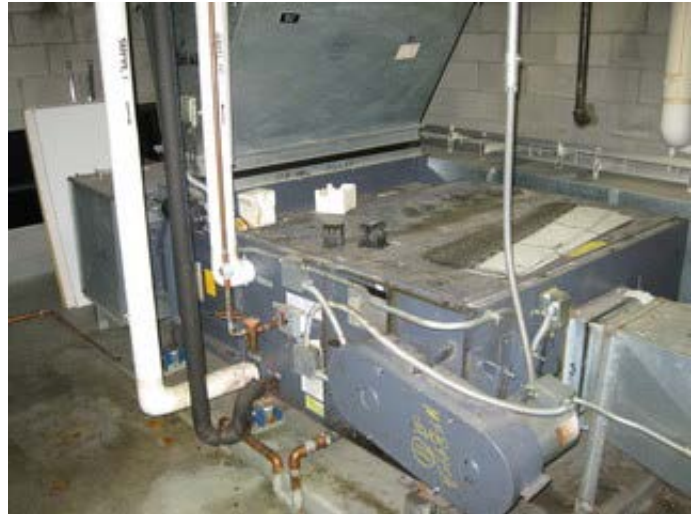
Air Handler

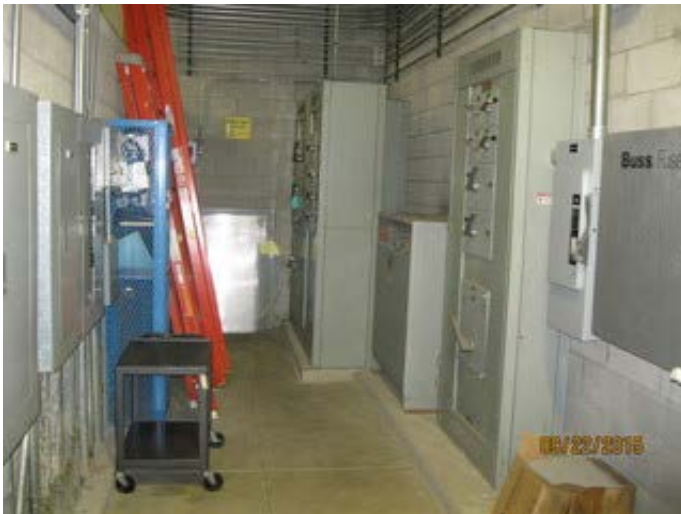
Description: The electrical system provided to the overall facility is a 480Y/277-volt, 3-phase, 4-wire, 800-amp main fused switch system installed in 1988, and is in good condition. Power is provided to the school by a single utility owned, pad-mounted transformer located in exterior of building near main utility room, and in good condition. The panel system, installed in 1988, is in good condition, and can be expanded to add additional capacity. The Classrooms are not equipped with adequate electrical outlets. The typical Classroom contains 16 general purpose outlets, 4 dedicated outlets for each Classroom computer, and 2 dedicated outlets for each Classroom television. Some Classrooms are equipped with as many as 18 general purpose outlets, while others are equipped with as few as 12 general purpose outlets. There are not any spaces that have no electrical outlets. The Corridors are not equipped with adequate electrical outlets for servicing. Adequate GFI protected exterior outlets are not provided around the perimeter of the building. The facility is equipped with an unsuitable emergency generator. Adequate lightning protection safeguards are not provided. Stage lighting power system including control panel, breakers, and dimmers is inadequately provided, and does not meet OSDM requirements. The overall electrical system does not meet Ohio School Design Manual requirements in supporting the current needs of the school, and will be inadequate to meet the facility's future needs.

Rating: 3 Needs Replacement

MDP/Transformer/Distribution Equipment

Recommendations: The entire electrical system requires replacement to meet Ohio School Design Manual guidelines for Classroom capacity, due to age, lack of OSDM-required features, and to facilitate the scope of work outlined in Item U. Equipment is 27 years old. Emergency generator is not working.

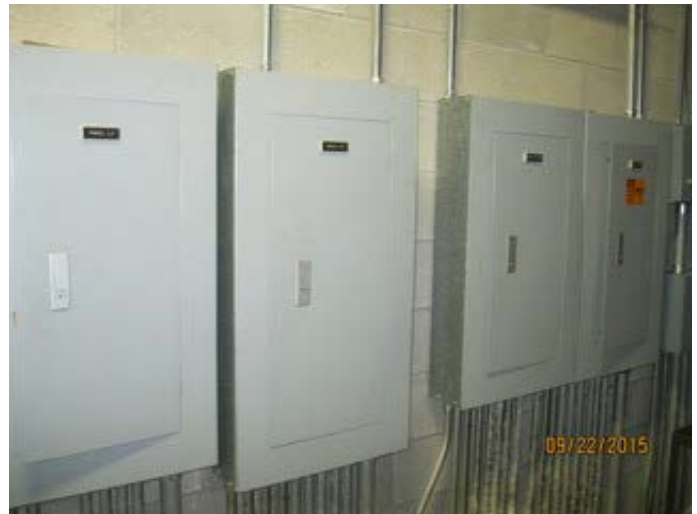
Electrical Panels

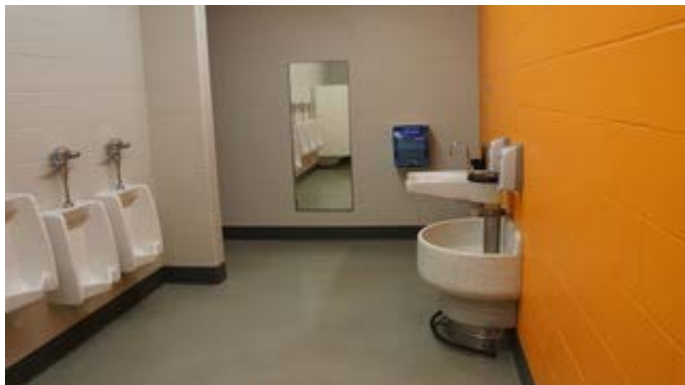
The service entrance is not equipped with a reduced pressure backflow preventer. A water treatment system is not provided. The domestic water supply piping in the overall facility is copper, was installed in 1988, and is in good condition. The waste piping in the overall facility is cast iron and PVC, was installed in 1988, and is in good condition. The facility is equipped with a 100-gallon gas water heater in good condition. The school contains 3 Large Group Restrooms for boys, 3 Large Group Restrooms for girls, 3 Restrooms associated with specialty Classrooms, and 5 Restrooms for staff. Boys' Large Group Restrooms contain 0 ADA and 6 non-ADA wall mounted flush valve toilets, 4 ADA and 8 non-ADA wall mounted flush valve urinals, as well as 1 ADA wall mounted lavatories and 1 non-ADA floor mounted, trough- lavatories. Girls' Large Group Restrooms contain 0 ADA and 14 non-ADA wall mounted flush valve toilets, as well as 1 ADA wall mounted lavatories and 1 non-ADA floor mounted, trough-lavatories. Additionally, there is 1 ADA wall mounted lavatory, that does not have the require pipe protection, and 1 non-ADA floor mounted, multi-station lavatories that are shared between boys and girls restrooms. Note: the ADA wall mounted lavatories are sized for adults at 34" and not children, at 31" Staff Restrooms contain 0 ADA and 7 non-ADA wall mounted flush valve toilets, 0 ADA and 1 non-ADA wall mounted urinals, as well as 0 ADA and 4 non-ADA wall mounted and 2 non-ADA countertop lavatories. Condition of fixtures is fair. The facility is equipped with 0 ADA and 1 non-ADA drinking fountains, as well as 2 ADA and 6 non-ADA electric water coolers, in fair condition. The 21 Elementary Classrooms are equipped with 0 ADA and 21 non-ADA sink mounted type drinking fountains, in good condition. Special Education Classroom is equipped with a toilet but not the OSDM required ADA Restroom facility, and fixtures are in fair condition. Kitchen is equipped with the required Restroom, and fixtures are in fair condition. Heath Clinic is equipped with the required Restroom, which is not ADA compliant, and fixtures are in fair condition. Kindergarten / Pre-K Classrooms are equipped with Restroom facilities, and fixtures are in fair condition. Kitchen fixtures consist of 1 hand sink, 1 single-compartment sink, 1 double-compartment sink, and 1 triple-compartment sink, which are in good condition. The Kitchen is equipped with a satisfactory grease interceptor. The Kitchen is provided the required 140 degree hot water supply via a mixing valve, which is in good condition. The school does not meet the OBC requirements for fixtures. Relative to LEED requirements, the school is not equipped with low flow type fixtures. Per OBC and OSDM requirements this facility should be equipped with 39 toilets, 12 urinals, 27 lavatories, 21 Classroom sink mounted drinking fountains, and 13 electric water coolers. Observations revealed that the school is currently equipped with 27 toilets, 13 urinals, 11 lavatories, 20 Classroom sink mounted drinking fountains, and 9 electric water coolers. ADA requirements are not met for fixtures and drinking fountains (see Item O). Custodial Closets are properly located and are adequately provided with required service sinks or floor drain sinks, which are in fair condition. Science Classroom / Lab utility sinks, gas connections, compressed air connections, and safety shower / eyewash are not provided, but are not required due to existing grade configuration. Due to existing grade configuration, no Biology or Chemistry Classroom acid waste systems are required. Adequate exterior wall hydrants are provided.

Boys Restroom

To facilitate the school's compliance with OBC and OSFC fixture requirements, provide 12 new toilets, 16 new lavatories, 4 new electric water coolers. See Item O for replacement of fixtures related to ADA requirements. Provide reduced pressure backflow preventer. Set ADA sinks at appropriate mounting height for existing grade configuration.

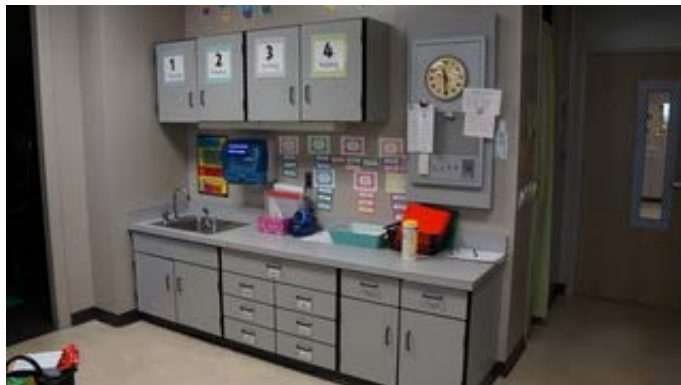
Typical Classroom Sink

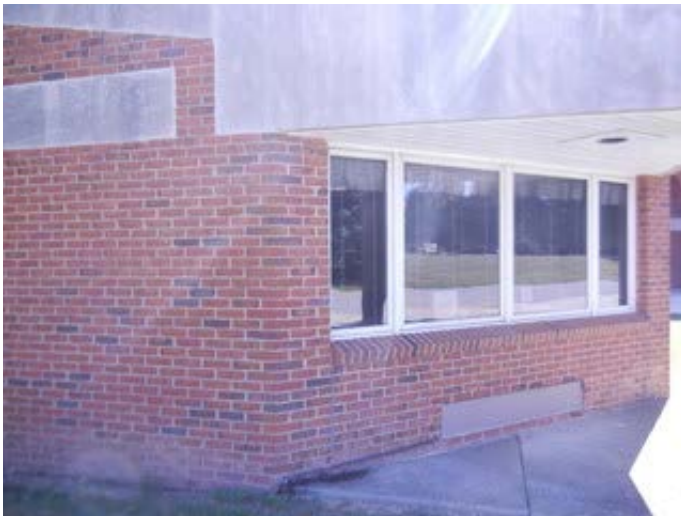
Description: The overall facility is equipped with aluminum clad wood windows with double glazed type window system, which was installed in 1988, and is in fair condition. The window system features operable windows in most of the building, and operable windows are equipped with opening limiters in fair condition and not equipped with insect screens. Window system seals are in poor condition, with moderate air and water infiltration being experienced. Window system hardware is in fair condition. The window system features integral blinds, which are in fair condition. Aluminum frame curtain wall systems are found in the original construction, in good condition. This facility does not feature any glass block windows. The exterior doors at the main entrance are equipped with aluminum sidelights and transoms with tempered double glazed insulated glazing in good condition. Exterior door vision panels are tempered double glazed insulated glazing. The school does not contain skylights. The school does not contain clerestories. Interior glass is OSDM-compliant. Window security grilles are not provided for ground floor windows. There is not a Greenhouse associated with this school.

Rating: 3 Needs Replacement

Typical Exterior Window

Recommendations: Provide a new insulated window system with integral blinds to meet with Ohio School Design Manual requirements throughout the facility due to condition.

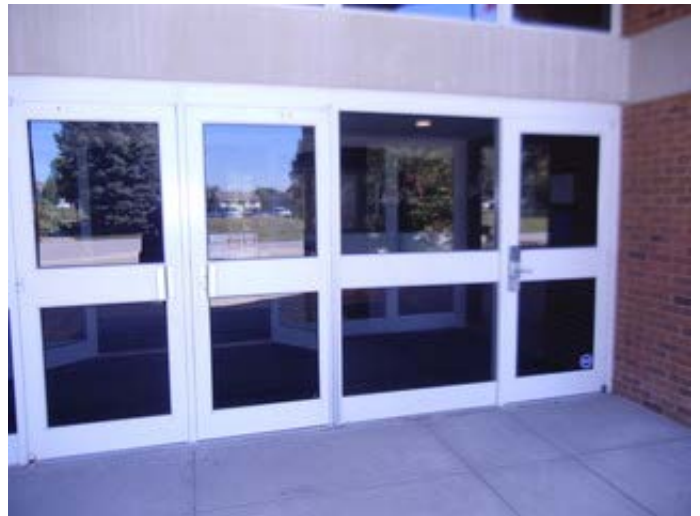
Curtain Wall System at Main Entry

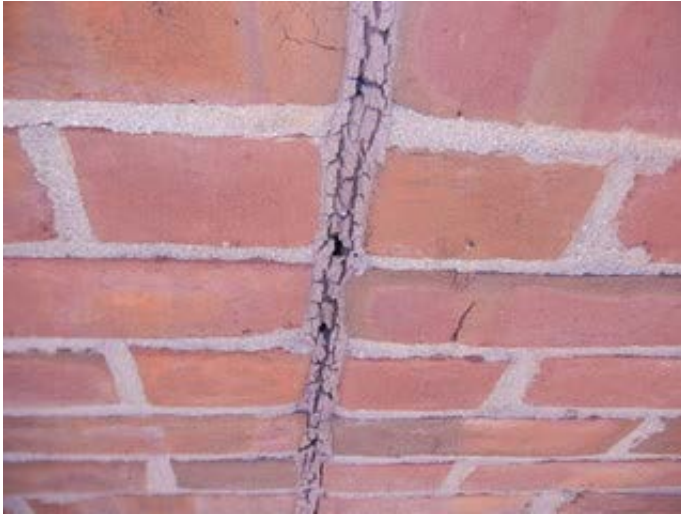
Description: The overall facility has a brick veneer on load bearing masonry wall system which displayed no locations of deterioration, and is in good condition. The exterior masonry appears to have appropriately spaced and adequately caulked control joints in poor condition. Control joints are provided at lintel locations, at doors and windows, building corners, and wall offsets and are in poor condition. The school does have sufficient expansion joints, and they are in fair condition. Exterior walls in the overall facility are adequately insulated. Brick veneer masonry walls are cavity walls. Weep holes and vents are provided at lintels, below sills, and the base of masonry cavity walls, and are in good condition. Weep holes are not rope type weeps. The exterior masonry has not been cleaned and sealed in recent years, and shows evidence of mortar deterioration below windows and at window sills, and has locations of efflorescence and mold. Architectural exterior accent materials consist of stone trim, which is in good condition. Exterior building fenestration in the overall facility represents 7.5% of the exterior surfaces. Interior Corridor and demising walls are concrete masonry units, and project full height from floor to bottom of deck, and are in good condition. Interior masonry appears to have adequately spaced and caulked control joints in good condition. Interior soffits are of drywall on metal stud type construction, and in good condition. The window sills are brick and are in fair condition. The exterior lintels are steel, and are in good condition. There are no chimneys. Canopies over entrances are exterior drywall on metal stud type construction, and are in poor condition. Exterior soffits are of exterior drywall on metal stud type construction, and in poor condition. Some exterior soffits have been faced with aluminum soffits and are in good condition. The school is not equipped with a loading dock.

Rating: 2 Needs Repair

Typical Control Joint

Recommendations: Provide masonry cleaning, caulking, and sealing as required through the overall facility. Recaulk all existing control joints. Repoint masonry window sills through the overall facility. Repair exterior drywall on exterior canopies and soffits.

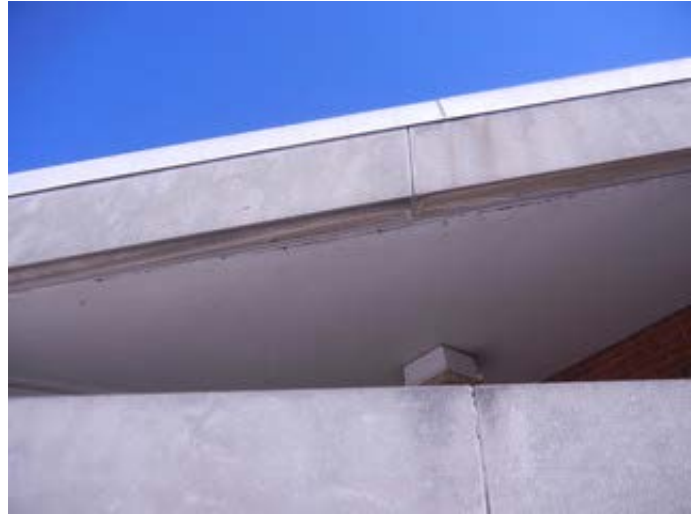
Typical Exterior Soffit

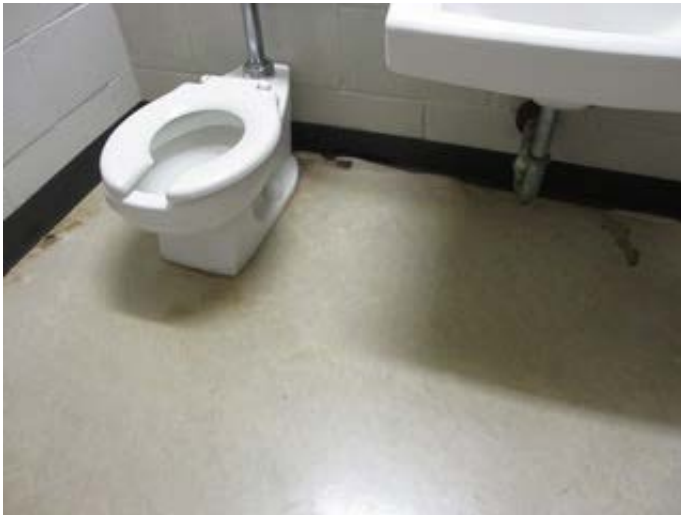
Provide New Flooring for Kindergarten Restrooms

Provide for the complete replacement of finishes, casework, and kitchen equipment.

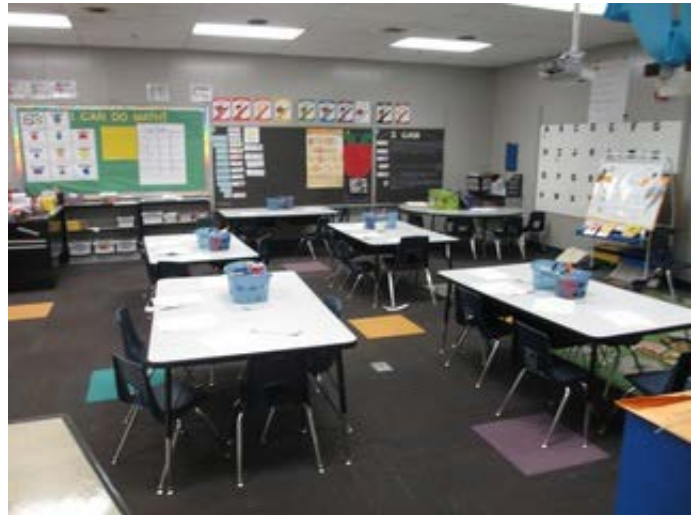
The overall facility features conventionally partitioned, operable partitioned, and demountable metal partitioned Classrooms with rubber and carpet tile type flooring in good condition, 2x4 ACT type ceilings in good to fair condition, as well as painted CMU and metal partition type wall finishes, and they are in good condition. The overall facility has Corridors with rubber type flooring, 2x4 type ceilings, as well as painted CMU and metal partition type wall finishes, and they are in good condition. The overall facility has Restrooms with epoxy non-slip type flooring, gypsum board type ceilings, as well as painted CMU type wall finishes, and they are in good condition. Toilet partitions are plastic, and are in good condition. Kindergarten restrooms feature resilient sheet flooring that is in poor condition. Classroom casework in the overall facility is wood type construction with plastic laminate finish, is inadequately provided, and in good to fair condition. The typical Classroom contains 7'-7" lineal feet of casework, and elementary Classroom casework is consistently 7'-7". Classrooms are provided adequate chalkboards, markerboards, smartboards, and tackboards, which are in good condition. There are no storage cubbies in this facility. The Art program is equipped with a kiln. The facility is equipped with wood non-louvered interior doors that are both flush mounted and recessed with proper ADA hardware and clearances, and in good condition. The Gymnasium space has VCT type flooring, open exposed type ceilings, as well as painted CMU type wall finishes, and they are in good condition. There are no bleachers in this Gymnasium. Gymnasium basketball backboards are electrically operated type, and are in good condition. The Media Center has carpet tile type flooring, 2x4 ACT type ceilings, as well as metal partition type wall finishes, and they are in good condition. Student Dining has rubber type flooring, 2x4 ACT type ceilings, as well as painted CMU type wall finishes, and they are in good condition. Existing Gymnasium, Student Dining, Media Center, and Music spaces are inadequately provided with appropriate sound attenuation acoustical surface treatments. The existing Kitchen is full service, is undersized based on current enrollment, and the existing Kitchen equipment, installed between 1988-2001, is in fair condition. The required 6" overhang from the Kitchen Hood on all three exposed sides of the cooking equipment is provided. Walk-in cooler and freezers are located within the Kitchen spaces and are in fair condition.

Typical Classroom Finishes

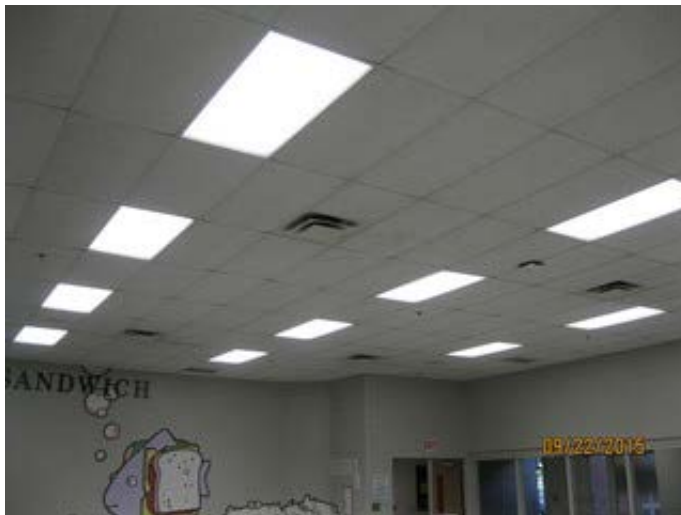
The typical Classrooms in the overall facility are equipped with T-8 lay-in 2x4 fluorescent fixtures with multi-level switching. Classroom fixtures are in good condition, providing an average illumination of 44 FC, which is less than the 50 FC recommended by the OSDM. The typical Corridors in the overall facility are equipped with T-8 lay-in 2x4 fluorescent fixtures with single level switching. Corridor fixtures are in good condition, providing an average illumination of 12 FC, which is less than the 20 FC recommended by the OSDM. The Primary Gymnasium spaces are equipped with T-8 2x4 pendant mount fluorescent fixture type lighting, in good condition, providing an average illumination of 50 FC, thus complying with the 50 ES FC recommended by the OSDM. The Media Center is equipped with lay-in 2x4, 6" recessed downlights, T-8 fluorescent fixture type lighting in good condition, providing an average illumination of 35 FC, which is less than the 50 FC recommended by the OSDM. The Student Dining spaces are equipped with lay-in 2x4 T-8 fluorescent fixture type lighting with multi-level switching. Student Dining fixtures are in good condition, providing an average illumination of 61 FC, thus complying with the 50 FC recommended by the OSDM. The Kitchen spaces are equipped with 1x4 surface mount T-8 fluorescent fixture type lighting with single level switching. Kitchen fixtures are in good condition, providing an average illumination of 62 FC, which is less than the 75-80 FC recommended by the OSDM. The Service Areas in the overall facility are equipped with 1x4 suspended T-8 fluorescent fixture type lighting in good condition. The typical Administrative spaces in the overall facility are equipped with lay-in 2x4 surface mount T-8 fluorescent fixture type lighting in good condition, providing adequate illumination based on OSDM requirements. The overall lighting systems of the facility are not fully compliant with Ohio School Design Manual requirements due to inadequate lighting levels and lack of multi-level switching.

Student Dining Lighting

Provide complete replacement of lighting system due to lighting levels, lack of multi-level switching, and installation of systems outlined in Item U.

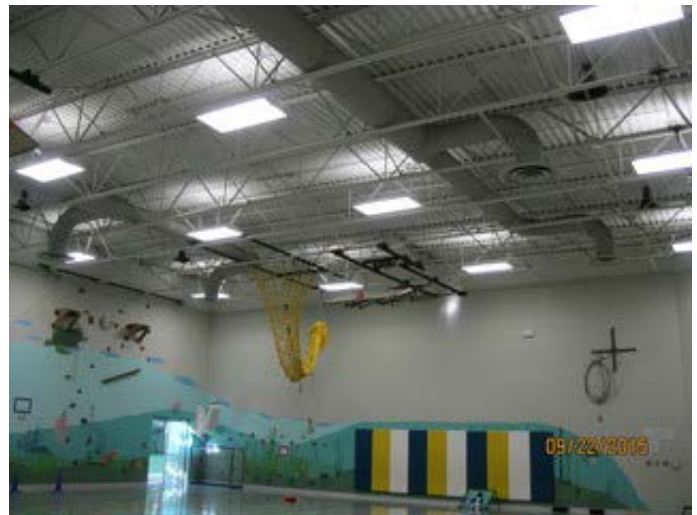
Gym Lighting

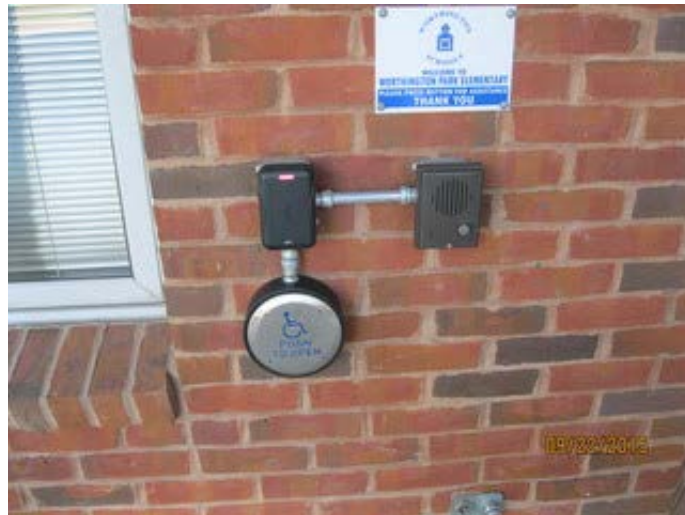
Card Reader

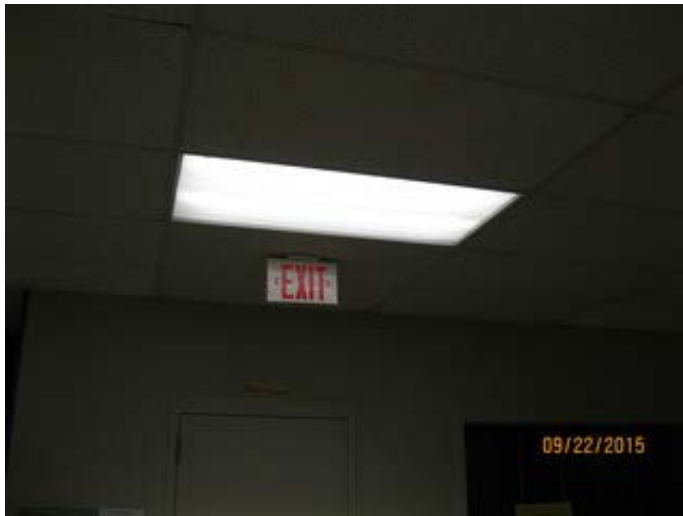
Description: The overall facility is equipped with an emergency egress lighting system consisting of non-compliant plastic construction exit signs, as well as OSDM compliant red lettered, cast aluminum construction, LED illuminated exit signs, and the system is in good condition. The facility is not equipped with emergency egress floodlighting, but is equipped with recessed fluorescent lighting used as emergency egress lighting, and the system is in poor condition. The system is not provided with appropriate emergency generator power. The system is not adequately provided throughout, and does not meet Ohio School Design Manual and Ohio Building Code requirements.

Exit Sign

Recommendations: Provide complete replacement of emergency / egress lighting system to meet Ohio School Design Manual and Ohio Building Code guidelines.

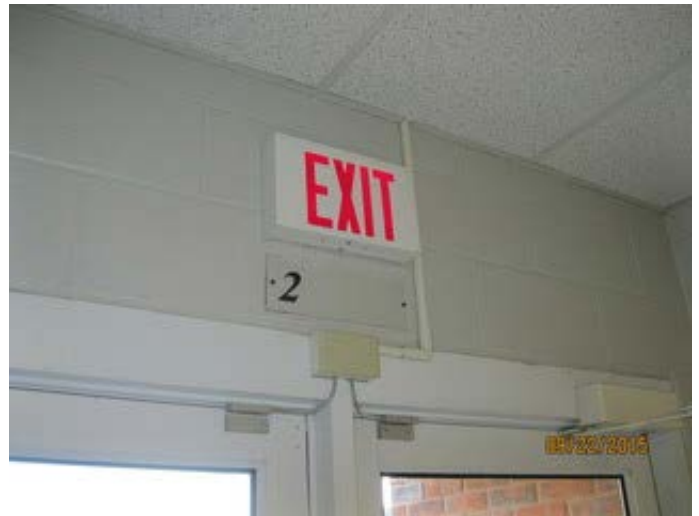
Exit Sign/Security Contacts

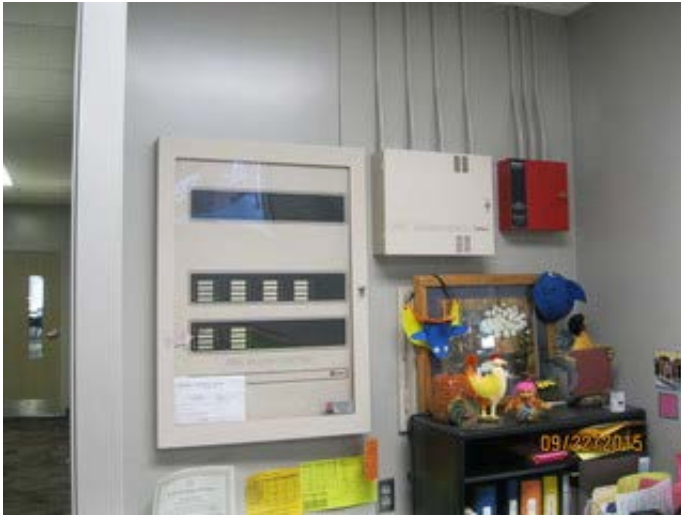
Description: The overall facility is equipped with a Simplex type fire alarm system, installed in 1988, and in good condition, consisting of manual pull stations, bells, and horn and strobe indicating devices. The system is automatic and is monitored by a third party. The system is equipped with sufficient audible horns, strobe indicating devices, flow switches, tamper switches, smoke detectors, and heat sensors. The system thus supports existing fire suppression systems. The system is adequately provided throughout, and does not have additional zone capabilities. The system is not fully compliant with Ohio Building Code, NFPA, and Ohio School Design Manual requirements.

Fire Alarm Control Panel

Recommendations: Provide new fire alarm system to meet OBC, NFPA, and Ohio School Design Manual guidelines.

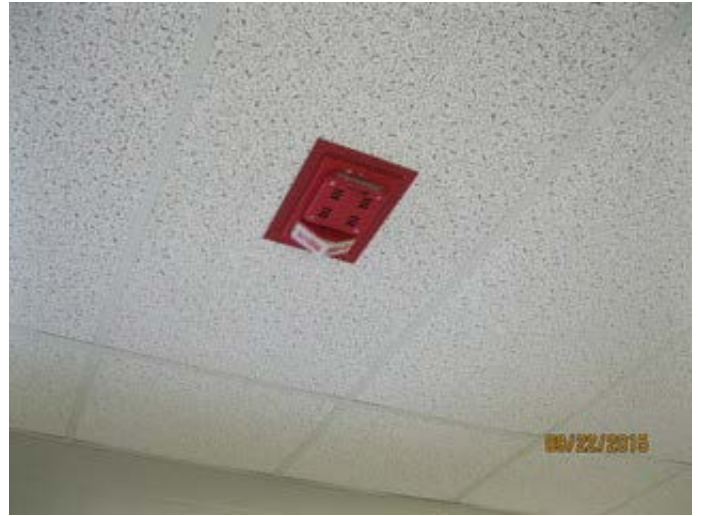
Ceiling Mounted Horn/Strobe

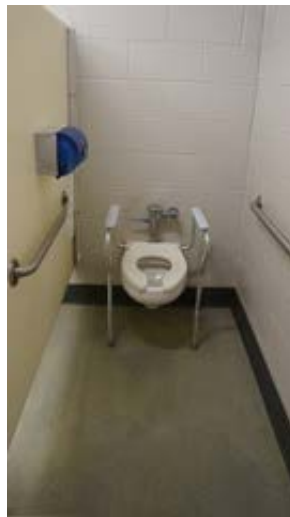
Non-ADA Toilet

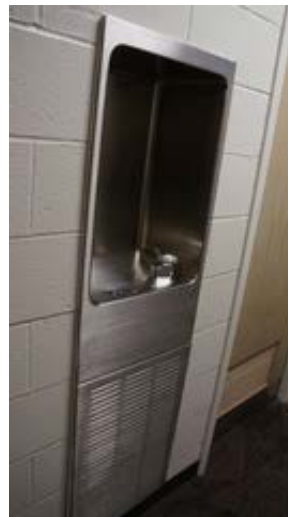
Non-ADA Water Cooler

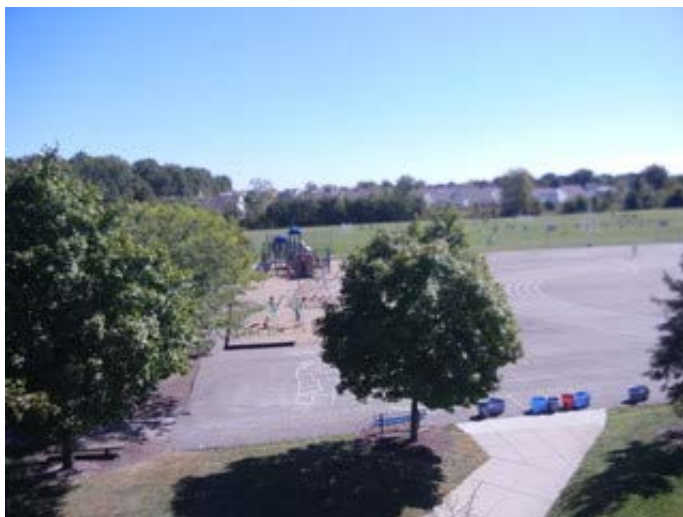
Play Areas

Provide fencing to separate asphalt play area from vehicular traffic. Provide fencing around dumpsters. Resurface asphalt parking lots and play area. Replace concrete dumpster pad due to condition. Replace broken and cracked sidewalks. Provide new playground equipment in order to provide more ADA-compliant play structures.

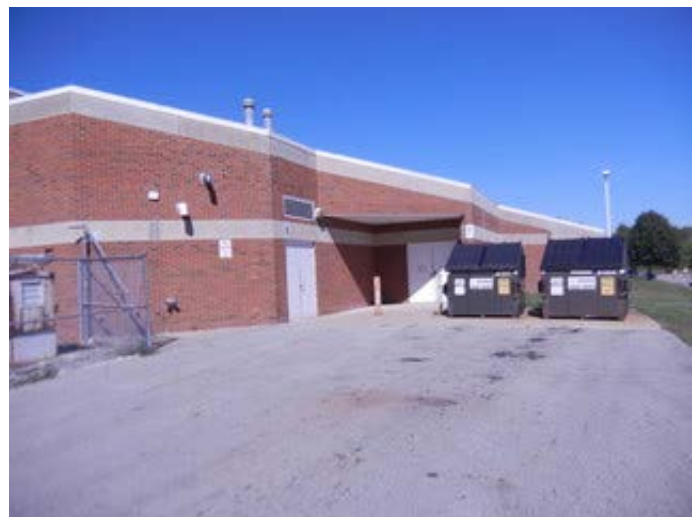
Dumpsters and Service Drive

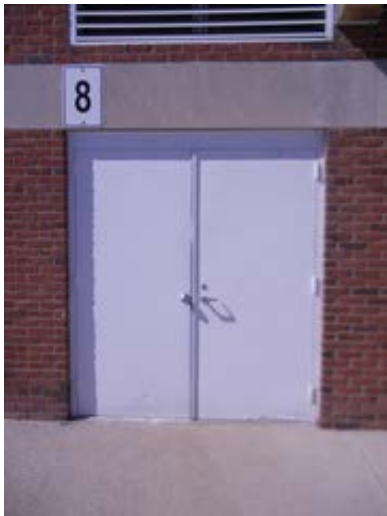
Description: Typical exterior doors in the overall facility are hollow type construction, installed on hollow metal frames, and in good condition. Typical exterior doors feature no vision panels, and appropriate hardware. A few exterior doors did not have appropriate hardware. Entrance doors in the overall facility are aluminum type construction, installed on aluminum frames, and in good condition. Entrance doors feature double glazed tempered glass vision panels, and sidelights, and appropriate hardware, however hardware is in poor condition. The facility is equipped with 1 roof access door, which is in fair condition. There are no overhead doors in the facility.

Typical Exterior Door with Inappropriate Hardware

Recommendations: Replace all entrance door hardware due to poor condition. Replace exterior door hardware as needed to meet ADA guidelines.

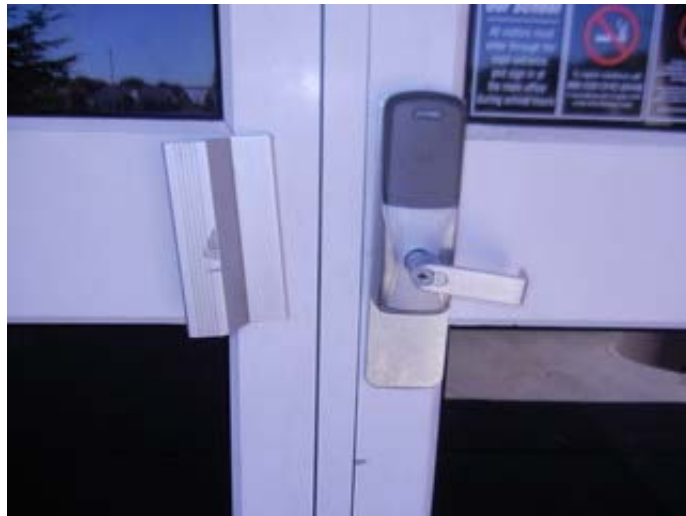
Entry Door Hardware

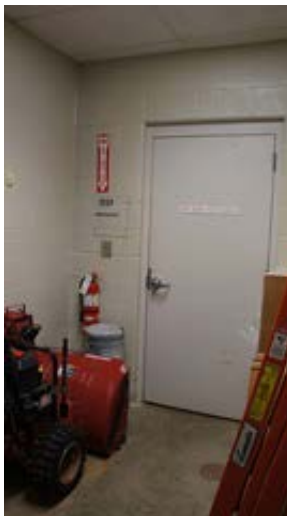
Boiler Room Fire Door

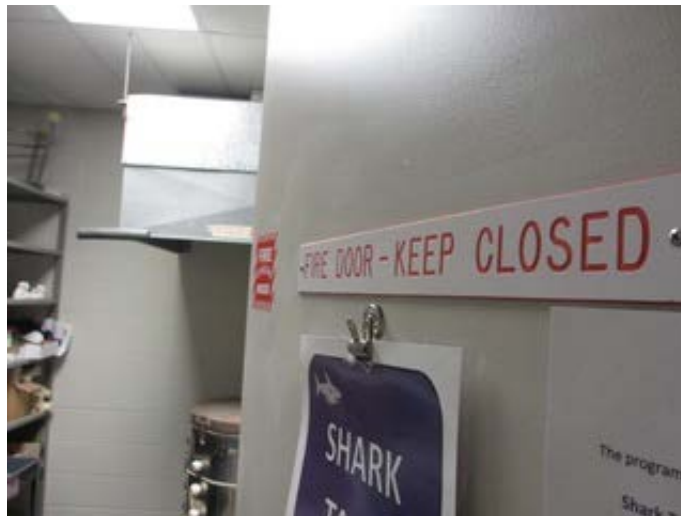
Kiln Room Fire Door

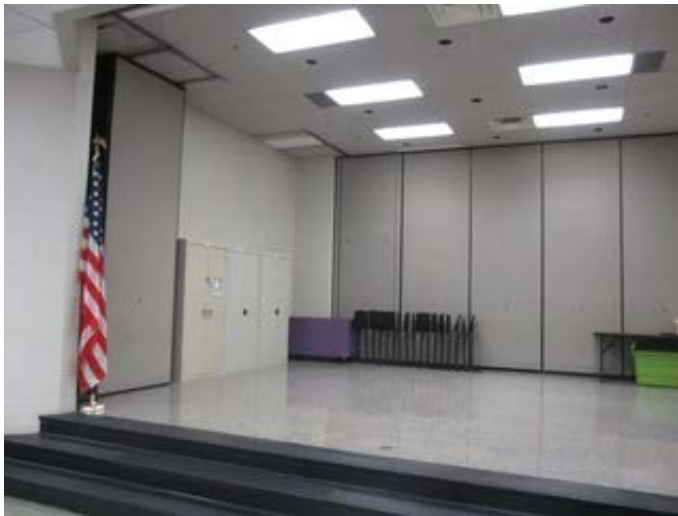
No Handrails Present

Add handrails to steps up to stage platform in Student Dining. Provide emergency generator, with funding provided via complete replacement of electrical system in Item D.

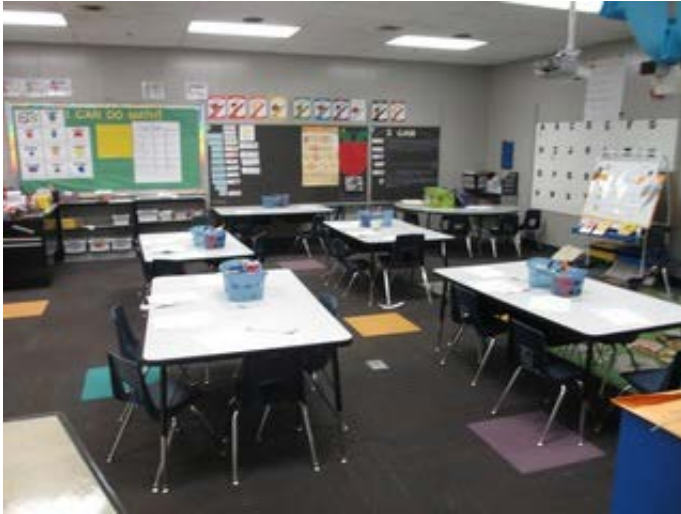
Description: The typical Classroom furniture is of consistent design, and in generally good condition, consisting of student desks & chairs, teacher desks & chairs, desk height file cabinets, small group tables, computer workstations, bookcases, and wastebaskets. The facility's furniture and loose equipment were evaluated in item 6.17 in the CEFPI section of this report, and on a scale of 1 to 10 the overall facility received a rating of 7 due to observed conditions.

Furniture is Consistent Throughout the Facility

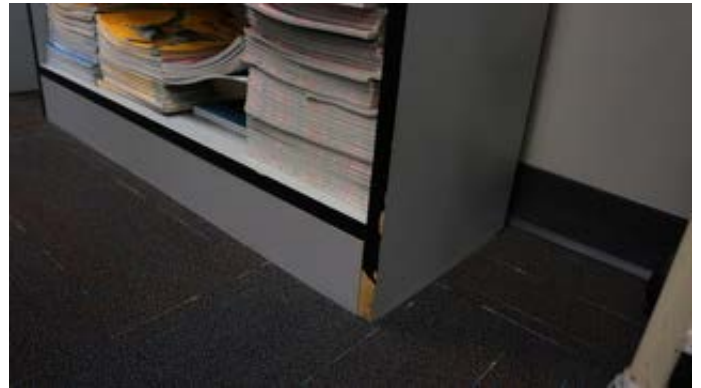
Furniture is Beginning to Show Wear

Recommendations: Existing conditions require no renovation or replacement at the present time, but furniture is beginning to show wear and will need to be replaced within 4-7 years.
