Building Information - Worthington City (45138) - Brookside Elementary

Program Type	Assessment Only
Setting	Suburban
Assessment Name	Brookside Elementary (003822) DRAFT
Assessment Date (on-site; non-EEA)	2015-09-28
Kitchen Type	Full Kitchen
Cost Set:	2015
Building Name	Brookside Elementary
Building IRN	3822
Building Address	6700 McVey Boulevard
Building City	Columbus
Building Zipcode	43235
Building Phone	(614) 450-5300
Acreage	13.43
Current Grades:	K-6
Teaching Stations	27
Number of Floors	1
Student Capacity	587
Current Enrollment	345
Enrollment Date	2015-09-01
Enrollment Date is the date in which the current enrollment was taken.	
Number of Classrooms	25
Historical Register	NO
Building's Principal	Ms. Jenny Wielinski
Building Type	Elementary

Building Construction Information - Worthington City (45138) - Brookside Elementary (3822)

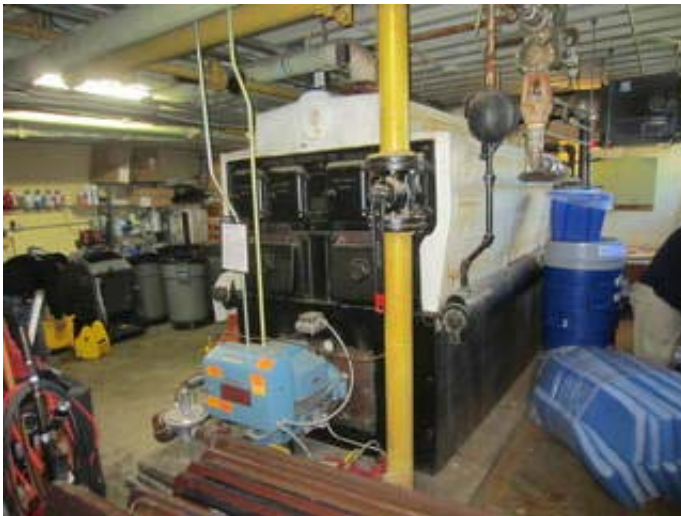
Natural Gas Fired Heated Water Boiler

Description: The existing system for the 1964 Original Construction is a natural gas fired heated water boiler type system, installed in 1964, with upgrades in 2009, and is in fair condition. The systems in the 1967 and 1988 Additions are an extension of that found in the 1964 Original Construction. 2-pipe vs. 4-pipe designations are not applicable in this facility, as no central air conditioning is provided. The facility is equipped with two (2) boilers. One was manufactured by Frank Prox Company, was installed in 1964, and is in fair to poor condition. The other was manufactured by Bryan Boilers, was installed in 2009, and is in good condition. Heating water is distributed to terminal units consisting of unit ventilators, cabinet heaters, fin tubes, fan coil units, and air handlers. The terminal equipment is original to each addition and is in fair condition. The system does not appear to comply with the 15 CFM per person fresh air requirements of the Ohio Building Code mechanical code and Ohio School Design Manual. The Automated Logic DDC type system temperature controls were installed in 2009 and are in good condition. The system does feature individual temperature controls in all spaces required by the OSDM. The overall system does not feature any central energy recovery systems. The facility is not equipped with louvered interior doors to facilitate Corridor utilization as return air plenums. The existing systems are ducted in the Gymnasium and Administrative Offices, but the ductwork cannot be integrated into a possible future system due to arrangement, air volume, and routing of existing ductwork. The existing systems for the remainder of the overall facility, are not ducted, but floor to structural deck heights will accommodate the installation of properly sized ductwork for a future Ohio School Design Manual approved system. The overall heating system is evaluated as not being in safe and efficient working order, and long term life expectancy of the existing system is not anticipated. The structure is not equipped with central air conditioning. The site does not contain an underground fuel tank.

Rating: 3 Needs Replacement

Recommendations: Provide new overall heating, ventilating, and air conditioning system to achieve compliance with Ohio Building Code and Ohio School Design Manual standards. Replace existing ductwork in the Gymnasium and Administrative Offices to facilitate efficient exchange of conditioned air. Convert the remainder of the overall facility to ducted system to facilitate efficient exchange of conditioned air.

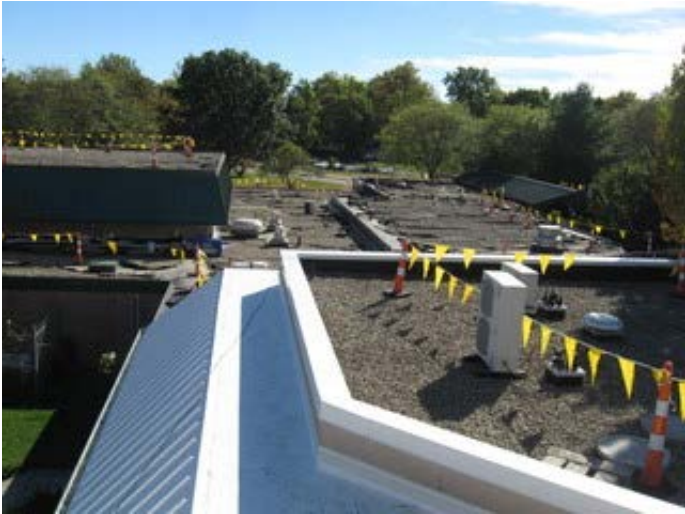
Overall Roof

Description: The roof over the overall facility is a ballasted membrane system and standing seam metal roof that were being replaced and repaired and under contract at time of the on-site assessment. Access to the roof was gained by access hatches that are in good condition. Fall safety protection cages are not required. There were no observations of standing water on the roof. Metal cap flashings and copings are under contract. Roof storm drainage is addressed through a system of roof drains, which are properly located, and in good condition. The roof is not equipped with overflow roof drains though they are needed on this building. No problems requiring attention were encountered with any roof penetrations. There are not any covered walkways attached to this structure.

Rating: 2 Needs Repair

Recommendations: Provide overflow roof drains as required per OBC.

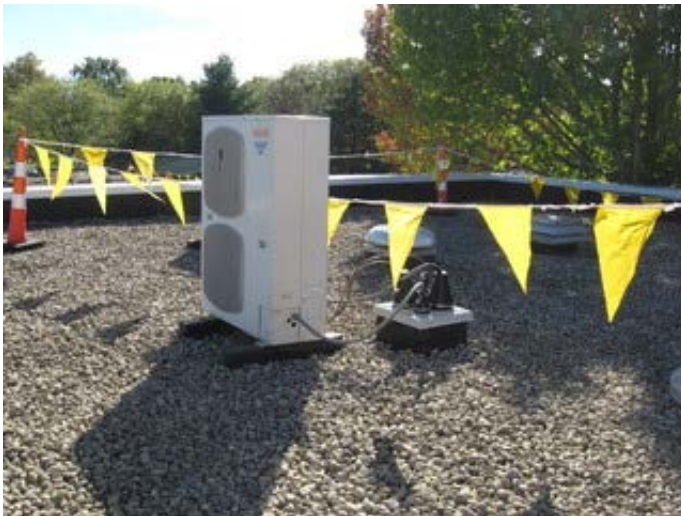
Split AC Condensing Unit

Description: The overall facility is not equipped with a central air conditioning system. The overall facility is not equipped with any window units. An isolated room system consisting of a ducted split HVAC system, with the condensing units located on pads outside on the Mechanical Room and fan coil units / air handlers located in the ceilings, is provided in Administrative Offices. An isolated room system consisting of a ductless split AC system, with the condensing unit on the roof, is provided in the Music spaces. The ventilation system in the overall facility consists of unit ventilators, original each addition and in fair condition, providing fresh air to Classrooms, and air handlers, original to each addition and in fair condition, providing fresh air to other miscellaneous spaces such as the Gymnasium. Relief air venting is provided by ceiling plenums, central relief fans, and air handlers. The ventilation system does not appear to meet the Ohio Building Code 15 CFM per occupant fresh air requirement. The overall system is not compliant with Ohio Building Code and Ohio School Design Manual requirements. Dust collection systems are not required in this facility. The Art program is equipped with a kiln, and the existing exhaust system is inadequate. General building exhaust systems for Restrooms, Storage Rooms, Art Rooms, and Custodial Closets are inadequately placed, and in fair condition.

Rating: 2 Needs Repair

Recommendations: Provide an air conditioning system to meet with Ohio Building Code and Ohio School Design Manual requirements. Replace general building exhaust systems located in Restrooms, Storage Rooms, Art Rooms, and Custodial Closets. Pricing included in Item A. Replace the existing Art Program kiln ventilation system.

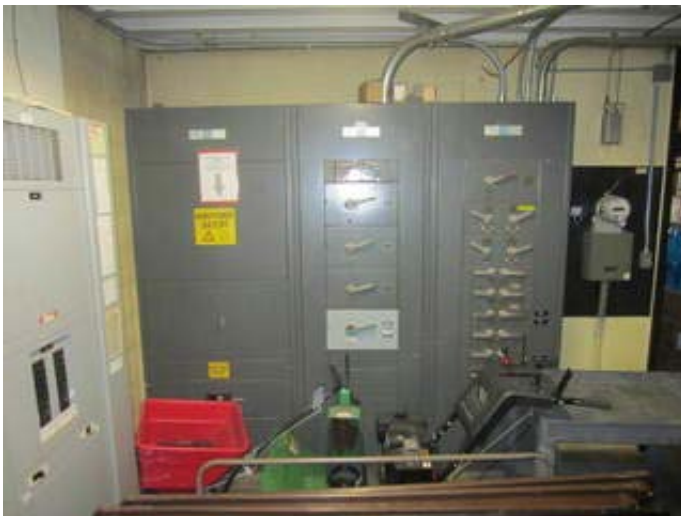
Main Electrical Distribution Panel

Description: The electrical system provided to the 1964 Original Construction is a 120/208 volts, 600 amp, 3 phase and 4 wire system installed in 1964, and is in fair condition. The systems in the 1967 and 1988 Additions are an extension of that found in the 1964 Original Construction. Power is provided to the school by multiple utility owned, pole-mounted transformers located outside the Mechanical Room, and are in good to fair condition. The panel systems, original to each addition, are in fair condition, and for the most part cannot be expanded to add additional capacity. The Classrooms are not equipped with adequate electrical outlets. The typical Classroom contains five (5) general purpose outlets, one (1) dedicated outlet for each Classroom computer, and zero (0) dedicated outlets for each Classroom television. Some Classrooms are equipped with as many as six (6) general purpose outlets, while others are equipped with as few as three (3) general purpose outlets. There are not any spaces that have no electrical outlets. The Corridors are equipped with adequate electrical outlets for servicing. GFI protected exterior outlets are adequately provided around the perimeter of the building. The facility is not equipped with an emergency generator. Adequate lightning protection safeguards are provided. The facility is not equipped with a Stage. The overall electrical system does not meet Ohio School Design Manual requirements in supporting the current needs of the school, and will be inadequate to meet the facility's future needs.

Rating: 3 Needs Replacement

Recommendations: The entire electrical system requires replacement to meet Ohio School Design Manual guidelines for overall capacity and due to condition and age, lack of OSDM-required features, to accommodate the addition of an air conditioning system. Provide an emergency generator, with funding included in the electrical system replacement. Provide adequate lightning protection safeguards in the overall facility, including associated grounding system, with funding included in the electrical system replacement.

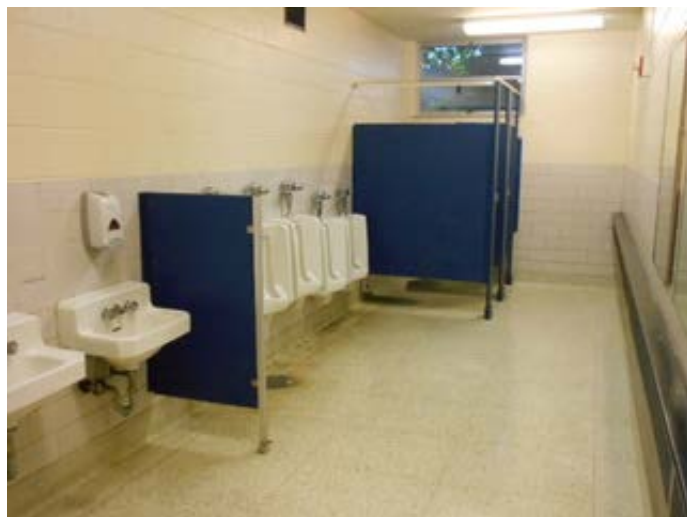
Large Group Boys' Restroom

3 Needs Replacement

In the overall facility, replace the remaining cast iron waste piping with PVC. In the 1964 Original Construction and the 1967 Addition, replace the remaining galvanized with copper. Provide a reduced pressure backflow preventer. To facilitate the school's compliance with OBC and OSFC fixture requirements throughout the overall facility, provide 23 new Classroom sinks with deck mounted bubblers. Due to age and condition, replace 15 toilets, 10 urinals and 16 lavatories throughout the facility. Due to age, condition, LEED, OBC and OSFC, replace 60 faucets and valves throughout the overall facility. Provide a new Emergency Shower in the Special Needs/Education Restroom. Provide a new grease interceptor/trap in the Kitchen. Provide 3 additional single electric water coolers. All fixtures, whether new or replaced, to be mounted at ADA compliant heights. Provide 3 additional exterior wall hydrants. See Item O for replacement, remounting of fixtures related to ADA requirements as well as toilet rooms for 1 Kitchen, 1 Clinic, 1 Coach's Office and 2 Staff Restrooms. Funding for replacement of Kitchen equipment and fixtures is provided for in Item J.

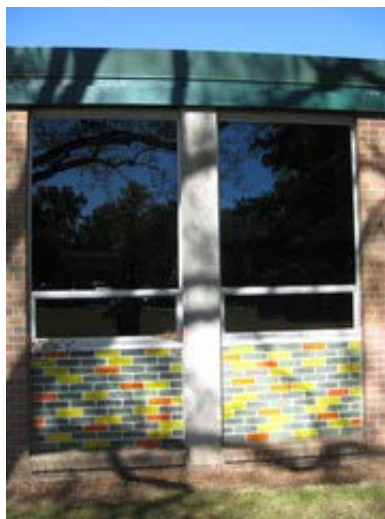
Aluminum Frame Windows

The 1964 Original Construction and the 1967 Addition are equipped with thermally broken aluminum frame windows with single glazing that was installed at an unknown date, and is in fair condition. The 1964 Original Construction and the 1967 Addition is also equipped with fixed hollow metal frame windows with single glazing that was installed at the time of construction, and is in fair condition. The window system features operable windows in most of the building, and operable windows are equipped with opening limiters in fair condition and insect screens in fair condition. Window system seals are in fair condition, with no air or water infiltration being experienced. Window system hardware is in fair condition. The window system features surface mounted blinds, which are in good condition. The 1988 Addition is equipped with thermally broken aluminum frame windows with single glazed type window system, which was installed in 1988, and is in fair condition. The window system features operable windows throughout the addition, and operable windows are equipped with opening limiters in fair condition and insect screens in fair condition. Window system seals are in fair condition, with no air or water infiltration being experienced. Window system hardware is in fair condition. The window system features surface mounted blinds, which are in fair condition. This facility is not equipped with any curtain wall systems. This facility does not feature any glass block windows. The exterior doors in the 1964 Original Construction and the 1967 Addition are equipped with hollow metal frame sidelights and transoms with tempered single pane glazing, in fair condition. Exterior door vision panels are tempered single pane. The exterior doors in the 1988 Addition are equipped with thermally broken aluminum frame sidelights and transoms with tempered single pane glazing, in fair condition. The school does not contain skylights. The school does not contain clerestories. Interior glass is not OSDM-compliant. Window security grilles are not provided for ground floor windows. There is not a Greenhouse associated with this school.

3 Needs Replacement

Provide a new insulated window system with integral blinds to meet with Ohio School Design Manual requirements. Replace window transoms and sidelights at exterior doors of the 1964 Original Construction and the 1966 Addition. Funding included in the total insulated glass/panel areas. Provide for the replacement of exterior door vision panel replacement.

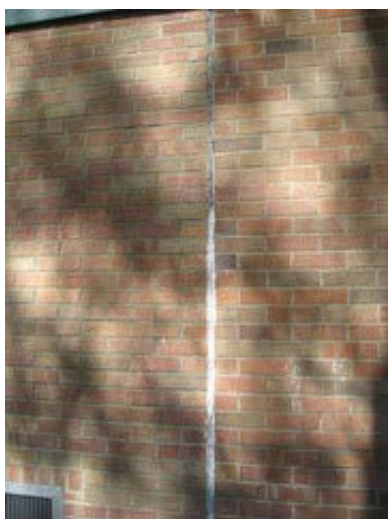
Expansion Joint

Description: The overall facility has a brick veneer on load bearing masonry wall system, which displayed no locations of deterioration, and is in good condition. The exterior masonry appears to have appropriately spaced and adequately caulked control joints in good condition. Control joints are not provided at lintel locations, at doors and windows, building corners, and wall offsets, though are not needed. The school does have sufficient expansion joints, and they are in poor condition. Exterior walls in the overall facility are inadequately insulated. Brick veneer masonry walls are not cavity walls. Weep holes and vents are not provided or required. The exterior masonry has not been cleaned and sealed in recent years, showing no evidence of mortar deterioration. Architectural exterior accent materials consist of stone and glazed brick, which are in good condition. Exterior building fenestration in the overall facility represents 19% of the exterior surfaces. Installation of new HVAC systems will result in removal of existing unit ventilators, necessitating the exterior masonry infill of associated exterior wall voids. Interior Corridor and demising walls are concrete masonry units and glazed block, project full height from floor to bottom of deck, and are in good condition. Interior masonry appears to have adequately spaced and caulked control joints in good condition. Interior soffits are of gypsum board type construction, and in good condition. The window sills are an element of the aluminum window system, and are in fair condition. The exterior lintels are steel, and are rusting, and in fair to poor condition. Chimneys are in fair condition. Canopies over entrances are steel frame with plaster type construction, and are in fair condition. Exterior soffits are of metal type construction, and in poor condition. The school is provided with a covered concrete conventional loading dock to facilitate the receipt of product, supplies, and foodstuffs, 100 square feet in size. The dock itself is in poor condition, and is equipped with bumper pads in poor condition.

Rating: 2 Needs Repair

Recommendations: Provide masonry cleaning and sealing as required through the overall facility. Recaulk existing expansion joints between the 1964 Original Construction and the 1967 Addition. Prep and paint exposed steel lintels through the overall facility. Exterior wall insulation deficiencies are addressed in Item J. Provide masonry infill at voids left by removal of exterior unit ventilator louvers in the 1964 Original Construction and the 1966 Addition. Repair chimney as required. Replace exterior soffits due to condition. Repair concrete loading dock as required.

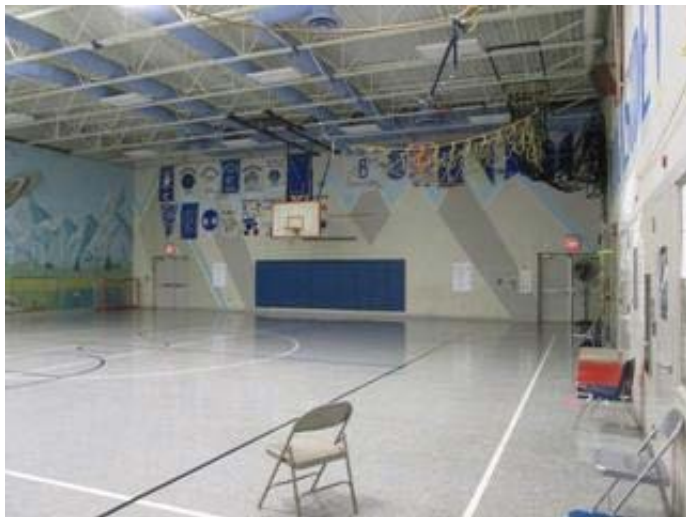
Gymnasium Finishes

The overall facility features conventionally partitioned Classrooms with LVT and carpet type flooring, perforated metal panel type ceilings, as well as painted block and glazed block type wall finishes, and they are in fair condition. The 1964 Original Construction and 1967 Addition has Corridors with terrazzo type flooring, acoustical tile or painted gypsum type ceilings, as well as painted block, glazed block, ceramic tile, brick, and stone type wall finishes, and they are in fair condition. The 1987 Addition has Corridors with terrazzo type flooring, acoustical tile or painted gypsum type ceilings, as well as painted block and plaster type wall finishes, and they are in fair condition. The overall facility has Restrooms with terrazzo type flooring, painted gypsum type ceilings, as well as painted block and glazed block type wall finishes, and they are in fair condition. Toilet partitions are plastic and metal, and are in good condition. Flexible partition walls have been provided in Classrooms between the two Courtyards, as well as between two Classrooms adjacent to the west Courtyard. Classroom casework in the overall facility is wood type construction with plastic laminate tops, is adequately provided, and in fair to poor condition. The typical Classroom contains 12 lineal feet of casework, and Classroom casework provided ranges from 10 to 15 feet. Classrooms are provided adequate chalkboards, markerboards, and tackboards, which are in fair condition. The student coat hooks and storage cubbies, located in the Classrooms are adequately provided, and in fair condition. The Art program is equipped with a kiln in fair condition, and existing kiln ventilation is inadequate. The kiln is located in the Boiler Room. The facility is equipped with wood non-louvered interior doors that are recessed with without proper ADA hardware, and in good to fair condition. The Gymnasium space has VCT type flooring, exposed type ceilings, as well as painted block type wall finishes, and they are in fair condition. There are no Gymnasium stands. Gymnasium basketball backboards are an electrically operated type, and are in fair condition. The Media Center, located in the 1964 Original Construction, has carpet type flooring, perforated metal panel type ceilings, as well as painted block and glazed block type wall finishes, and they are in fair condition. Student Dining, located in the 1964 Original Construction, has VCT type flooring, acoustical tile type ceilings, as well as painted block and glazed block type wall finishes, and they are in fair condition. There is no Stage in the overall facility. Stage related equipment is demountable and was located in a storage room adjacent to the Gymnasium during the assessment. Existing Gymnasium and Student Dining spaces are adequately provided with appropriate sound attenuation acoustical surface treatments. Existing Media Center and Music spaces are not provided with appropriate sound attenuation acoustical surface treatments. The existing Kitchen is full service, is adequately sized based on current enrollment, and the existing Kitchen equipment, installed over 20 years ago, and is in fair to poor condition. The Kitchen hood is in fair condition, and is equipped with the required UL 300 compliant wet chemical fire suppression system. The required 6" overhang on all three exposed sides of the cooking equipment is provided by the hood. Kitchen hood exhaust ductwork is of proper construction, material, insulation, and installed as required by the OSDM and OBCMC. A walk-in cooler is located within the Kitchen spaces, and is in fair condition.

2 Needs Repair

Provide for the complete replacement of finishes and casework due to condition and installation of systems outlined in Items A, C, D, E, K, L, M, N, T, U, and W. Funding for replacement of interior door hardware is provided in Item O. Provide for the replacement of the Art Program kiln, with funding for the exhaust system provided in Item C. Remove Corridor transfer grilles, fill voids, and coordinate with adjacent finishes. Provide for the replacement of toilet accessories. Provide for two Gymnasium Basketball Backboards. Provide for appropriate acoustical sound attenuation surface treatments in the Music spaces and Media Center. Provide for the replacement of a walk-in cooler due to age and condition. Funding for the walk-in cooler and freezer is provided for in the cost of the total Kitchen equipment replacement. Provide for the replacement of the Kitchen Hood due to age and condition. Provide for the replacement of Kitchen equipment due to age and condition. Provide for additional wall insulation. Provide for the repair of terrazzo flooring due to condition. Provide for hard plaster removal due to work in Item T. Provide for the replacement of toilet accessories.

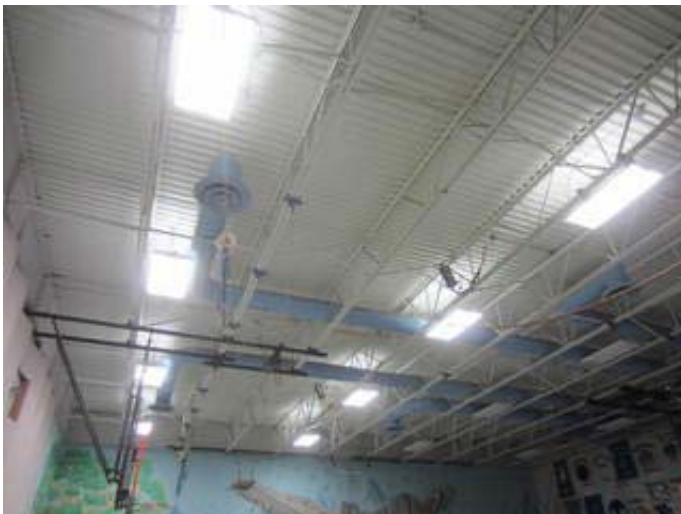
Gymnasium Fluorescent Light Fixtures

Description: The typical Classrooms in the overall facility are equipped with 2-lamp T-8 1x4 surface mount continuous strip fluorescent fixtures with dual level switching. Classroom fixtures are in fair condition, providing an average illumination of 65 FC, thus complying with the 50 FC recommended by the OSDM. The typical Corridors in the overall facility are equipped with 2- and 4-lamp T-8 2x4 lay-in direct fluorescent fixtures with single level switching. Corridor fixtures are in fair condition, providing an average illumination of 30 FC, thus complying with the 20 FC recommended by the OSDM. The Gymnasium spaces are equipped with 6-lamp T-5 2x8 suspended fluorescent fixtures type lighting, in good to fair condition, providing an average illumination of 30 FC, which is less than the 50 FC recommended by the OSDM. The Student Dining spaces are equipped with 4-lamp T-8 2x4 lay-in direct fluorescent fixtures type lighting, in fair condition, providing an average illumination of 30 FC, which is less than the 50 FC recommended by the OSDM. The Media Center is equipped with 4-lamp T-8 surface mount fluorescent fixture type lighting in good to fair condition, providing an average illumination of 55 FC, thus complying with the 50 FC recommended by the OSDM. The Kitchen spaces are equipped with T-8 1x4 surface mount continuous strip fluorescent fixture type lighting with dual level switching. Kitchen fixtures are in fair condition, providing an average illumination of 65 FC, which is less than the 75-80 FC recommended by the OSDM. The Service Areas in the overall facility are equipped with 2-lamp T-8 1x4 suspended fluorescent fixture type lighting in fair condition, providing inadequate illumination based on OSDM requirements. The typical Administrative spaces in the overall facility are equipped with 3-lamp T-8 2x4 lay-in direct fluorescent fixture type lighting in fair condition, providing adequate illumination based on OSDM requirements. The overall lighting systems of the facility are not fully compliant with Ohio School Design Manual requirements due to age, condition, inadequate lighting levels, and lack of multi-level switching.

Rating: 3 Needs Replacement

Recommendations: Provide complete replacement of lighting system due to age, condition, lighting levels, lack of multilevel switching, and installation of systems outlined in Items A, C, J, and U.

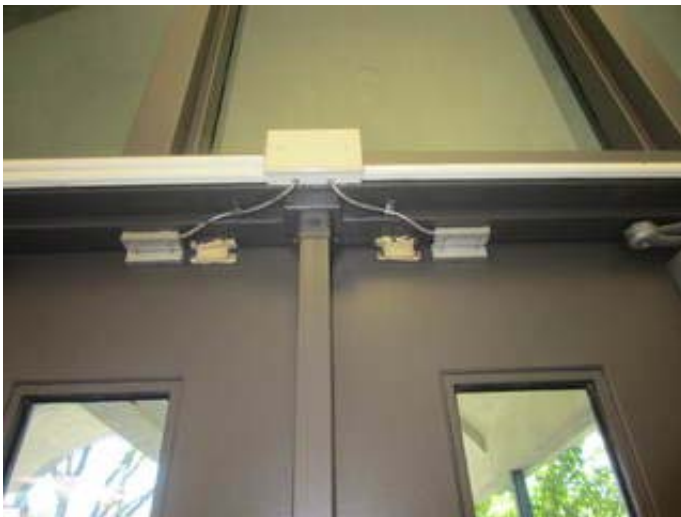
Security System Door Contacts

Description: The overall facility contains a motion sensor and door contact type security system in fair condition. Motion detectors are not adequately provided in main entries, central gathering areas, offices, main Corridors, and spaces where 6 or more computers are located. Exterior doors are equipped with door contacts. An automatic visitor control system is provided. Compliant color CCTV cameras are provided at the main entry area only and is not provided at parking lots, central gathering areas, and main Corridors. CCTV is monitored in Administrative Area with the use of a LCD TV / monitor. A compliant computer controlled access control system integrating alarms and video signals, with appropriate UPS backup, is not provided. The system is not equipped with card / biometric readers. The security system is not adequately provided throughout, and the system is not fully compliant with Ohio School Design Manual guidelines. There are playground fencing issues requiring attention, as the site and playground areas are not fully fenced to meet OSDM guidelines. The exterior site lighting system is equipped with surface mounted HID high pressure sodium entry lights in fair condition. Pedestrian walkways are illuminated with surface and pole mounted HID high pressure sodium light fixtures in fair to poor condition. Parking and bus pick-up / drop off areas are illuminated by pole mounted HID high pressure sodium light fixtures in fair condition. The exterior site lighting system provides inadequate illumination due to insufficient fixture capacity, sparse placement of fixtures, age, and condition.

Rating: 3 Needs Replacement

Recommendations: Provide complete replacement of security system to meet Ohio School Design Manual guidelines. Provide complete replacement of exterior site lighting system to meet Ohio School Design Manual guidelines. Provide playground fencing as required to meet OSDM guidelines, with funding included in the security system replacement.

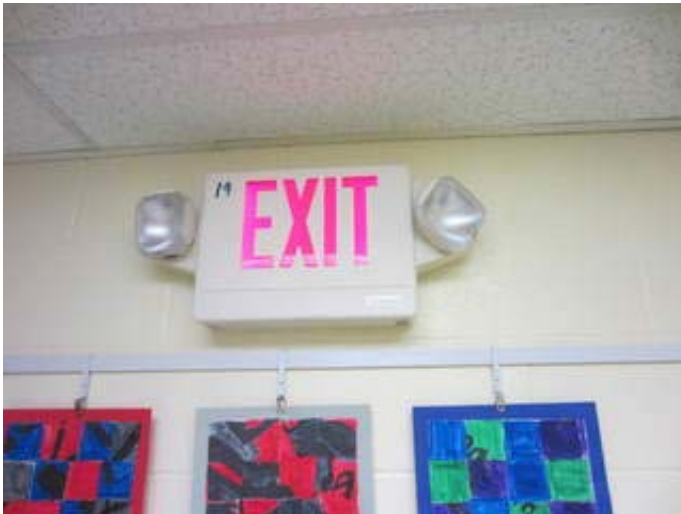
Exit Sign with Emergency Egress Lighting

Rating: 3 Needs Replacement

Recommendations: Provide complete replacement of emergency / egress lighting system to meet Ohio School Design Manual and Ohio Building Code guidelines.

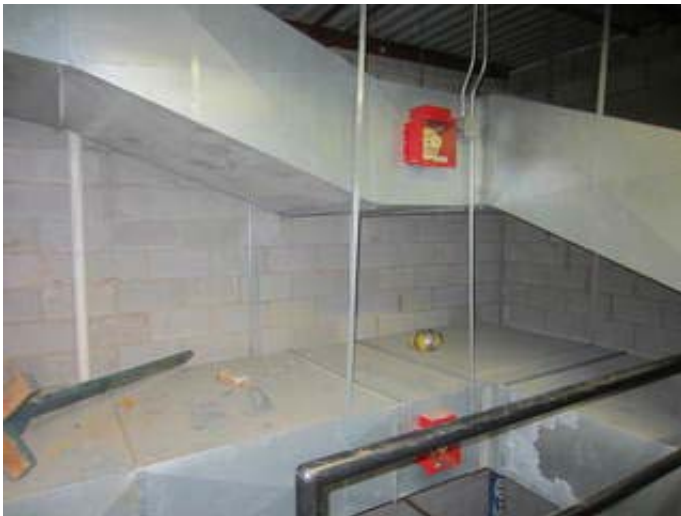
Fire Alarm System Duct Detector

Rating: 3 Needs Replacement

Recommendations: Provide complete replacement of fire alarm system to meet OBC, NFPA, and Ohio School Design Manual guidelines.
