Building Information - Worthington City (45138) - Granby Elementary School

Program Type	Assessment Only
Setting	Suburban
Assessment Name	Granby Elementary School
Assessment Date (on-site; non-EEA)	2015-09-23
Kitchen Type	Full Kitchen
Cost Set:	2015
Building Name	Granby Elementary School
Building IRN	98079
Building Address	1490 Hard Rd
Building City	Columbus
Building Zipcode	43235
Building Phone	614-450-4500
Acreage	17.93
Current Grades:	K-6
Teaching Stations	18
Number of Floors	1
Student Capacity	612
Current Enrollment	441
Enrollment Date	2015-09-14
Enrollment Date is the date in which the current enrollment was taken.	
Number of Classrooms	22
Historical Register	NO
Building's Principal	Patti Schlaegel
Building Type	Elementary

Granby Elementary School, which is not on the National Register of Historic Buildings, and originally constructed in 1988, is a 1 story, 59,004 square foot brick school building located in an suburban residential setting. The existing facility features a conventionally partitioned and open concept design, and does not utilize modular buildings. The structure of the overall facility contains brick on concrete masonry unit type exterior wall construction, wit

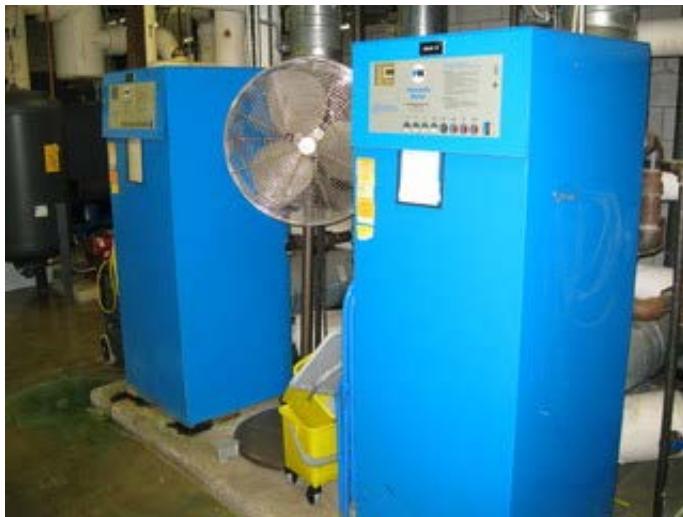
The existing system for the overall facility is a gas fired heating hot water system, installed in 1988, and is in fair condition. The heating and chilled water system in the overall facility is a 2-pipe system, without a capacity for simultaneous heating and cooling operation, which is not compliant with the OSDM requirements for basic system type. The 2 gas fired boilers, manufactured by PK, were installed in 1994 and are in fair condition. Heating water is distributed to terminal units consisting of unit ventilators, cabinet heaters, unit heaters, and air handlers. The terminal equipment was installed in 1988 and is in fair condition. The system does not comply with the 15 CFM per person fresh air requirements of the Ohio Building Code mechanical code and Ohio School Design Manual. The DDC type system temperature controls were installed in 1999 and are in fair condition. The system does feature individual temperature controls in all spaces required by the OSDM. The overall system does not feature any central energy recovery systems. The facility is not equipped with louvered interior doors to facilitate Corridor utilization as return air plenums. The existing system is ducted in the Gymnasium, Cafeteria, Main Office, and Library, but the ductwork cannot be integrated into a possible future system due to arrangement, air volume, and routing of existing ductwork. The existing system is not ducted in the Classrooms, and floor to structural deck heights will not accommodate the installation of properly sized ductwork for a future Ohio School Design Manual approved system. The overall heating system is evaluated as being in safe but inefficient working order, and long term life expectancy of the existing system is not anticipated. The structure is equipped with central air conditioning. The site does not contain underground fuel tanks.

Gas Fired Boilers

Provide new overall heating, ventilating, and air conditioning system to achieve compliance with Ohio Building Code and Ohio School Design Manual standards. Convert to ducted system to facilitate efficient exchange of conditioned air. Provide architectural soffits to accommodate the installation of ductwork in the Classrooms.

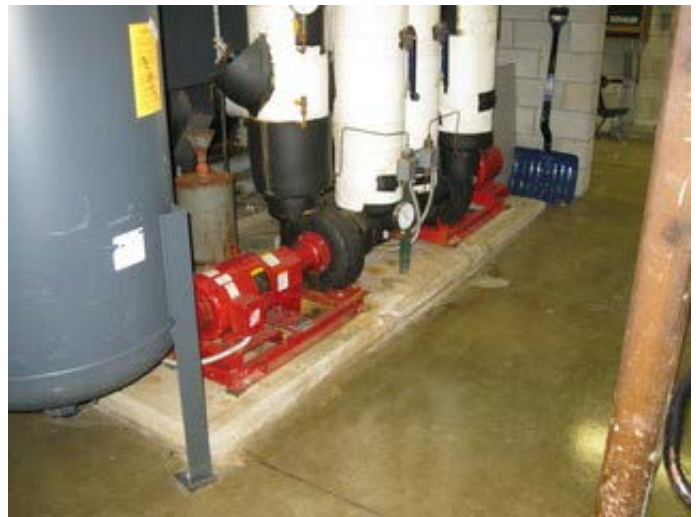
Pumps

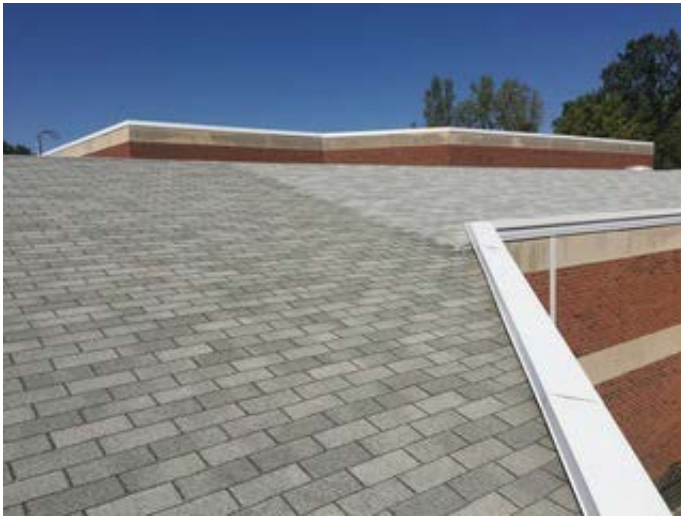
Description: The roof over the overall facility is a ballasted EPDM roof system and fiberglass shingle system that was installed in 1988 and is in poor condition. There are no District reports of current leaking. There are some areas of rusted VCT floor within the building, this could be a sign of past roof leaks. Access to the roof was gained by access door and ladder that are in fair condition. Fall safety protection cages are not required, and are not provided. There were no observations of standing water on the roof. Metal cap flashings and metal copings are in poor condition. Roof storm drainage is addressed through a system of gutters and downspouts, and roof drains, which are properly located, and in good condition. The roof is not equipped with overflow roof drains though they will be required in areas of roof replacement. No problems requiring attention were encountered with any roof penetrations. There are not any covered walkways attached to this structure.

Rating: 3 Needs Replacement

Fiberglass Shingled Roofing

Recommendations: The roof over the overall facility requires replacement to meet Ohio School Design Manual guidelines due to condition, age of system and projected lifecycle. Provide overflow drains throughout the overall facility. The flashing and / or coping on the overall facility require replacement due to condition.

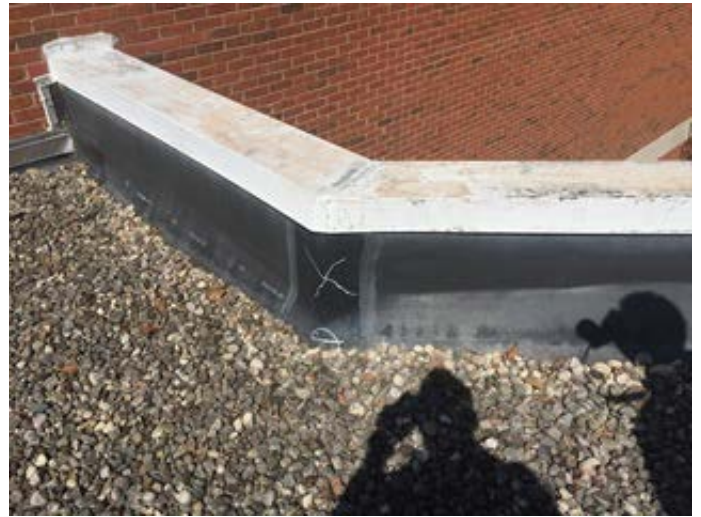
EPDM Roofing and Metal Coping

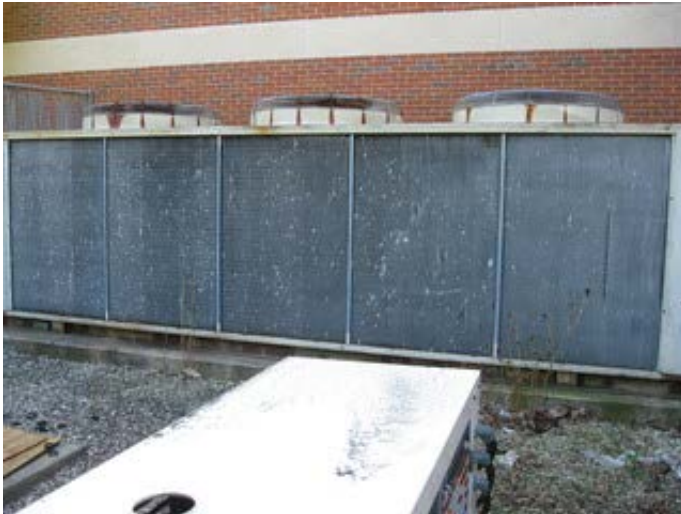
Description: The overall facility is equipped with a water cooled central air conditioning system, which is in poor condition. A chiller produces chilled water and chilled water pumps distribute the chilled water to the terminal units. The equipment is in poor condition. The ventilation system consists of unit ventilators, installed in 1988 and in fair condition, providing fresh air to Classrooms, and air handlers, installed in 1988 and in fair condition, providing fresh air to other miscellaneous spaces such as Gymnasiums, Student Dining, and Media Center. Relief air venting is provided ceiling plenums. The ventilation system does not meet the Ohio Building Code 15 CFM per occupant fresh air requirement. The overall system is not compliant with Ohio Building Code and Ohio School Design Manual requirements. Dust collection systems are not required in this facility. The Art program is equipped with a kiln, and existing kiln ventilation is adequate, and in fair condition. General building exhaust systems for Restrooms are adequately placed, and in fair condition.

Air Cooled Condenser

Recommendations: Provide an air conditioning system to meet with Ohio Building Code and Ohio School Design Manual requirements. Replace general building exhaust systems located in Restrooms. Pricing included in Item A.

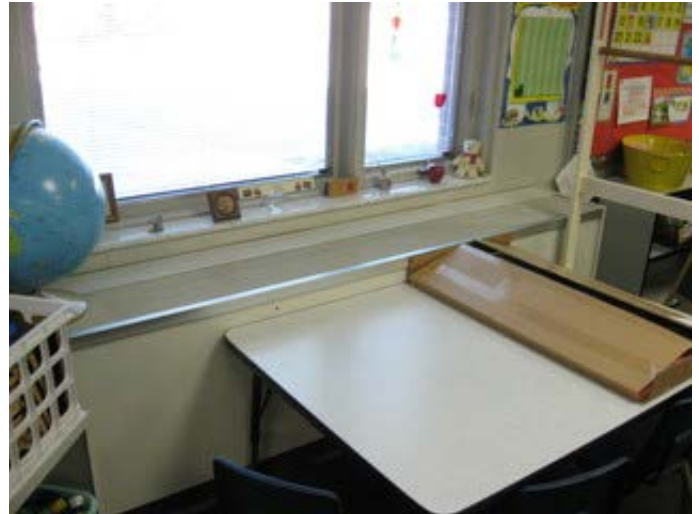
Unit Ventilator

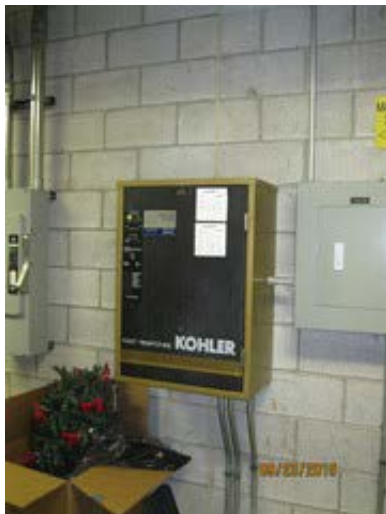
Description: The electrical system provided to the overall facility is a 480/277-volt, 3-phase, 4-wire, 800-amp system, installed in 1988, and is in good condition. Power is provided to the school by a single utility owned, pad-mounted transformer, located in exterior fenced-in area, and in good condition. The panel system, installed in 1988, is in good condition, and can be expanded to add additional capacity. The Classrooms are not equipped with adequate electrical outlets. The typical Classroom contains 12 general purpose outlets, 2 dedicated outlets for each Classroom computer, and 2 dedicated outlets for each Classroom television. Some Classrooms are equipped with as many as 16 general purpose outlets, while others are equipped with as few as 10 general purpose outlets. There are not any spaces that have no electrical outlets. The Corridors are not equipped with adequate electrical outlets for servicing. Adequate GFI protected exterior outlets are not provided around the perimeter of the building. The facility is equipped with a suitable emergency generator. Adequate lightning protection safeguards are not provided. Stage lighting power system, including dimmers, is inadequately provided, in good condition, and does not meet OSDM requirements. The overall electrical system does not meet Ohio School Design Manual requirements in supporting the current needs of the school, and will be inadequate to meet the facility's future needs.

Rating: 2 Needs Repair

Emergency Panel and Automatic Transfer Switch

Recommendations: Provide additional panels, circuits and outlets, to increase capacity for Classrooms and Corridors. Provide control panel, dimmers, and breakers to support the Stage lighting system. Provide adequate lightning protection safeguards.

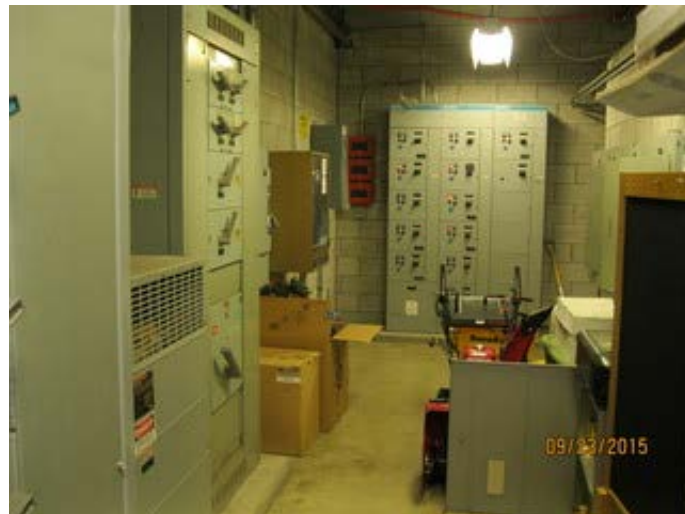
Electrical Distribution

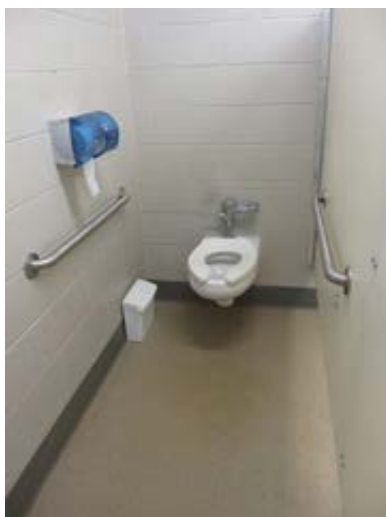
The service entrance is not equipped with a reduced pressure backflow preventer. A water treatment system is not provided. The domestic water supply piping in the overall facility is copper, was installed in 1988, and is in good condition. The waste piping in the overall facility is cast and PVC, was installed in 1988, and is in good condition. The facility is equipped with a gas water heater in good condition, with a separate 175-gallon storage tank in good condition. The school contains 3 Large Group Restrooms for boys, 3 Large Group Restrooms for girls, 3 Restrooms associated with specialty Classrooms, and 5 Restrooms for staff. Boys' Large Group Restrooms contain 0 ADA and 6 non-ADA wall mounted flush valve toilets, 4 ADA and 8 non-ADA wall mounted flush valve urinals, as well as 1 ADA wall mounted lavatories and 1 non-ADA floor mounted, trough- lavatories. Girls' Large Group Restrooms contain 0 ADA and 14 non-ADA wall mounted flush valve toilets, as well as 1 ADA wall mounted lavatories and 1 non-ADA floor mounted, trough-lavatories. Additionally, there is 1 ADA wall mounted lavatory, that does not have the required pipe protection, and 1 non-ADA floor mounted, multi-station lavatories that are shared between boys and girls restrooms. Note: the ADA wall mounted lavatories are sized for adults at 34" and not children, at 31" Staff Restrooms contain 0 ADA and 7 non-ADA wall mounted flush valve toilets, 0 ADA and 1 non-ADA wall mounted urinals, as well as 0 ADA and 4 non-ADA wall mounted and 2 non-ADA countertop lavatories. Condition of fixtures is fair. The facility is equipped with 0 ADA and 1 non-ADA drinking fountains, as well as 2 ADA and 6 non-ADA electric water coolers, in fair condition. The 21 Elementary Classrooms are equipped with 0 ADA and 21 non-ADA sink mounted type drinking fountains, in good condition. Special Education Classroom is equipped with a toilet but not the OSDM required ADA Restroom facility, and fixtures are in fair condition. Kitchen is equipped with the required Restroom, and fixtures are in fair condition. Heath Clinic is equipped with the required Restroom, which is not ADA compliant, and fixtures are in fair condition. Kindergarten / Pre-K Classrooms are equipped with Restroom facilities, and fixtures are in fair condition. Kitchen fixtures consist of 1 hand sink, 1 single-compartment sink, 1 double-compartment sink, and 1 triple-compartment sink, which are in good condition. The Kitchen is equipped with a satisfactory grease interceptor. The Kitchen is provided the required 140 degree hot water supply via a mixing valve, which is in good condition. The school does not meet the OBC requirements for fixtures. Relative to LEED requirements, the school is not equipped with low flow type fixtures. Per OBC and OSDM requirements this facility should be equipped with 39 toilets, 12 urinals, 27 lavatories, 21 Classroom sink mounted drinking fountains, and 13 electric water coolers. Observations revealed that the school is currently equipped with 27 toilets, 13 urinals, 11 lavatories, 20 Classroom sink mounted drinking fountains, and 9 electric water coolers. ADA requirements are not met for fixtures and drinking fountains (see Item O). Custodial Closets are properly located and are adequately provided with required service sinks or floor drain sinks, which are in fair condition. Science Classroom / Lab utility sinks, gas connections, compressed air connections, and safety shower / eyewash are not provided, but are not required due to existing grade configuration. Due to existing grade configuration, no Biology or Chemistry Classroom acid waste systems are required. Adequate exterior wall hydrants are provided.

Ambulatory - non-ADA Toilet

To facilitate the school's compliance with OBC and OSFC fixture requirements, provide 12 new toilets, 16 new lavatories, 4 new electric water coolers. See Item O for replacement of fixtures related to ADA requirements. Provide reduced pressure backflow preventer. Set ADA sinks at appropriate mounting height for existing grade configuration and include pipe protection (See corresponding photograph).

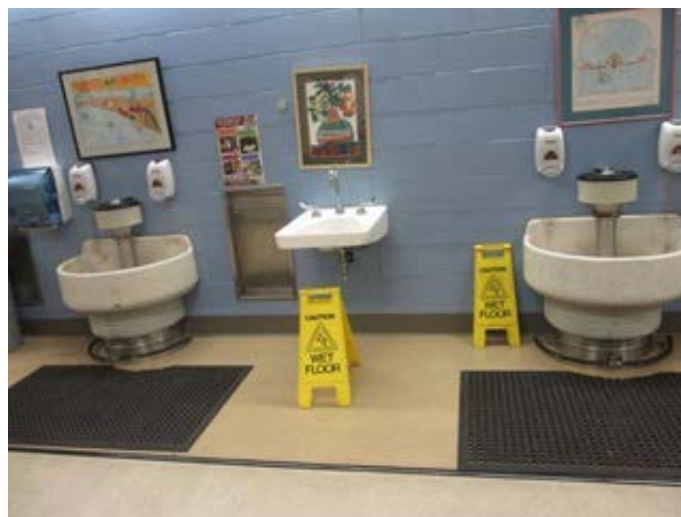
Hand Washing Stations & ADA Sink

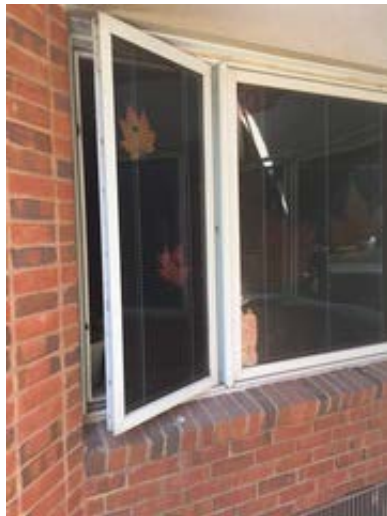
Description: The overall facility is equipped with aluminum clad wood windows with double glazed type window system, which was installed in 1988, and is in fair condition. The window system features operable windows in most of the building, and operable windows are equipped with opening limiters in fair condition and not equipped with insect screens. Window system seals are in poor condition, with moderate air and water infiltration being experienced. Window system hardware is in fair condition. The window system features integral blinds, which are in fair condition. Aluminum frame curtain wall systems are found in the original construction, in good condition. This facility does not feature any glass block windows. The exterior doors at the main entrance are equipped with aluminum sidelights and transoms with tempered double glazed insulated glazing in good condition. Exterior door vision panels are tempered double glazed insulated glazing. The school does not contain skylights. The school does not contain clerestories. Interior glass is OSDM-compliant. Window security grilles are not provided for ground floor windows. There is not a Greenhouse associated with this school.

Rating: 3 Needs Replacement

Typical Window

Recommendations: Provide a new insulated window system with integral blinds to meet with Ohio School Design Manual requirements throughout the facility due to condition.

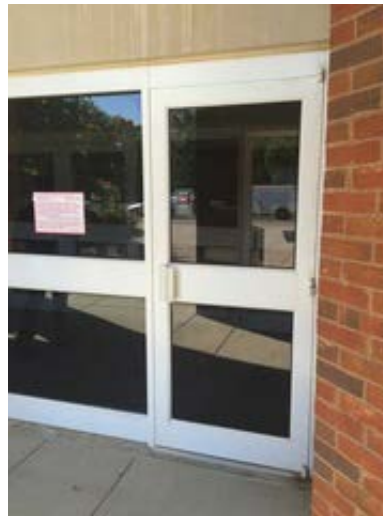
Typical Curtain Wall

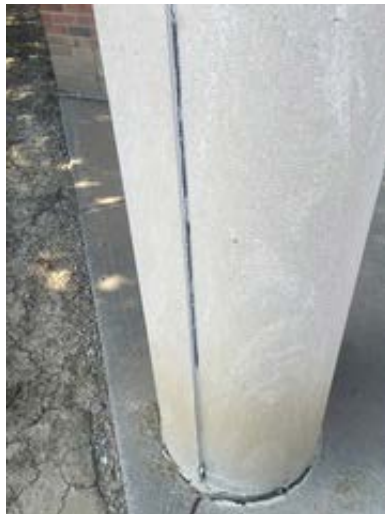
Description: The overall facility has a brick veneer on load bearing masonry wall system which displayed locations of deterioration, and is in fair condition. The exterior masonry appears to have appropriately spaced and adequately caulked control joints in poor condition. Control joints are provided at lintel locations, at doors and windows, building corners, and wall offsets and are in poor condition. The school does have sufficient expansion joints, and they are in poor condition. Exterior walls in the overall facility are adequately insulated. Brick veneer masonry walls are cavity walls. Weep holes and vents are provided at lintels, below sills, and the base of masonry cavity walls, and are in good condition. Weep holes are not rope type weeps. The exterior masonry has not been cleaned and sealed in recent years, and shows evidence of mortar deterioration below windows, at unit ventilator drains, and around the base of the wall. The exterior masonry also has locations of efflorescence and mold. Architectural exterior accent materials consist of stone trim, which is in fair condition. Caulking around stone trim is in poor condition. Exterior building fenestration in the overall facility represents 7.5% of the exterior surfaces. Interior Corridor and demising walls are concrete masonry units, and project full height from floor to bottom of deck, and are in good condition. Interior masonry appears to have adequately spaced and caulked control joints in good condition. Interior soffits are of drywall on metal stud type construction, and in good condition. The window sills are brick and are in fair condition. The exterior lintels are steel, and are in good condition. There are no chimneys. Canopies over entrances are exterior drywall on metal stud type construction, and are in fair condition. Exterior soffits are of exterior drywall on metal stud type construction, and in fair condition. Some exterior soffits have been faced with aluminum and are in good condition. The school is provided with a uncovered concrete conventional loading dock to facilitate the receipt of product, supplies, and foodstuffs, 300 square feet in size featuring no overhead doors. The dock itself is in fair condition, and is equipped with bumper pads in good condition.

Rating: 2 Needs Repair

Caulk at Stone Column

Recommendations: Provide masonry cleaning, caulking, and sealing as required through the overall facility. Recaulk all existing control joints. Replace caulk around stone trim, unit ventilator louvers, and storefronts. Repair exterior drywall on exterior canopies and soffits. Concrete repairs at loading dock will be addressed in Item P.

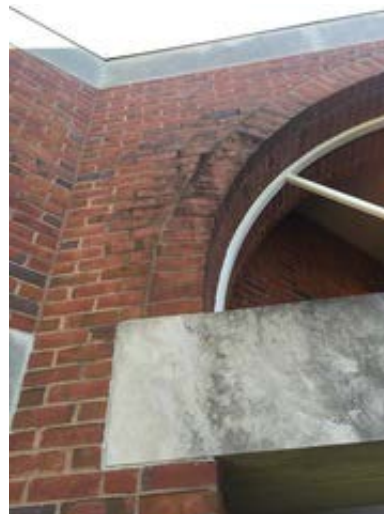
Mold on Exterior Brick and Stone

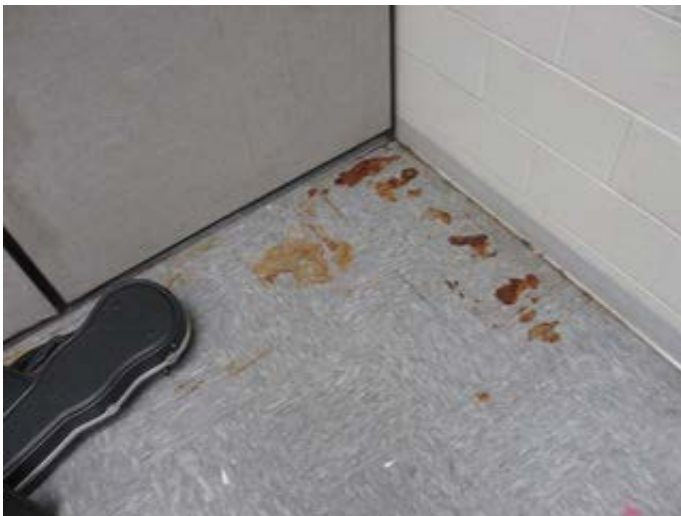
2 Needs Repair

Rusted Flooring

Provide for the addition of casework as required per the OSDM. Provide for the replacement of Stage and Gymnasium flooring due to rusted tiles and outdated materials. Provide for the replacement of all kitchen equipment installed before 1995. Provide for the replacement of flooring in custodial office. Provide for the full replacement of acoustical ceiling tile due to complete lighting system replacement outlined in Item K.

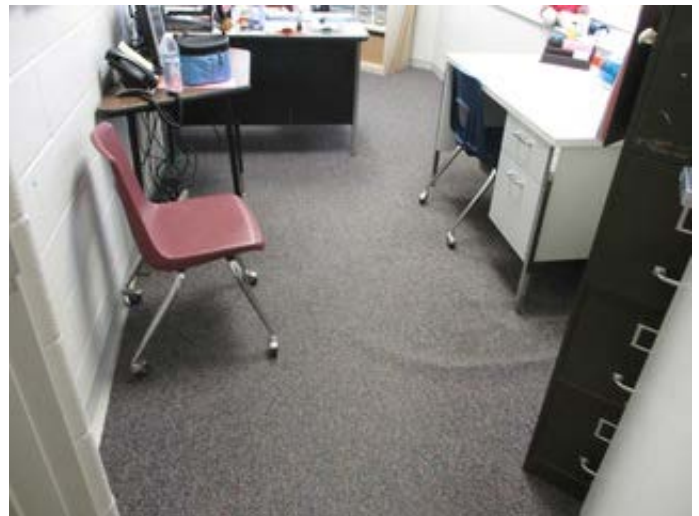
Replace Flooring in Custodial Office

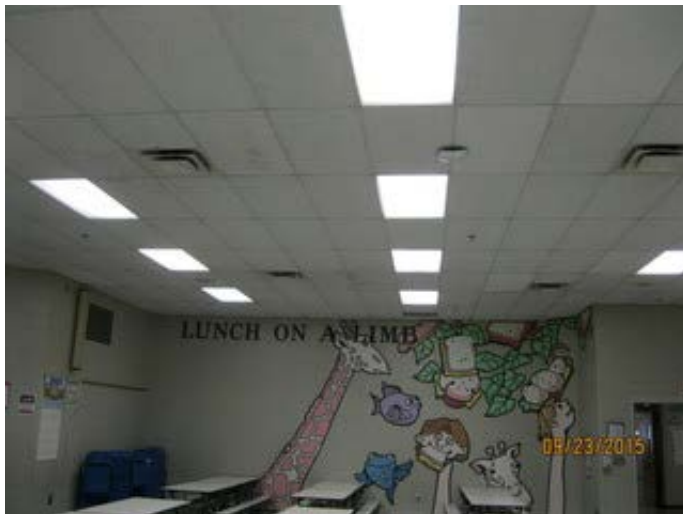
The typical Classrooms in the overall facility are equipped with T-8 lay-in 2x4 fluorescent fixtures with single level switching. Classroom fixtures are in good condition, providing an average illumination of 46 FC, which is less than the 50 FC recommended by the OSDM. The typical Corridors in the overall facility are equipped with T-8 lay-in 2x4 fluorescent fixtures with single level switching. Corridor fixtures are in good condition, providing an average illumination of 24 FC, thus complying with the 20 FC recommended by the OSDM. The Primary Gymnasium spaces are equipped with pendant T-8 2x4 mount fluorescent fixtures, in good condition, providing an average illumination of 66 FC, thus complying with the 50 ES FC recommended by the OSDM. The Media Center is equipped with lay-in 2x4 T-8 fluorescent fixture type lighting in good condition, providing an average illumination of 55 FC, thus complying with the 50 FC recommended by the OSDM. The Student Dining spaces are equipped with lay-in 2x4 T-8 fluorescent fixture type lighting with multi-level switching. Student Dining fixtures are in good condition, providing an average illumination of 60 FC, thus complying with the 50 FC recommended by the OSDM. The Kitchen spaces are equipped with 1x4 surface mount T-8 fluorescent fixture type lighting with single level switching. Kitchen fixtures are in good condition, providing an average illumination of 72 FC, which is less than the 75-80 FC recommended by the OSDM. The Service Areas in the overall facility are equipped with 1x4 surface mount T-8 fluorescent fixture type lighting in good condition. The typical Administrative spaces in the overall facility are equipped with lay-in 2x4 T-8 fluorescent fixture type lighting in good condition, providing adequate illumination based on OSDM requirements. The overall lighting systems of the facility are not compliant with Ohio School Design Manual requirements due to inadequate lighting levels and lack of multi-level switching.

Dining Area Lighting

Provide complete replacement of lighting system due to lighting levels and lack of multi-level switching.

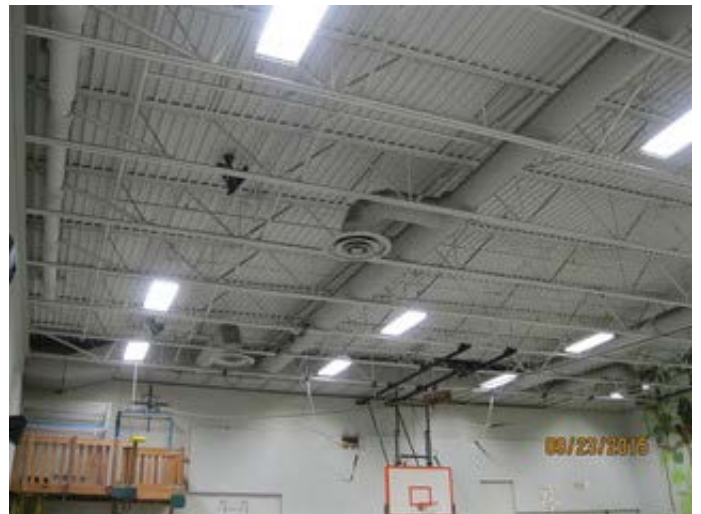
Gym Lighting

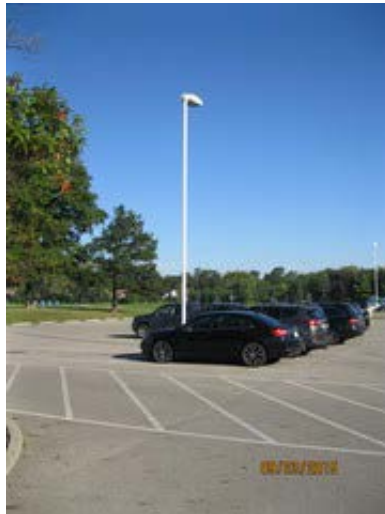
Description: The overall facility contains a Security Command motion detector, intrusion, and door contact type security system in good condition. Motion detectors are not adequately provided in main entries, central gathering areas, offices, main Corridors, and spaces where 6 or more computers are located. Exterior doors are equipped with door contacts. An automatic visitor control system is not provided. Compliant color CCTV cameras are not provided at main entry areas, parking lots, central gathering areas, and main Corridors. CCTV is not monitored in Administrative Area. A compliant computer controlled access control system integrating alarms and video signals, with appropriate UPS backup, is not provided. The system is equipped with card readers. The security system is not adequately provided throughout, and the system is not compliant with Ohio School Design Manual guidelines. The exterior site lighting system is equipped with surface mounted high pressure sodium entry lights in good condition. Pedestrian walkways are illuminated with wall mounted fixtures in good condition. Parking and bus pick-up / drop off areas are illuminated by pole mounted high pressure sodium fixtures in good condition. The exterior site lighting system provides inadequate illumination due to insufficient fixture capacity.

Rating: 3 Needs Replacement

Site Lighting Pole

Recommendations: Provide new security system and exterior site lighting to meet Ohio School Design Manual guidelines. Add exterior site lighting to provide adequate illumination.

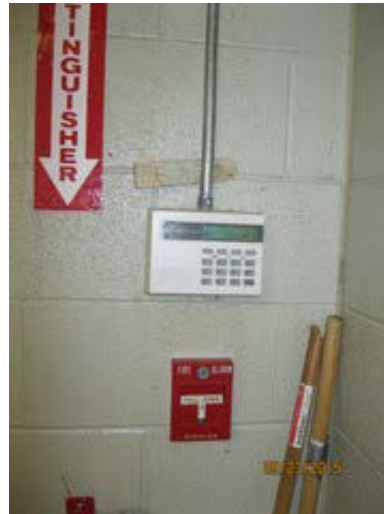
Security System Keypad / Panel

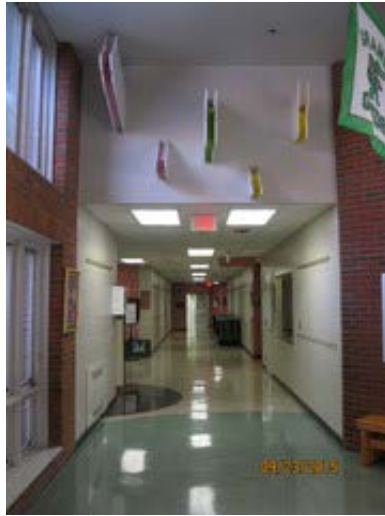
Description: The overall facility is equipped with an emergency egress lighting system consisting of non-compliant plastic construction, as well as OSDM compliant red lettered, LED illuminated exit signs, and the system is in good condition. The facility is not equipped with emergency egress floodlighting, but is equipped with recessed fluorescent lighting used as emergency egress lighting, and the system is in good condition. The system is provided with appropriate capacity on emergency generator and on separate circuits. The system is adequately provided throughout, and does not meet Ohio School Design Manual and Ohio Building Code requirements.

Rating: 2 Needs Repair

Exit Sign

Recommendations: Provide partial replacement of the emergency / egress lighting system to meet Ohio School Design Manual and Ohio Building Code guidelines.

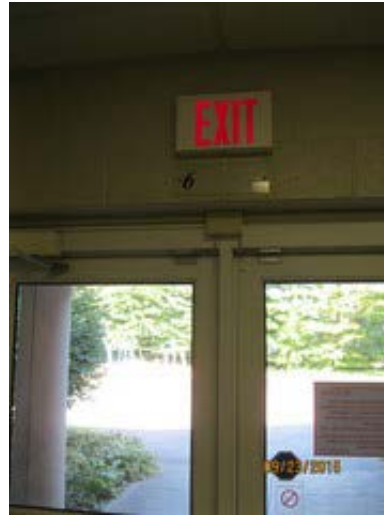
Exit Sign and Door Security Contacts

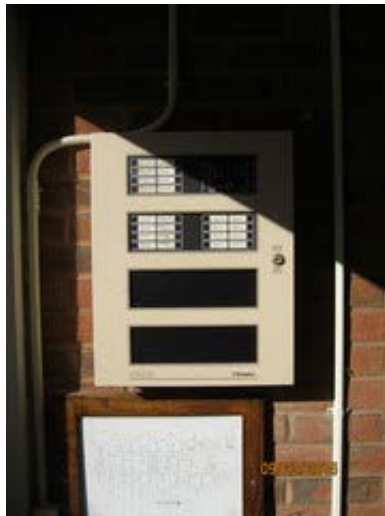
Description: The overall facility is equipped with a Simplex type fire alarm system, installed in 1988, and in good condition, consisting of manual pull stations, bells, and horn and strobe indicating devices. The system is automatic and is monitored by a third party. The system is equipped with sufficient audible horns, strobe indicating devices, flow switches, and tamper switches. The system is not equipped with sufficient smoke detectors or heat sensors. The system thus will support future fire suppression systems. The system is adequately provided throughout, and does not have additional zone capabilities. The system is not fully compliant with Ohio Building Code, NFPA, and Ohio School Design Manual requirements.

Rating: 3 Needs Replacement

Fire Alarm Remote Annunciator

Recommendations: Provide complete replacement of the fire alarm system to meet OBC, NFPA, and Ohio School Design Manual guidelines.

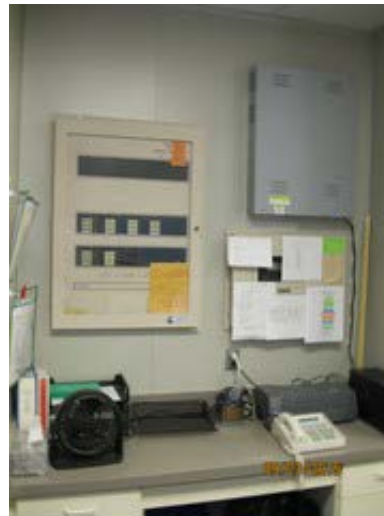
Fire Alarm Control Panel

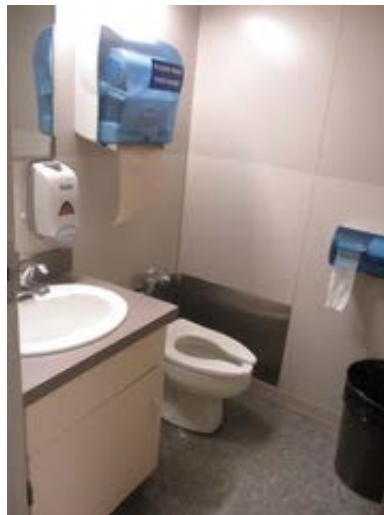
Rating: 3 Needs Replacement

Non-ADA Health Clinic Restroom

Recommendations: Provide ADA-compliant signage, stage access, electric water coolers, toilets, sinks, toilet partitions, toilet accessories, and remounted mirrors in the overall facility to facilitate the school's meeting of ADA requirements.

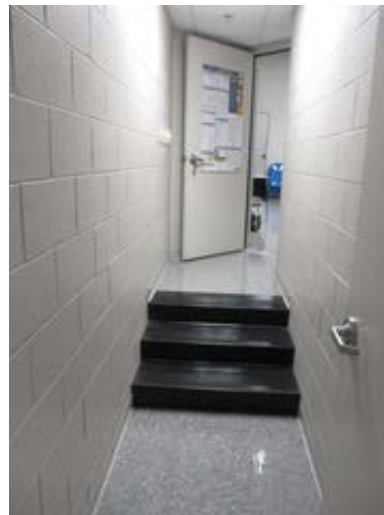
Non-ADA Stage Access

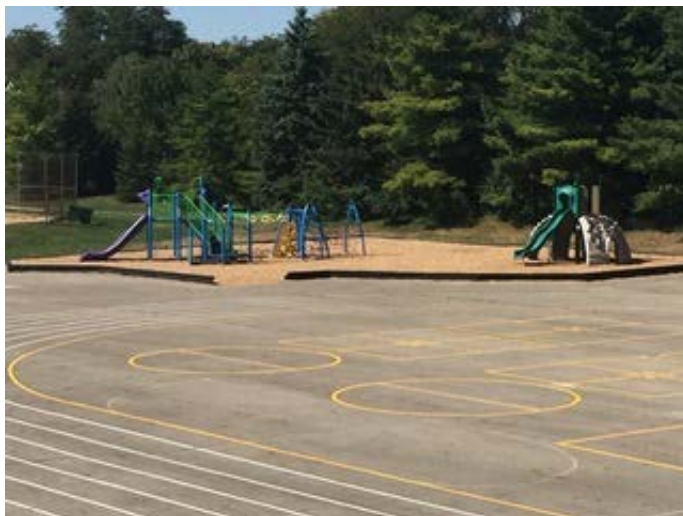
2 Needs Repair

Asphalt Play Area

Provide fencing to separate asphalt play area from vehicular traffic. Provide fencing around dumpsters and replace fencing around mechanical equipment. Resurface asphalt play areas. Replace concrete dumpster pad due to condition. Replace broken and cracked sidewalks and concrete loading dock.

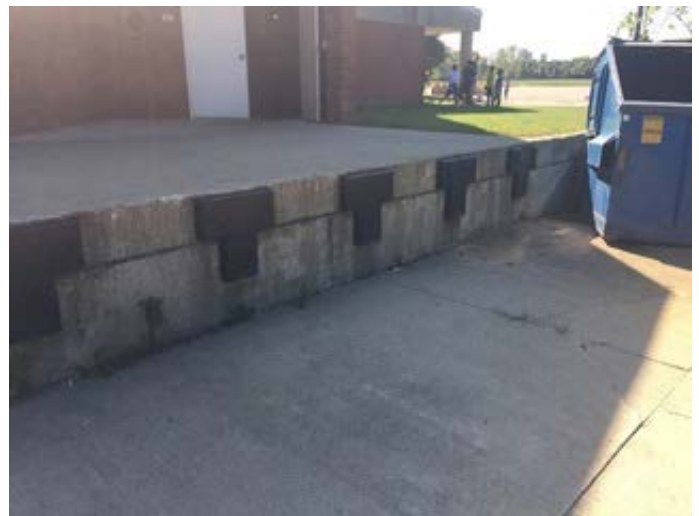
Concrete Loading Dock

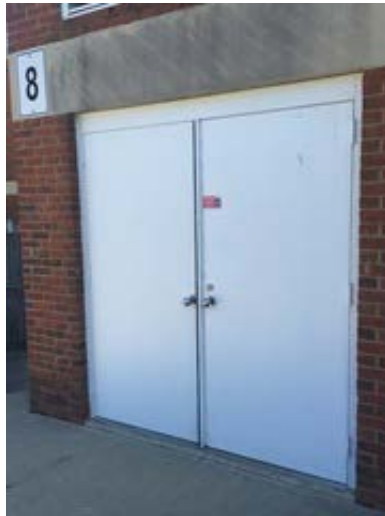
Description: Typical exterior doors in the overall facility are hollow type construction, installed on hollow metal frames, and in good condition. Typical exterior doors feature no vision panels, and inappropriate hardware. Entrance doors in the overall facility are aluminum type construction, installed on aluminum frames, and in good condition. Entrance doors feature double glazed tempered glass vision panels, and sidelights, and appropriate hardware. The facility is equipped with 1 roof access door, which is in fair condition. There are no overhead doors in the facility.

Rating: 2 Needs Repair

Typical Exterior Door with Inappropriate Hardware

Recommendations: Replace exterior door hardware as needed to comply with ADA Guidelines. Replace roof access door.

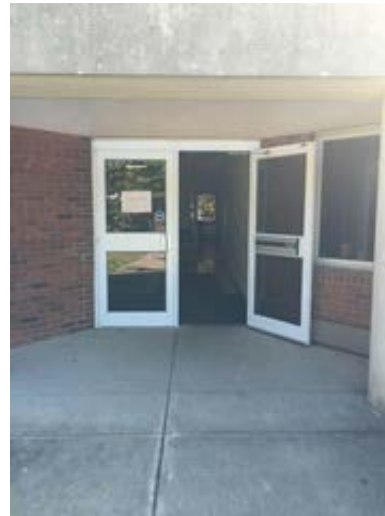
Typical Entrance Door

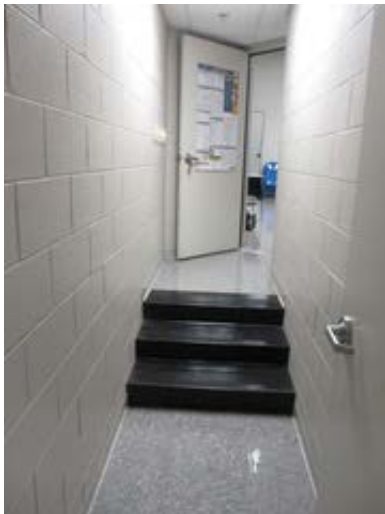
2 Needs Repair

No Handrails Present

Provide for new handrails at Cafetorium steps. Provide new emergency generator.
