Building Information - Worthington City (45138) - Liberty Elementary

Liberty Elementary School, which is not on the National Register of Historic Buildings, and originally constructed in 1981, is a single story, 54,714 square foot brick school building located in a suburban residential setting. The existing facility features a conventionally partitioned Open Concept design, and does not utilize modular buildings. The structure of the overall facility contains brick veneer on load-bearing masonry type exterior wall construction, with brick, painted CMU, metal partition type wall construction in the interior. The floor system consists of concrete slab on grade. The roof structure is metal purlin on rigid frame type construction. The roofing system of the overall facility is standing seam metal, installed in 1981 and ballasted EPDM installed in 2007. The ventilation system of the building is adequate to meet the needs of the users. The Classrooms are undersized in terms of the current standards established by the State of Ohio. Physical Education and Student Dining spaces consist of one Multipurpose space, one Gymnasium and separate Student Dining. The electrical system for the facil

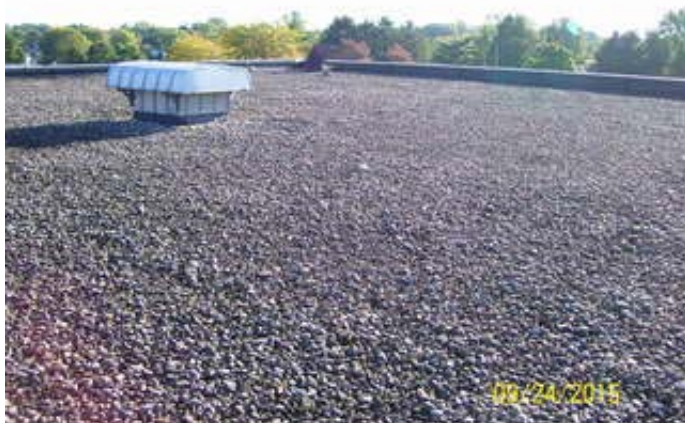
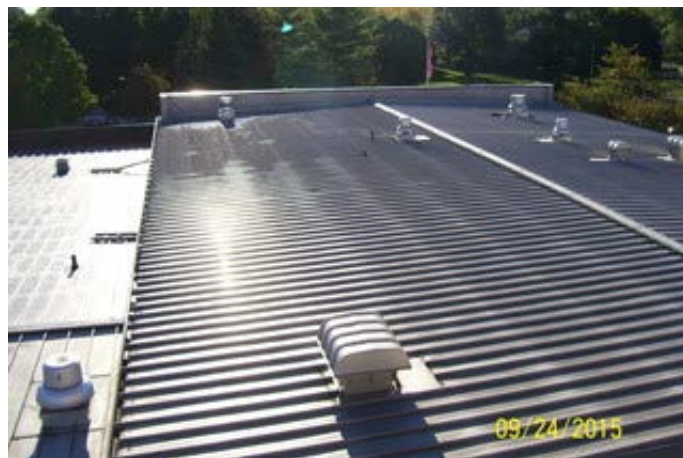
The roof over the overall facility is a standing seam metal system that was installed in 1981 and is in poor condition. The roof over the gymnasium is a ballasted EPDM system that was installed in 2007 and is in fair condition. There are District reports of current leaking and signs of past leaking were observed during the physical assessment. Water spots were observed on ceiling tiles in many locations throughout the building. Access to the roof was gained by access hatch in fair condition and a ladder in poor condition. Fall safety protection cages are not required and have not been provided. There were no observations of standing water on the roof. Metal cap flashings are in poor condition. Roof storm drainage is addressed through a system of gutters and downspouts, which are properly located, and in fair to poor condition. The roof is not equipped with overflow roof drains. Roof penetration deficiencies observed requiring attention include areas that have been repeatedly caulked and taped over many years of minor repairs. There is a covered walkway attached to this structure at the front of the building. It is constructed of standing seam metal roofing on post and beam metal framing and is in poor condition. A roofing report provided by the district summarizes the facility roofing as: "The roof system installed on the Liberty Elementary School consists of a combination of EPDM over the gymnasium, and standing seam metal on the two lower roof sections. The gymnasium roof consists of ballasted EPDM over EPS insulation and a steel deck. This section has internal roof drains. The gymnasium roof has recently been replaced due to the wind storm damage from Hurricane Ike. The ballasted EPDM should provide a satisfactory service life through 2023. The standing seam metal roof is in fair condition. Upon inspection several open end laps were observed. Repairs have been attempted at these areas with caulking to EPDM seam tape. The open end laps should be properly repaired with butyl tape. With annual inspections and preventative maintenance the metal roof areas should provide a satisfactory service life through 2014."

Ballasted Roof at Gymnasium

Typical Metal Roof

The roof over the overall facility requires replacement to meet Ohio School Design Manual guidelines due to condition and age of system and projected lifecycle.

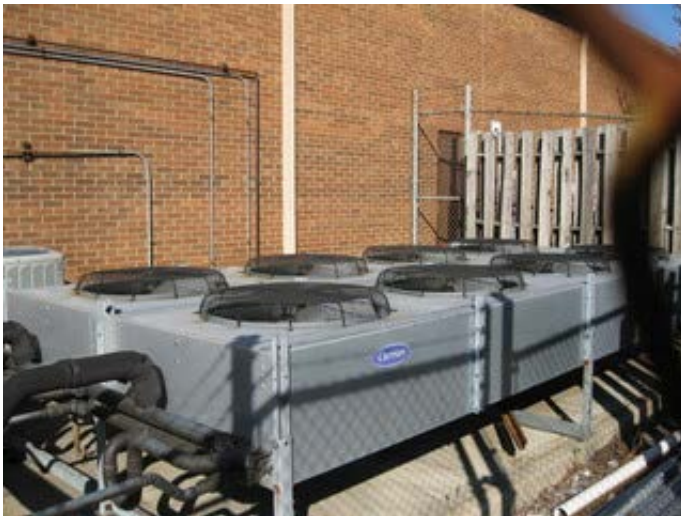
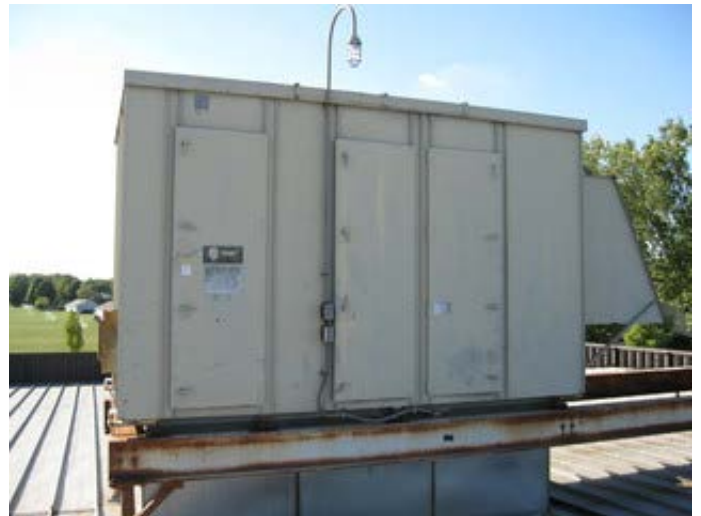
Description: The overall facility is equipped with a chilled water type central air conditioning system, which is in good condition. A chiller produces chilled water and pumps distribute chilled water to terminal units. The equipment is in good condition. The ventilation system in the overall facility consists of air handlers, installed in 1994 and in poor condition, providing fresh air to Classrooms, and air handlers, installed in 1994 and in poor condition, providing fresh air to other miscellaneous spaces such as Gymnasiums, Student Dining, and Media Center. Relief air venting is provided by ceiling plenums. The ventilation system does meet the Ohio Building Code 15 CFM per occupant fresh air requirement. The overall system is not compliant with Ohio Building Code and Ohio School Design Manual requirements. Dust collection systems are not required in this facility. The Art program is equipped with a kiln, and existing kiln ventilation is inadequate. General building exhaust systems for Restrooms are adequately placed, and in fair condition.

Air Cooled Condenser

Air Handler

Recommendations: Replace the existing roof mounted air handlers due to existing condition. Replace the existing kiln exhaust system with new.

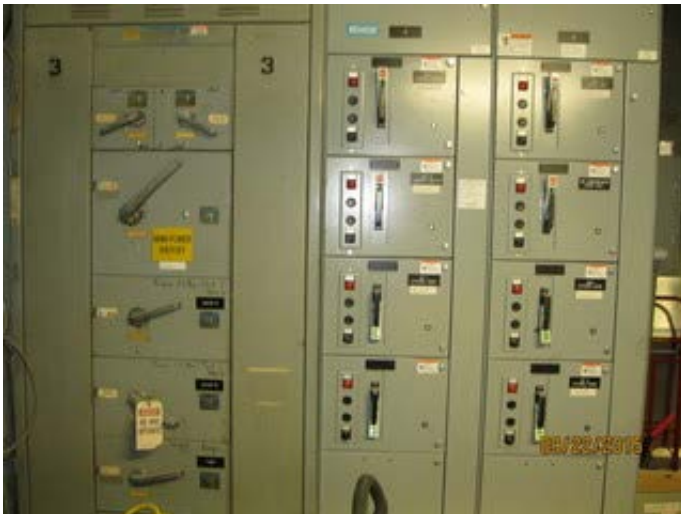
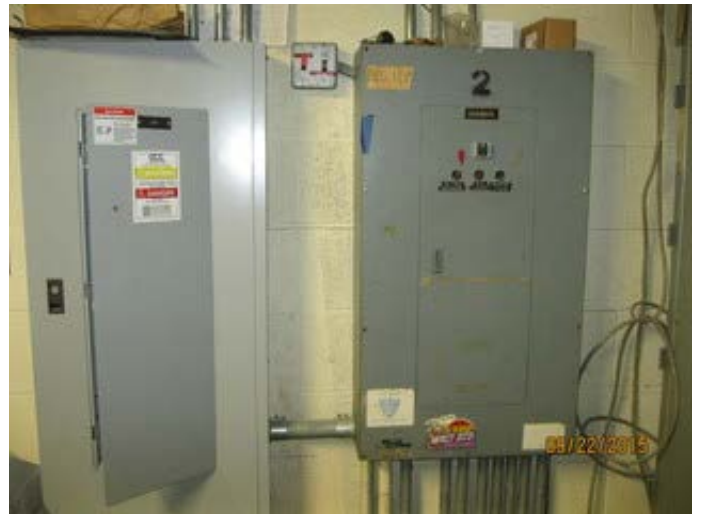
Description: The electrical system provided to the overall facility is a 480/277-volt, 3-phase, 4-wire, 800-amp system installed in 1980, and is in good condition. Power is provided to the school by a single utility owned, pad-mounted transformer located in exterior fenced-in area, and in good condition. The panel system, installed in 1980, is in good condition, and can be expanded to add additional capacity. The Classrooms are not equipped with adequate electrical outlets. The typical Classroom contains 16 general purpose outlets, 2 dedicated outlets for each Classroom computer, and 4 dedicated outlets for each Classroom television. Some Classrooms are equipped with as many as 18 general purpose outlets, while others are equipped with as few as 16 general purpose outlets. There are not any spaces that have no electrical outlets. The Corridors are not equipped with adequate electrical outlets for servicing. Adequate GFI protected exterior outlets are not provided around the perimeter of the building. The facility is equipped with a suitable emergency generator. Adequate lightning protection safeguards are not provided. Stage lighting power system including control panel, breakers, and dimmers is inadequately provided, in good condition and does not meet OSDM requirements. The overall electrical system meets does not meet Ohio School Design Manual requirements in supporting the current needs of the school, and will be adequate to meet the facility's future needs.

Main Electrical Switchgear

Electrical Panels

Recommendations: The entire electrical system requires replacement to meet Ohio School Design Manual guidelines for Classroom capacity, due to condition and age, and lack of OSDM-required features.

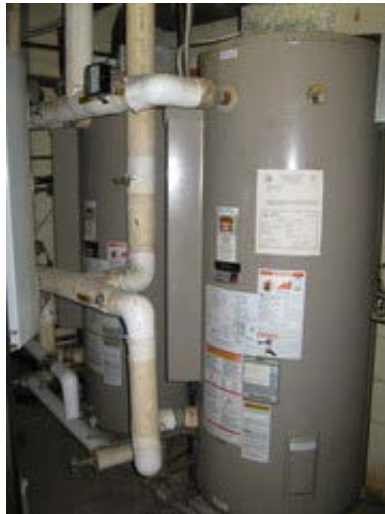
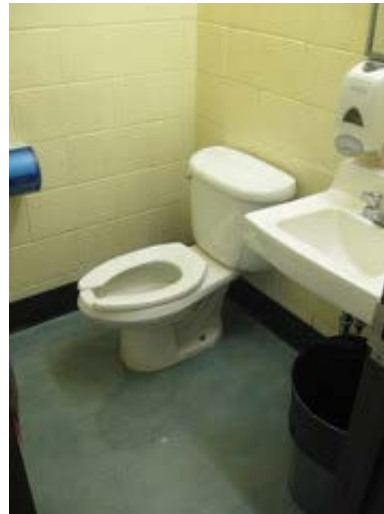
Description: The service entrance is not equipped with a reduced pressure backflow preventer. A water treatment system is not provided. The domestic water supply piping in the overall facility is copper, was installed in 1981, and is in good condition. The waste piping in the overall facility is cast iron and PVC, was installed in 1981, and is in good condition. The facility is equipped with (2) 100-gallon gas water heaters in good condition. The school contains 3 Large Group Restrooms for boys, 3 Large Group Restrooms for girls, 3 Restrooms associated with specialty Classrooms, and 4 Restrooms for staff. Boys' Large Group Restrooms contain 0 ADA and 6 non-ADA wall mounted flush valve toilets, 5 ADA and 7 non-ADA wall mounted flush valve urinals, as well as 1 ADA and 6 non-ADA wall mounted lavatories. Girls' Large Group Restrooms contain 0 ADA and 14 non-ADA wall mounted flush valve toilets, as well as 3 ADA and 4 non-ADA wall mounted lavatories. Staff Restrooms contain 1 ADA and 6 non-ADA wall mounted flush valve toilets, 1 ADA and 1 non-ADA wall mounted urinals, as well as 1 ADA and 4 non-ADA wall mounted lavatories. Condition of fixtures is fair. The facility is equipped with 0 ADA and 0 non-ADA drinking fountains, as well as 1 ADA and 3 non-ADA electric water coolers, in fair condition. The 20 Elementary Classrooms are equipped with 17 ADA and 0 non-ADA sink mounted type drinking fountains, in fair condition. Special Education Classroom is not equipped with the required Restroom facilities. Kitchen is equipped with the required Restroom, and fixtures are in good/fair condition. Heath Clinic is equipped with the required Restroom, and fixtures are in fair condition. Kindergarten Classrooms are equipped with Restroom facilities, and fixtures are in poor condition. Kitchen fixtures consist of 1 hand sink and 1 triple-compartment sink, which are in good condition. The Kitchen is equipped with a satisfactory grease interceptor. The Kitchen is provided the required 140 degree hot water supply via a mixing valve, which is in good condition. Adequate exterior wall hydrants are provided.

Water Heater

Restroom

Recommendations: Provide reduced pressure backflow preventer. To facilitate the school's compliance with OBC and OSFC fixture requirements, provide 3 new toilets / 15 new lavatories / 0 new urinals / 14 new electric water coolers / new lavatory mounted type drinking fountains. Due to age, condition, LEED, and OSFC requirements, provide 3 new toilets / 15 new lavatories / 0 new urinals / 14 new electric water coolers / new lavatory mounted type drinking fountains. See Item O for replacement of fixtures related to ADA requirements. Provide / Replace required sink mounted type drinking fountains in Elementary Classroom spaces.

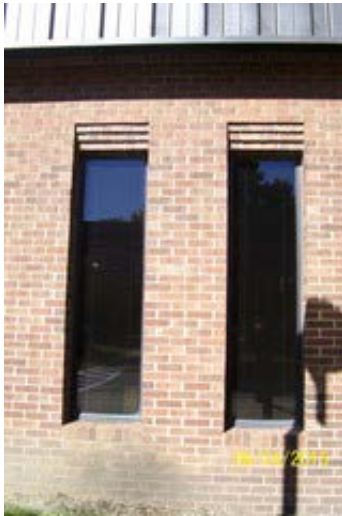
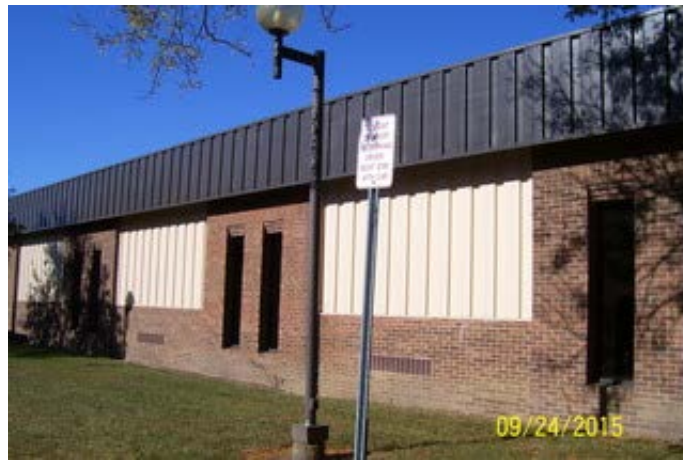
Description: The overall facility is equipped with aluminum frame windows with single glazed type window system, which was installed in 1981, and is in poor condition. The window system features inoperable windows throughout the building. Window system seals are in poor condition, with frequent air and water infiltration being experienced. Window system hardware is in fair condition. The window system features integral blinds, which are in fair condition. This facility is not equipped with any curtain wall systems. This facility does not feature any glass block windows. The exterior doors in the overall facility are equipped with aluminum sidelights and transoms with single pane glazing, in fair condition. Exterior door vision panels are tempered, single pane. The school does not contain skylights. The school does not contain any clerestories. Interior glass is OSDM-compliant. Window security grilles are not provided for ground floor windows. There is not a Greenhouse associated with this school.

Typical Windows

Recommendations: Provide a new insulated window system with integral blinds to meet with Ohio School Design Manual requirements. Exterior door vision panel replacement is addressed in Item S in exterior door replacement scope.

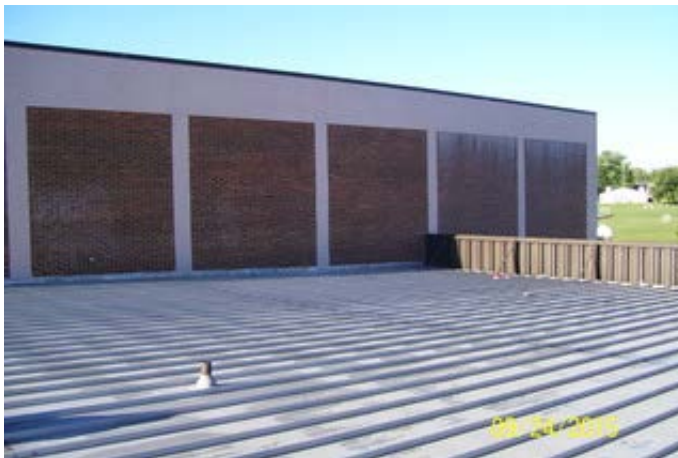
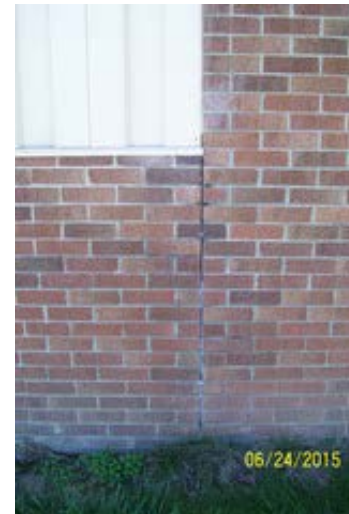
Description: The overall facility has a brick veneer on load bearing masonry wall system, which displayed locations of deterioration, and is in fair to poor condition. Several areas of cracking and settlement were observed, particularly associated with the gymnasium mezzanine. The exterior masonry appears to have appropriately spaced, but inadequately caulked control joints in poor condition. Control joints are provided at lintel locations, at doors and windows, building corners, and wall offsets. The school does have sufficient expansion joints, and they are in poor condition. Exterior walls in the overall facility are inadequately insulated. Brick veneer masonry walls are cavity walls. Weep holes are provided in sufficient quantity (at 24"-48" on center) at the base of masonry cavity walls, and are in fair to poor condition. Weep holes are not rope type weeps. Vents are not provided. The exterior masonry has not been cleaned and sealed in recent years, shows evidence of mortar deterioration, and has locations of efflorescence, mold, and graffiti. Architectural exterior accent material consists of metal panels, which are in fair to poor condition with dents and areas of finish deterioration being observed. Exterior building fenestration in the overall facility represents 7% of the exterior surfaces. Interior Corridor and demising walls are concrete masonry units, do not project full height from floor to bottom of deck, and are in fair condition. Interior masonry appears to have adequately spaced and caulked control joints in fair condition. Interior soffits are of gypsum board on metal framing type construction, and in fair condition. The window sills are brick, and are in fair condition. The exterior lintels are precast masonry, and are in fair condition. There are no chimneys. Canopies over entrances are steel type construction, and are in poor condition. Exterior soffits are of metal deck type construction, and in poor condition. The school is provided with an uncovered, concrete conventional loading dock to facilitate the receipt of product, supplies, and foodstuffs, 300 square feet in size. The dock itself is in fair condition, and is equipped with bumper pads in fair condition.

Typical Wall to be Cleaned

Typical Joint to be Caulked

Recommendations: Provide tuckpointing in all areas of mortar deterioration as required through the overall facility. Provide masonry cleaning, sealing, and caulking as required through the overall facility. Recaulk existing control joints. Repair or replace corrugated metal accent panels. Costs to replace entrance canopy are addressed in Item B.

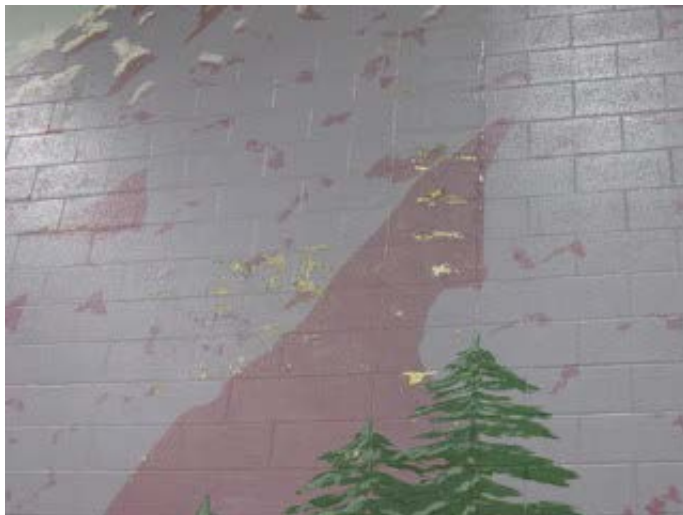
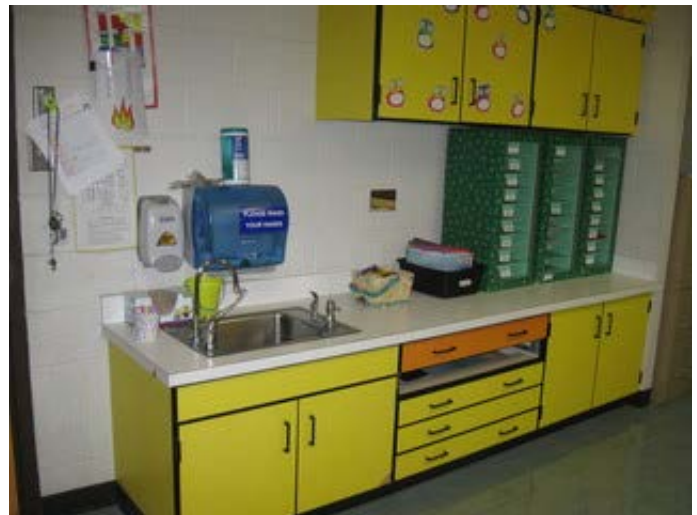
The overall facility features conventionally partitioned Classrooms with vinyl and carpet tile type flooring, 2x4 ACT type ceilings, as well as demountable walls and painted CMU type wall finishes, and they are in poor condition. The overall facility has Corridors with vinyl type flooring, 2x4 ACT type ceilings, as well as brick and painted CMU type wall finishes, and they are in fair condition. The overall facility has Restrooms with concrete or terrazzo type flooring, gypsum type ceilings, as well as painted CMU type wall finishes, and they are in poor condition. Toilet partitions are plastic, and are in good condition. Classroom casework in the overall facility is wood type construction with plastic laminate tops, is inadequately provided, and in poor condition. The typical Classroom contains 9'-0" lineal feet of casework. Classrooms are provided adequate chalkboards, markerboards, tackboards which are in fair condition. The Classroom storage cubbies, located in the Classrooms, are adequately provided, and in poor condition. The Art program is equipped with a kiln in fair condition, and existing kiln ventilation is inadequate. The facility is equipped with wood louvered interior doors that are flush mounted with proper ADA hardware and clearances, and in fair condition. The Gymnasium space(s) have vinyl type flooring, open type ceilings, as well as painted CMU type wall finishes, and they are in poor condition. Gymnasium basketball backboards are fixed type, and are in good condition. The Media Center, located in the 1981 Addition, has carpet type flooring, 2x4 ACT type ceilings, as well as painted CMU and metal partitions type wall finishes, and they are in fair condition. Student Dining, located in the 1981 Addition, has vinyl type flooring, 2x4 ACT type ceilings, as well as painted CMU type wall finishes, and they are in poor condition. OSDM-required fixed equipment for Stage is inadequately provided, and in poor condition. Existing Gymnasium, Student Dining, Media Center, and Music spaces are inadequately provided with appropriate sound attenuation acoustical surface treatments. The existing Kitchen is full service, is undersized based on current enrollment, and the existing Kitchen equipment, installed in 1981, is in fair condition.

Gym wall

Cabinets

Provide complete replacement of finishes and casework due to condition and installation of systems outlined in Items (A / C / D / E / I / K / L / M / N / T / U / W).

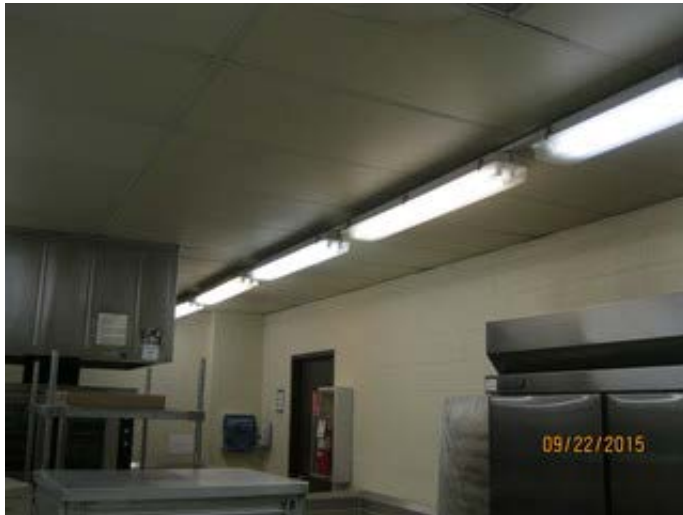
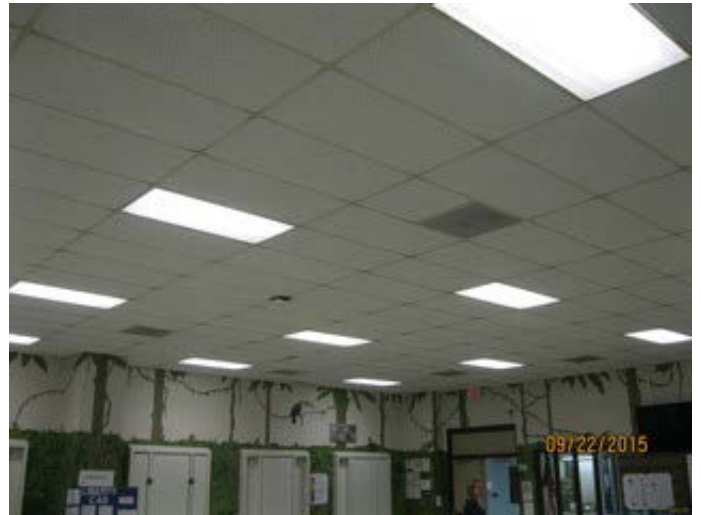
The typical Classrooms in the overall facility are equipped with T-8 lay-in 2x4 fluorescent fixtures with single level switching. Classroom fixtures are in good condition, providing an average illumination of 27 FC, which is less than the 50 FC recommended by the OSDM. The typical Corridors in the overall facility are equipped with T-8 lay-in 2x4 fluorescent fixtures with dual level switching. Corridor fixtures are in good condition, providing an average illumination of 8 FC, which is less than the 20 FC recommended by the OSDM. The Primary Gymnasium spaces are equipped with pendant T-8 2x4 mount fluorescent fixture type lighting, in good condition, providing an average illumination of 47 FC, which is less than the 50 ES FC recommended by the OSDM. The Media Center is equipped with lay-in 2x4 T-8 fluorescent fixture type lighting in good condition, providing an average illumination of 30 FC, which is less than the 50 FC recommended by the OSDM. The Student Dining spaces are equipped with lay-in 2x4 T-8 fluorescent fixture type lighting with multi-level switching. Student Dining fixtures are in good condition, providing an average illumination of 25 FC, which is less than the 50 FC recommended by the OSDM. The Kitchen spaces are equipped with 1x4 surface mount T-8 fluorescent fixture type lighting with multi-level switching. Kitchen fixtures are in good condition, providing an average illumination of 74 FC, which is less than the 75-80 FC recommended by the OSDM. The Service Areas in the overall facility are equipped with 1x4 suspended T-8 fluorescent fixture type lighting in good condition. The typical Administrative spaces in the overall facility are equipped with lay-in 2x4 T-8 fluorescent fixture type lighting in good condition, providing adequate illumination based on OSDM requirements. The overall lighting systems of the facility are not compliant with Ohio School Design Manual requirements due to inadequate lighting levels and lack of multi-level switching.

Kitchen Lighting

Student Dining Lighting

Provide complete replacement of lighting system due to lighting levels and lack of multi-level switching.

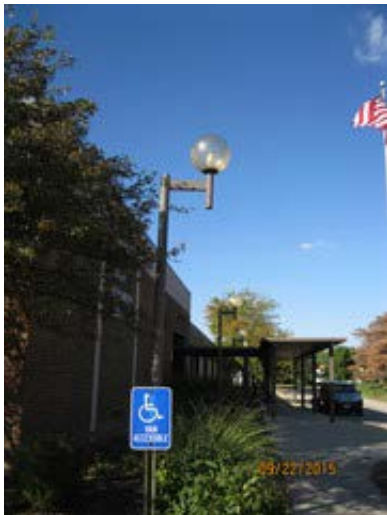
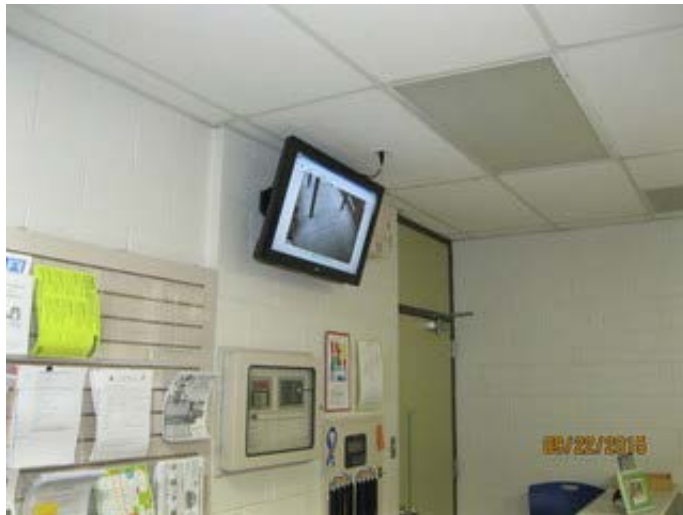
Description: The overall facility contains a Security Command motion detector, intrusion, and door contact type security system in good condition. Motion detectors are inadequately provided in main entries, central gathering areas, offices, main Corridors, and spaces where 6 or more computers are located. Exterior doors are equipped with door contacts. An automatic visitor control system is not provided. Compliant color CCTV cameras are not provided at main entry areas, parking lots, central gathering areas, and main Corridors. CCTV is not monitored in Administrative Area. A compliant computer controlled access control system integrating alarms and video signals, with appropriate UPS backup, is not provided. The system is equipped with card readers. The security system is adequately provided throughout, and the system is not compliant with Ohio School Design Manual guidelines. The exterior site lighting system is equipped with wall mounted HID high pressure sodium entry lights in poor condition. Pedestrian walkways are illuminated with pole fixtures in fair condition. Parking and bus pick-up / drop off areas are illuminated by pole mounted high pressure sodium fixtures in poor condition. The exterior site lighting system provides inadequate illumination due to insufficient fixture capacity and sparse placement of fixtures.

Exterior Raceway Pole Lighting

Security Camera

Recommendations: Provide a new security system and site lighting to meet OSDM requirements.

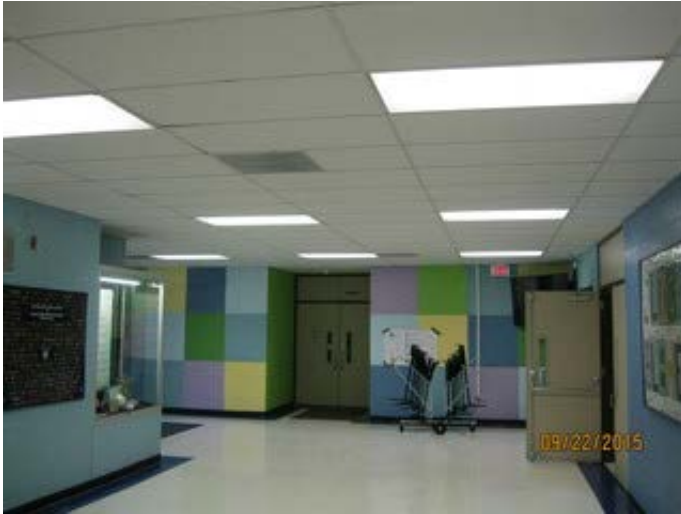
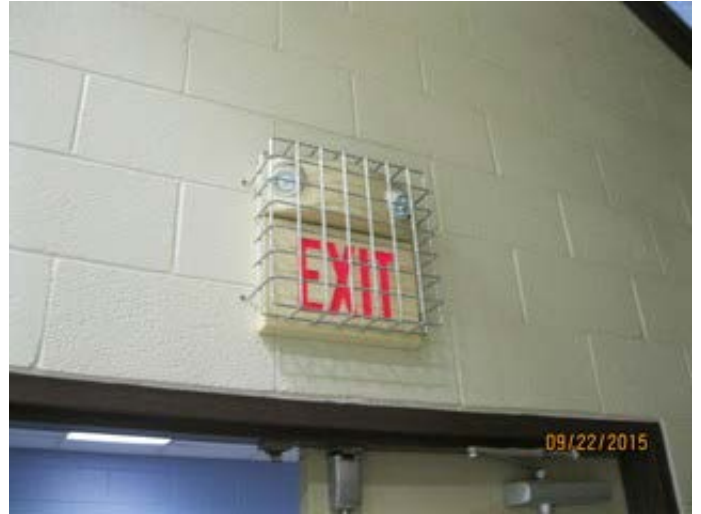
- Description:** The overall facility is equipped with an emergency egress lighting system consisting of non-compliant incandescent, plastic construction, as well as OSDM compliant red lettered, LED illuminated exit signs, and the system is in good condition. The facility is equipped with emergency egress floodlighting, and the system is in good condition. The system is provided with appropriate battery backup. The system is adequately provided throughout, and does not meet Ohio School Design Manual and Ohio Building Code requirements.
- Rating:** 3 Needs Replacement
- Recommendations:** Provide complete replacement of emergency / egress lighting system to meet Ohio School Design Manual and Ohio Building Code guidelines and in conjunction with work in Item U.

Exit Sign/Corridor Lighting

Exit Sign

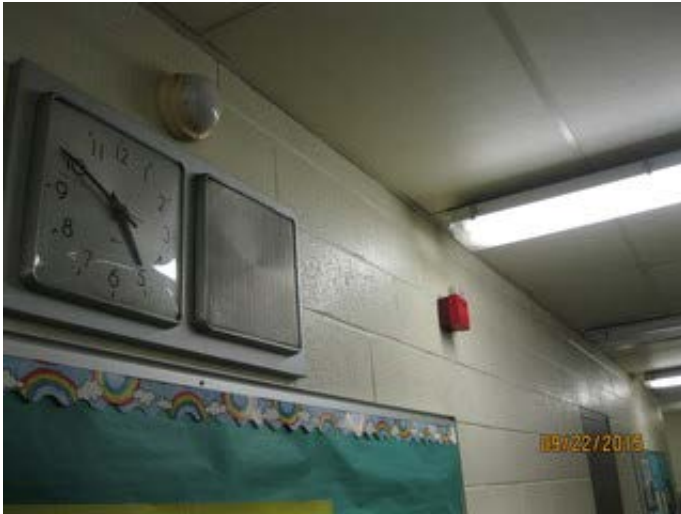
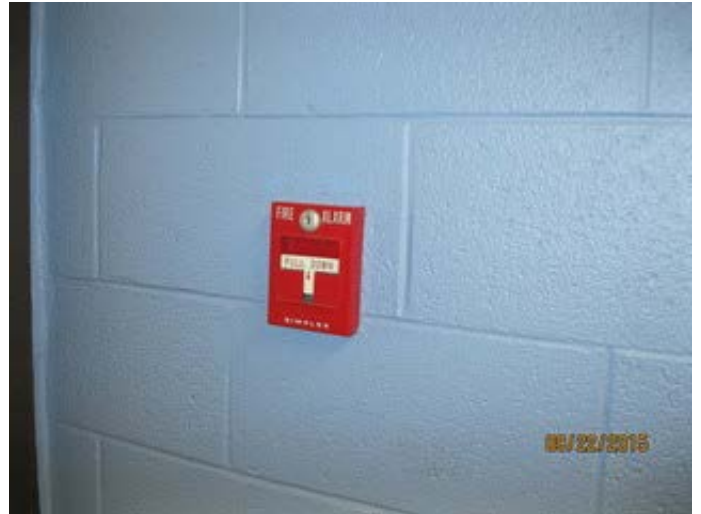
Description: The overall facility is equipped with a Simplex type fire alarm system, in good condition, consisting of manual pull stations, bells, and horn and strobe indicating devices. The system is automatic and is monitored by a third party. The system is equipped with sufficient audible horns and strobe indicating devices. The system is not equipped with sufficient flow switches, tamper switches, smoke detectors or heat sensors. The system thus will not support future fire suppression systems. The system is not adequately provided throughout, and does not have additional zone capabilities. The system is not compliant with Ohio Building Code, NFPA, and Ohio School Design Manual requirements.

Fire Alarm Horn Strobe

Fire Alarm Pull Station

Recommendations: Provide new fire alarm system to meet OBC, NFPA, and Ohio School Design Manual guidelines.

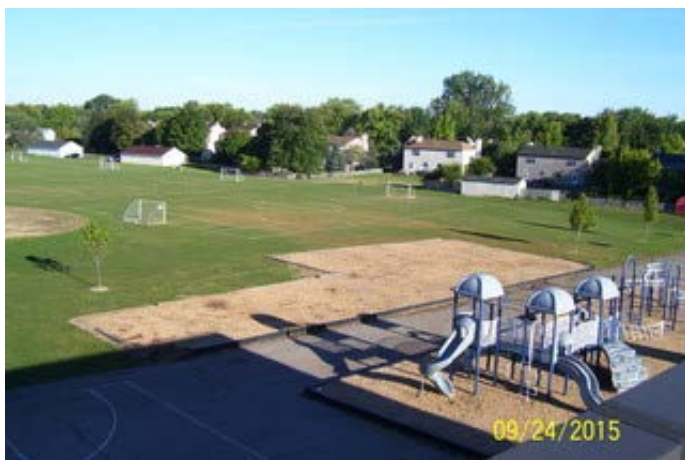
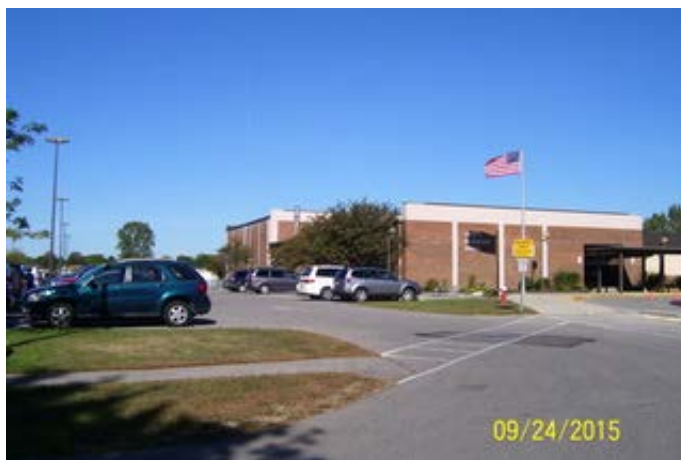
The 12.5-acre flat site is located in a suburban residential setting with moderate tree and shrub type landscaping. The larger 25-acre site is shared with Sutter Park Pre-School. Outbuildings include a maintenance shed. There are no apparent problems with erosion or ponding, however, staff reported problems with water infiltration during heavy rain events. The site is bordered by lightly traveled city streets. There is a single entrance onto the site for vehicular traffic connected to a loop which is currently used for student loading and unloading from passenger vehicles only. The bus circulation is combined with Sutter Park Preschool and enters from the main Sutter Park entrance from Sutter Parkway. There is a curbside bus loading and unloading zone adjacent to the school, which is not separated from other vehicular traffic. Visitor parking is facilitated by 10 non-ADA spaces in an asphalt lot within the vehicle loop in fair condition. There are barriers in place to prevent through access from this parking area and loop to the main shared parking lot between the two schools. Staff parking is in the shared asphalt parking lot in fair condition, containing 108 and 6 ADA parking places, which provides adequate parking for staff members, and the disabled. While adequate ADA parking is provided along with an accessible route close to the main entrance, ADA parkers must be informed ahead of time to enter from Sutter Parkway and not Saddle Run. The site and parking lot drainage design, consisting of sheet drainage, provides adequate evacuation of storm water, and no problems with parking lot ponding were observed. Concrete curbs in fair condition are located in areas adjacent to the school only. Concrete sidewalks are properly sloped, are located to provide a logical flow of pedestrian traffic, and are in fair condition. Trash pick-up and service drive pavement is heavy duty and is in fair condition, and is equipped with a concrete pad area for dumpsters, which is in fair condition. Exterior steps and handrails occur in association with the loading dock, and are in fair condition. There is chain link fencing adjacent to the dock which separates mechanical and electrical equipment from the parking lot, and also at the south end of the playground area which separates it from vehicular traffic, and is in fair condition. The playground equipment is primarily constructed of coated steel and high density plastic, and is in good condition. Playground equipment is placed to provide compliant fall zones, and on a compliant wood fiber mulch of sufficient, with a basketball court and dropshot being provided on an asphalt surface in fair condition. The site is equipped with tables in poor condition. The athletic facilities are comprised of baseball/kickball and soccer fields, and are in fair condition. Site features are suitable for outdoor instruction.

Typical Play Areas

Typical Parking Area

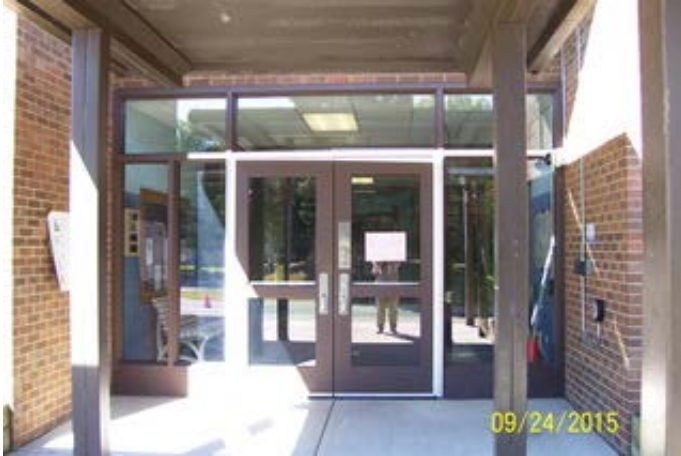
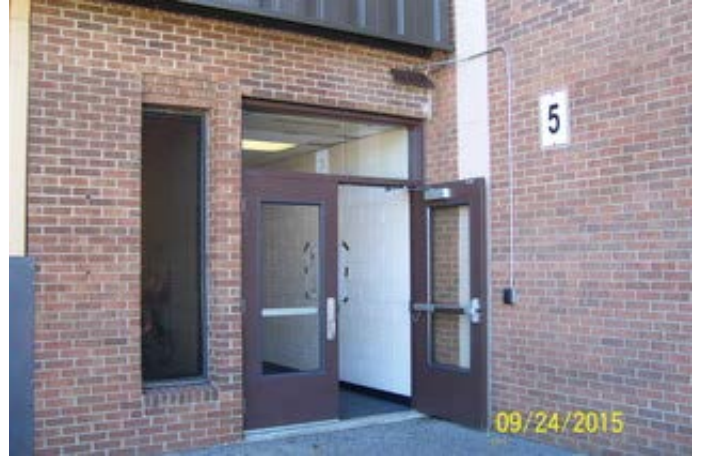
Description: Typical exterior doors in the overall facility are hollow metal type construction, installed on hollow metal frames, and in fair condition. Typical exterior doors feature single-glazed, tempered glass vision panels, and appropriate hardware. Entrance doors in the overall facility are hollow metal type construction, installed on hollow metal frames, and in fair condition. Entrance doors feature single-glazed vision panels, transoms, sidelights, and appropriate hardware. The facility is not equipped with any roof access doors. There are no overhead doors in the facility.

Main Entrance Doors

Secondary Entrance Doors

Recommendations: Replace single-glazed vision panels in entrance doors.

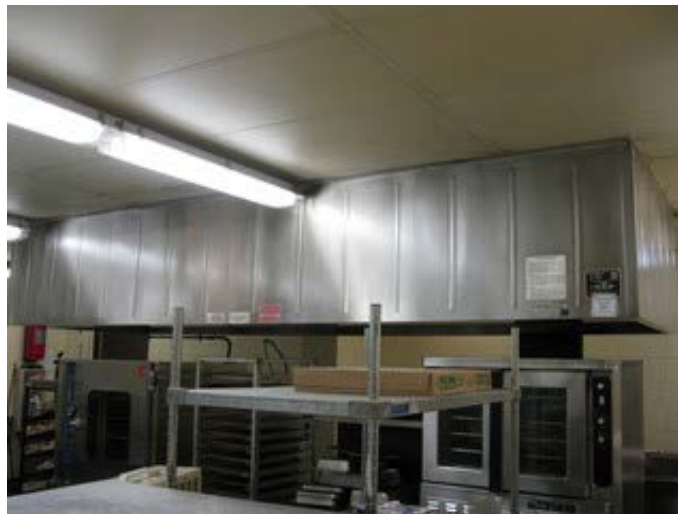
Description: The overall facility is not equipped with an automated fire suppression system. Exit Corridors are situated such that dead-end Corridors are not present. Stair towers and guardrails are not present in this single story structure. The facility does not have any exterior stairways from intermediate floors. The Kitchen hood is in fair condition, and is equipped with the required UL 300 compliant wet chemical fire suppression system. The cooking equipment is not interlocked to shut down in the event of discharge of the fire suppression system. Fire extinguishers are provided in sufficient quantity. Existing fire extinguishers are adequately spaced. The facility is equipped with an emergency generator. The emergency generator is a natural gas fired type unit, and is located outside the building. The emergency generator is in fair condition, and does not provide adequate capacity for the future needs of the school. The existing water supply is provided by a tie-in to the city system, and is insufficient to meet the future fire suppression needs of the school. Rooms with a capacity greater than 50 occupants are equipped with adequate egress.

Kitchen Hood

Recommendations: Provide new automated fire suppression system to meet Ohio School Design Manual guidelines. Provide increased water service of a capacity sufficient to support the fire suppression system, funding included in fire suppression funding. Provide new emergency generator, with funding provided via complete replacement of electrical system in Item D. Provide interlock to de-energize cooking equipment upon discharge of the Kitchen hood fire suppression system.

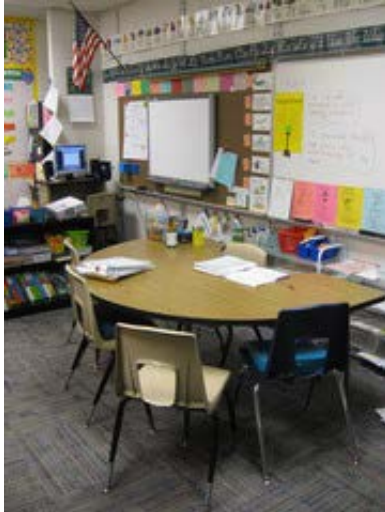
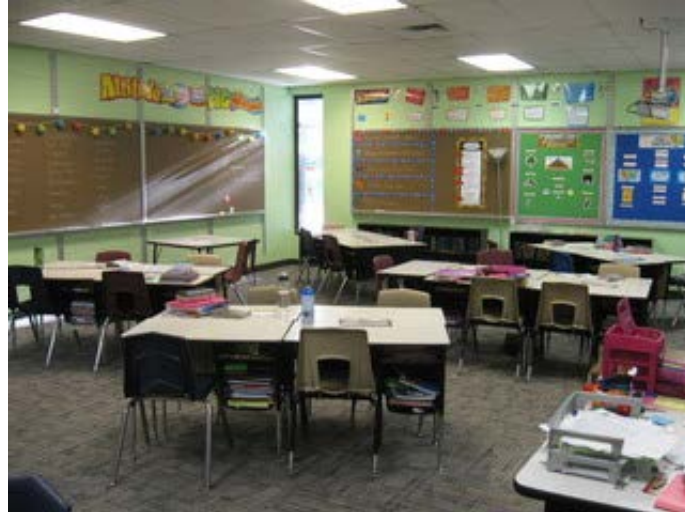
Description: The typical Classroom furniture is mismatched, and in generally poor condition, consisting of student desks & chairs, teacher desks & chairs, desk height file cabinets, reading tables, computer workstations, bookcases, wastebaskets, other. The facility's furniture and loose equipment were evaluated in item 6.17 in the CEFPI section of this report, and on a scale of 1 to 10 the overall facility received a rating of 4 due to observed conditions, and due to the fact that it lacks some of the Design Manual required elements.

Classroom

Recommendations: Provide for replacement of outdated or inadequate furnishings.

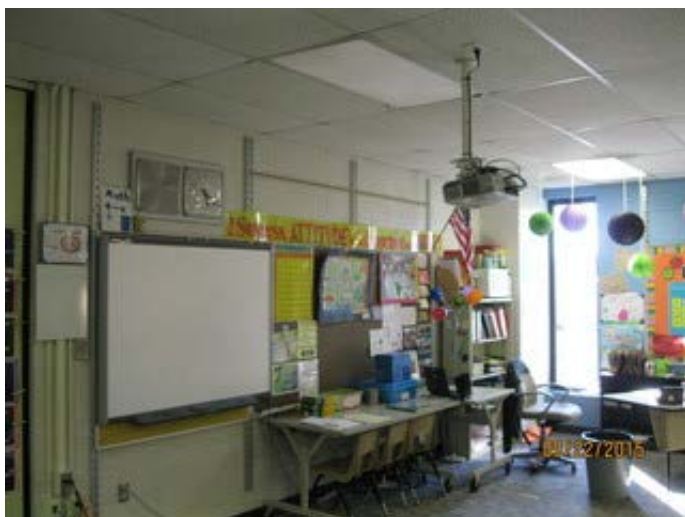
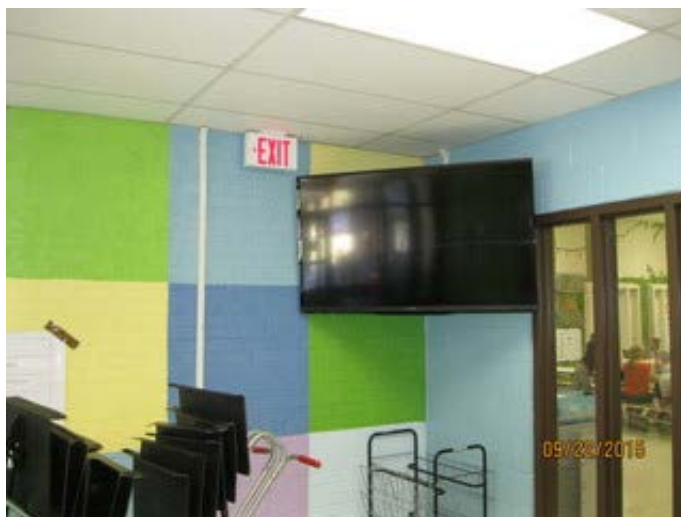
Description: The typical Classroom is equipped with the required four technology data ports for student use, one data port for teacher use, one voice port with a digitally based phone system, one cable port and monitor, and a 2-way PA system that can be initiated by either party to meet Ohio School Design Manual requirements. The facility is equipped with a centralized clock system. Specialized electrical / sound system requirements of Gymnasium, Stage, Student Dining, and Music spaces are inadequately provided, and in good condition. OSDM-compliant computer network infrastructure is provided. The facility does contain a media distribution center, and provides Computer Labs for use by students.

Classroom Smartboard/Projector

Television

Recommendations: Provide complete replacement of technology systems to meet Ohio School Design Manual requirements, and to sustain the capacity to keep pace with technological development.
