Building Information - Worthington City (45138) - McCord Middle School

Program Type	Assessment Only
Setting	Suburban
Assessment Name	McCord Middle School
Assessment Date (on-site; non-EEA)	2015-09-23
Kitchen Type	Full Kitchen
Cost Set:	2015
Building Name	McCord Middle School
Building IRN	95794
Building Address	1500 Hard Rd
Building City	Columbus
Building Zipcode	43235
Building Phone	614-450-4000
Acreage	20.45
Current Grades:	7-8
Teaching Stations	17
Number of Floors	1
Student Capacity	606
Current Enrollment	503
Enrollment Date	2015-09-14
Enrollment Date is the date in which the current enrollment was taken.	
Number of Classrooms	24
Historical Register	NO
Building's Principal	Michael Kuri
Building Type	Middle

McCord Middle School, which not on the National Register of Historic Buildings, and originally constructed in 1986, is a single story, 74,518 square foot brick school building is located in an suburban residential setting. The existing facility features a conventionally partitioned and open concept design, and does not utilize modular buildings. The structure of the overall facility contains brick type exterior wall construction, with CMU type wall construction in the interio

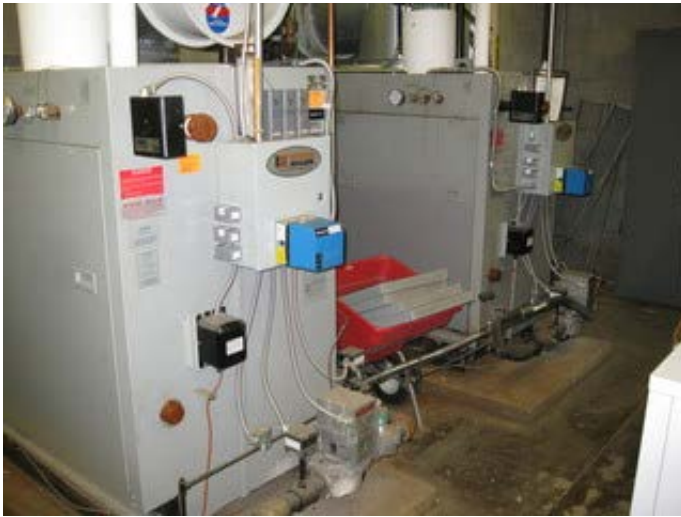
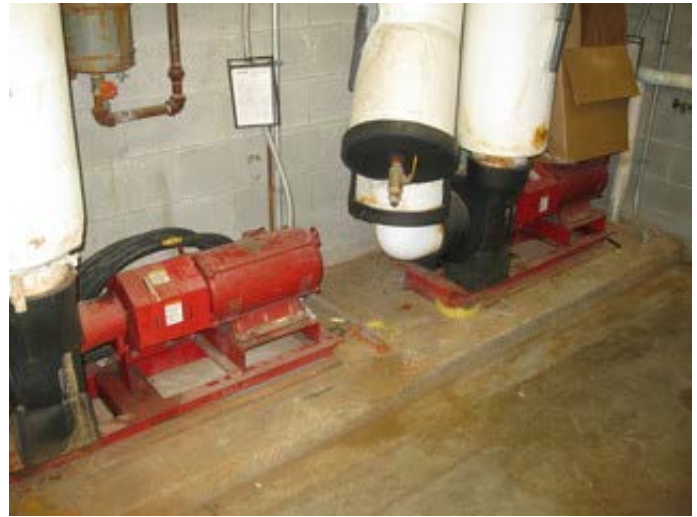
Description: The existing system for the overall facility is a gas fired heating hot water system, installed in 1986, and is in fair condition. The heating and chilled water system in the overall facility is a 2-pipe system, without a capacity for simultaneous heating and cooling operation, which is not compliant with the OSDM requirements for basic system type. The 3 gas fired boilers, manufactured by Bryan and Thermal Solutions, were installed in 2008 and 2015 and are in fair-to-good condition. Heating water is distributed to terminal units consisting of unit ventilators, cabinet heaters, unit heaters, and air handlers. The terminal equipment was installed in 1986 and is in fair condition. The system does not comply with the 15 CFM per person fresh air requirements of the Ohio Building Code mechanical code and Ohio School Design Manual. The DDC type system temperature controls were installed in 1999 and are in fair condition. The system does feature individual temperature controls in all spaces required by the OSDM. The overall system does not feature any central energy recovery systems. The facility is not equipped with louvered interior doors to facilitate Corridor utilization as return air plenums. The existing system is ducted in the Cafeteria, Gymnasium, Library, and Main Office, but the ductwork cannot be integrated into a possible future system due to arrangement, air volume, and routing of existing ductwork. The existing system is not ducted in the Classrooms, and floor to structural deck heights will not accommodate the installation of properly sized ductwork for a future Ohio School Design Manual approved system. The overall heating system is evaluated as being in safe but inefficient working order, and long term life expectancy of the existing system is not anticipated. The structure is equipped with central air conditioning. The site does not contain underground fuel tanks.

Rating: 3 Needs Replacement

Gas Fired Boilers

Pumps

Recommendations: Provide new overall heating, ventilating, and air conditioning system to achieve compliance with Ohio Building Code and Ohio School Design Manual standards. Convert to ducted system to facilitate efficient exchange of conditioned air. Provide architectural soffits to accommodate the installation of ductwork in the Classrooms.

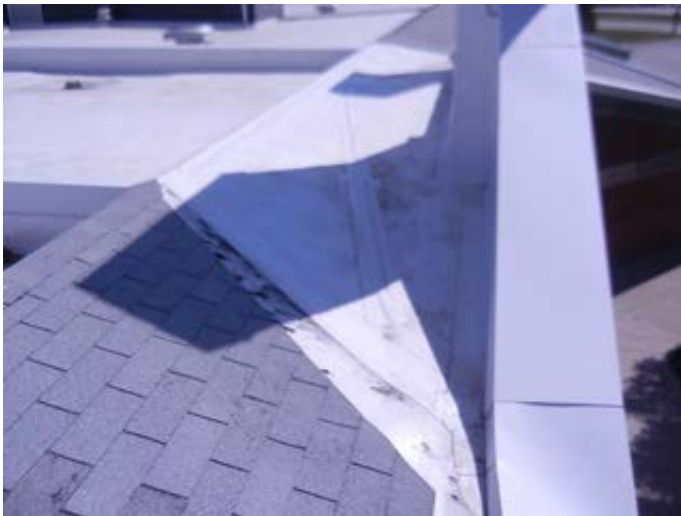
Description: The roof over the overall facility is an EPDM and asphalt shingle system that was installed in 2011, and is in good condition. The asphalt shingles are in fair condition and were not replaced during the 2011 installation of the EPDM. There are reports of current leaking in the gym and room 115. Signs of past leaking were observed during the physical assessment. Access to the roof was gained by an access door, access hatch, and access ladder, all which are in good to fair condition. Fall safety protection cages are not required and have not been provided. There were no observations of standing water on the roof. Metal cap flashing are in good condition. Roof storm drainage is addressed through a system of roof drains and gutters and downspouts, which are properly located, and in good condition. The roof is not equipped with overflow roof drains. No problems requiring attention were encountered with any roof penetrations. There are not any covered walkways attached to this structure.

Rating: 2 Needs Repair

Asphalt Shingles

Recommendations: Replace the asphalt shingles due to age and condition. Add overflow roof drains. Further investigation into roof leaking in the gymnasium and classroom 115 is required.

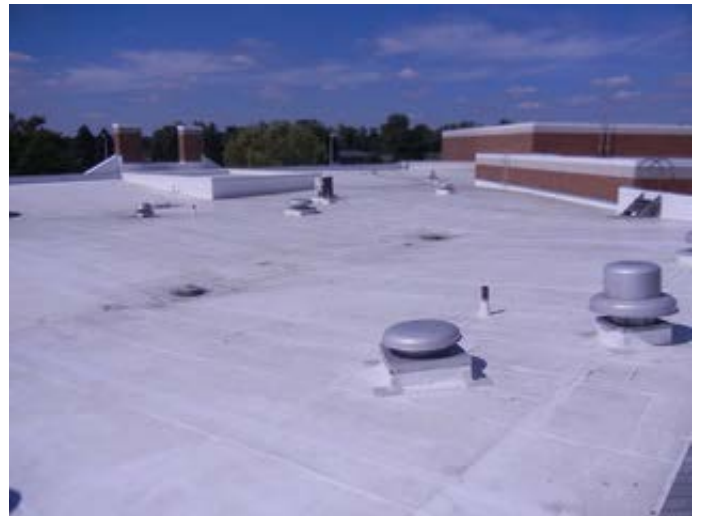
EPDM Roof

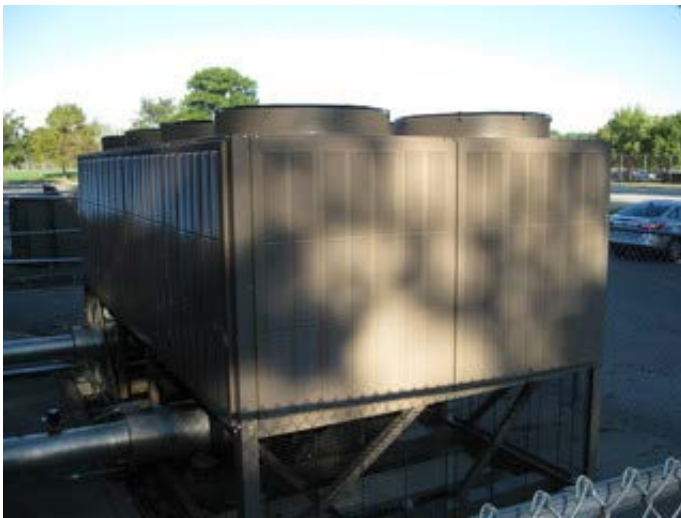
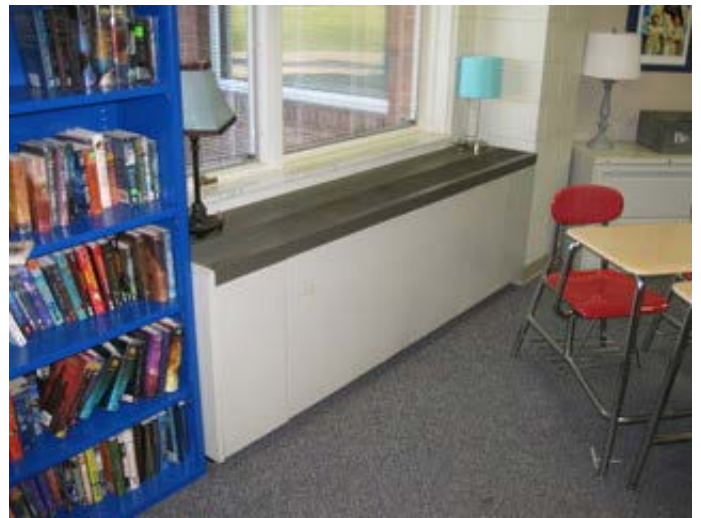
Description: The overall facility is equipped with an air cooled chilled water type central air conditioning system, which is in good condition. An air cooled chiller produces chilled water and pumps distribute chilled water to terminal units. The equipment is in good condition. The ventilation system in the overall facility consists of unit ventilators, installed in 1986 and in fair condition, providing fresh air to Classrooms, and air handlers, installed in 1986 and in fair condition, providing fresh air to other miscellaneous spaces such as Gymnasiums, Student Dining, and Media Center. Relief air venting is provided by ceiling plenums. The ventilation system does not meet the Ohio Building Code 15 CFM per occupant fresh air requirement. The overall system is not compliant with Ohio Building Code and Ohio School Design Manual requirements. Dust collection systems are not required in this facility. The Art program is equipped with a kiln, and existing kiln ventilation is adequate, and in fair condition. General building exhaust systems for Restrooms are adequately placed, and in fair condition.

Rating: 3 Needs Replacement

Air Cooled Chiller

Unit Ventilator

Recommendations: Provide an air conditioning system to meet with Ohio Building Code and Ohio School Design Manual requirements. Replace general building exhaust systems located in Restrooms. Pricing included in Item A. Existing air cooled chiller to be reused.

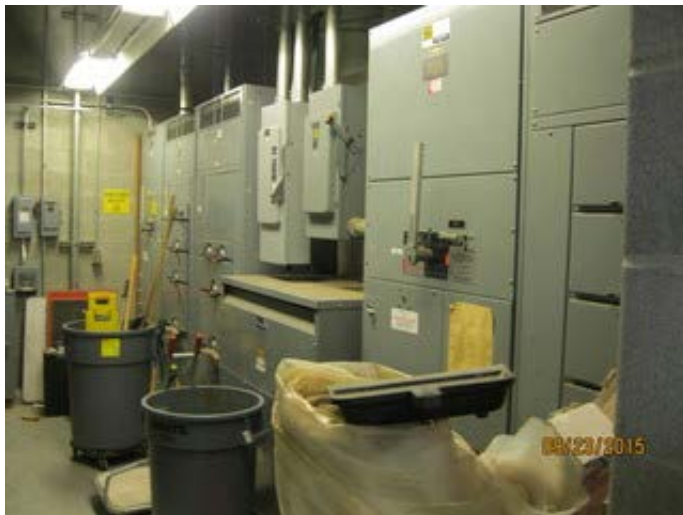
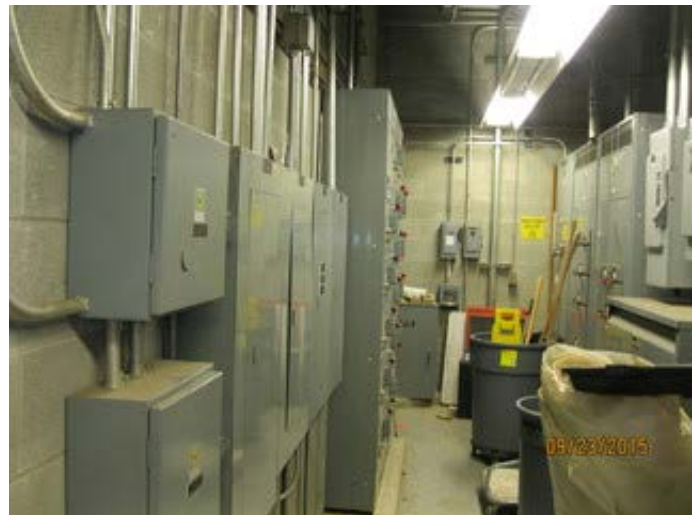
Description: The electrical system provided to the overall facility is a 480/277-volt, 3-phase, 4-wire, 1,200-amp system, installed in 1986, and is in good condition. Power is provided to the school by a single utility owned, pad-mounted transformer, located in exterior fenced-in area, and in good condition. The panel system, installed in 1986, is in good condition, and can be expanded to add additional capacity. The Classrooms are not equipped with adequate electrical outlets. The typical Classroom contains 10 general purpose outlets, 2 dedicated outlets for each Classroom computer, and 2 dedicated outlets for each Classroom television. Some Classrooms are equipped with as many as 16 general purpose outlets, while others are equipped with as few as 8 general purpose outlets. There are not any spaces that have no electrical outlets. The Corridors are not equipped with adequate electrical outlets for servicing. Adequate GFI protected exterior outlets are not provided around the perimeter of the building. The facility is equipped with a suitable emergency generator. Adequate lightning protection safeguards are not provided. Stage lighting power system, including control panel, breakers, and dimmers is inadequately provided, in good condition, and does not meet OSDM requirements. The overall electrical system does not meet Ohio School Design Manual requirements in supporting the current needs of the school, and will be inadequate to meet the facility's future needs.

Rating: 2 Needs Repair

Main Electrical Distribution Equipment

Electrical Distribution Panels

Recommendations: Provide additional panels, circuits and outlets, to increase capacity for Classrooms and Corridors. Provide control panel, dimmers, and breakers to support the Stage lighting system. Provide adequate lightning protection safeguards.

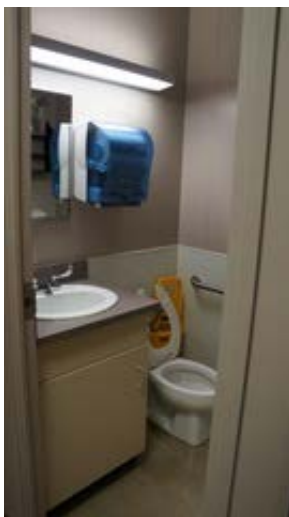
The service entrance is not equipped with a reduced pressure backflow preventer. A water treatment system is not provided. The domestic water supply piping in the overall facility is copper, was installed in 1986, and is in good condition. The waste piping in the overall facility is cast iron and PVC, was installed in 1986, and is in good condition. The facility is equipped with 1 gas water heater in poor condition, with 2 separate 300-gallon storage tanks in poor condition. The school contains 2 Large Group Restrooms for boys, 2 Large Group Restrooms for girls, 1 Locker Room Restrooms for boys, 1 Locker Room Restrooms for girls, 0 Restrooms associated with specialty Classrooms, and 7 Restrooms for staff. Boys' Large Group Restrooms contain 0 ADA and 4 non-ADA wall mounted flush valve toilets, 0 ADA and 7 non-ADA wall mounted flush valve urinals, as well as 0 ADA and 6 non-ADA wall mounted lavatories. Girls' Large Group Restrooms contain 0 ADA and 9 non-ADA wall mounted flush valve toilets, as well as 0 ADA and 6 non-ADA wall mounted lavatories. Boys' Locker Room Restrooms contain 0 ADA and 2 non-ADA wall mounted flush valve toilets, 0 ADA and 2 non-ADA wall mounted flush valve urinals, 0 ADA and 2 non-ADA wall mounted lavatories, as well as 0 ADA and 6 unused, non-ADA showers. Girls' Locker Room Restrooms contain 0 ADA and 3 non-ADA wall mounted flush valve toilets, as well as 0 ADA and 2 non-ADA wall mounted lavatories, as well as 0 ADA and 6 unused, non-ADA showers. Staff Restrooms contain 0 ADA and 7 non-ADA wall mounted flush valve toilets, 0 ADA and 0 non-ADA urinals, as well as 0 ADA and 7 non-ADA wall mounted lavatories. Condition of fixtures is good. The facility is equipped with 0 ADA and 2 non-ADA drinking fountains, as well as 6 ADA and 0 non-ADA electric water coolers, in fair condition. Middle School Special Education Classrooms are not equipped with ADA or non-ADA sink mounted type drinking fountains. Special Education Classroom is not equipped with the required Restroom facilities. Kitchen is equipped with the required Restroom, and fixtures are in fair condition. Health Clinic is equipped with the required Restroom, and fixtures are in fair condition. Due to existing grade configuration, Kindergarten / Pre-K Classroom Restroom considerations are not relevant. The school does not meet the OBC requirements for fixtures. Relative to LEED requirements, the school is not equipped with low flow type fixtures. Per OBC and OSDM requirements this facility should be equipped with 53 toilets, 13 urinals, 41 lavatories, 1 Classroom sink mounted drinking fountains, and 21 electric water coolers. Observations revealed that the school is currently equipped with 26 toilets, 9 urinals, 24 lavatories, 0 Classroom sink mounted drinking fountains, and 8 electric water coolers. ADA requirements are not met for fixtures and drinking fountains (see Item O). Custodial Closets are properly located and are adequately provided with required service sinks or floor drain sink, which are in fair condition. Kitchen fixtures consist of 1 hand sink, 1 single-compartment sink, 1 double-compartment sink, and 1 triple-compartment sink, which are in good condition. The Kitchen is equipped with a satisfactory grease interceptor. The Kitchen is provided the required 140 degree hot water supply via a mixing valve, which is in good condition. Science Classrooms are equipped with required utility sink, gas / compressed air connections, and safety shower / eyewash in good condition. Due to existing grade configuration, no Biology or Chemistry Classroom acid waste systems are required. Adequate exterior wall hydrants are provided.

3 Needs Replacement

Non-ADA Clinic Restroom

To facilitate the school's compliance with OBC and OSFC fixture requirements, provide 27 new toilets / 17 new lavatories / 4 new urinals / 13 new electric water coolers / 1 new lavatory mounted type drinking fountains. To reach a minimum requirement for LEED with low flow type fixtures, the 59 current toilet and urinal valves and current lavatory fixtures would need to be replaced (Replacement fixtures included in cost table). See Item O for replacement of fixtures related to ADA requirements. Provide reduced pressure backflow preventer. Replace the domestic hot water heater.

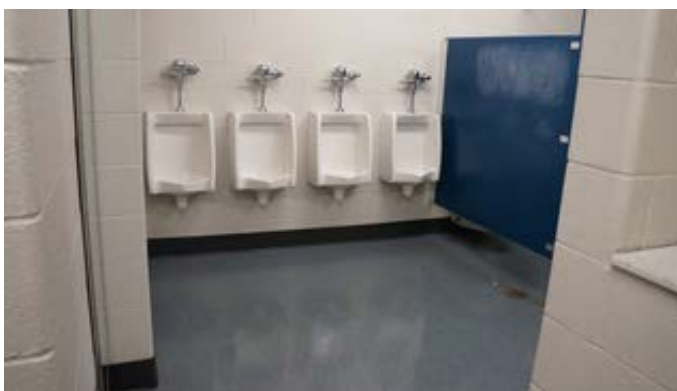
Typical Boys Restroom - Non-ADA

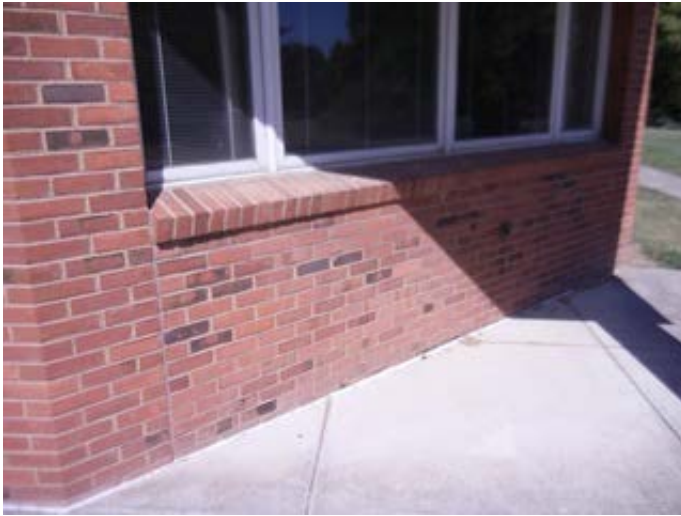
Description: The overall facility is equipped with thermally broken aluminum frame windows with double glazed type window systems, which were installed in 1986, and is in fair to poor condition. The window system features operable windows throughout the building, operable windows are equipped with opening limiters in fair condition. Window system seals are in poor condition, with no air and water infiltration being experienced. Window system hardware is in fair condition. The windows system features windows with integral blinds, which are in fair condition. This facility is equipped with curtain wall systems, which is in good condition. The facility does not contain glass block windows. The exterior doors in the overall facility are equipped with thermally broken sidelights and transoms with tempered glass in good condition. Exterior door vision panels are tempered. The building does not contain any skylight. The school does not contain any clerestories. Interior glass is OSDM compliant and in good condition. Window security grilles are not provided for ground floor windows. There is not a greenhouse associated with this school.

Rating: 3 Needs Replacement

Typical window

Recommendations: Replace all existing windows with new insulated window systems with integral blinds that meet OSDM requirements.

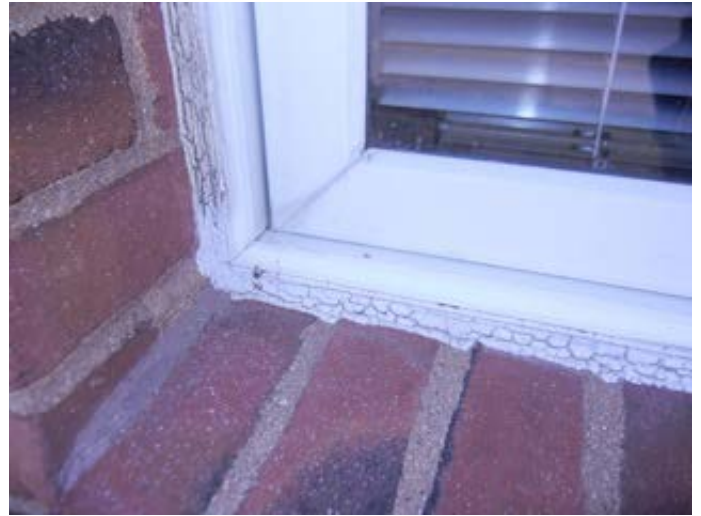
Poor window seal condition

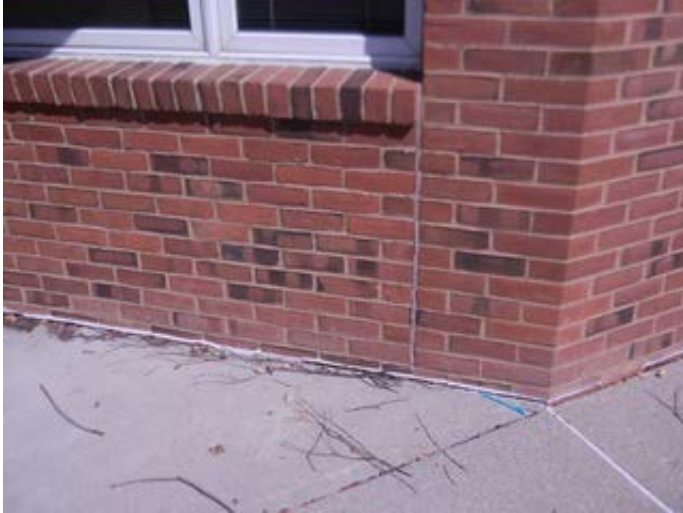
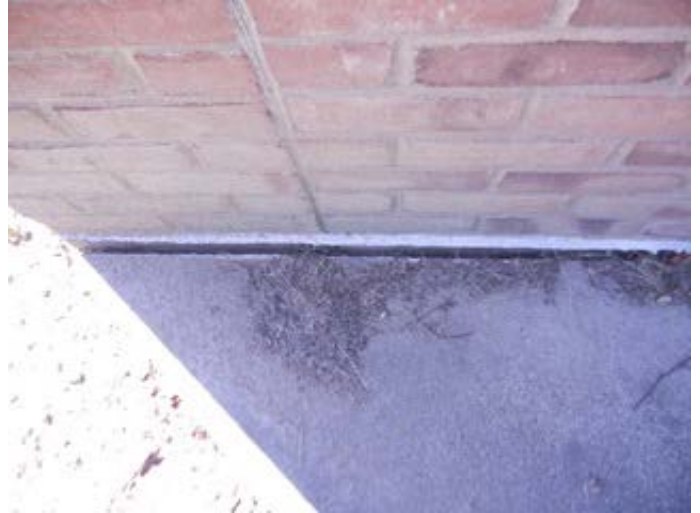
Description: The overall facility is equipped with concrete masonry unit foundation walls on concrete footings, which displayed no locations of significant differential settlement, cracking, or leaking, and is in good condition. No significant issues related to foundation cracking or spalling were encountered. The district reports that there has been no past leaking. No grading or site drainage deficiencies were noted around the perimeter of the structure that are contributing or could contribute to foundation / wall structural deterioration.

No foundation issues

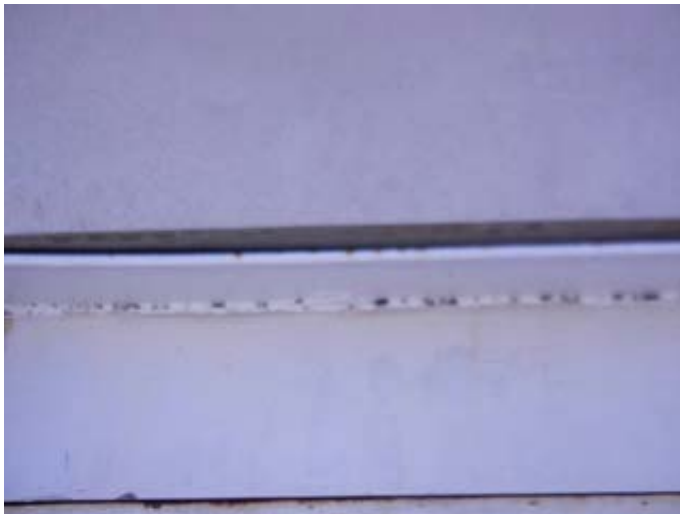
Rating: 3 Needs Replacement

Sagging steel lintel

Recommendations: Provided masonry cleaning, sealing, caulking as required through the overall facility. Recaulk existing control joints and expansion joints. Replace, prep, and paint exposed steel lintels that are sagging and rusting.

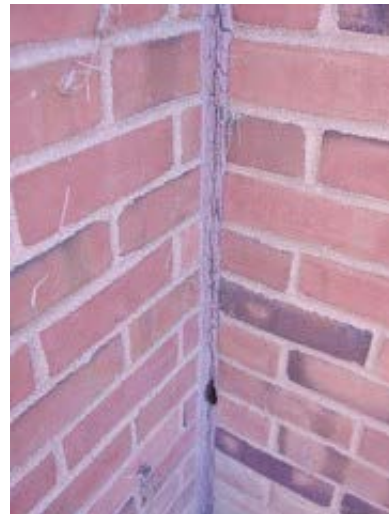
Exterior caulking in poor condition

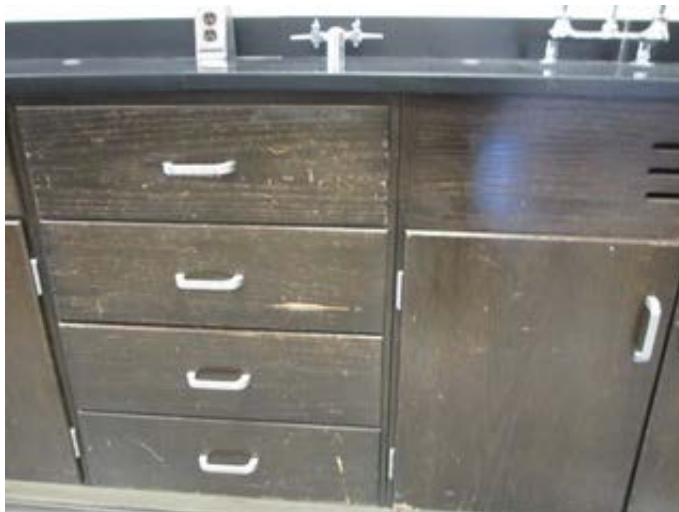
The overall facility features conventionally partitioned, operable partitioned, and metal demountable partitioned Classrooms with either VCT in good condition, or broadloom carpet type flooring in poor condition, 2x4 ACT type ceilings in fair condition, as well as metal and CMU type wall finishes, and they are in good condition. The overall facility has Corridors with rubber type flooring in good condition, 2x4 ACT type ceilings in fair condition, as well as painted CMU and metal type wall finishes, and they are in good condition. The overall facility has Restrooms with epoxy non-slip type flooring, 2x4 ACT type ceilings, as well as painted CMU type wall finishes, and they are in good condition. Toilet partitions are plastic and are in good condition. Classroom casework in the overall facility is wood type construction with plastic laminate tops, is adequately provided, and in good condition. Lab casework in the overall facility is of wood type construction with solid surface tops and is in fair to poor condition. The typical Classroom contains 0 lineal feet of casework, and the typical lab contains 84 lineal feet of casework with sections spanning from 18 to 30 feet. Classrooms are provided adequate chalkboards, markerboards, smartboards, and tackboards which are in good condition. The lockers, located in the Corridors, are adequately provided, and in good condition. The Art program is equipped with a kiln in good condition. The facility is equipped with wood non-louvered interior doors that are both flush mounted and recessed, with proper ADA hardware and clearances, and in good condition. The Gymnasium space has athletic wood type flooring, open type ceilings, as well as painted CMU type wall finishes, and they are in good condition. Wood Gymnasium flooring has been well maintained, will accommodate multiple future sandings and refinishings, and is rated at an early stage of its product lifecycle. Gymnasium telescoping stands are plastic type construction, in good condition. Gymnasium basketball backboards are electrically operated type, and are in good condition. The Media Center has carpet tile type flooring, 2x4 ACT type ceilings, as well as painted CMU type wall finishes, and they are in good condition. Student Dining has sheet rubber type flooring, 2x4 ACT type ceilings, as well as painted CMU type wall finishes, and they are in good condition. Existing Gymnasium, Student Dining, Media Center, and Music spaces are adequately provided with appropriate sound attenuation acoustical surface treatments. The existing Kitchen is full service, is undersized based on current enrollment, and the existing Kitchen equipment, installed between 1986-2002, is in good to fair condition. The required 6" overhang on all three exposed sides of the cooking equipment is provided by the hood. Walk-in cooler and freezer are located within the kitchen and are in good condition.

3 Needs Replacement

Casework is in Poor Condition

Provide for the replacement of lab casework due to poor and worn condition. Provide for the replacement of all broadloom carpet due to poor and worn condition. Provide for the full replacement of acoustical ceiling tiles due to complete lighting system replacement outlined in Item K. Provide for the replacement of kitchen equipment due to age and condition.

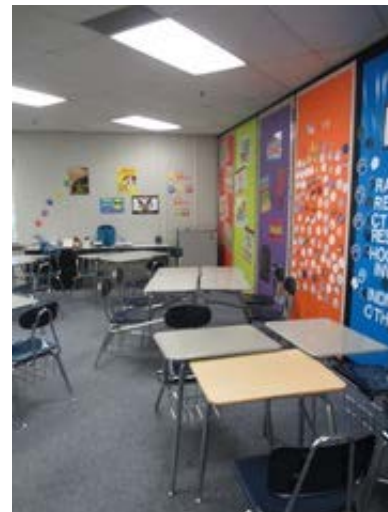
Broadloom Carpeting is Worn in Traffic Path

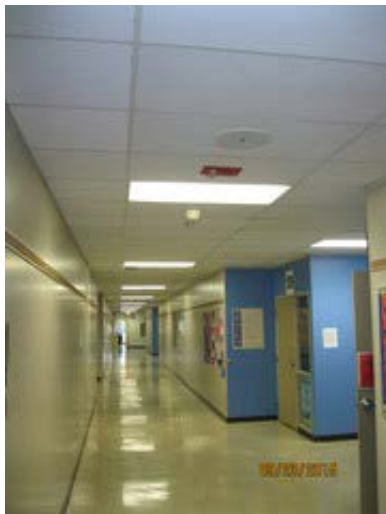
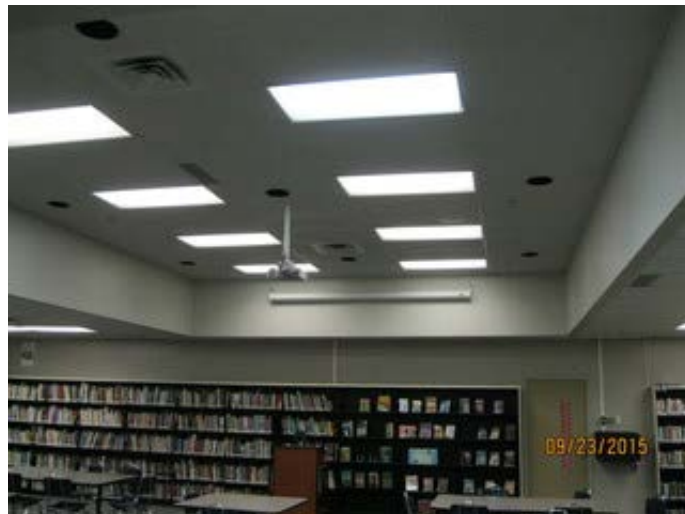
The typical Classrooms in the overall facility are equipped with T-8 lay-in 2x4 fluorescent fixtures with single level switching. Classroom fixtures are in good condition, providing an average illumination of 45 FC, which is less than the 50 FC recommended by the OSDM. The typical Corridors in the overall facility are equipped with T-8 lay-in 2x4 fluorescent fixtures with dual level switching. Corridor fixtures are in good condition, providing an average illumination of 6 FC, which is less than the 20 FC recommended by the OSDM. The Primary Gymnasium spaces are equipped with pendant T-8 2x4 type lighting, in good condition, providing an average illumination of 48 FC, which is less than the 50 MS FC recommended by the OSDM. The Media Center is equipped with lay-in 2x4 T-8 fluorescent fixture type lighting in good condition, providing an average illumination of 42 FC, which is less than the 50 FC recommended by the OSDM. The Student Dining spaces are equipped with lay-in 2x4 T-8 fluorescent fixture type lighting with multi-level switching. Student Dining fixtures are in good condition, providing an average illumination of 33 FC, which is less than the 50 FC recommended by the OSDM. The Kitchen spaces are equipped with 1x4 surface mount T-8 fluorescent fixture type lighting with single level switching. Kitchen fixtures are in good condition, providing an average illumination of 44 FC, which is less than the 75-80 FC recommended by the OSDM. The Service Areas in the overall facility are equipped with 1x4 suspended T-8 fluorescent fixture type lighting in good condition. The typical Administrative spaces in the overall facility are equipped with lay-in 2x4 T-8 fluorescent fixture type lighting in good condition, providing adequate illumination based on OSDM requirements. The overall lighting systems of the facility are not compliant with Ohio School Design Manual requirements due to inadequate lighting levels and lack of multi-level switching.

3 Needs Replacement

Corridor Lighting

Media Center Lighting

Provide complete replacement of lighting system due to lighting levels and lack of multi-level switching.

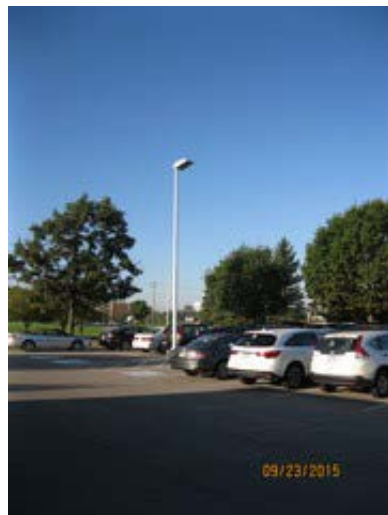
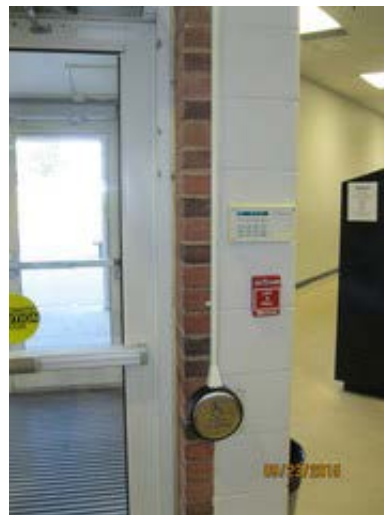
Description: The overall facility contains a Security Command motion detector, intrusion, and door contact type security system in good condition. Motion detectors are not adequately provided in main entries, central gathering areas, offices, main Corridors, and spaces where 6 or more computers are located. Exterior doors are equipped with door contacts. An automatic visitor control system is not provided. Compliant color CCTV cameras are not provided at main entry areas, parking lots, central gathering areas, and main Corridors. CCTV is not monitored in Administrative Area. A compliant computer controlled access control system integrating alarms and video signals, with appropriate UPS backup, is not provided. The system is equipped with card readers. The security system is adequately provided throughout, and the system is not compliant with Ohio School Design Manual guidelines. The exterior site lighting system is equipped with surface mounted high pressure sodium entry lights in good condition. Pedestrian walkways are illuminated with wall mounted fixtures in good condition. Parking and bus pick-up / drop off areas are illuminated by pole mounted high pressure sodium fixtures in good condition. The exterior site lighting system provides inadequate illumination due to insufficient fixture capacity.

Rating: 3 Needs Replacement

Exterior Parking Lot Pole Fixture

Security System Keypad and Fire Alarm Pull Station

Recommendations: Provide new security system and exterior site lighting to meet Ohio School Design Manual guidelines.

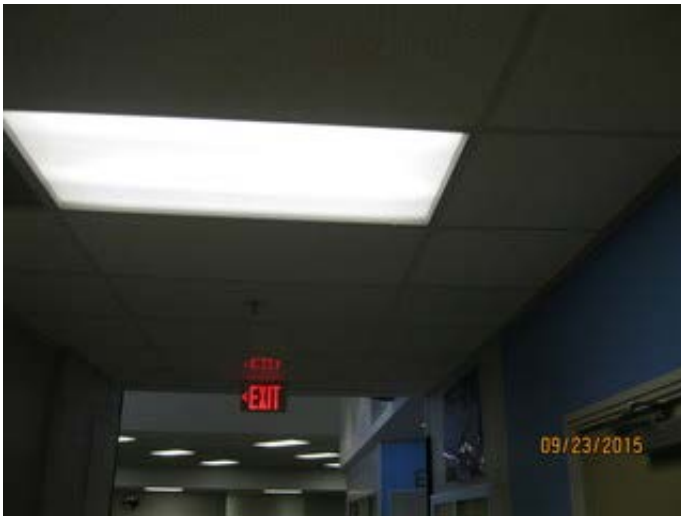
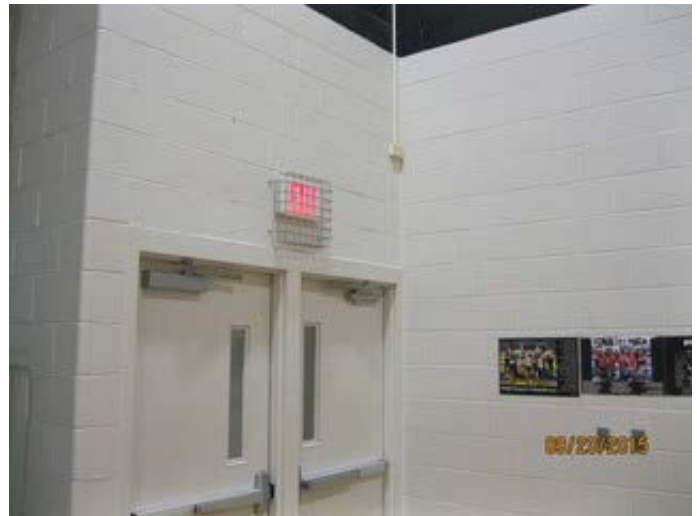
Description: The overall facility is equipped with an emergency egress lighting system consisting of non-compliant plastic construction, as well as OSDM compliant red lettered, LED illuminated exit signs, and the system is in good condition. The facility is not equipped with emergency egress floodlighting, but is equipped with recessed fluorescent lighting used as emergency egress lighting, and the system is in good condition. The system is provided with power via an emergency generator, and on separate circuits. The system is adequately provided throughout, and does not meet Ohio School Design Manual and Ohio Building Code requirements.

Rating: 3 Needs Replacement

Exit Sign

Exit Sign in Gym

Recommendations: Provide complete replacement of emergency / egress lighting system to meet Ohio School Design Manual and Ohio Building Code guidelines.

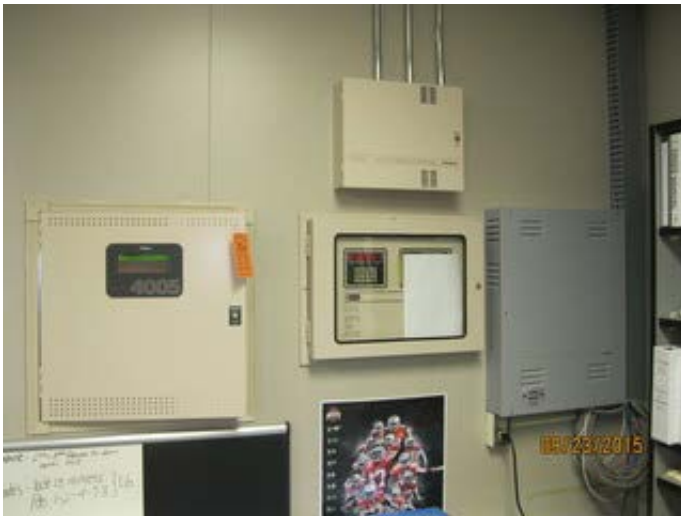
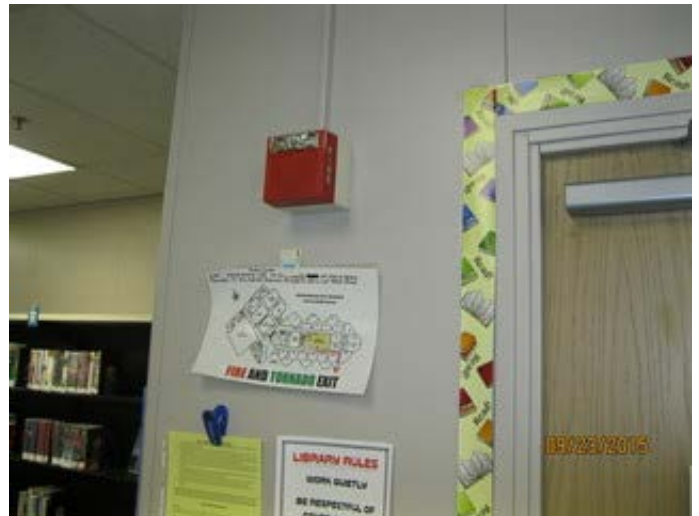
Description: The overall facility is equipped with a Simplex type fire alarm system, installed in 1986, and in good condition, consisting of manual pull stations, bells, and horn and strobe indicating devices. The system is automatic and is monitored by a third party. The system is equipped with sufficient audible horns, strobe indicating devices, flow switches, tamper switches, smoke detectors, and heat sensors. The system thus supports existing fire suppression systems. The system is adequately provided throughout, and does not have additional zone capabilities. The system is not fully compliant with Ohio Building Code, NFPA, and Ohio School Design Manual requirements.

Rating: 3 Needs Replacement

Fire Alarm Control Panel and Central Time Panel

Fire Alarm Horn/Strobe

Recommendations: Provide complete replacement of the fire alarm system to meet OBC, NFPA, and Ohio School Design Manual guidelines.

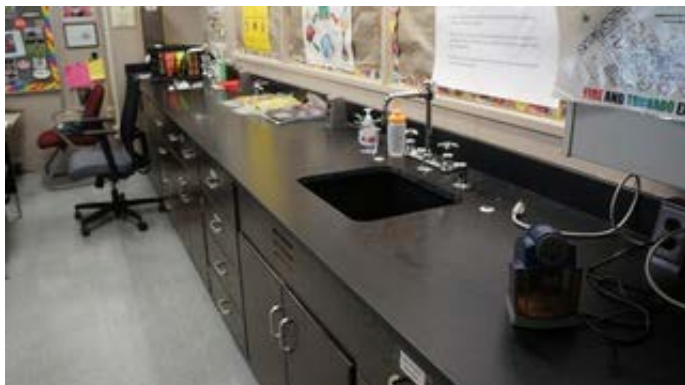
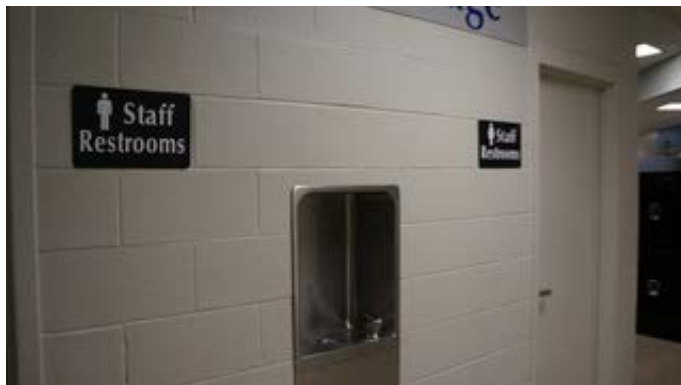
Rating: 3 Needs Replacement

Non-ADA Science Classroom Fixtures

Non-ADA Staff Water Cooler

Recommendations: Provide ADA-compliant signage, electric water coolers, toilets, sinks, urinals, toilet partitions, toilet accessories in the overall facility to facilitate the school's meeting of ADA requirements. Provide minimum required ADA shower per OSDM Guidelines: one for the Special Education space and one each for the locker rooms. Remount mirrors in the 9 restroom to comply with ADA standards. Retrofit 4 science labs each with one ADA compliant sink station.

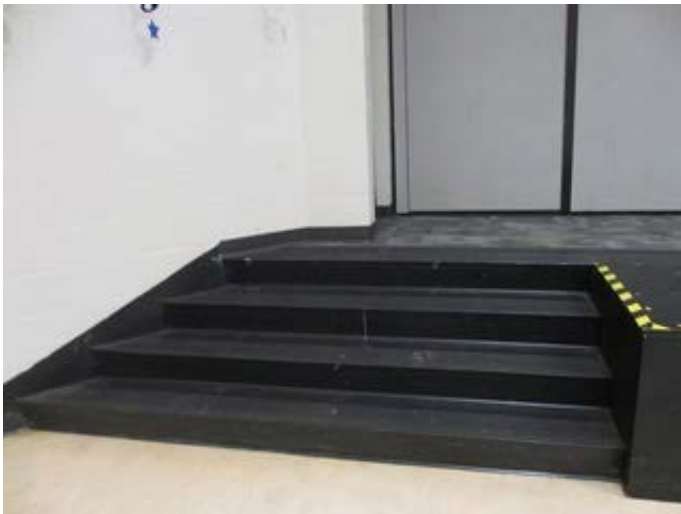
2 Needs Repair

Need Handrails at Cafeteria Steps

Provide new handrails to meet the requirements of the Ohio Building Code. Provide new emergency generator.

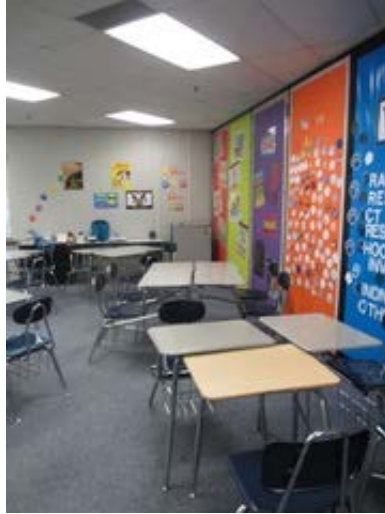
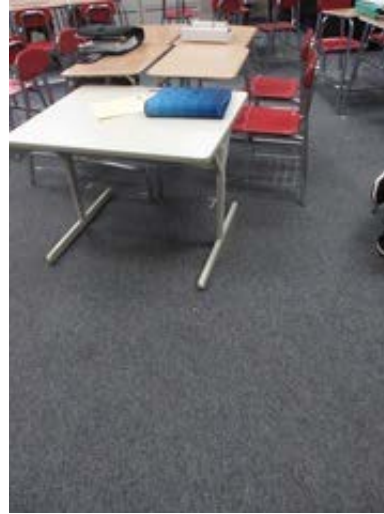
Description: The typical Classroom furniture is mismatched, and in generally good condition, consisting of student desks & chairs, teacher desks & chairs, desk height file cabinets, reading tables, computer workstations, bookcases, and wastebaskets. The facility's furniture and loose equipment were evaluated in item 6.17 in the CEFPI section of this report, and on a scale of 1 to 10 the overall facility received a rating of 6 due to observed conditions.

Rating: 2 Needs Repair

Mismatched Furnishings

Furniture is Inconsistent in Design

Recommendations: Provide for replacement of outdated or inadequate furnishings.
