Building Information - Worthington City (45138) - Phoenix Middle School & Worthington Academy

Program Type	Assessment Only
Setting	Suburban
Assessment Name	Phoenix Middle School & Worthington Academy
Assessment Date (on-site; non-EEA)	2015-09-23
Kitchen Type	Full Kitchen
Cost Set:	2015
Building Name	Phoenix Middle School & Worthington Academy
Building IRN	9511
Building Address	2341 Snouffer Rd
Building City	Worthington
Building Zipcode	43085
Building Phone	614-450-4100
Acreage	32.78
Current Grades:	7-12
Teaching Stations	18
Number of Floors	1
Student Capacity	720
Current Enrollment	271
Enrollment Date	2015-09-14
Enrollment Date is the date in which the current enrollment was taken.	
Number of Classrooms	33
Historical Register	NO
Building's Principal	Adham Schirg
Building Type	Middle/High

Phoenix Middle School, which not on the National Register of Historic Buildings, and originally constructed in 1969, is a single story, 68,400 square foot brick school building located in a suburban residential setting. The existing facility features a conventionally partitioned and open concept design, and does not utilize modular buildings. The structure of the overall facility contains brick t

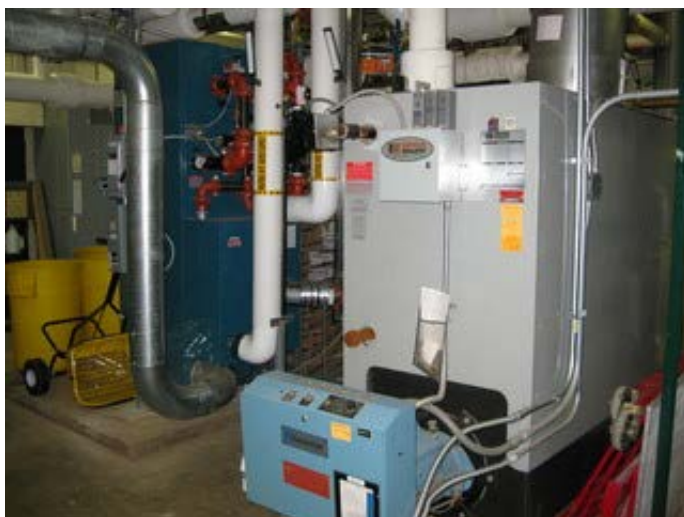
The existing system for the overall facility is a gas fired heating hot water system, installed in 1969, and is in fair condition. The heating and chilled water system in the overall facility is a 2-pipe system, without a capacity for simultaneous heating and cooling operation, which is not compliant with the OSDM requirements for basic system type. The 3 gas fired boilers, manufactured by Bryan and Thermal Solutions, were installed in 2007 and 2015 and are in fair-to-good condition. Heating water is distributed to terminal units consisting of unit ventilators, cabinet heaters, unit heaters, and air handlers. The terminal equipment was installed in 1969 and is in fair condition. The system does not comply with the 15 CFM per person fresh air requirements of the Ohio Building Code mechanical code and Ohio School Design Manual. The DDC type system temperature controls were installed in 1999 and are in good condition. The system does feature individual temperature controls in all spaces required by the OSDM. The overall system does not feature any central energy recovery systems. The facility is not equipped with louvered interior doors to facilitate Corridor utilization as return air plenums. The existing system is ducted in the Gymnasium, Main Office, Library, and Classrooms, but the ductwork cannot be integrated into a possible future system due to arrangement, air volume, and routing of existing ductwork. The existing system is not ducted in the Cafeteria, and floor to structural deck heights will not accommodate the installation of properly sized ductwork for a future Ohio School Design Manual approved system. The overall heating system is evaluated as being in safe but inefficient working order, and long term life expectancy of the existing system is not anticipated. The structure is equipped with central air conditioning. The site does not contain underground fuel tanks.

Gas Fired Boilers

Provide new overall heating, ventilating, and air conditioning system to achieve compliance with Ohio Building Code and Ohio School Design Manual standards. Convert to ducted system to facilitate efficient exchange of conditioned air. Provide architectural soffits to accommodate the installation of ductwork in the Cafeteria.

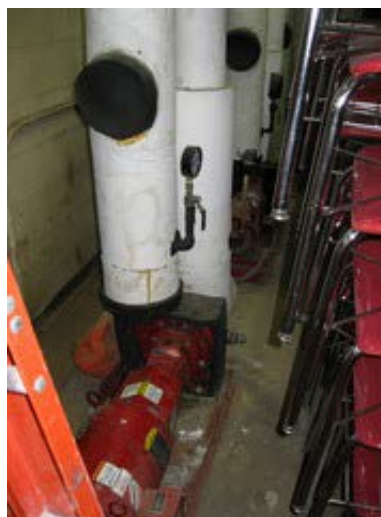
Heating Hot Water Pumps

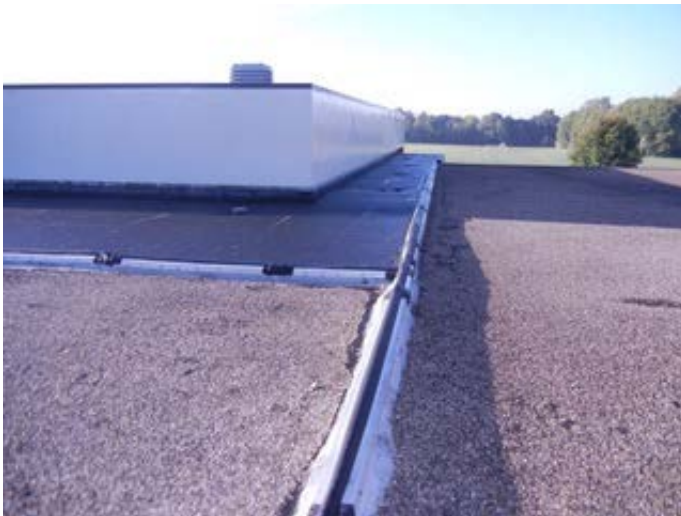
Description: The roof over the Original Construction is a PES Reinforced Thermoplastic system that was installed in 1995 and is in fair condition, and a Built Up Roof system that was installed at an unknown date in and is in fair condition. The roof over the 1988 Addition is a Built Up Roof system that was installed in 1988 and is in fair condition, and a EPDM roof system that was installed in 1988 and is in poor condition. There are no District reports of current leaking. No signs of past leaking were observed during the physical assessment. Access to the roof was gained by access hatch that is in fair condition. Fall safety protection cages are not required, and have not been provided. There were no observations of standing water on the roof. Metal roof edges are in good condition. Roof storm drainage is addressed through a system of roof drains and scupper drains, which are properly located, and in good condition. The roof is not equipped with overflow roof drains though they will be required in areas of roof replacement. No problems requiring attention were encountered with any roof penetrations. There are not any covered walkways attached to this structure.

Rating: 3 Needs Replacement

Built Up Roof in Foreground and EPDM Roof in Background

Recommendations: The roof over the overall facility requires replacement to meet Ohio School Design Manual guidelines due to condition and age of system. Overflow drains will need to be added on the overall facility.

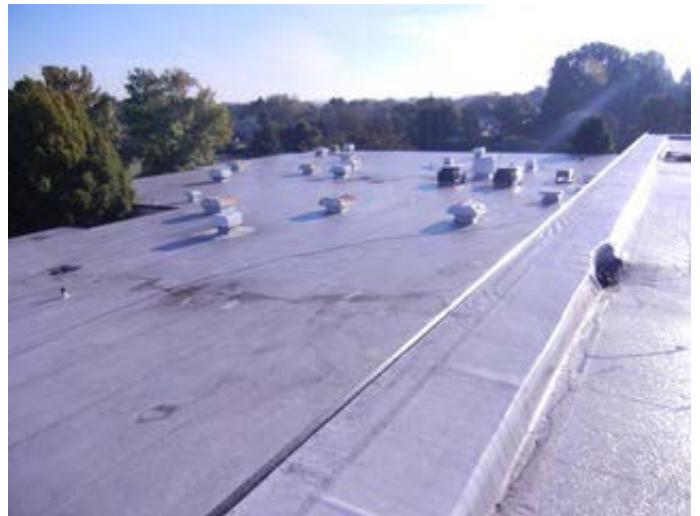
Thermoplastic Roof System

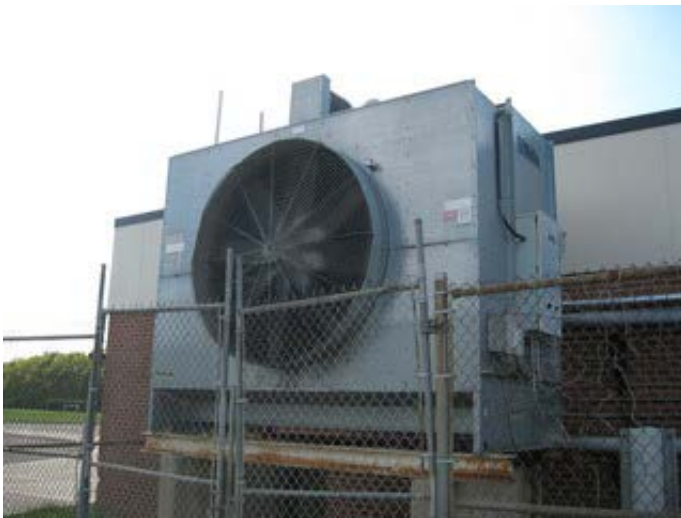
Description: The overall facility is equipped with a water cooled chilled water type central air conditioning system, which is in good condition. A water cooled chiller makes chilled water and a pump distributes chilled water to the terminal units. The equipment is in good condition. The ventilation system in the overall facility consists of unit ventilators and air handlers, installed in 1969 and in fair condition, providing fresh air to Classrooms, and unit ventilators and air handlers, installed in 1969 and in fair condition, providing fresh air to other miscellaneous spaces such as Gymnasiums, Student Dining, and Media Center. Relief air venting is provided by ceiling plenums. The ventilation system does not meet the Ohio Building Code 15 CFM per occupant fresh air requirement. The overall system is not compliant with Ohio Building Code and Ohio School Design Manual requirements. Dust collection systems are not required in this facility. The Art program is equipped with a kiln, and existing kiln ventilation is inadequate, and in fair condition. General building exhaust systems for Restrooms are adequately placed, and in fair condition.

Rating: 2 Needs Repair

Cooling Tower

Recommendations: Provide an air conditioning system to meet with Ohio Building Code and Ohio School Design Manual requirements. Replace general building exhaust systems located in Restrooms. Pricing included in Item A. Provide a new kiln exhaust system.

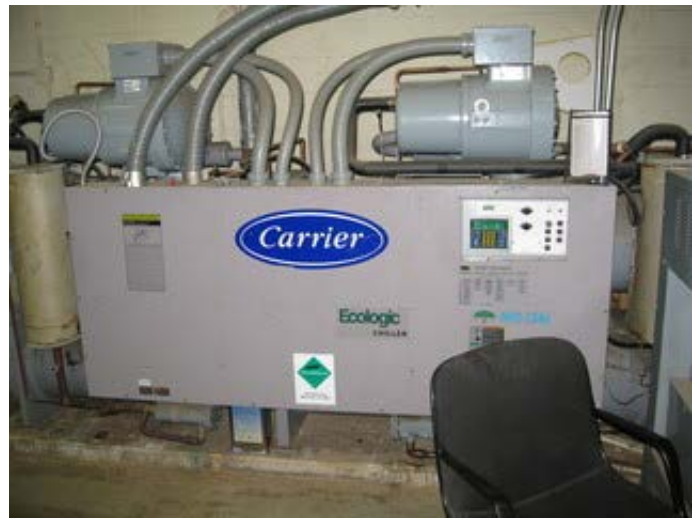
Water Cooled Chiller

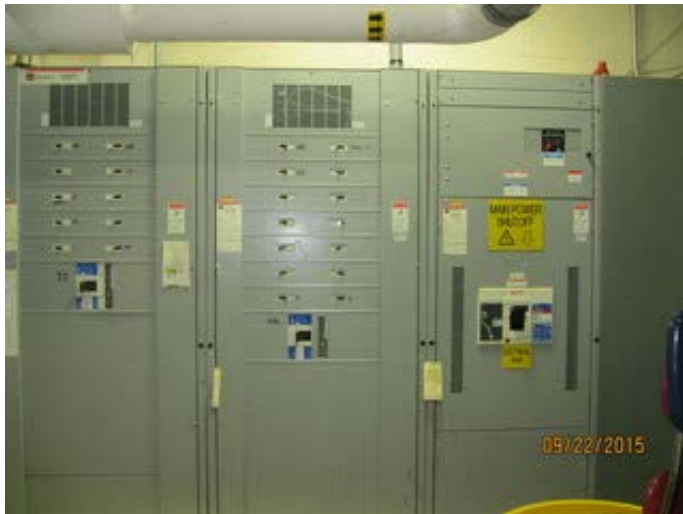
Description: The electrical system provided to the overall facility is a 120/208-volt, 3-phase, 4-wire, 1,600-amp system installed in 1999, and is in good condition. Power is provided to the school by a single utility owned, pad-mounted transformer located in exterior fenced-in courtyard, and in good condition. The panel system, installed in 1999, is in good condition, and can be expanded to add additional capacity. The Classrooms are not equipped with adequate electrical outlets. The typical Classroom contains 10 general purpose outlets, 2 dedicated outlets for each Classroom computer, and 2 dedicated outlets for each Classroom television. Some Classrooms are equipped with as many as 20 general purpose outlets, while others are equipped with as few as 10 general purpose outlets. There are not any spaces that have no electrical outlets. The Corridors are not equipped with adequate electrical outlets for servicing. Adequate GFI protected exterior outlets are not provided around the perimeter of the building. The facility is not equipped with an emergency generator. Inadequate lightning protection safeguards are provided. Stage lighting power system including control panel, breakers, and dimmers is inadequately provided, in good condition and does not meet OSDM requirements. The overall electrical system does not meet Ohio School Design Manual requirements in supporting the current needs of the school, and will be inadequate to meet the facility's future needs.

Rating: 3 Needs Replacement

Main Electrical Distribution Equipment

Recommendations: The entire electrical system requires replacement to meet Ohio School Design Manual guidelines for Classroom capacity, lack of OSDM-required features, and to facilitate the scope of work outlined in Item U.

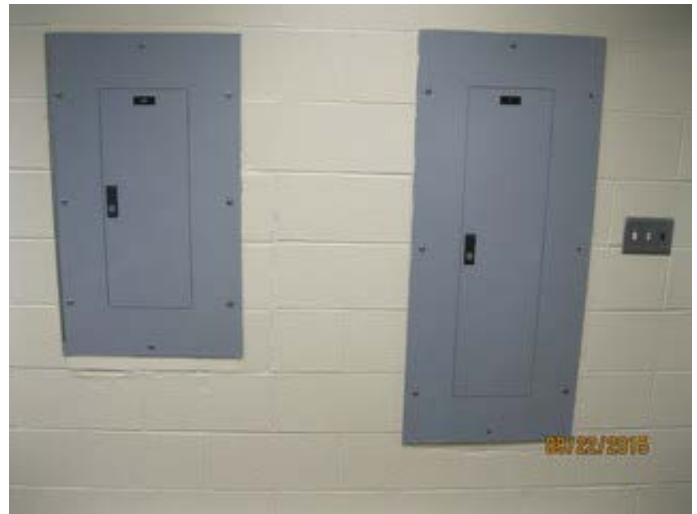
Corridor Electrical Panels

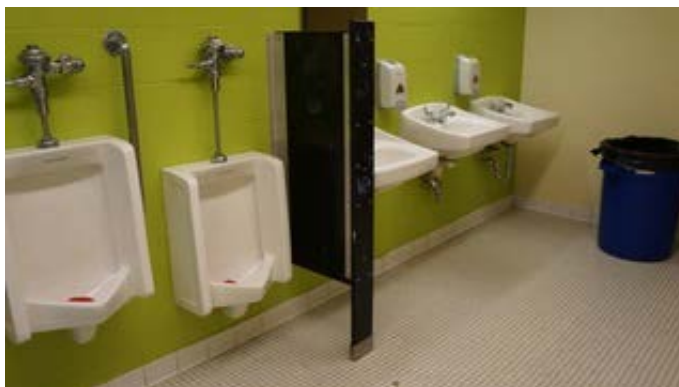
The service entrance is not equipped with a reduced pressure backflow preventer. A water treatment system is not provided. The domestic water supply piping in the overall facility is copper, was installed in 1969, and is in good condition. The waste piping in the overall facility is cast iron and PVC, was installed in 1969, and is in good condition. The facility is equipped with 1 gas water heater in poor condition, with 1 separate 300-gallon storage tank in poor condition. The school contains 3 Large Group Restrooms for boys, 3 Large Group Restrooms for girls, 1 Locker Room Restrooms for boys, 1 Locker Room Restrooms for girls, 1 Restrooms associated with specialty Classrooms, and 5 Restrooms for staff. Boys' Large Group Restrooms contain 1 ADA and 4 non-ADA wall mounted flush valve toilets, 1 ADA and 10 non-ADA wall mounted flush valve urinals, as well as 2 ADA and 6 non-ADA wall mounted lavatories. Girls' Large Group Restrooms contain 1 ADA and 10 non-ADA wall mounted flush valve toilets, as well as 2 ADA and 6 non-ADA wall mounted lavatories. Boys' Locker Room Restrooms contain 0 ADA and 1 non-ADA wall mounted flush valve toilets, 0 ADA and 1 non-ADA wall mounted flush valve urinals, 0 ADA and 1 non-ADA wall mounted lavatories, as well as 0 ADA and 9 non-ADA showers. The showers are used for storage. Girls' Locker Room Restrooms contain 0 ADA and 1 non-ADA wall mounted flush valve toilets, as well as 0 ADA and 1 non-ADA wall mounted lavatories, as well as 0 ADA and 9 non-ADA showers. Staff Restrooms contain 4 ADA and 5 non-ADA floor mounted tank type toilets, 0 ADA and 0 non-ADA urinals, as well as 0 ADA and 5 non-ADA wall mounted lavatories. Condition of fixtures is fair. The facility is equipped with 0 ADA and 1 non-ADA drinking fountains, as well as 4 ADA and 3 non-ADA electric water coolers, in fair condition. (Middle / High) School Special Education Classrooms are not equipped with sink mounted type drinking fountains. Special Education Classroom is equipped with the required Restroom facilities, and fixtures are in fair condition. Kitchen is equipped with the required Restroom, and fixtures are in good condition. Heath Clinic is equipped with the required Restroom, and fixtures are in good condition. Due to existing grade configuration, Kindergarten / Pre-K Classroom Restroom considerations are not relevant. The school does not meet the OBC requirements for fixtures. Relative to LEED requirements, the school is not equipped with low flow type fixtures. Per OBC and OSDM requirements this facility should be equipped with 41 toilets, 19 urinals, 36 lavatories, 1 Classroom sink mounted drinking fountains, and 19 electric water coolers. Observations revealed that the school is currently equipped with 25 toilets, 12 urinals, 25 lavatories, 0 Classroom sink mounted drinking fountains, and 8 electric water coolers. ADA requirements are not met for fixtures and drinking fountains (see Item O). Custodial Closets are properly located and are adequately provided with required service sinks or floor drain sinks, which are in good condition. Kitchen fixtures consist of 1 double-compartment sink and 1 triple-compartment sink, which are in fair condition. The Kitchen is not equipped with a satisfactory grease interceptor. The Kitchen is provided the required 140 degree hot water supply via a mixing valve, which is in good condition. Science Classrooms are equipped with required utility sink, gas / compressed air connections, and safety shower / eyewash in poor condition. Adequate exterior wall hydrants are provided.

Boys ADA Sink - Needs Pipe Protection

To facilitate the school's compliance with OBC and OSFC fixture requirements, provide 16 new toilets / 11 new lavatories / 7new urinals / 11 new electric water coolers / 1 new lavatory mounted type drinking fountains. See Item O for replacement of fixtures related to ADA requirements. Provide reduced pressure backflow preventer. Replace the domestic hot water system. Provide a grease interceptor for the kitchen.

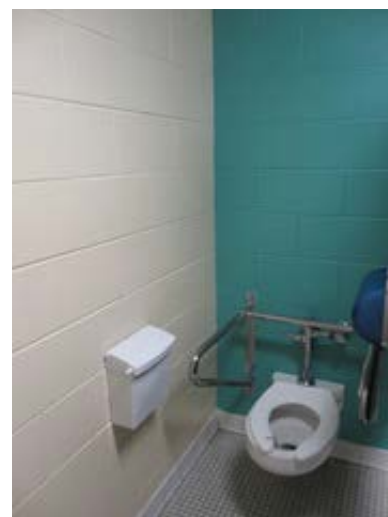
Girls Toilet - Ambulatory, not ADA

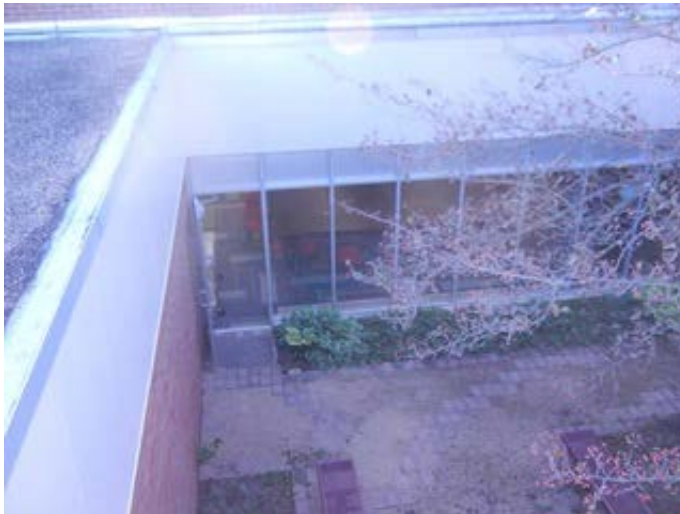
The original construction is equipped with steel windows with single pane glazing type window system, which was installed in 1969 and is in fair condition. The window system features operable windows in most of the building, and operable windows are equipped with opening limiters in fair condition. There are no screens on the windows. Window system seals are in good condition, with no air and water infiltration being experienced. Window system hardware is in good condition. The window system does not feature blinds. Aluminum frame curtain wall systems are found in the original construction and are in fair condition. Aluminum frame curtain wall systems are also found in the 1988 Addition, and are in good condition. This facility does not feature any glass block windows. The exterior doors in the overall facility are equipped with aluminum and steel frame sidelights and transoms with tempered, double pane glazing in good condition. Exterior door vision panels are tempered, single pane glazing. The school does contain 3 - 3'x3' acrylic bubble type skylights in fair condition. The school does contain clerestories. Interior glass is OSDM-compliant. Window security grilles are not provided for ground floor windows. There is not a Greenhouse associated with this school.

Curtain Wall System in Original Construction

Provide a new insulated window system with integral blinds to meet with Ohio School Design Manual requirements. Replace curtain wall system in the original construction due to age and condition. Replace 3 3'x3' skylights in the overall facility. Exterior door vision panel replacement is addressed in Item S in exterior door replacement scope.

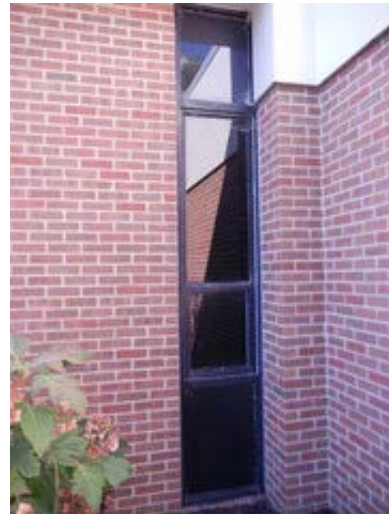
Typical Window

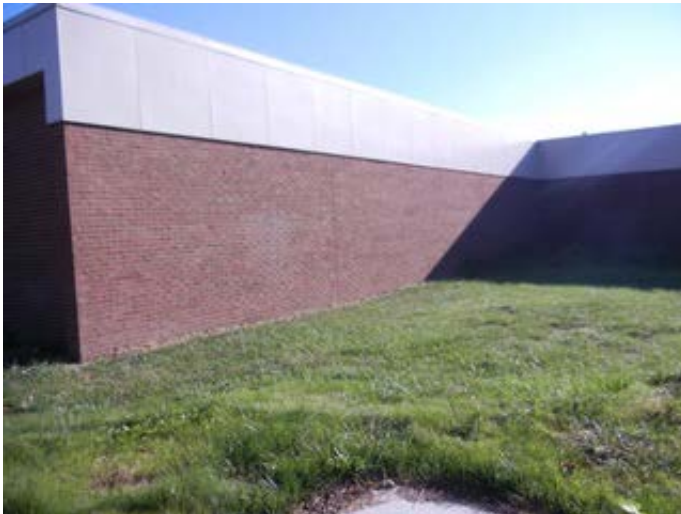
Description: The overall facility has a brick veneer on load bearing masonry wall system, which displayed no locations of deterioration, and is in good condition. The overall facility also features curtain wall systems with steel frame construction, which displayed no locations of deterioration, and is in good condition. The exterior masonry appears to have appropriately spaced and adequately caulked control joints in good condition, with the exception 2 two joints that are in poor condition. Control joints are provided at lintel locations, at doors and windows, building corners, and wall offsets and are in good condition. The school does have sufficient expansion joints, and they are in good condition. Exterior walls in the original construction are inadequately insulated. Brick veneer masonry walls in the original construction are not cavity walls. Exterior walls in the 1988 addition are adequately insulated. Brick veneer masonry walls in the 1988 addition are cavity walls. Weep holes and vents are not provided or required in the original construction. Weep holes and vents are not provided but are required in the 1988 addition due to its cavity wall construction. The exterior masonry has not been cleaned and sealed in recent years, and has locations of efflorescence. Architectural exterior accent materials consist of asbestos cement board fascia panels which are in poor condition. Exterior building fenestration in the overall facility represents 4% of the exterior surfaces. Interior Corridor and demising walls are concrete masonry units, project full height from floor to bottom of deck, and are in good condition. Interior masonry appears to have adequately spaced and caulked control joints in good condition. Interior soffits are of steel stud and gypsum board type construction, and in good condition. The window sills are brick, and are in fair condition. The exterior lintels are steel, and are in good condition. Chimneys are in fair condition. Chimney cap exhibits cracking and spalling. Canopies over entrances are canvas type construction, and are in good condition. Exterior soffits are of asbestos cement board on wood framing type construction, and in poor condition. The school is not equipped with a loading dock.

Rating: 2 Needs Repair

Brick Exterior Wall with Fascia Panels

Recommendations: Provide tuckpointing in all areas of mortar deterioration as required through the overall facility. Provide masonry cleaning, sealing, and caulking as required through the overall facility. Recaulk existing control joints. Repoint brick window sills through the overall facility. Exterior wall insulation deficiencies are addressed in Item J. Remove asbestos cement board panels and replace with non-hazardous material. Abatement is addressed in Item T. Replace or repair chimney cap.

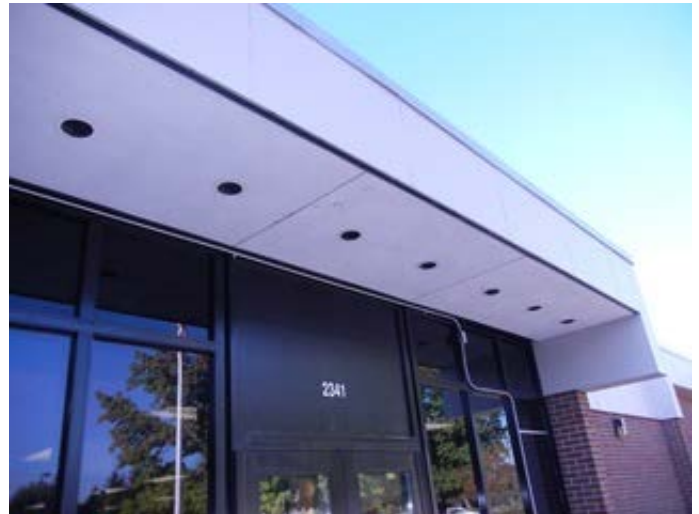
Soffit and Fascia Panels at Main Entry

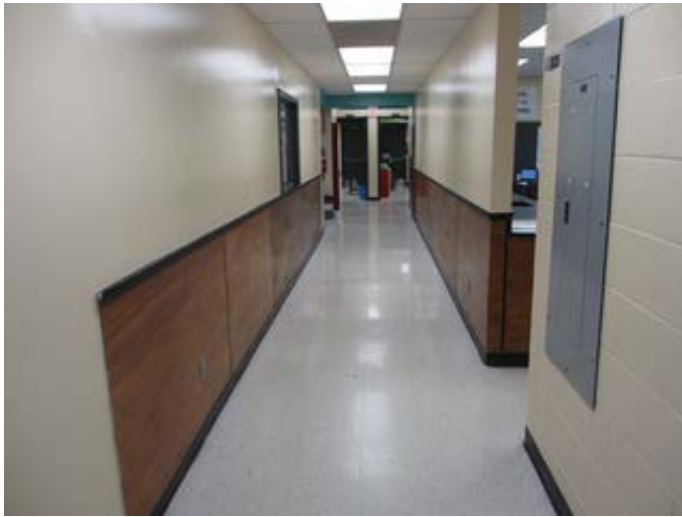
The overall facility features conventionally partitioned, operable partitioned, and demountable metal partitioned Classrooms with carpet tile type flooring, 2x4 ACT type ceilings, as well as painted CMU type wall finishes, and they are in good condition. The overall facility has Corridors with LVT type flooring, 2x4 ACT type ceilings, as well as painted CMU type wall finishes, and they are in good condition. The overall facility has Restrooms with ceramic tile type flooring, gypsum board type ceilings, as well as painted CMU type wall finishes, and they are in good condition. Toilet partitions are plastic and are in good condition. Casework in the overall facility is wood type construction with plastic laminate face and tops, is adequately provided, and in fair condition. The typical Classroom contains 0 lineal feet of casework. Lab casework is of metal construction with solid surface tops, is adequately provided, and in fair condition. Classrooms are provided adequate chalkboards, markerboards, smartboards, and tackboards which are in good condition. The lockers, located in the Corridors, are adequately provided, and in good condition. The Art program is equipped with a kiln in good condition. The facility is equipped with both wood louvered and non-louvered interior doors that are both flush mounted and recessed without proper ADA hardware and clearances, and in good condition. The Gymnasium space has athletic wood type flooring, open exposed type ceilings, as well as painted CMU type wall finishes, and they are in good condition. Wood Gymnasium flooring has been well maintained, will accommodate multiple future sandings and refinishings, and is rated at an early stage of its product lifecycle. Gymnasium telescoping stands are plastic type construction in good condition. Gymnasium basketball backboards are electrically operated type, and are in good condition. The Media Center, located in the original building, has carpet tile type flooring in good condition, 2x4 ACT type ceilings, as well as painted gypsum board and painted CMU type wall finishes, and they are in good condition. Student Dining, located in the Original Building, has VAT type flooring, 2x4 ACT type ceilings, as well as painted CMU type wall finishes, and they are in good condition. Existing Gymnasium, Student Dining, Media Center, and Music spaces are adequately provided with appropriate sound attenuation acoustical surface treatments. The existing Kitchen is full service, is undersized based on current enrollment, and the existing Kitchen equipment, installed in 1977-2007, is in fair condition. Walk-in cooler and freezer are located on the building's exterior, and are accessed by an exterior door and are in fair condition.

Replace Dated Finishes in Science Wing

Provide for the replacement of VAT in student dining and Rockbridge with VET. Provide for the replacement of VCT and base in stage area due to worn and rusted condition. Provide for the complete replacement of finishes in the science wing including wall finishes- tear out wainscot. Provide for the complete replacement of casework in the guidance office. Provide for the complete replacement of all kitchen equipment. Provide for the funding of classroom partitions. Provide for the full replacement of acoustical ceiling tile due to the complete replacement of the lighting system outlined in Item K.

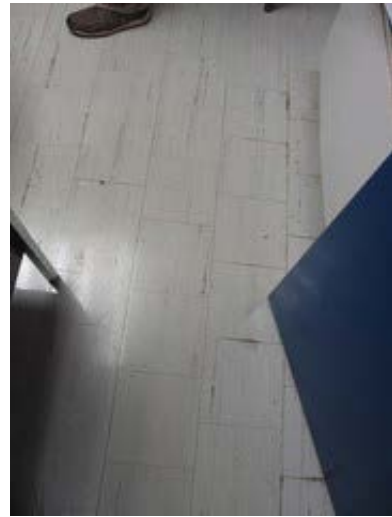
Replace all VAT with VET.

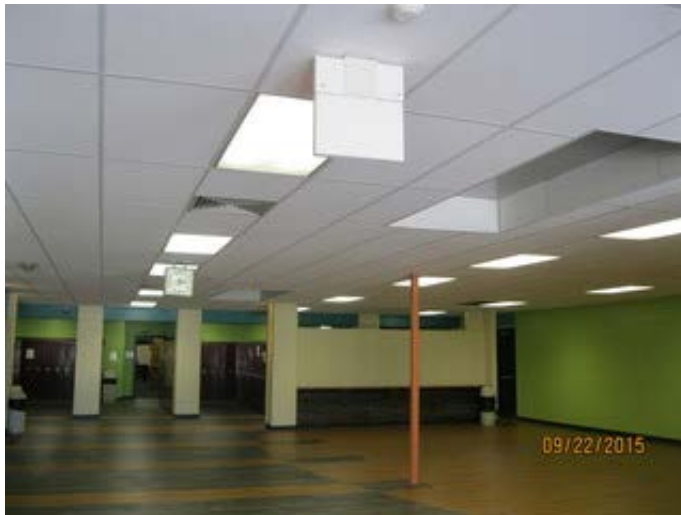
The typical Classrooms in the overall facility are equipped with T-8 lay-in 2x4 fluorescent fixtures with multi-level switching. Classroom fixtures are in good condition, providing an average illumination of 58 FC, thus complying with the 50 FC recommended by the OSDM. The typical Corridors in the overall facility are equipped with T-8 1x4 lay-in 2x4 fluorescent fixtures with dual level switching. Corridor fixtures are in good condition, providing an average illumination of 19 FC, which is less than the 20 FC recommended by the OSDM. The Primary Gymnasium spaces are equipped with pendant T-8 2x4 mount fluorescent fixture type lighting, in good condition, providing an average illumination of 78 FC, thus complying with the 50 MS FC recommended by the OSDM. The Media Center is equipped with lay-in 2x4 T-8 fluorescent fixture type lighting in good condition, providing an average illumination of 62 FC, thus complying with the 50 FC recommended by the OSDM. The Student Dining spaces are equipped with lay-in 2x4 T-8 fluorescent fixture type lighting with multi-level switching. Student Dining fixtures are in good condition, providing an average illumination of 103 FC, thus complying with the 50 FC recommended by the OSDM. The Kitchen spaces are equipped with 1x4 lay-in, drywall mounted T-8 fluorescent fixture type lighting with multi-level switching. Kitchen fixtures are in good condition, providing an average illumination of 58 FC, which is less than the 75-80 FC recommended by the OSDM. The Service Areas in the overall facility are equipped with 1x4 suspended T-8 fluorescent fixture type lighting in good condition. The typical Administrative spaces in the overall facility are equipped with lay-in 2x4 T-8 fluorescent fixture type lighting in good condition, providing adequate illumination based on OSDM requirements. The overall lighting systems of the facility are not fully compliant with Ohio School Design Manual requirements due to inadequate lighting levels

Corridor/Entrance Area Lighting

Provide complete replacement of lighting system due to lighting levels, lack of multi-level switching, and installation of systems outlined in Item U.

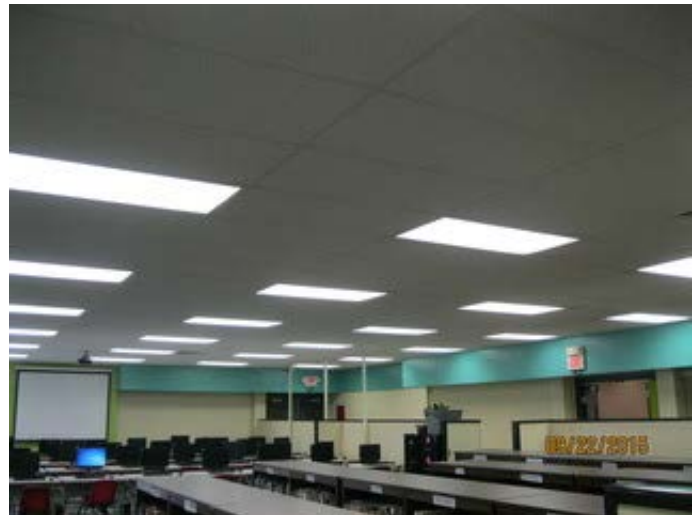
Media Center Lighting

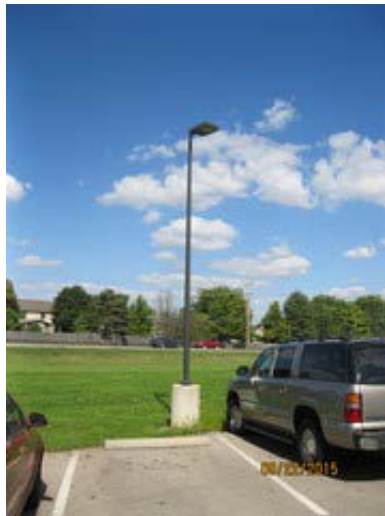
Description: The overall facility contains a Security Command motion detector, intrusion, and door contact type security system in good condition. Motion detectors are not adequately provided in main entries, central gathering areas, offices, main Corridors, and spaces where 6 or more computers are located. Exterior doors are equipped with door contacts. An automatic visitor control system is provided. Compliant color CCTV cameras are not provided at main entry areas, parking lots, central gathering areas, and main Corridors. CCTV is not monitored in Administrative Area. A compliant computer controlled access control system integrating alarms and video signals, with appropriate UPS backup, is not provided. The system is equipped with card readers. The security system is adequately provided throughout, and the system is not compliant with Ohio School Design Manual guidelines. The exterior site lighting system is equipped with surface mounted high pressure sodium entry lights in good condition. Pedestrian walkways are not illuminated. Parking and bus pick-up / drop off areas are illuminated by pole mounted metal halide fixtures in good condition. The exterior site lighting system provides inadequate illumination due to sparse placement of fixtures.

Rating: 3 Needs Replacement

Parking Lot Pole Lighting

Recommendations: Provide new security system and exterior site lighting to meet OSDM requirements.

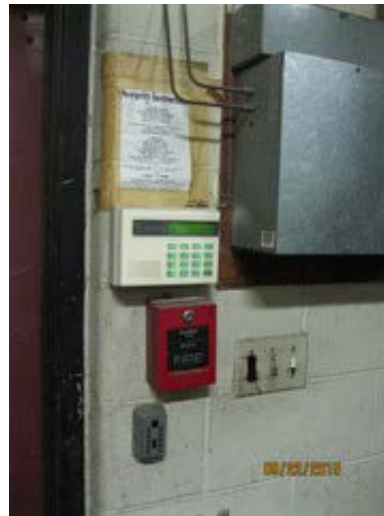
Security System Keypad

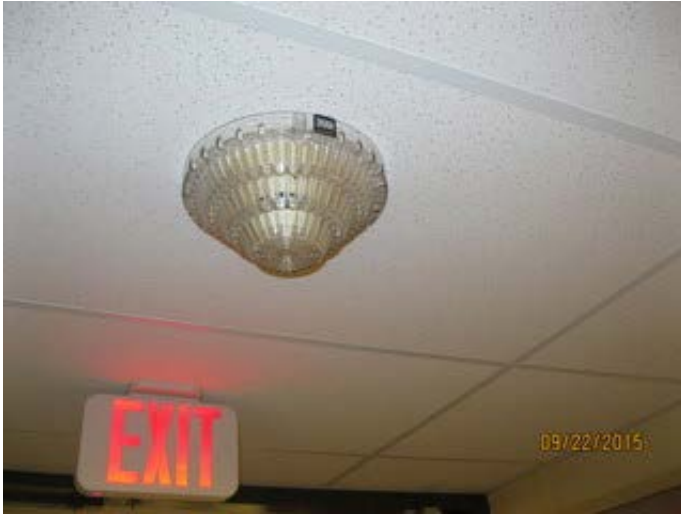
- Description:** The overall facility is equipped with an emergency egress lighting system consisting of non-compliant incandescent, plastic construction exit signs, as well as OSDM compliant red lettered, LED illuminated exit signs, and the system is in good condition. The facility is equipped with emergency egress floodlighting, and the system is in good condition. The system is provided with appropriate battery backup. The system is adequately provided throughout, and does not meet Ohio School Design Manual and Ohio Building Code requirements.
- Rating:** 3 Needs Replacement
- Recommendations:** Provide new emergency / egress lighting system to meet Ohio School Design Manual and Ohio Building Code guidelines and in conjunction with work in Item U.

Exit Sign/FA Smoke Detector

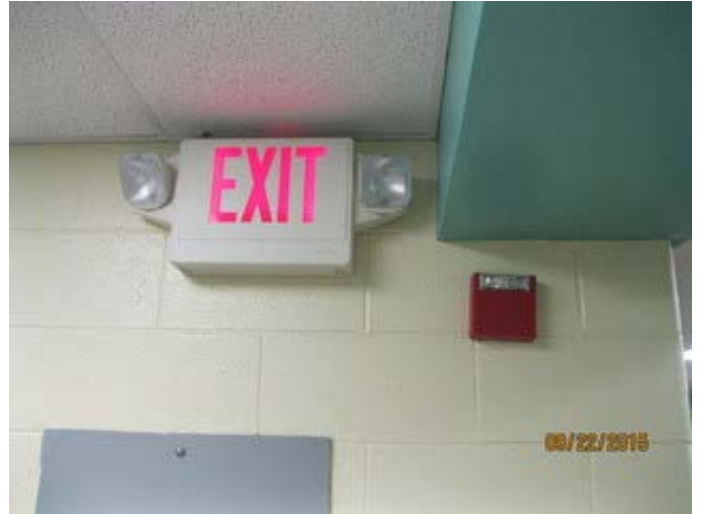
Combo. Exit Sign/Remote Heads/FA Horn Strobe

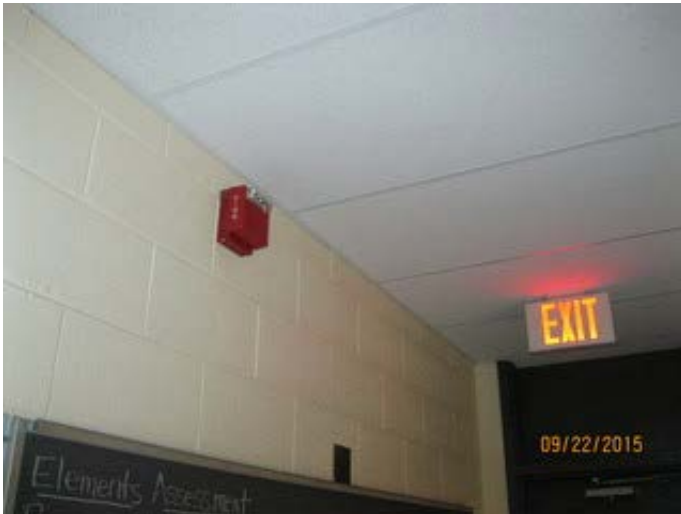
Description: The overall facility is equipped with a Simplex type fire alarm system, installed in 1999, and in good condition, consisting of manual pull stations, bells, and horn and strobe indicating devices. The system is automatic and is monitored by a third party. The system is equipped with sufficient audible horns, strobe indicating devices, and smoke detectors. The system is not equipped with any flow switches, tamper switches, or heat sensors. The system thus will not support future fire suppression systems. The system is adequately provided throughout, and does not have additional zone capabilities. The system is not compliant with Ohio Building Code, NFPA, and Ohio School Design Manual requirements.

Rating: 3 Needs Replacement

Fire Alarm Horn Strobe

Recommendations: Provide new fire alarm system to meet OBC, NFPA, and Ohio School Design Manual guidelines.

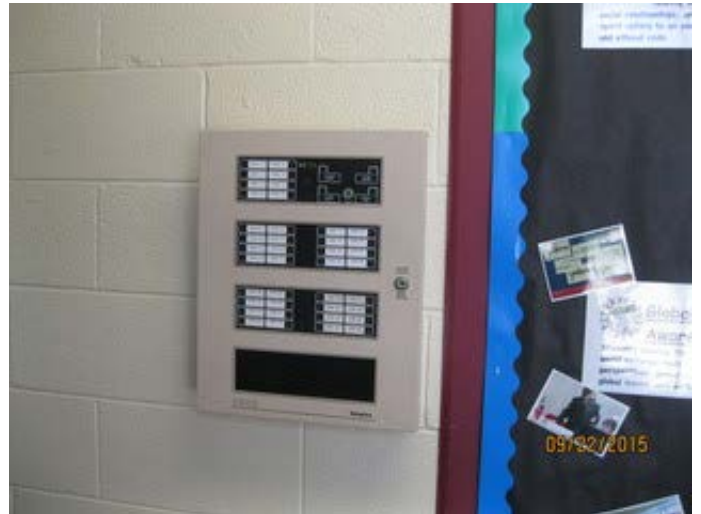
Fire Alarm Remote Annunciator

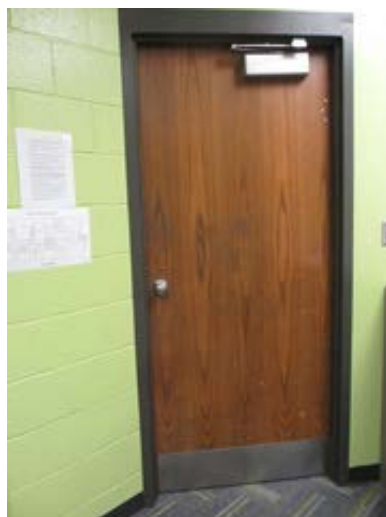
Non-ADA Door Hardware

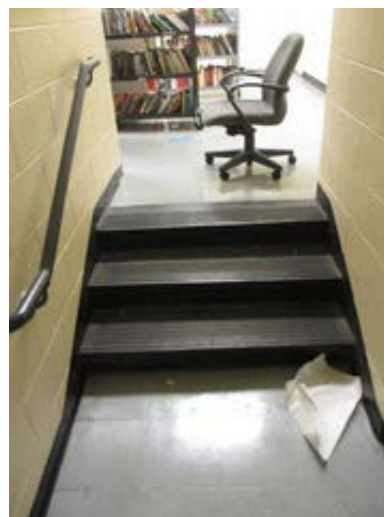
Non-ADA Stage Access

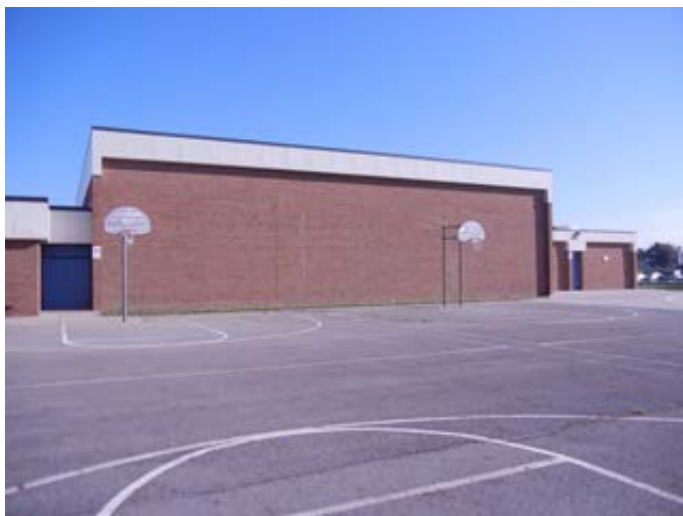
2 Needs Repair

Asphalt Play Area

Replace asphalt in play area and rear parking lot areas in poor condition. Resurface asphalt in front driveway and parking lot. Provide heavy duty asphalt at service drive and provide a concrete pad for dumpsters. Provide fencing to separate asphalt play area from vehicular traffic. Provide fencing around dumpsters.

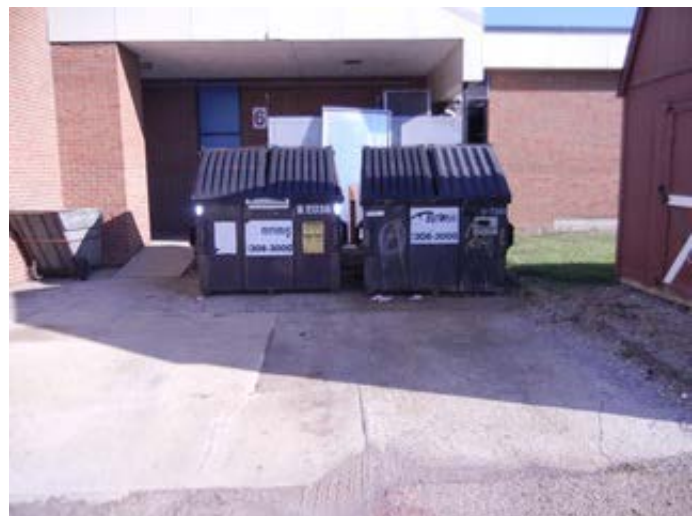
Dumpsters and Service Drive

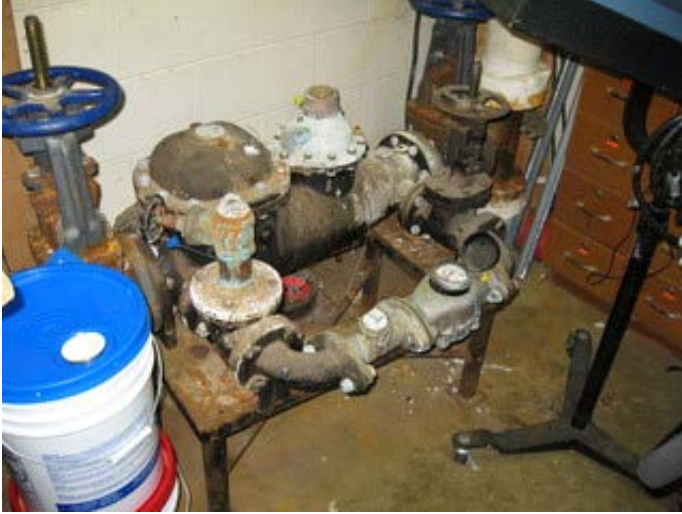
Description: The domestic water supply system is tied in to the city system, features 3" service and 2" water meter, and is in poor condition. The District was not able to provide water supply flow test data. The existing domestic water service appears to meet the facility's current needs. The facility is not equipped with an automated fire suppression system, and the existing water supply will not provide adequate support for a future system. The domestic water service is not equipped with a water booster pump. The system provides adequate pressure for the future needs of the school.

Water Main

Recommendations: Provide a new city water supply line of adequate capacity to support the existing needs of the facility, as well as a future automated fire suppression system. Funding provided in Item U.

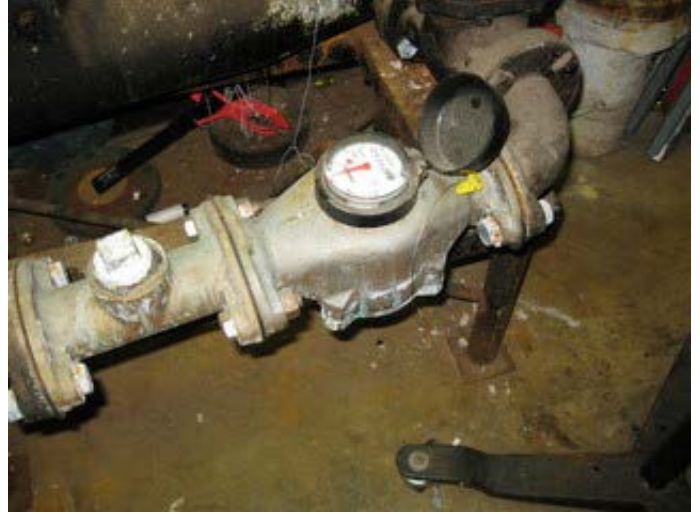
Water Meter

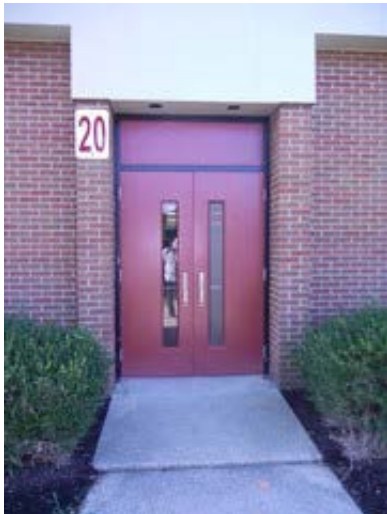
Description: Typical exterior doors in the overall facility are hollow metal type construction, installed on hollow metal frames, and in fair condition. Typical exterior doors feature single glazed tempered glass vision panels, and appropriate hardware. A couple exterior doors did not have appropriate ADA hardware. Entrance doors in the overall facility are aluminum type construction, installed on aluminum frames, and in good condition. Entrance doors feature double glazed tempered glass vision panels, transoms, sidelights, and appropriate hardware. The facility is equipped with 1 roof access door that leads to a mechanical space, which is in poor condition. There are no overhead doors in the facility.

Rating: 3 Needs Replacement

Typical Exterior Door

Recommendations: Replace all exterior doors to comply with Ohio Building Code, ADA, and Ohio School Design Manual guidelines. Replace existing roof access door.

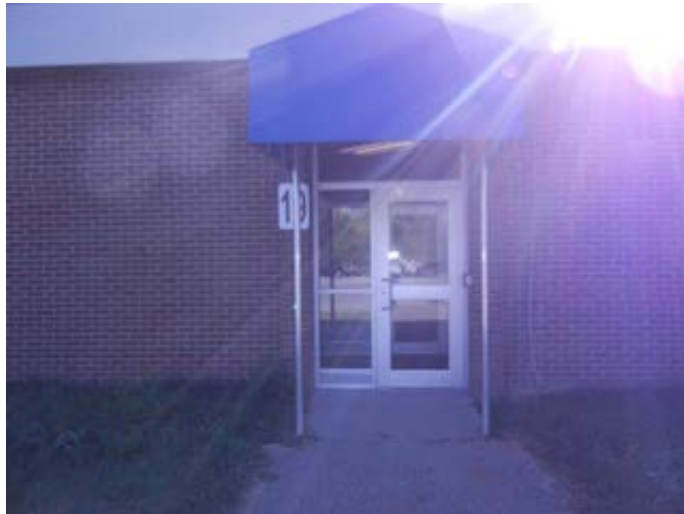
Typical Entrance Door

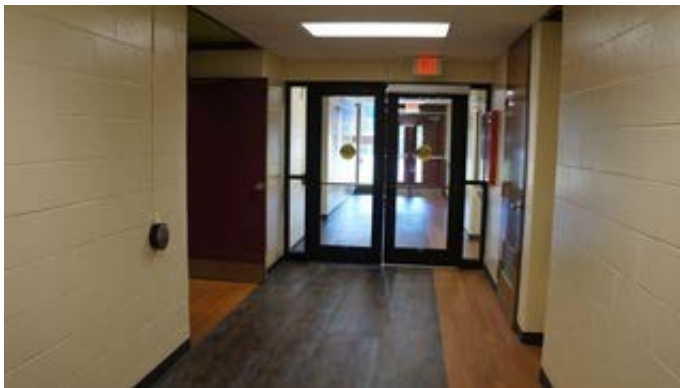
Corridor C

Description: The School District provided the AHERA Three Year Reinspection Reports, prepared by Gandee & Associates, Inc. and dated May 2014, documenting known and assumed locations of asbestos and other hazardous materials. The district did not provide documentation of any abatement projects since that time. According to the report, Pipe Fitting Insulation containing hazardous materials are located in the 1969 Original Construction in good condition. These materials were described in the report to be in friable condition with no reported damage. According to the report, Resilient Floor Covering and mastic containing hazardous materials are located several areas in the 1969 Original Construction, with no condition reported. These materials were described in the report to be in non-friable condition with no damage reported. In many areas, the tile has been removed but the mastic remains. Due to the construction date, there is no potential for lead based paint. Fluorescent lighting will require special disposal.

Rating: 3 Needs Replacement

Recommendations: Remove all hazardous materials, inclusive of asbestos-containing materials in the 1969 Addition, as noted in the attached AHERA Three Year Reinspection Report. Provide for disposal of fluorescent lighting.

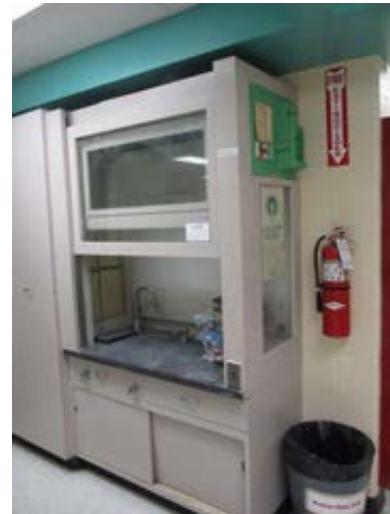
Fume Hood

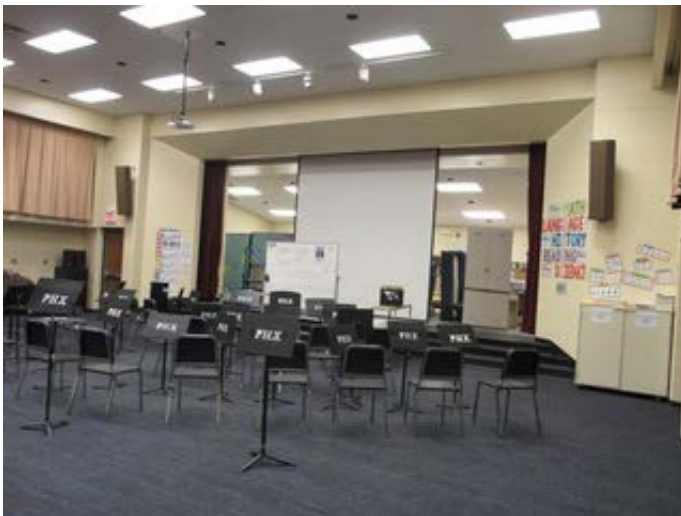
Rating: 2 Needs Repair

No Handrails Present

Recommendations: Provide new handrails to meet the requirements of the Ohio Building Code. Provide new automated fire suppression system to meet Ohio School Design Manual guidelines. Provide increased water service of a capacity sufficient to support the fire suppression system, funding included in fire suppression funding. Provide new emergency generator, with funding provided via complete replacement of electrical system in Item D.

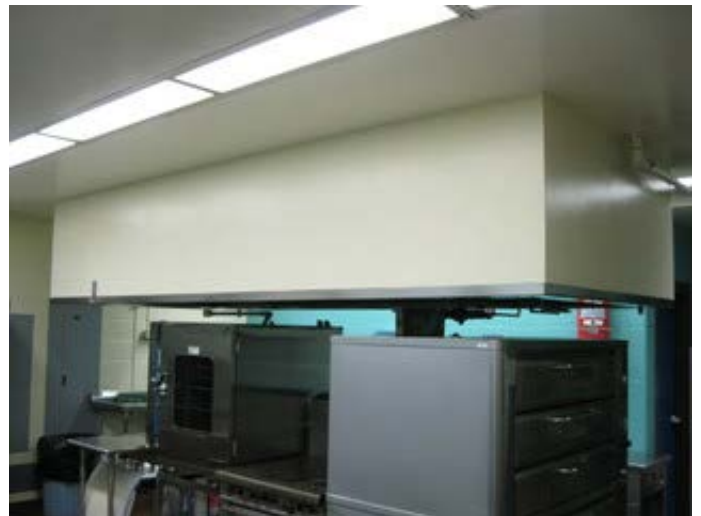
Kitchen Hood
