**Building Information - Worthington City (45138) - Slate Hill Elementary**

Program Type	Assessment Only
Setting	Suburban
Assessment Name	Slate Hill Elementary
Assessment Date (on-site; non-EEA)	2015-09-22
Kitchen Type	Full Kitchen
Cost Set:	2015
Building Name	Slate Hill Elementary
Building IRN	110460
Building Address	7625 Alta View Blvd
Building City	Worthington
Building Zipcode	43085
Building Phone	(614) 450-5000
Acreage	16.28
Current Grades:	K-6
Teaching Stations	30
Number of Floors	1
Student Capacity	684
Current Enrollment	559
Enrollment Date	2015-09-14
Enrollment Date is the date in which the current enrollment was taken.	
Number of Classrooms	
Historical Register	<b>NO</b>
Building's Principal	Ken Pease
Building Type	Elementary

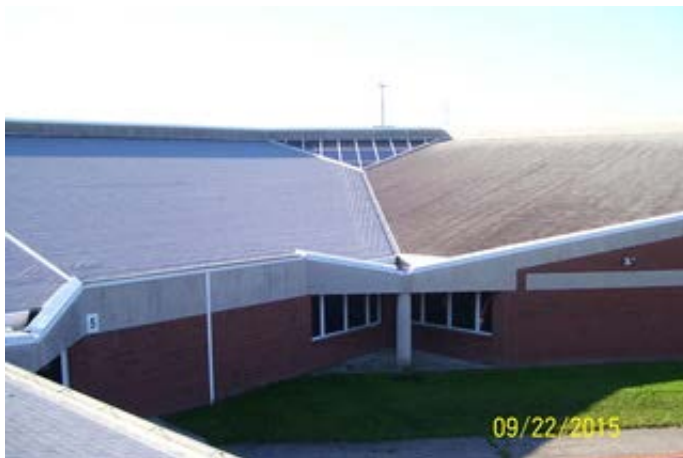
The roof over the overall facility is a combination of fully adhered EPDM membrane roof system, ballasted EPDM roof system, and 3-tab fiberglass shingle system, was installed in 1991, and is in poor condition. Signs of past leaking were observed during the physical assessment, especially in the over the office where water is coming through. Access to the roof was gained by access hatch that is in good condition. Fall safety protection cages are not required, and are not provided. There were no observations of standing water on the roof. Metal cap flashings and copings are in poor condition. EPDM flashing require replacement. Areas at the shingled roof that were recently replaced need to be replaced again. Roof storm drainage is addressed through a system of gutters and downspouts and roof drains which are properly located, and in fair condition. The roof is equipped with overflow roof drains in areas associated with the sloped roofs in sufficient quantity and in fair condition. Overflow drains are not provided in flat areas of the roof and should be provided in conjunction with recommended roof replacement. Problems requiring attention were encountered at several roof penetrations where membrane flashings had separated from the membrane roofing. Shingles are missing and plywood sheathing is exposed in an area at the southwest corner. There are not any covered walkways attached to this structure. The facility includes a skylight system throughout the roof that is in poor condition and needs resealed immediately and eventually replaced.

Typical Shingle Roof Areas

The roof over the overall facility requires replacement to meet Ohio School Design Manual guidelines due to condition, age, and projected lifecycles of systems. The flashing and coping on the overall facility require replacement due to condition. The skylights are addressed in Item F. Replace exposed plywood deck at southwest corner where shingles are missing.

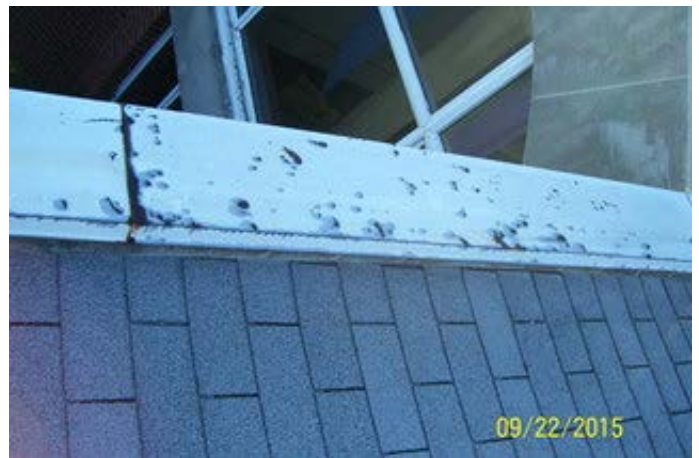
Typical Coping to be Replaced

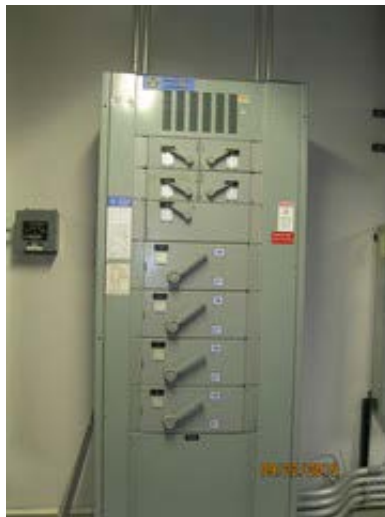
**Description:** The electrical system provided to the overall facility is a 120/208-volt, 3-phase, 4-wire, 200-amp, 2,000-amp main fused switch system installed in 1990, and is in good condition. Power is provided to the school by a single utility owned, pad-mounted transformer located in exterior fenced-in area, and in good condition. The panel system, installed in 1990, is in good condition, and can be expanded to add additional capacity. The Classrooms are not equipped with adequate electrical outlets. The typical Classroom contains 20 general purpose outlets, 4 dedicated outlets for each Classroom computer, and 2 dedicated outlets for each Classroom television. Some Classrooms are equipped with as many as 26 general purpose outlets, while others are equipped with as few as 18 general purpose outlets. There are not any spaces that have no electrical outlets. The Corridors are equipped with adequate electrical outlets for servicing. Adequate GFI protected exterior outlets are not provided around the perimeter of the building. The facility is equipped with a suitable emergency generator. Adequate lightning protection safeguards are not provided. Stage lighting power system including control panel, breakers, and dimmers is inadequately provided, and does not meet OSDM requirements. The overall electrical system does not meet Ohio School Design Manual requirements in supporting the current needs of the school, and will not be adequate to meet the facility's future needs.

Electrical Distribution Equipment

**Recommendations:** The entire electrical system requires replacement to meet Ohio School Design Manual guidelines for Classroom capacity and lack of OSDM-required features. Provide additional panels (circuits / outlets) to increase capacity for Classrooms. Provide control panel, dimmers, and breakers to support the Stage lighting system. Provide adequate lightning protection safeguards.

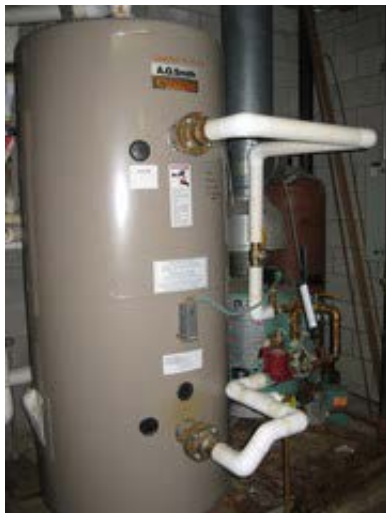
The service entrance is not equipped with a reduced pressure backflow preventer. A water treatment system is not provided. The domestic water supply piping in the overall facility is copper, was installed in 1991, and is in good condition. The waste piping in the overall facility is cast iron, was installed in 1991, and is in good condition. The facility is equipped with a gas water heater poor condition, with a separate 200-gallon storage tank in poor condition. The school contains 2 Large Group Restrooms for boys, 2 Large Group Restrooms for girls, 4 Restrooms associated with specialty Classrooms, and 7 Restrooms for staff. Boys' Large Group Restrooms contain 0 ADA and 6 non-ADA wall mounted flush valve toilets, 4 ADA and 6 non-ADA wall mounted flush valve urinals, as well as 1 ADA and 8 non-ADA wall mounted lavatories. Girls' Large Group Restrooms contain 0 ADA and 13 non-ADA wall mounted flush valve toilets, as well as 1 ADA and 8 non-ADA wall mounted lavatories. Staff Restrooms contain 0 ADA and 7 non-ADA wall mounted flush valve toilets, 0 ADA and 0 non-ADA mounted urinals, as well as 0 ADA and 7 non-ADA wall mounted lavatories. Condition of fixtures is good. The facility is equipped with 0 ADA and 0 non-ADA drinking fountains, as well as 3 ADA and 3 non-ADA electric water coolers, in good condition. The 20 Elementary Classrooms are equipped with 20 ADA and 0 non-ADA sink mounted type drinking fountains, in good condition. Special Education Classroom is not equipped with the required Restroom facilities. Kitchen is equipped with the required Restroom, and fixtures are in good condition. Heath Clinic is equipped with the required Restroom, and fixtures are in good condition. Kindergarten is all equipped with Restroom facilities, and fixtures are in good condition. Kitchen fixtures consist of 1 single-compartment sink, 1 hand sink, 1 double-compartment sink, and 1 triple-compartment sink, which are in good condition. The Kitchen is equipped with a satisfactory grease interceptor. The Kitchen is provided the required 140 degree hot water supply via a mixing valve, which is in good condition. The school does not meet the OBC requirements for fixtures. Relative to LEED requirements, the school is not equipped with low flow type fixtures. Per OBC and OSDM requirements this facility should be equipped with 34 toilets, 14 urinals, 40 lavatories, 20 Classroom sink mounted drinking fountains, and 20 electric water coolers. Observations revealed that the school is currently equipped with 30 toilets, 10 urinals, 29 lavatories, 20 Classroom sink mounted drinking fountains, and 6 electric water coolers. ADA requirements are not met for fixtures and drinking fountains (see Item O). Custodial Closets are properly located and are adequately provided with required service sinks or floor drain sinks, which are in good condition. Adequate exterior wall hydrants are provided.

Domestic Water Heater

To facilitate the school's compliance with OBC and OSFC fixture requirements, provide 3 new toilets, 11 new lavatories, 4 new urinals, 14 new electric water coolers. Provide reduced pressure backflow preventer. Provide a new domestic hot water heater.

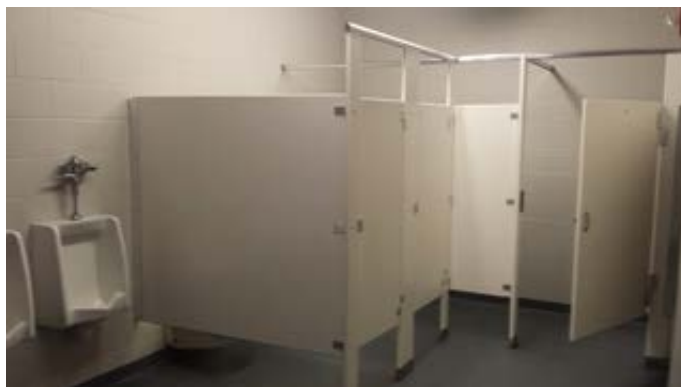
Typical Restroom

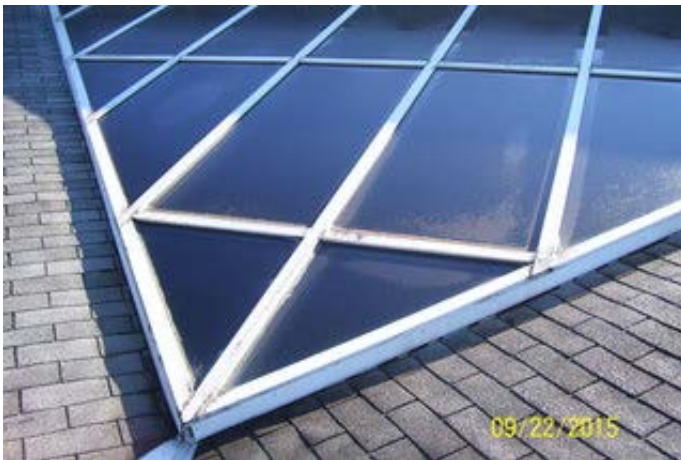
Typical Skylight System to be Replaced

**Recommendations:** Replace skylight system in the overall facility.

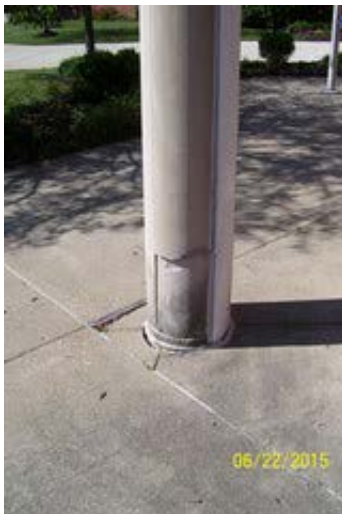
**Description:** The overall facility has a brick veneer on load bearing masonry wall system, which displayed minor instances of deterioration, and is in fair condition. The exterior masonry appears to have appropriately spaced and adequately caulked control joints in fair condition. Control joints are provided at lintel locations, at doors and windows, building corners, and wall offsets and are in fair condition. The school does have sufficient expansion joints, and they are in fair condition. Exterior walls in the overall facility are adequately insulated. Brick veneer masonry walls are cavity walls. Weep holes are provided in sufficient quantity (at 48" on center) below stone accents and above bricks, and are in fair condition. Weep holes are not rope type weeps; vents are not provided. The exterior masonry has not been cleaned and sealed in recent years, and shows no evidence of mortar deterioration. No efflorescence was observed, however mold was noted in several locations. Graffiti was also noted in a couple locations. Architectural exterior accent material consist of stone, which is in good condition, with the exception of column covers in several locations, which should be replaced. Exterior building fenestration (including the skylight systems) in the overall facility represents 20% of the exterior surfaces. Interior corridor and demising walls are metal operable partition walls, do not project full height from floor to bottom of deck, and are in good condition. Interior masonry appears to have adequately spaced and caulked control joints in good condition. Interior soffits are of drywall and ACT type construction, and in good condition. The window sills are brick, and are in good condition. The exterior lintels are precast steel, and are in fair condition. There are no chimneys. Canopies over entrances are steel and masonry type construction, and are in fair condition. Exterior soffits are of suspended exterior gypsum board type construction, and in fair condition. There are several areas with minor damage that require repair of the gypsum board. The school is not equipped with a loading dock.

Typical Column Cover to be Replaced

**Recommendations:** Provide tuckpointing in all areas of mortar deterioration as required through the overall facility. Provide masonry cleaning, sealing, caulking as required through the overall facility. Recaulk existing control joints. Prep and paint exposed steel lintels through the overall facility. Replace stone column covers in several locations. Repair exterior soffit gypsum board where required.

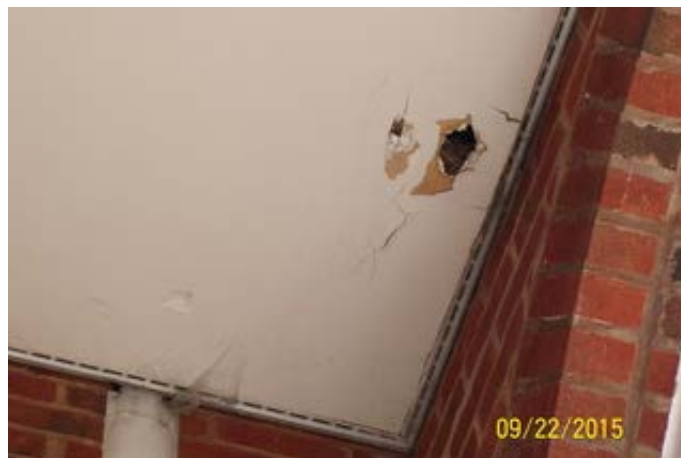
Typical Soffit to be Repaired

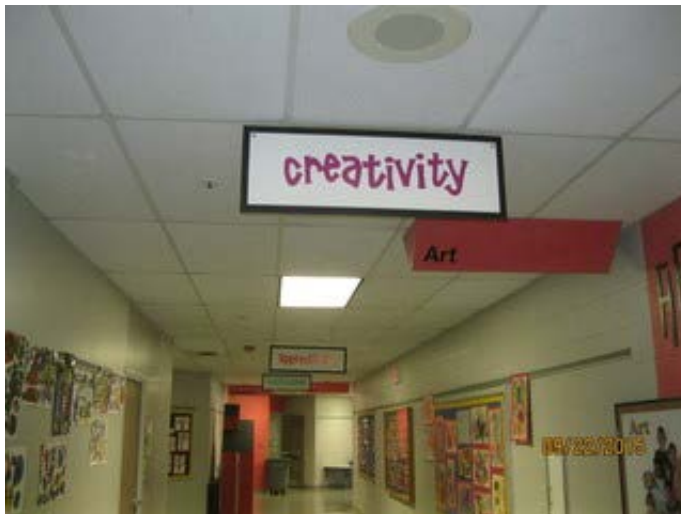
The typical Classrooms in the overall facility are equipped with T-8 lay-in 2x4 fluorescent fixtures with multi-level switching. Classroom fixtures are in good condition, providing an average illumination of 32 FC, which is less than the 50 FC recommended by the OSDM. The typical Corridors in the overall facility are equipped with T-8 lay-in 2x4 fluorescent fixtures with single level switching. Corridor fixtures are in good condition, providing an average illumination of 15 FC, which is less than the 20 FC recommended by the OSDM. The Primary Gymnasium spaces are equipped with T-8 2x4 pendant mount fluorescent fixture type lighting, in good condition, providing an average illumination of 45 FC, which is less than the 50 ES FC recommended by the OSDM. The Media Center is equipped with lay-in 2x4 T-8 fluorescent fixture type lighting in good condition, providing an average illumination of 31 FC, which is less than the 50 FC recommended by the OSDM. The Student Dining spaces are equipped with lay-in 2x4 T-8 fluorescent fixture type lighting with multi-level switching. Student Dining fixtures are in poor condition, providing an average illumination of 32 FC, which is less than the 50 FC recommended by the OSDM. The Kitchen spaces are equipped with 1x4 surface mount T-8 fluorescent fixture type lighting with single level switching. Kitchen fixtures are in good condition, providing an average illumination of 74 FC, which is less than the 75-80 FC recommended by the OSDM. The Service Areas in the overall facility are equipped with lay-in 2x4 T-8 fluorescent fixture type lighting in good condition. The typical Administrative spaces in the overall facility are equipped with lay-in 2x4 T-8 fluorescent fixture type lighting in good condition, providing adequate illumination based on OSDM requirements. The overall lighting systems of the facility are not fully compliant with Ohio School Design Manual requirements due to inadequate lighting levels and lack of multi-level switching.

Corridor Lighting

Provide complete replacement of lighting system due to lighting levels and lack of multi-level switching.

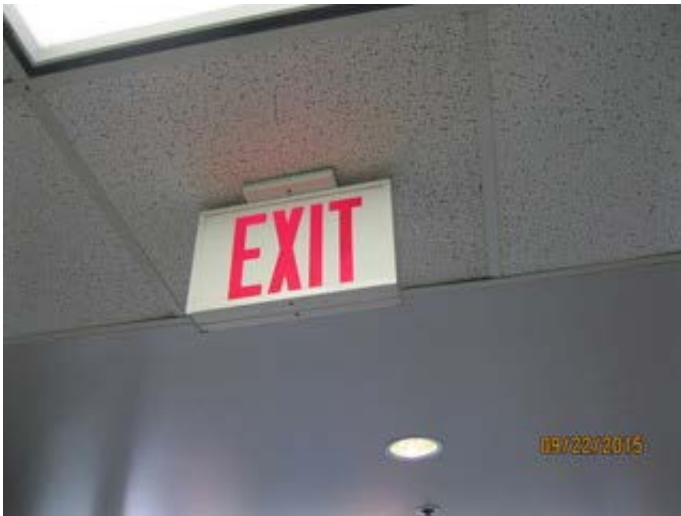
**Description:** The overall facility is equipped with an emergency egress lighting system consisting of non-compliant incandescent, plastic construction, as well as OSDM compliant red lettered, cast aluminum construction, LED illuminated exit signs, and the system is in good condition. The facility is not equipped with emergency egress floodlighting, but is equipped with recessed fluorescent lighting used as emergency egress lighting, and the system is in good condition. The system is provided with appropriate emergency generator power. The system is adequately provided throughout, and does not meet Ohio School Design Manual and Ohio Building Code requirements.

Exit Sign

**Recommendations:** Provide replacement of emergency / egress lighting system to meet Ohio School Design Manual and Ohio Building Code guidelines.

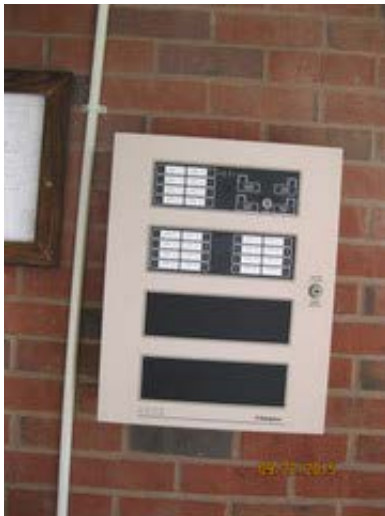
**Description:** The overall facility is equipped with a Simplex type fire alarm system, installed in 1990, and in good condition, consisting of manual pull stations, bells, and horn and strobe indicating devices. The system is automatic and is monitored by a third party. The system is equipped with sufficient audible horns, strobe indicating devices, flow switches, tamper switches, smoke detectors, and heat sensors. The system thus supports existing fire suppression systems. The system is adequately provided throughout, and does not have additional zone capabilities. The system is not fully compliant with Ohio Building Code, NFPA, and Ohio School Design Manual requirements.

Fire Alarm Remote Annunciator

**Recommendations:** Provide new fire alarm system to meet OBC, NFPA, and Ohio School Design Manual guidelines.

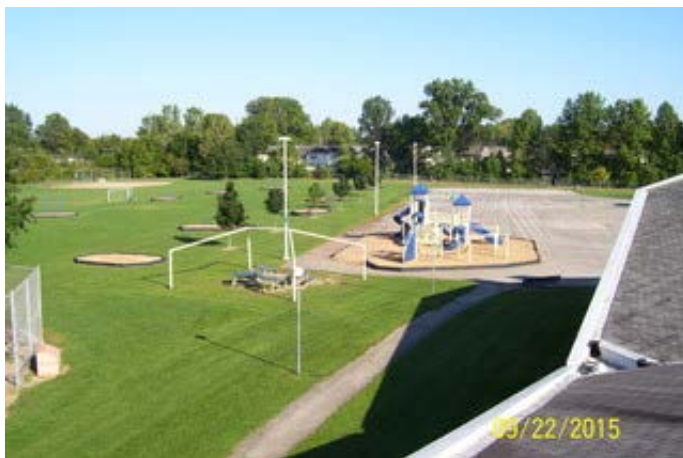
Play Areas

Replace playground equipment to provide more ADA-compliant play structures.

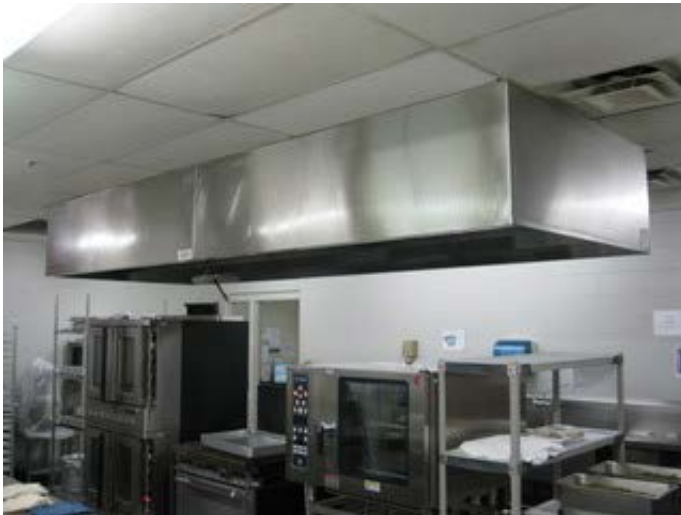
**Description:** The overall facility is equipped with a compliant automated fire suppression system in good condition. Exit Corridors are situated such that dead-end Corridors are not present. Stair towers and guardrails are not present in this single story structure. The facility does not have any exterior stairways from intermediate floors. The Kitchen hood is in good condition, and is equipped with the required UL 300 compliant wet chemical fire suppression system. The cooking equipment is not interlocked to shut down in the event of discharge of the fire suppression system. Fire extinguishers are provided in sufficient quantity. Existing fire extinguishers are adequately spaced. The facility is equipped with an emergency generator. The emergency generator is a diesel type unit, and is located outside the building. The emergency generator is in poor condition, and does not provide adequate capacity for the future needs of the school. The existing water supply is provided by a tie-in to the city system, and is sufficient to meet the future fire suppression needs of the school. Rooms with a capacity greater than 50 occupants are equipped with adequate egress.

Kitchen Hood

**Recommendations:** Provide interlock to de-energize cooking equipment upon discharge of the Kitchen hood fire suppression system.
