Building Information - Worthington City (45138) - Worthington Hills Elementary

Program Type	Assessment Only
Setting	Suburban
Assessment Name	Worthington Hills Elementary
Assessment Date (on-site; non-EEA)	2015-09-24
Kitchen Type	Warming Kitchen
Cost Set:	2015
Building Name	Worthington Hills Elementary
Building IRN	64089
Building Address	1221 Candlewood Dr
Building City	Columbus
Building Zipcode	43235
Building Phone	(614) 450-4700
Acreage	12.00
Current Grades:	K-6
Teaching Stations	24
Number of Floors	1
Student Capacity	606
Current Enrollment	461
Enrollment Date	2015-09-14
Enrollment Date is the date in which the current enrollment was taken.	
Number of Classrooms	24
Historical Register	NO
Building's Principal	Joe Jude
Building Type	Elementary

Building Construction Information - Worthington City (45138) - Worthington Hills Elementary (64089)

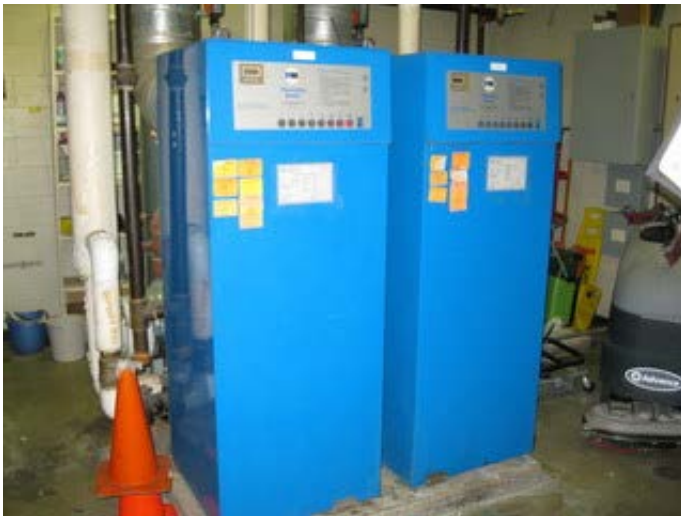
The existing system for the overall facility is a gas fired heating hot water system, installed in 1999, and is in fair condition. The heating water system in the overall facility is a 2-pipe system, with a capacity for simultaneous heating and cooling operation, which is compliant with the OSDM requirements for basic system type. The 2 gas fired boilers, manufactured by PK, were installed in 1999 and are in fair condition. Heating water is distributed to terminal units consisting of VAV boxes. The terminal equipment was installed in 1999 and is in good condition. The system does comply with the 15 CFM per person fresh air requirements of the Ohio Building Code mechanical code and Ohio School Design Manual. The DDC type system temperature controls were installed in 1999 and are in fair condition. The system does feature individual temperature controls in all spaces required by the OSDM. The overall system does not feature any central energy recovery systems. The facility is not equipped with louvered interior doors to facilitate Corridor utilization as return air plenums. The existing system is ducted, though lack of need for HVAC system replacement at this time negates any need to evaluate the potential integration of existing ductwork into a new system. The overall heating system is evaluated as being in safe and efficient working order, and long term life expectancy of the existing system is not anticipated. The structure is not equipped with central air conditioning. The site does not contain underground fuel tanks.

Gas Fired Boilers

Existing conditions require no renovation or replacement at this time.

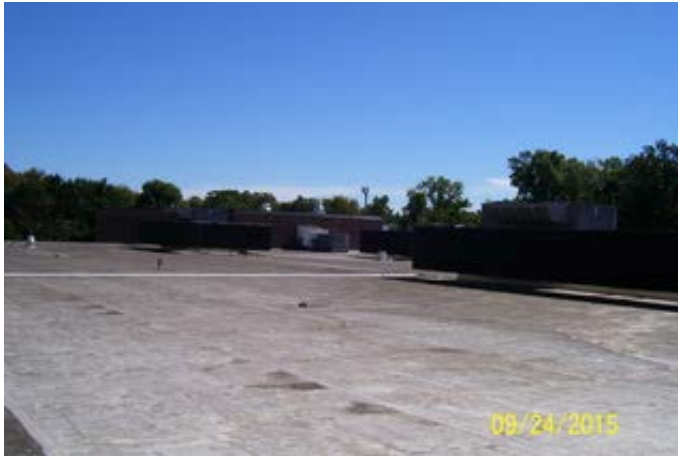
The roof over the overall facility is a mechanically attached PVC system that was installed in 2010 and is in good condition. There are no District reports of current leaking. No signs of past leaking were observed during the physical assessment. Access to the roof was gained by an access door that is in good condition. Access to all roof levels is provided. The access ladder to the gymnasium roof was in poor condition and should be replaced. Fall safety protection cages are not provided and are not required. There were no observations of standing water on the roof. Metal cap flashings are in good condition. Roof storm drainage is addressed through a system of roof drains, which are properly located, and in good condition. No problems requiring attention were encountered with any roof penetrations. There are not any covered walkways attached to this structure. A 2011 district roofing report summarizes the current conditions as follows: "The roof system on Worthington Hills Elementary consists of a mechanically attached PVC roof system. The current roofing is approximately 1 years old and in good serviceable condition. The roof area is typical of a school facility and rooftop equipment and projections are moderate. The roof area drains to internal roof drains. The roof system is new and with annual inspections and preventative maintenance this roof should meet its expected service life of 2025."

Typical Roof

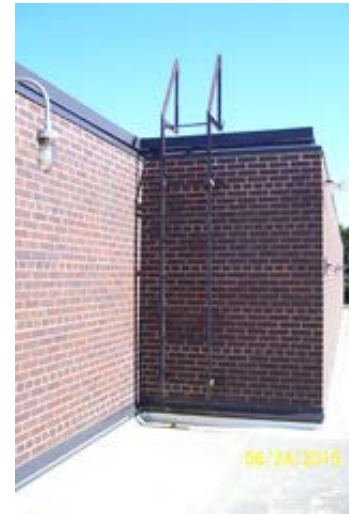
Access Ladder to be Replaced

Replace one roof ladder.

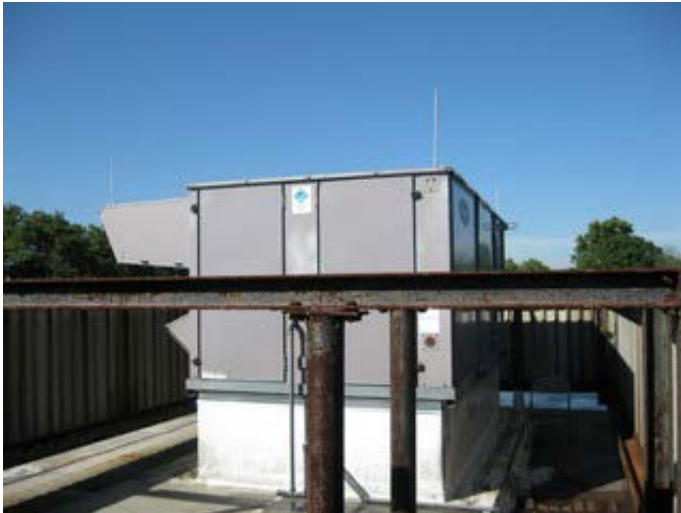
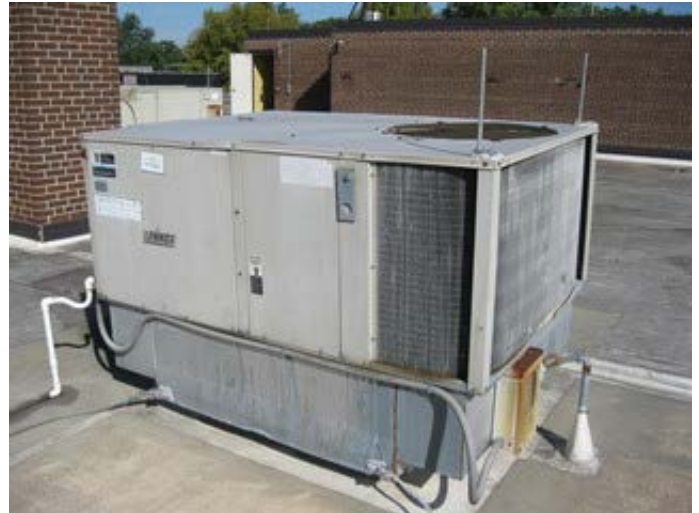
Description: The overall facility is equipped with an air cooled forced air type central air conditioning system, which is in poor condition. Rooftop units deliver conditioned air to VAV boxes, which condition the spaces. The rooftop units are in poor condition. The ventilation system in the overall facility consists of rooftop units, installed in 1999 and in poor condition, providing fresh air to Classrooms, and rooftop units, installed in 1999 and in poor condition, providing fresh air to other miscellaneous spaces such as Gymnasiums, Student Dining, and Media Center. Relief air venting is provided by ceiling plenums. The ventilation system does meet the Ohio Building Code 15 CFM per occupant fresh air requirement. The overall system is not compliant with Ohio Building Code and Ohio School Design Manual requirements. Dust collection systems are not required in this facility. The Art program is equipped with a kiln, and existing kiln ventilation is inadequate. General building exhaust systems for Restrooms are adequately placed, and in fair condition.

Rating: 3 Needs Replacement

Rooftop Units

Recommendations: Replace the existing rooftop units due to existing condition. Provide a new kiln exhaust system.

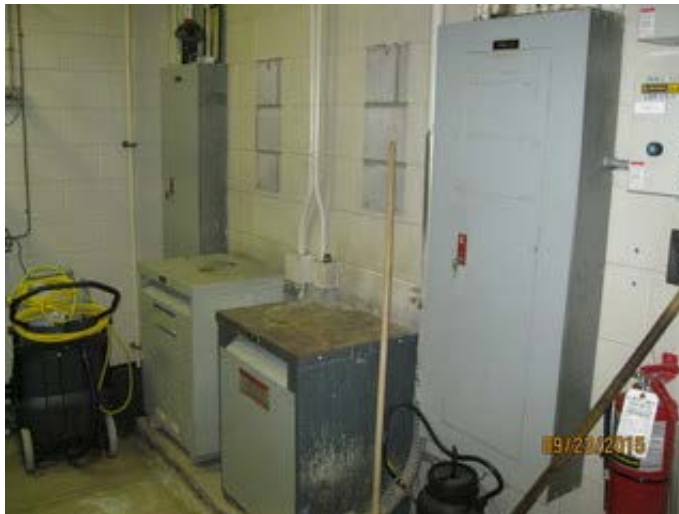
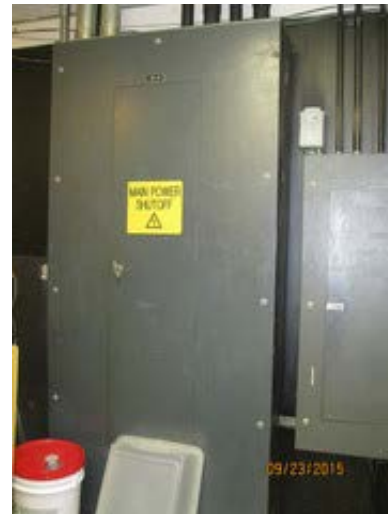
Description: The electrical system provided to the overall facility is a 480/277-volt, 3-phase, 4-wire, 800-amp system installed in 1970, and is in poor condition. Power is provided to the school by a single utility owned, pad-mounted transformer located in exterior fenced-in area, and in good condition. The panel system, installed in 1990 and 1998, is in poor condition, and cannot be expanded to add additional capacity. The Classrooms are not equipped with adequate electrical outlets. The typical Classroom contains 14 general purpose outlets, 2 dedicated outlets for each Classroom computer, and 2 dedicated outlets for each Classroom television. Some Classrooms are equipped with as many as 12 general purpose outlets, while others are equipped with as few as 12 general purpose outlets. There are not any spaces that have no electrical outlets. The Corridors are not equipped with adequate electrical outlets for servicing. Adequate GFI protected exterior outlets are not provided around the perimeter of the building. The facility is not equipped with an emergency generator. Adequate lightning protection safeguards are provided. The existing facility is not equipped with a permanent Stage. The overall electrical system does not meet Ohio School Design Manual requirements in supporting the current needs of the school, and will be inadequate to meet the facility's future needs.

Rating: 3 Needs Replacement

Electrical Distribution Equipment

Recommendations: The entire electrical system requires replacement to meet Ohio School Design Manual guidelines for Classroom capacity, due to condition and age, lack of OSDM-required features, to accommodate the addition of an air conditioning system, and to facilitate the scope of work outlined in Item U.

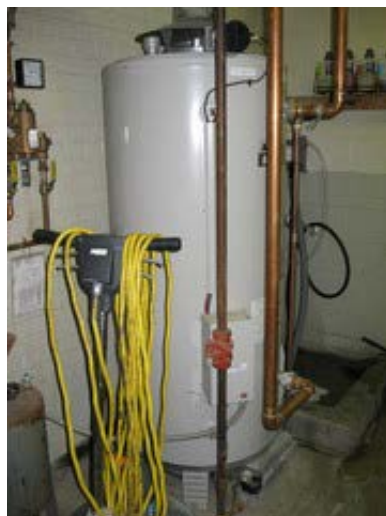
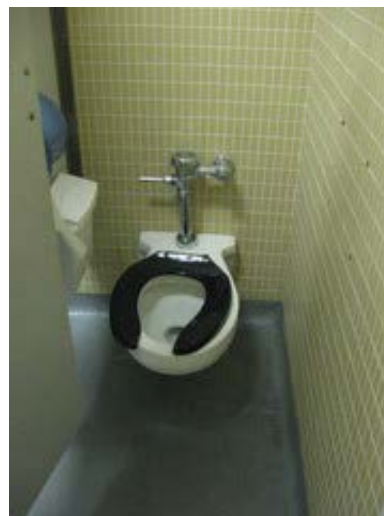
The service entrance is not equipped with a reduced pressure backflow preventer. A water treatment system is not provided. The domestic water supply piping in the overall facility is copper, was installed in 1970, and is in fair condition. The waste piping in the overall facility is cast iron and PVC, was installed in 1970, and is in fair condition. The facility is equipped with a 100-gallon gas water heater in good condition. The school contains 2 Large Group Restrooms for boys, 2 Large Group Restrooms for girls, 2 Restrooms associated with specialty Classrooms, and 8 Restrooms for staff. Boys' Large Group Restrooms contain 0 ADA and 6 non-ADA wall mounted flush valve toilets, 5 ADA and 6 non-ADA wall mounted flush valve urinals, as well as 6 ADA and 4 non-ADA wall mounted lavatories. Girls' Large Group Restrooms contain 0 ADA and 12 non-ADA wall mounted flush valve toilets, as well as 6 ADA and 4 non-ADA wall mounted lavatories. Staff Restrooms contain 1 ADA and 6 non-ADA wall mounted flush valve toilets, 0 ADA and 2 non-ADA wall mounted urinals, as well as 1 ADA and 7 non-ADA wall mounted lavatories. Condition of fixtures is good. The facility is equipped with 0 ADA and 0 non-ADA drinking fountains, as well as 3 ADA and 4 non-ADA electric water coolers, in good condition. The 10 Elementary Classrooms are equipped with 0 ADA and 10 non-ADA sink mounted type drinking fountains, in fair condition. The Special Education Classroom is not equipped with the required Restroom facilities, and fixtures are in fair condition. The Kitchen is equipped with the required Restroom, and fixtures are in fair condition. The Heath Clinic is equipped with the required Restroom, and fixtures are in fair condition. The Kindergarten Classrooms are equipped with Restroom facilities, and fixtures are in poor condition. Kitchen fixtures consist of 1 hand sink, 1 double-compartment sink, and 1 triple-compartment sink, which are in good condition. The Kitchen is equipped with a satisfactory grease interceptor. The Kitchen is provided the required 140 degree hot water supply via a mixing valve, which is in good condition. The school does not meet the OBC requirements for fixtures. Relative to LEED requirements, the school is not equipped with low flow type fixtures. Per OBC and OSDM requirements this facility should be equipped with 31 toilets, 13 urinals, 38 lavatories, 22 Classroom sink mounted drinking fountains, and 19 electric water coolers. Observations revealed that the school is currently equipped with 25 toilets, 13 urinals, 23 lavatories, 10 Classroom sink mounted drinking fountains, and 7 electric water coolers. ADA requirements are not met for fixtures and drinking fountains. Custodial Closets are properly located and are adequately provided with required service sinks or floor drain sinks, which are in fair condition. Adequate exterior wall hydrants are provided.

3 Needs Replacement

Domestic Water Heater

To facilitate the school's compliance with OBC and OSFC fixture requirements, due to age, condition, LEED, provide 6 new toilets / 15 new lavatories / 0 new urinals, 15 new electric water coolers, 12 new lavatory mounted type drinking fountains. Provide reduced pressure backflow preventer.

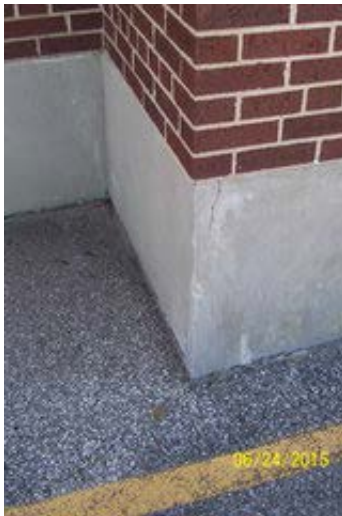
Description: The Original Building and 1999 Addition are equipped with concrete masonry unit foundation walls on concrete footings, which displayed no locations of significant differential settlement, cracking, or leaking, and are in fair condition. The 1988 Addition is equipped with poured concrete foundation walls on concrete footings, which displayed no locations of significant differential settlement, cracking, or leaking, and are in fair condition. Minor issues related to foundation cracking or spalling were encountered around the 1988 addition. The District reports that there has been no past leaking. No grading or site drainage deficiencies were noted around the perimeter of the structure that are contributing to or could contribute to foundation or wall structural deterioration.

Rating: 2 Needs Repair

Minor Cracking to be Repaired

Recommendations: Repair areas of cracking and spalling through the 1988 Addition.

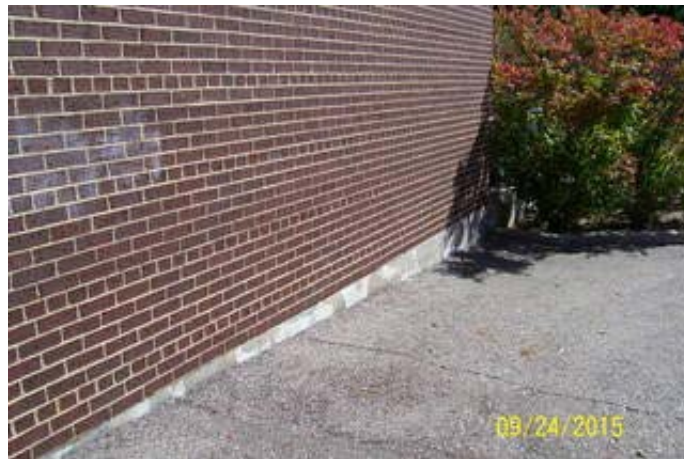
Minor Spalling to be Repaired

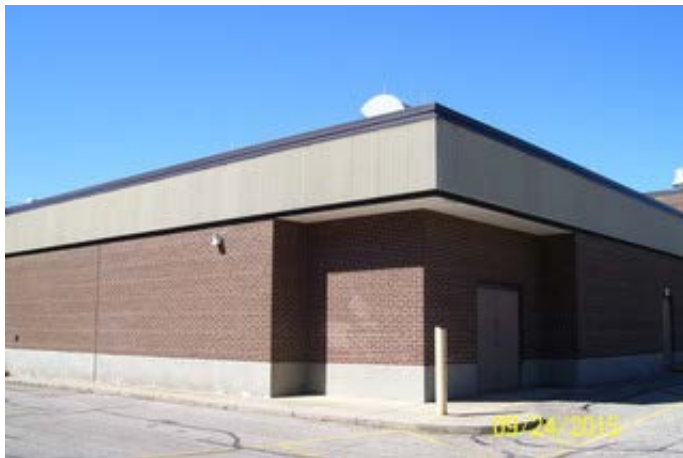
The Original Building, 1988 Addition, and 1999 Addition have a brick veneer on load bearing masonry wall system, which displayed few locations of deterioration, and is in fair condition. In the overall facility, the exterior masonry appears to have appropriately spaced and adequately caulked control joints in fair condition. Control joints are provided at lintel locations, at doors and windows, building corners, and wall offsets and are in fair condition. The school does have sufficient expansion joints, and they are in fair condition. Exterior walls in the Original Building are inadequately insulated. Brick veneer masonry walls are not cavity walls. Exterior walls in the 1988 Addition and 1999 Addition are adequately insulated. Brick veneer masonry walls are cavity walls. In the Original Building, weep holes are not provided. Weep holes in the 1988 and 1999 Additions are provided in sufficient quantity at 24"-48" on center at lintels, below sills, and the base of masonry cavity walls, and are in fair condition. Weep holes are not rope type weeps. Vents are not provided in the Original Building or the 1988 Addition, but are provided in sufficient quantity in the 1999 Addition. The exterior masonry has not been cleaned and sealed in recent years, and shows minor evidence of mortar deterioration in the Original Building. There are also few locations of efflorescence and mold. Architectural exterior accent materials consist of ribbed concrete panels, which are in fair condition and need to be re-jointed. Exterior building fenestration in the Original Building represents 10.5% of the exterior surfaces. Exterior building fenestration in the 1988 Addition represents 1.8% of the exterior surfaces. Exterior building fenestration in the 1999 Addition represents 3.5% of the exterior surfaces. Interior Corridor and demising walls are concrete masonry units and demountable partitions, project full height from floor to bottom of deck, and are in good condition. Interior masonry appears to have adequately spaced and caulked control joints in good condition. Interior soffits are of stud and drywall type construction, and in fair condition. The window sills are brick or stone, and are in fair condition. The exterior lintels are steel, and are in fair condition. The chimney is in fair condition. Exterior soffits are of exterior drywall type construction, and in fair to poor condition. Several locations were observed with cracking of plaster that should be repaired. The school is provided with an uncovered, concrete conventional loading dock to facilitate the receipt of product, supplies, and foodstuffs, ~200 square feet in size. The dock itself is in fair to poor condition, and is equipped with bumper pads in fair condition. Dock repairs are covered in item P Site Condition.

Typical Exterior Materials

Provide tuckpointing in all areas of mortar deterioration as required in the Original Building, and at the joints between the ribbed concrete panels as required. Provide masonry cleaning and sealing as required through the overall facility. Repair and repaint areas of cracking at exterior soffits on the Original Building and 1988 Addition.

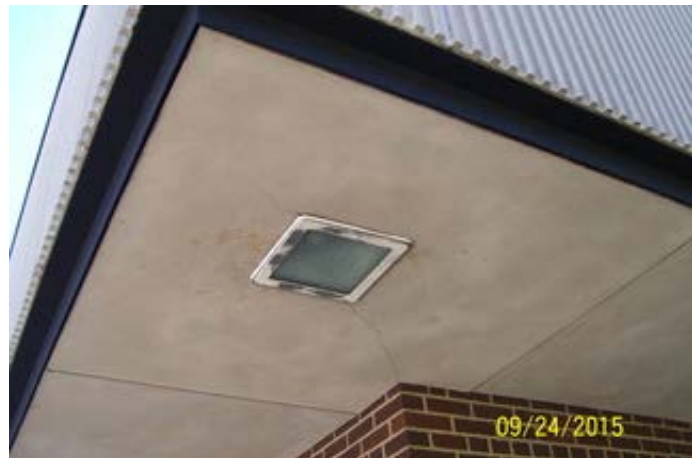
Typical Soffit to be Repaired

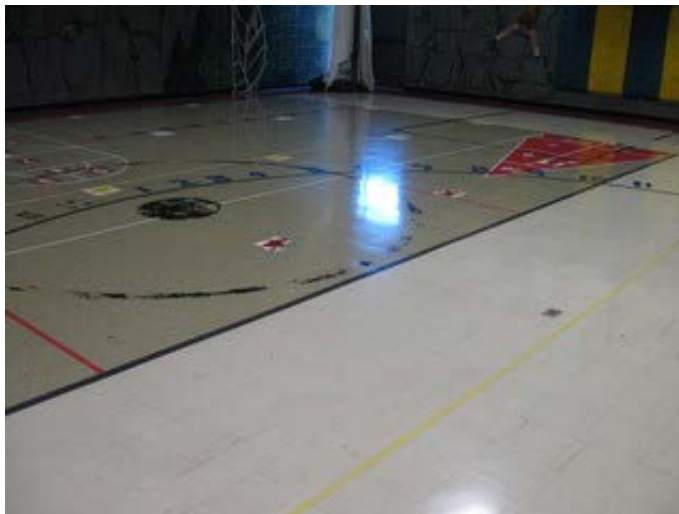
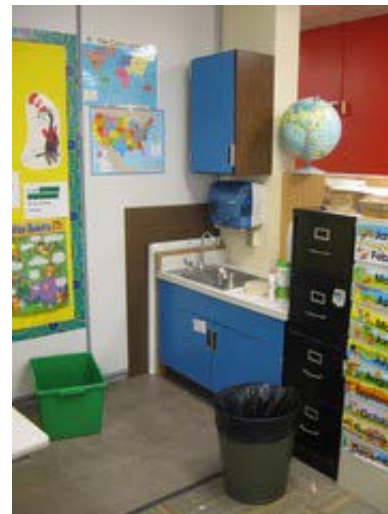
The overall facility features conventionally partitioned Open Space Classrooms with VCT and carpet tile type flooring, 2x4 ACT type ceilings, as well as painted CMU, metal partitions, and brick type wall finishes, and they are in good condition. The overall facility has Corridors with rubber type flooring, 2x4 ACT type ceilings, as well as painted metal partition type wall finishes, and they are in fair condition. The overall facility has Restrooms with concrete type flooring, 2x4 ACT type ceilings, as well as painted CMU type wall finishes, and they are in good condition. Toilet partitions are plastic, and are in fair condition. Classroom casework in the overall facility is wood type construction with plastic laminate tops, is adequately provided, and in fair condition. The typical Classroom contains 5'-4" lineal feet of casework, and Classroom casework provided ranges from 5 to 6 feet. Classrooms are provided adequate chalkboards, markerboards, tackboards which are in good condition. The Classroom storage cubbies, located in the Classrooms, are adequately provided, and in good condition. The Art program is equipped with a kiln. The facility is equipped with wood non-louvered interior doors that are flush mounted with proper ADA hardware and clearances, and in good condition. The Gymnasium space have VCT type flooring, open type ceilings, as well as painted CMU type wall finishes, and they are in fair condition. Gymnasium basketball backboards are fixed type, and are in fair condition. The Media Center has carpet tile type flooring, 2x4 ACT type ceilings, as well as metal partition type wall finishes, and they are in fair condition. Student Dining, located in the 1999 Addition, has VCT type flooring, 2x4 ACT type ceilings, as well as Painted CMU and painted CMU type wall finishes, and they are in good condition. No stage is provided. Existing Gymnasium, Student Dining, Media Center, and Music spaces are inadequately provided with appropriate sound attenuation acoustical surface treatments. The existing Kitchen is full service, is undersized based on current enrollment, and the existing Kitchen equipment, installed in 1977-2000, is in good/fair condition.

3 Needs Replacement

Gym Floor

Classroom Casework

Provide replacement of all finishes and casework due to condition and age. Provide cubbies in lieu of inadequate student storage space, currently addressed with exposed hooks and a shelf. Provide for the replacement of kitchen equipment due to age.

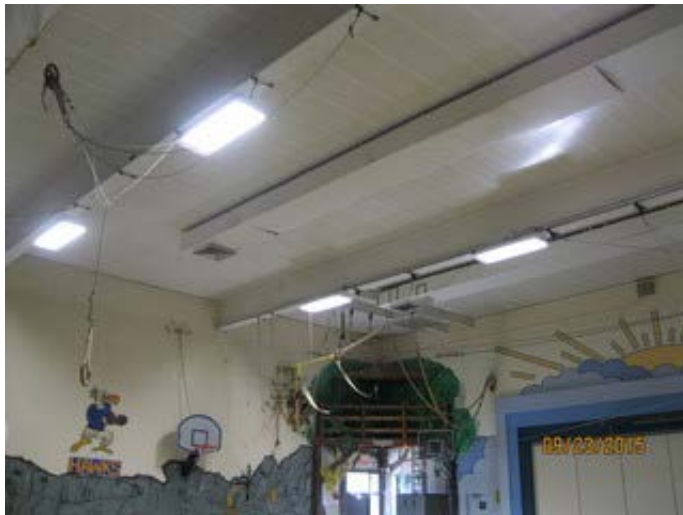
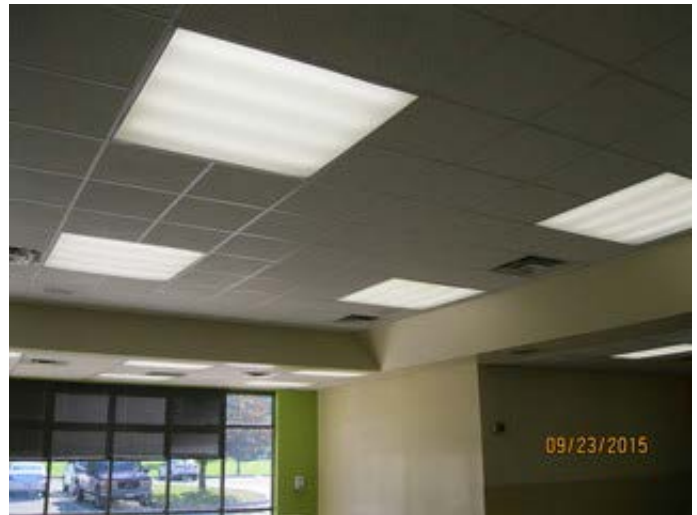
The typical Classrooms in the overall facility are equipped with T-8 lay-in fluorescent fixtures with dual level switching. Classroom fixtures are in good condition, providing an average illumination of 60 FC, thus complying with the 50 FC recommended by the OSDM. The typical Corridors in the overall facility are equipped with T-8 lay-in 2x4 fluorescent fixtures with single level switching. Corridor fixtures are in good condition, providing an average illumination of 31 FC, thus complying with the 20 FC recommended by the OSDM. The Primary Gymnasium spaces are equipped with pendant T-8 2x4 fluorescent fixture type lighting, in good condition, providing an average illumination of 40 FC, which is less than the 50 ES FC recommended by the OSDM. The Media Center is equipped with lay-in 2x4 T-8 fluorescent fixture type lighting in good condition, providing an average illumination of 47 FC, which is less than the 50 FC recommended by the OSDM. The Student Dining spaces are equipped with 4x4 lay-in and 2x4 lay-in T-8 fluorescent fixture type lighting with multi level switching. Student Dining fixtures are in good condition, providing an average illumination of 43 FC, which is less than the 50 FC recommended by the OSDM. The Kitchen spaces are equipped with lay-in 2x4 T-8 fluorescent fixture type lighting with multi level switching. Kitchen fixtures are in good condition, providing an average illumination of 37 FC, which is less than the 75-80 FC recommended by the OSDM. The Service Areas in the overall facility are equipped with 1x4 surface mount T-8 fluorescent fixture type lighting in fair condition. The typical Administrative spaces in the overall facility are equipped with lay-in 2x4 T-8 fluorescent fixture type lighting in good condition, providing adequate illumination based on OSDM requirements. The overall lighting systems of the facility are not compliant with Ohio School Design Manual requirements due to inadequate lighting levels and lack of multi-level switching.

3 Needs Replacement

Gym Lighting

Dining Room Lighting

Provide complete replacement of lighting system due to lighting levels, lack of multilevel switching, and installation of systems outlined in Item U.

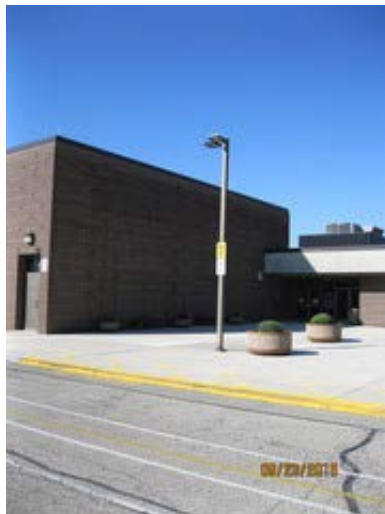
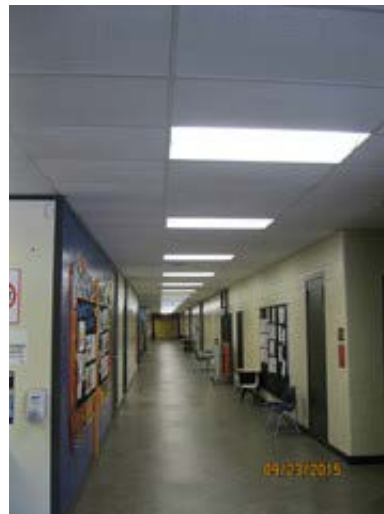
Description: The overall facility contains a private labeled motion detector, intrusion, and door contact type security system in good condition. Motion detectors are inadequately provided in main entries, central gathering areas, offices, main Corridors, and spaces where 6 or more computers are located. Exterior doors are equipped with door contacts. An automatic visitor control system is not provided. Compliant color CCTV cameras are not provided at main entry areas, parking lots, central gathering areas, and main Corridors. CCTV is not monitored in Administrative Area. A compliant computer controlled access control system integrating alarms and video signals, with appropriate UPS backup, is not provided. The system is equipped with card readers. The security system is not adequately provided throughout, and the system is not compliant with Ohio School Design Manual guidelines. Pedestrian walkways are illuminated with pole fixtures in good condition. Parking and bus pick-up / drop off areas are illuminated by pole mounted LED fixtures in good condition. The exterior site lighting system provides adequate illumination.

Rating: 3 Needs Replacement

Site Lighting/LED Pole Lights

Security System Detector and Corridor Lighting

Recommendations: Provide new security system to meet Ohio School Design Manual guidelines.

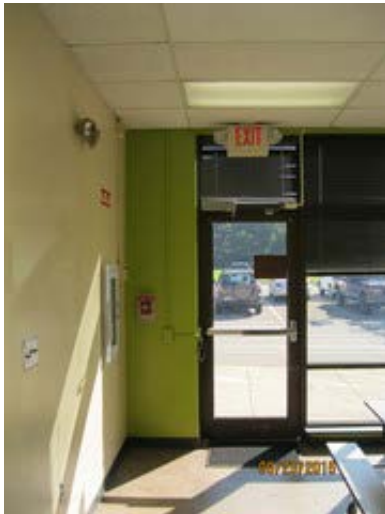
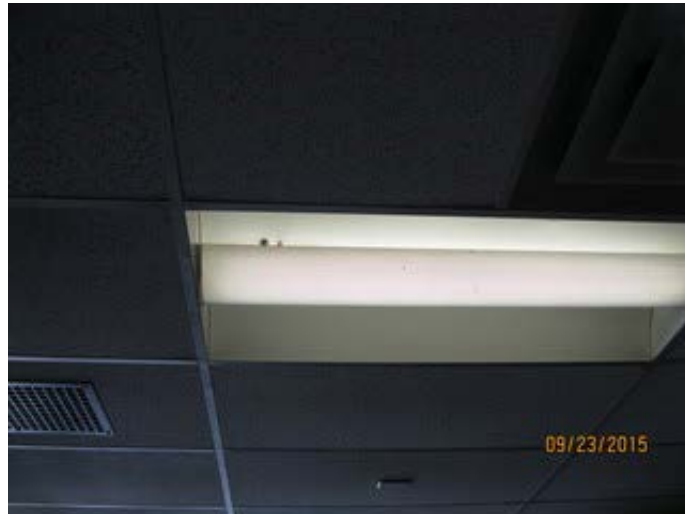
Description: The overall facility is equipped with an emergency egress lighting system consisting of non-compliant, plastic construction, as well as OSDM compliant red lettered, LED illuminated exit signs, and the system is in good condition. The facility is equipped with emergency egress floodlighting, and is equipped with recessed fluorescent lighting used as emergency egress lighting, and the system is in good condition. The system is provided with appropriate battery backup. The system is adequately provided throughout, and does not meet Ohio School Design Manual and Ohio Building Code requirements.

Rating: 3 Needs Replacement

Exit Sign/Remote Head/FA Pull Station

Recessed Lighting With Battery Pack

Recommendations: Provide complete replacement of emergency / egress lighting system to meet Ohio School Design Manual and Ohio Building Code guidelines and in conjunction with work in Item U.

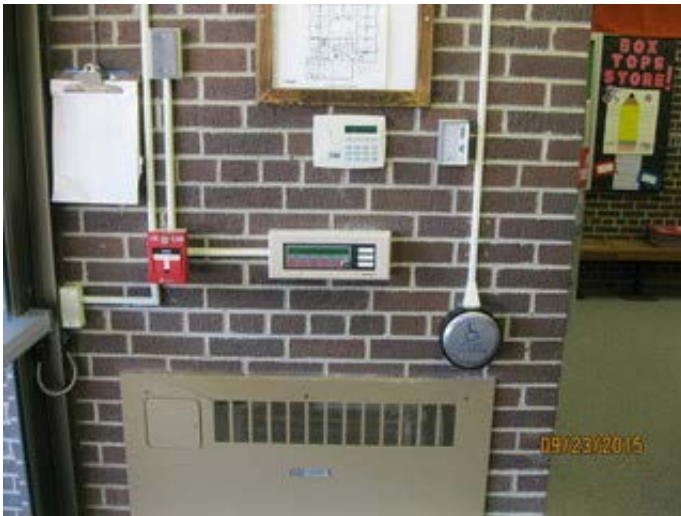
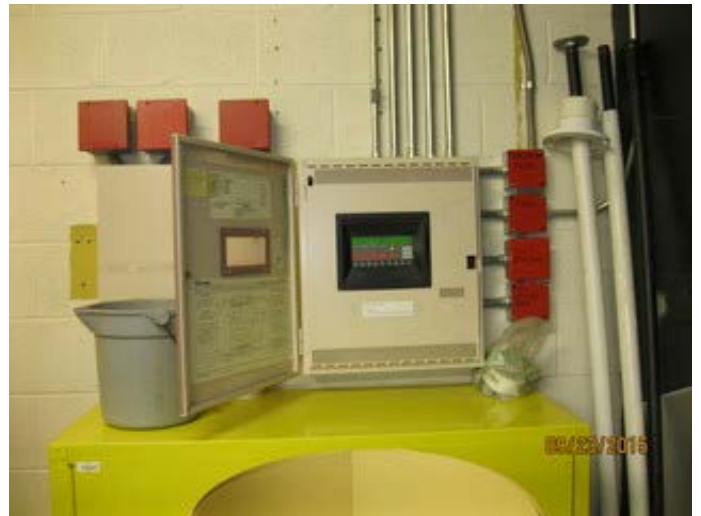
Description: The overall facility is equipped with a Simplex type fire alarm system in good condition, consisting of manual pull stations, bells, and horn and strobe indicating devices. The system is automatic and is monitored by a third party. The system is equipped with sufficient audible horns and strobe indicating devices. The system is not equipped with sufficient smoke detectors or heat sensors. The system is not equipped with any flow switches or tamper switches. The system thus will not support future fire suppression systems. The system is adequately provided throughout, and does not have additional zone capabilities. The system is not fully compliant with Ohio Building Code, NFPA, and Ohio School Design Manual requirements.

Rating: 3 Needs Replacement

FA Remote Annunciator/Security System Panel

Fire Alarm Control Panel

Recommendations: Provide new fire alarm system to meet OBC, NFPA, and Ohio School Design Manual guidelines.

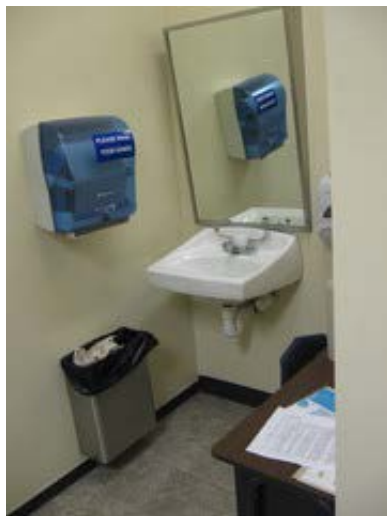
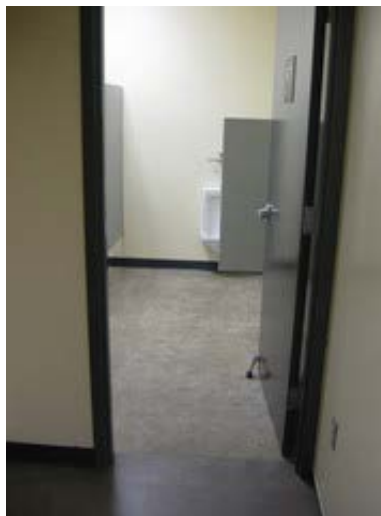
Rating: 3 Needs Replacement

Single Occupant Restroom

Typical Restroom Door

Recommendations: Provide ADA-compliant signage, electric water coolers, toilets, sinks, toilet partitions, toilet accessories, re-mounting of mirrors, doors and frames, door hardware in the overall facility to facilitate the school's meeting of ADA requirements. Plumbing fixtures corrected in Item E.

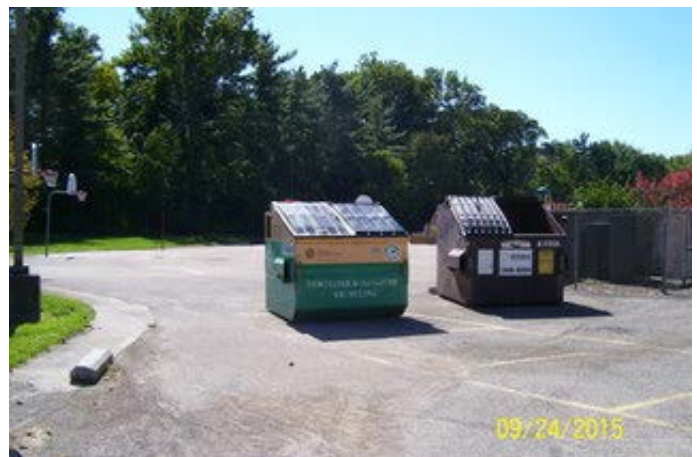
2 Needs Repair

Location to be Fenced

Provide fencing adjacent to the loading dock to provide a vehicular barrier between the playground and parking lot. Repair the exterior steps associated with the loading dock, and provide heavy duty concrete pads for the dumpsters.

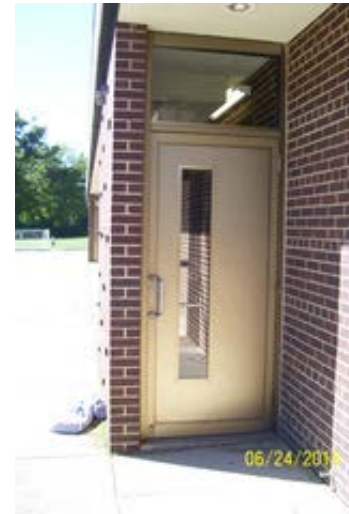
Rating: 2 Needs Repair

Damaged Door to be Replaced

Recommendations: Replace five exterior doors due to poor condition.

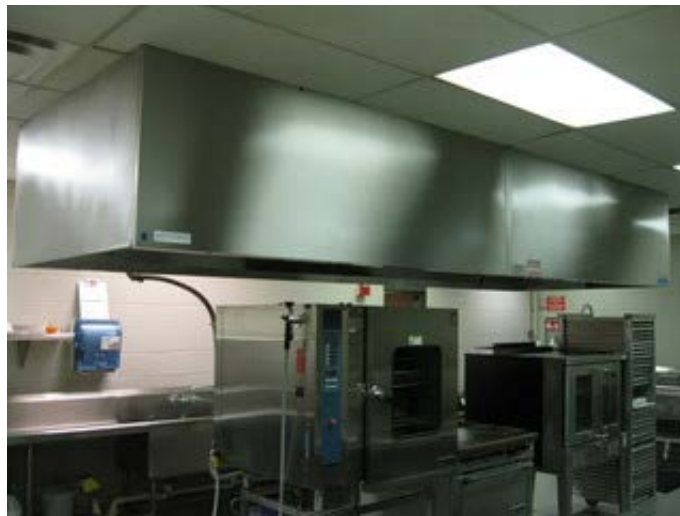
Description: The overall facility is not equipped with an automated fire suppression system. The Kitchen hood is in good condition, and is equipped with the required UL 300 compliant wet chemical fire suppression system. The cooking equipment is interlocked to shut down in the event of discharge of the fire suppression system. Fire extinguishers are provided in sufficient quantity. Existing fire extinguishers are adequately spaced. The facility is not equipped with an emergency generator. The existing water supply is provided by a tie-in to the city system, and is insufficient to meet the future fire suppression needs of the school. Rooms with a capacity greater than 50 occupants are equipped with adequate egress.

Rating: 3 Needs Replacement

Kitchen Hood

Recommendations: Provide new automated fire suppression system to meet Ohio School Design Manual guidelines. Provide increased water service of a capacity sufficient to support the fire suppression system, funding included in fire suppression funding. Provide new emergency generator, with funding provided via complete replacement of electrical system in Item D.

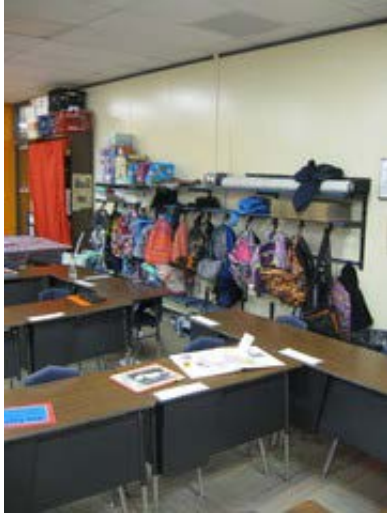
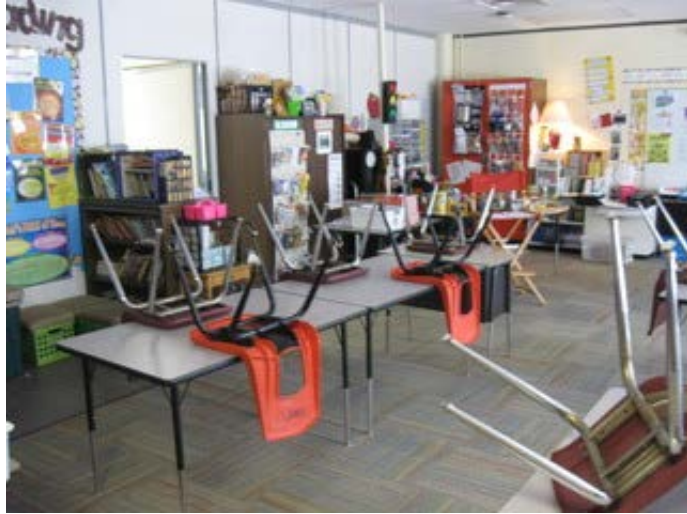
Description: The typical Classroom furniture is of consistent design, and in generally fair condition, consisting of student desks & chairs, teacher desks & chairs, desk height file cabinets, reading tables, computer workstations, bookcases, wastebaskets, other. The facility's furniture and loose equipment were evaluated in item 6.17 in the CEFPI section of this report, and on a scale of 1 to 10 the overall facility received a rating of 6 due to observed conditions, and due to the fact that it lacks some of the Design Manual required elements.

Rating: 3 Needs Replacement

classroom

Recommendations: Provide for replacement of outdated or inadequate furnishings.

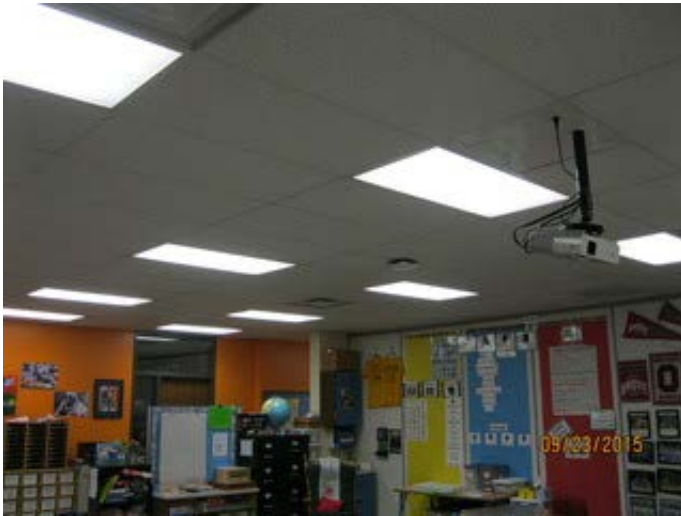
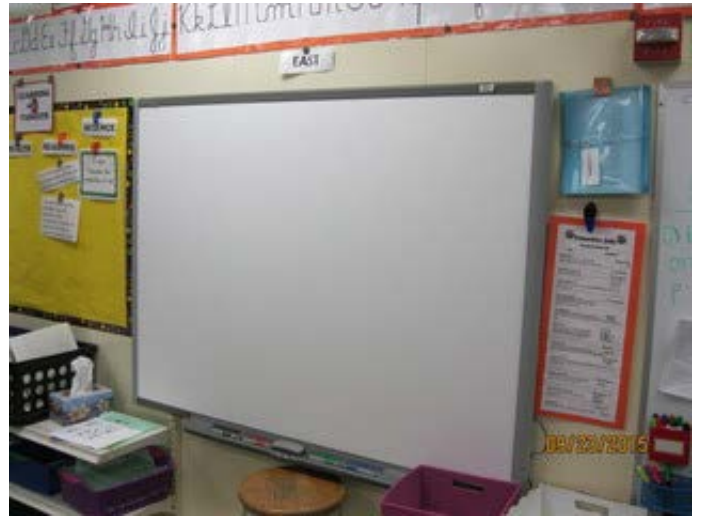
Rating: 3 Needs Replacement

Classroom Projector

Classroom Smartboard

Recommendations: Provide complete replacement of technology systems to meet Ohio School Design Manual requirements, and to sustain the capacity to keep pace with technological development.
