Building Information - Worthington City (45138) - Bluffsview Elementary School

Program Type	Assessment Only
Setting	Suburban
Assessment Name	Bluffsview Elementary School
Assessment Date (on-site; non-EEA)	2015-09-23
Kitchen Type	Full Kitchen
Cost Set:	2015
Building Name	Bluffsview Elementary School
Building IRN	112128
Building Address	7111 Linworth Road
Building City	Columbus
Building Zipcode	43235
Building Phone	614-450-5400
Acreage	12.12
Current Grades:	K-6
Teaching Stations	19
Number of Floors	1
Student Capacity	612
Current Enrollment	459
Enrollment Date	2015-09-14
Enrollment Date is the date in which the current enrollment was taken.	
Number of Classrooms	28
Historical Register	NO
Building's Principal	Cindy Fox
Building Type	Elementary

Bluffsvie Elementary School, which is not on the National Register of Historic Buildings, and originally constructed in 1991, is a single story, 60,089 square foot brick school building located in a suburban residential setting. The existing facility features a conventionally partitioned design, and does not utilize modular buildings. The structure of the overall facility contains brick and CMU type exterior wall construction, with CMU and meta

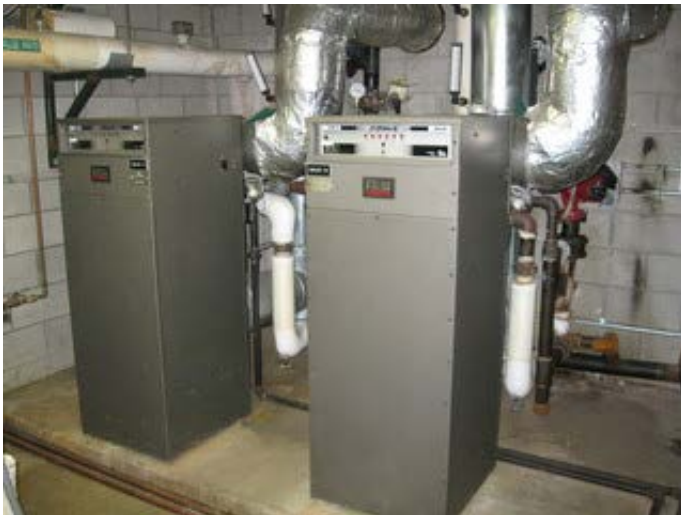
Gas Fired Boilers

Description: The existing system for the overall facility is a gas fired heating hot water system, installed in 1991, and is in good condition. The heating and chilled water system in the overall facility is a 4-pipe system, with a capacity for simultaneous heating and cooling operation, which is compliant with the OSDM requirements for basic system type. The 2 gas fired boilers, manufactured by RBL, were installed in 1991 and are in good condition. Heating water is distributed to terminal units consisting of cabinet heaters, unit heaters, and air handlers. The terminal equipment was installed in 1991 and is in fair condition. The system does comply with the 15 CFM per person fresh air requirements of the Ohio Building Code mechanical code and Ohio School Design Manual. The DDC type system temperature controls were installed in 1999 and are in fair condition. The system does feature individual temperature controls in all spaces required by the OSDM. The overall system does not feature any central energy recovery systems. The facility is not equipped with louvered interior doors to facilitate Corridor utilization as return air plenums. The existing system is ducted, though lack of need for HVAC system replacement at this time negates any need to evaluate the potential integration of existing ductwork into a new system. The overall heating system is evaluated as being in safe and efficient working order, and long term life expectancy of the existing system is anticipated. The structure is equipped with central air conditioning. The site does not contain underground fuel tanks.

Recommendations: Existing conditions require no renovation or replacement at the present time.

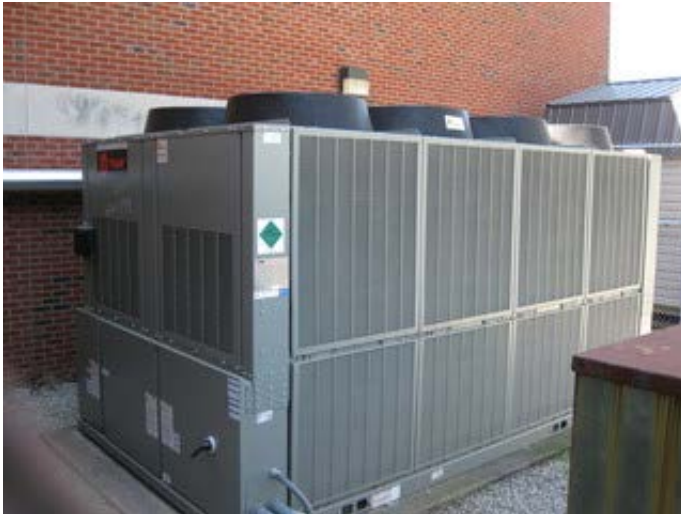
Air Cooled Chiller

Description: The overall facility is equipped with an air cooled chilled water type central air conditioning system, which is in good condition. A chiller provides chilled water and pumps distribute chilled water to terminal units. The equipment is in good condition. The ventilation system in the overall facility consists of air handlers, installed in 1991 and in fair condition, providing fresh air to Classrooms, and air handlers, installed in 1991 and in fair condition, providing fresh air to other miscellaneous spaces such as Gymnasiums, Student Dining, and Media Center. Relief air venting is provided by ceiling plenums. The ventilation system does meet the Ohio Building Code 15 CFM per occupant fresh air requirement. The overall system is not compliant with Ohio Building Code and Ohio School Design Manual requirements. Dust collection systems are not required in this facility. The Art program is equipped with a kiln, and existing kiln ventilation is adequate, and in good condition. General building exhaust systems for Restrooms are adequately placed, and in fair condition.

Recommendations: Existing conditions require no renovation or replacement at the present time.

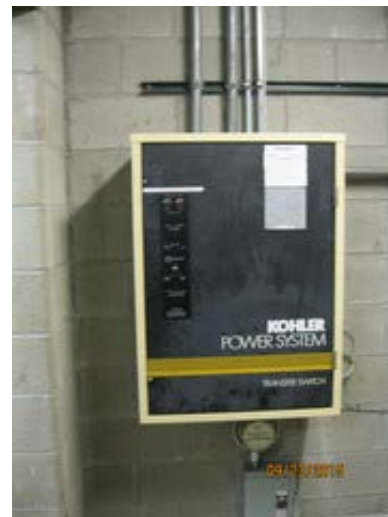
Emergency Generator / ATS

Description: The electrical system provided to the overall facility is a 120/208Y, 3-phase, 4-wire, 2,000-amp system installed in 1991, and is in good condition. Power is provided to the school by a single utility owned, pad-mounted transformer, located in exterior fenced-in area, and in poor condition. The panel system, installed in 1990, is in good condition, and can be expanded to add additional capacity. The Classrooms are not equipped with adequate electrical outlets. The typical Classroom contains 12 general purpose outlets, 2 dedicated outlets for each Classroom computer, and 2 dedicated outlets for each Classroom television. Some Classrooms are equipped with as many as 14 general purpose outlets, while others are equipped with as few as 2 general purpose outlets. There are not any spaces that have no electrical outlets. The Corridors are not equipped with adequate electrical outlets for servicing. Adequate GFI protected exterior outlets are not provided around the perimeter of the building. The facility is equipped with a suitable emergency generator. Adequate lightning protection safeguards are not provided. Stage lighting power system, including dimmers, is inadequately provided, in good condition, and does not meet OSDM requirements. The overall electrical system does not meet Ohio School Design Manual requirements in supporting the current needs of the school, and will be adequate to meet the facility's future needs.

Rating: 2 Needs Repair

Recommendations: Provide additional panels, circuits and outlets, to increase capacity for Classrooms and Corridors. Provide new transformer due to poor condition. Provide control panel, dimmers, and breakers to support the Stage lighting system. Provide adequate lightning protection safeguards.

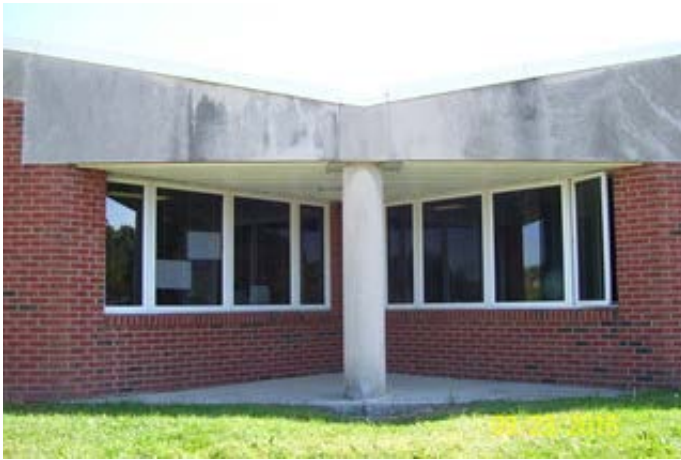
Typical Windows

Description: The overall facility is equipped with thermally broken, aluminum windows with double glazed glazing type window system, which was installed in 1991, and is in fair condition. The window system features operable windows throughout the building, and operable windows are equipped with opening limiters in fair condition and insect screens in fair condition. Window system seals are in fair condition, with minimal air and water infiltration being experienced. Window system hardware is in fair condition. The window system features integral blinds, which are in fair condition. Aluminum frame curtain wall systems are found in the overall facility, in fair condition. This facility does not feature any glass block windows. The exterior doors in the overall facility are equipped with thermally broken aluminum frame sidelights and transoms with tempered glass, in good condition. Exterior door vision panels are tempered glazing. The school does contain 5 aluminum frame double glazed skylights in poor condition. The school does not contain any clerestories. Interior glass is OSDM-compliant. Window security grilles are not provided for ground floor windows. There is not a Greenhouse associated with this school.

Rating: 3 Needs Replacement

Recommendations: Replace skylights in the overall facility.

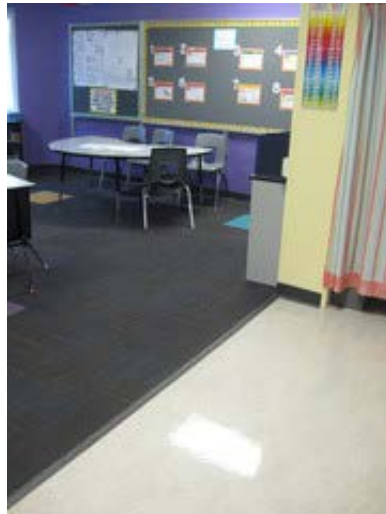
Typical Classroom Finishes

Rating: 2 Needs Repair

Recommendations: Provide for the full replacement of acoustical ceiling tile due to complete lighting system replacement outlined in Item K.
