**Building Information - Worthington City (45138) - Colonial Hills Elem**

Program Type	Assessment Only
Setting	Suburban
Assessment Name	Colonial Hills Elementary
Assessment Date (on-site; non-EEA)	2015-09-22
Kitchen Type	Full Kitchen
Cost Set:	2015
Building Name	Colonial Hills Elem
Building IRN	6999
Building Address	5800 Greenwich
Building City	Worthington
Building Zipcode	43085
Building Phone	(614) 450-5400
Acreage	12.53
Current Grades:	K-6
Teaching Stations	20
Number of Floors	1
Student Capacity	498
Current Enrollment	402
Enrollment Date	2015-09-14
Enrollment Date is the date in which the current enrollment was taken.	
Number of Classrooms	19
Historical Register	<b>NO</b>
Building's Principal	Madeline Partlow
Building Type	Elementary

Colonial Hills Elementary, which is not on the National Register of Historic Buildings, and originally constructed in 1955, is a 1 story, 43,578 square foot brick school building located in a suburban residential setting. The existing facility features a conventionally partitioned design, and does utilize modular buildings. The structure of the overall facility contains brick on CMU type exterior wall construction, with brick, painted CMU, and meta

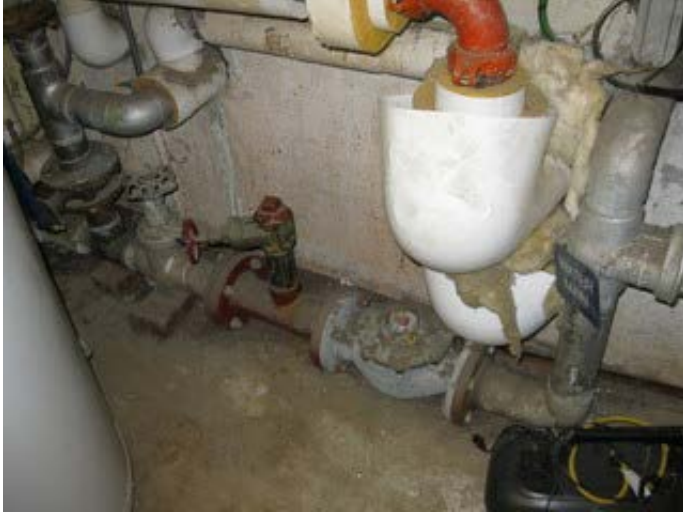
Water Main

- Description:** The domestic water supply system is tied in to the city system, features 3" service and 3" water meter, and is in fair condition. The District was not able to provide water supply flow test data. The existing domestic water service appears to meet the facility's current needs. The facility is not equipped with an automated fire suppression system, and the existing water supply will not provide adequate support for a future system. The domestic water service is not equipped with a water booster pump. The system provides adequate pressure for the future needs of the school.
- Rating:** 1 Satisfactory
- Recommendations:** Provide a new city water supply line of adequate capacity to support the existing needs of the facility, as well as a future automated fire suppression system. Funding provided in Item U.
