Building Information - Worthington City (45138) - Evening Street Elementary

Building Construction Information - Worthington City (45138) - Evening Street Elementary (10868)

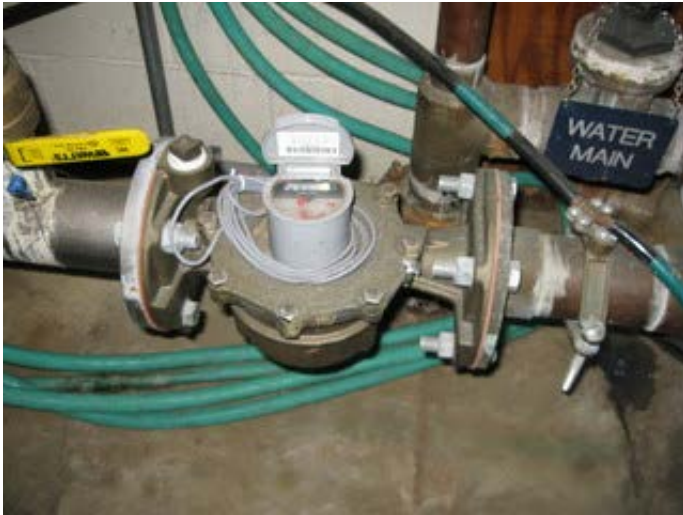
Water Meter

- Description:** The domestic water supply system is tied in to the city system, features 3" service and 2" water meter, and is in fair condition. The District was not able to provide water supply flow test data. The existing domestic water service appears to meet the facility's current needs. The facility is not equipped with an automated fire suppression system, and the existing water supply will not provide adequate support for a future system. The domestic water service is not equipped with a water booster pump. The system provides adequate pressure for the future needs of the school.
- Rating:** 1 Satisfactory
- Recommendations:** Provide a new city water supply line of adequate capacity to support the existing needs of the facility, as well as a future automated fire suppression system. Funding provided in Item U.
