**Building Information - Worthington City (45138) - Kilbourne Middle School**

**85,536** Total Existing Square Footage  
**1939,1939,1965,1995** Building Dates  
**7-8** Grades  
**376** Current Enrollment  
**20** Teaching Stations  
**2.70** Site Acreage

Kilbourne Middle School, which is not on the National Register of Historic Buildings, and originally constructed in 1939, is a two story, 85,536 square foot brick school building is located in a suburban residential setting. The existing facility features a conventionally partitioned design, and does not utilize modular buildings. The structure of the original building contains brick type exterior wall construction, with plaster on CMU type wall construction in the interior. The floor system consists of metal form deck on steel joist. The roof structure is wood joist. The roofing system is a shingle tile, installed in 1939. The structure of the 1991 addition contains brick type exterior wall construction, with CMU type wall construction in the interior. The floor system consists of metal form deck on steel joist. The roof structure is metal form deck on steel joist. The roofing system is ballasted EPDM, installed in 2015. The c

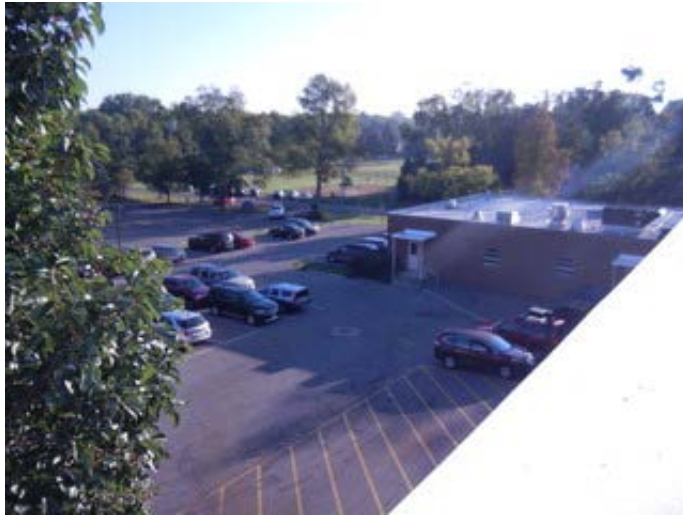
Parking

Add concrete pad for dumpster.

Item	Cost	Unit	Whole Building	Auditorium (1939) 5,476 ft²	Original Construction (1939) 39,222 ft²	Addition 1 (1965) 33,588 ft²	Addition 2 (1995) 7,250 ft²	Sum	Comments
Provide Concrete Dumpster Pad:	\$2,400.00	each			1 Required			\$2,400.00	(for two dumpsters)
Base Sitework Allowance for Unforeseen Circumstances	\$50,000.00	allowance			Required			\$50,000.00	Include this and one of the next two. (Applies for whole building, so only <b>one</b> addition should have this item)
Sitework Allowance for Unforeseen Circumstances for buildings between 0 SF and 100,000 SF	\$1.50	sq.ft. (of entire building addition)		Required	Required	Required	Required	\$128,304.00	Include this one <b>or</b> the next. (Each addition should have this item)
Sum:			\$180,704.00	\$8,214.00	\$111,233.00	\$50,382.00	\$10,875.00

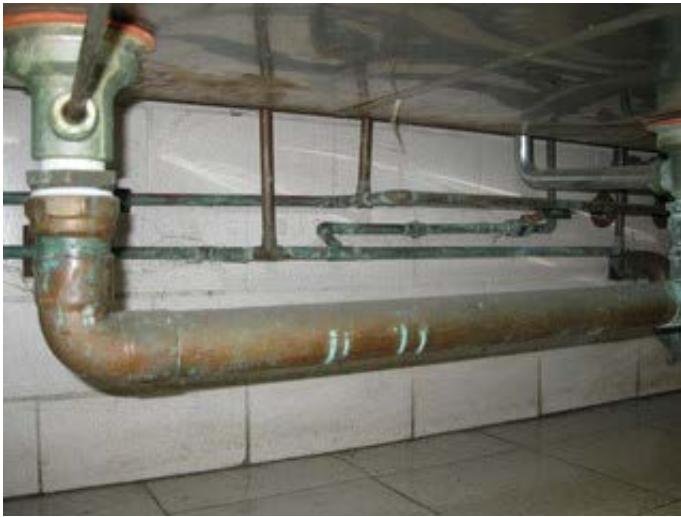
Kitchen Sink Waste

**Recommendations:** Existing conditions require no renovation or replacement at the present time.

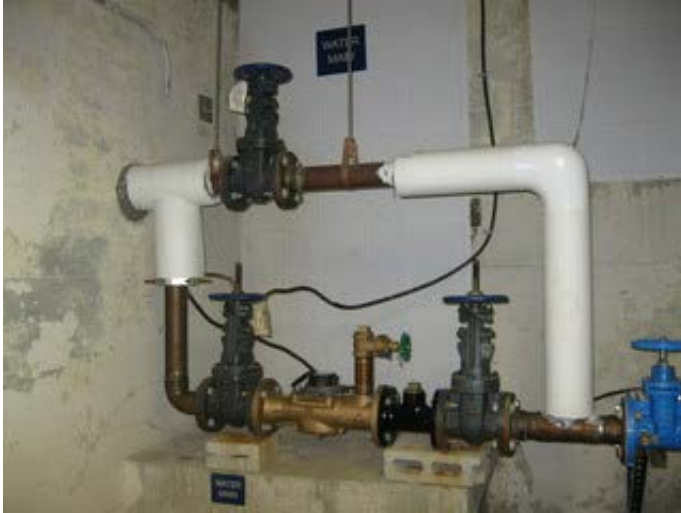
Main Water Service With Meter

**Recommendations:** Existing conditions require no renovation or replacement at the present time.
