Building Information - Worthington City (45138) - Liberty Elementary

Liberty Elementary School, which is not on the National Register of Historic Buildings, and originally constructed in 1981, is a single story, 54,714 square foot brick school building located in a suburban residential setting. The existing facility features a conventionally partitioned Open Concept design, and does not utilize modular buildings. The structure of the overall facility contains brick veneer on load-bearing masonry type exterior wall construction, with brick, painted CMU, metal partition type wall construction in the interior. The floor system consists of concrete slab on grade. The roof structure is metal purlin on rigid frame type construction. The roofing system of the overall facility is standing seam metal, installed in 1981 and ballasted EPDM installed in 2007. The ventilation system of the building is adequate to meet the needs of the users. The Classrooms are undersized in terms of the current standards established by the State of Ohio. Physical Education and Student Dining spaces consist of one Multipurpose space, one Gymnasium and separate Student Dining. The electrical system for the facil

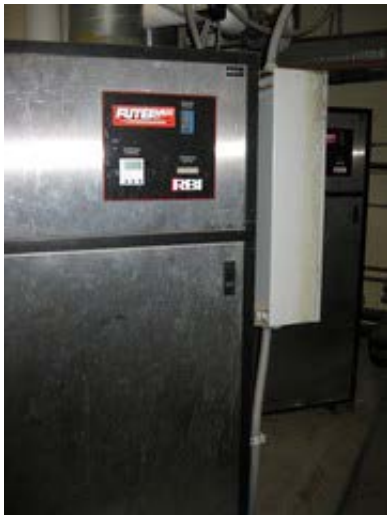
The existing system for the overall facility is a gas fired heating hot water system, installed in 1981, and is in fair condition. The heating and chilled water system in the overall facility is a 4-pipe system, with a capacity for simultaneous heating and cooling operation, which is compliant with the OSDM requirements for basic system type. The 2 gas fired boilers, manufactured by RBI, were installed in 2006 and are in good condition. Heating water is distributed to terminal units consisting of cabinet heaters, unit heaters, and air handlers. The terminal equipment was installed in 1994 and is in poor to fair condition. The system does comply with the 15 CFM per person fresh air requirements of the Ohio Building Code mechanical code and Ohio School Design Manual. The DDC type system temperature controls were installed in 1995 and are in good condition. The system does feature individual temperature controls in all spaces required by the OSDM. The overall system does not feature any central energy recovery systems. The facility is not equipped with louvered interior doors to facilitate Corridor utilization as return air plenums. The existing system is ducted, though lack of need for HVAC system replacement at this time negates any need to evaluate the potential integration of existing ductwork into a new system. The overall heating system is evaluated as being in safe and efficient working order, and long term life expectancy of the existing system is not anticipated. The structure is equipped with central air conditioning. The site does not contain underground fuel tanks.

Gas Fired Boiler

Existing conditions require no renovation or replacement at the present time.

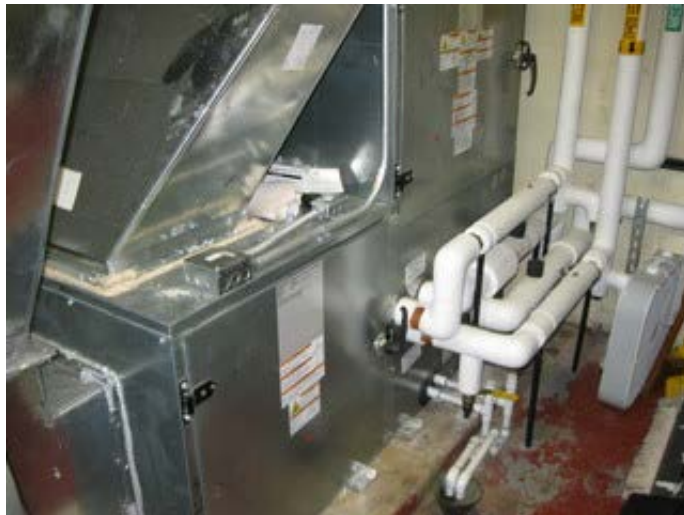
Air Handler

Description: The overall facility is equipped with a chilled water type central air conditioning system, which is in good condition. A chiller produces chilled water and pumps distribute chilled water to terminal units. The equipment is in good condition. The ventilation system in the overall facility consists of air handlers, installed in 1994 and in poor condition, providing fresh air to Classrooms, and air handlers, installed in 1994 and in poor condition, providing fresh air to other miscellaneous spaces such as Gymnasiums, Student Dining, and Media Center. Relief air venting is provided by ceiling plenums. The ventilation system does meet the Ohio Building Code 15 CFM per occupant fresh air requirement. The overall system is not compliant with Ohio Building Code and Ohio School Design Manual requirements. Dust collection systems are not required in this facility. The Art program is equipped with a kiln, and existing kiln ventilation is inadequate. General building exhaust systems for Restrooms are adequately placed, and in fair condition.

Rating: 2 Needs Repair

Recommendations: Replace the existing roof mounted air handlers due to existing condition. Replace the existing kiln exhaust system with new.

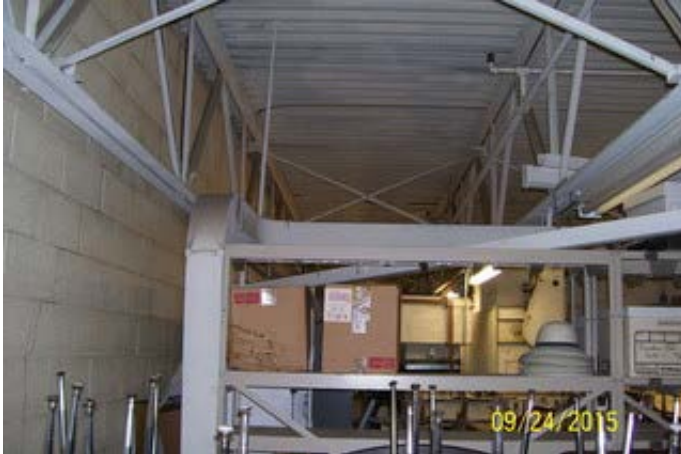
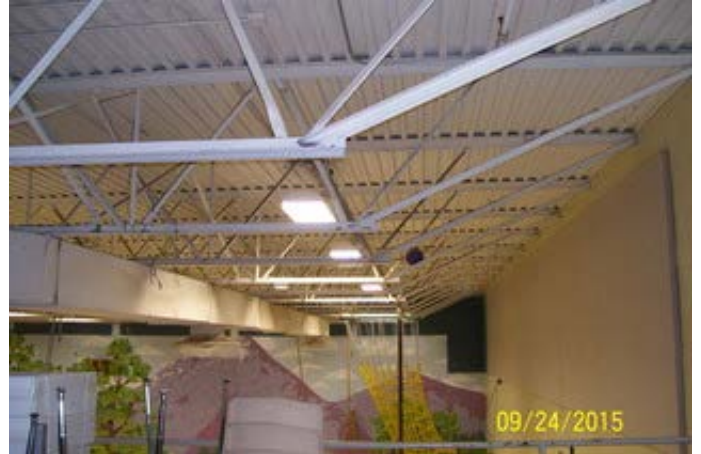
Typical Roof Structure

Recommendations: Existing conditions require no renovation or replacement at the present time.

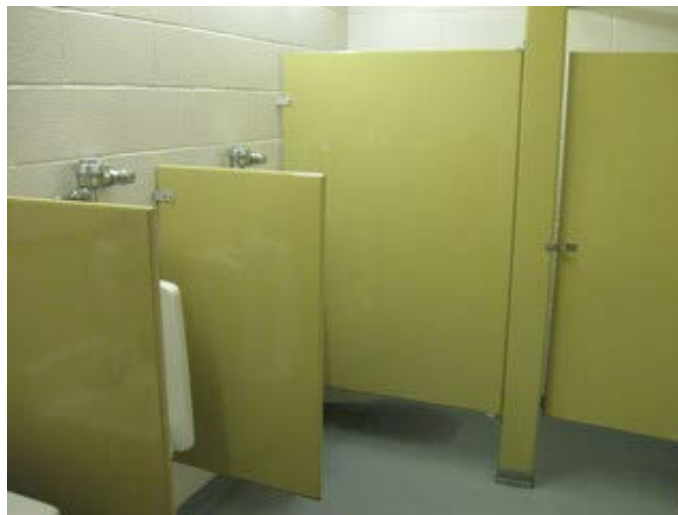
restroom

Item	Cost	Unit	Whole Building	Original Construction (1981)	Sum	Comments
Handicapped Hardware:	\$350.00	set		54,714 ft ² 13 Required	\$4,550.00	(includes installation / hardware only)
Signage:	\$0.20	sq.ft. (of entire building addition)		Required	\$10,942.80	(per building area)
Lifts:	\$15,000.00	unit		1 Required	\$15,000.00	(complete)
Electric Water Coolers:	\$1,800.00	unit		8 Required	\$14,400.00	(replacement double ADA)
Electric Water Coolers:	\$3,000.00	unit		1 Required	\$3,000.00	(new double ADA)
Toilet/Urinals/Sinks:	\$3,800.00	unit		18 Required	\$68,400.00	(new ADA)
Toilet/Urinals/Sinks:	\$1,500.00	unit		8 Required	\$12,000.00	(replacement ADA)
Toilet Partitions:	\$1,000.00	stall		8 Required	\$8,000.00	(ADA - grab bars, accessories included)
Remount Restroom Mirrors to Handicapped Height:	\$285.00	per restroom		8 Required	\$2,280.00	
Provide Toilet Accessories:	\$1,000.00	per restroom		8 Required	\$8,000.00

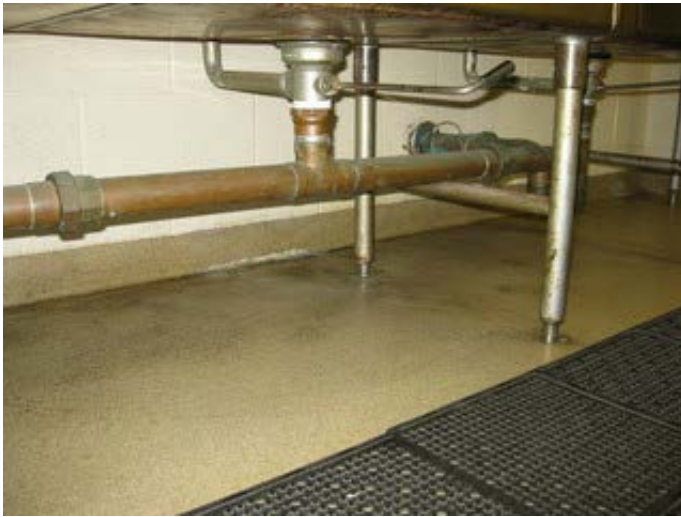
Kitchen Sink Waste

Recommendations: Existing conditions require no renovation or replacement at the present time.

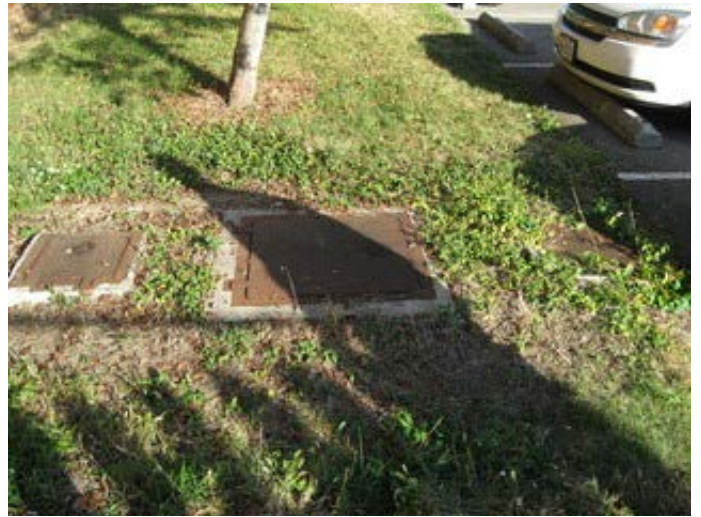
Grease Interceptor

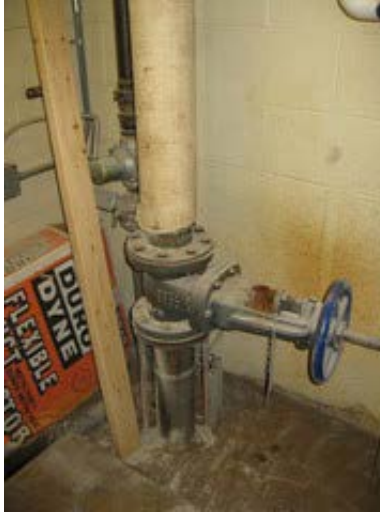
- Description:** The domestic water supply system is tied in to the city system, features 3" service, and is in good condition. The District was not able to provide water supply flow test data. The existing domestic water service appears to meet the facility's current needs. The facility is not equipped with an automated fire suppression system, and the existing water supply will not provide adequate support for a future system. The domestic water service is not equipped with a water booster pump. The system provides adequate pressure for the future needs of the school.
- Rating:** 1 Satisfactory
- Recommendations:** Provide a new city water supply line of adequate capacity to support the existing needs of the facility, as well as a future automated fire suppression system. Funding provided in Item U.

Water Main
