Building Information - Worthington City (45138) - Phoenix Middle School & Worthington Academy

Program Type	Assessment Only
Setting	Suburban
Assessment Name	Phoenix Middle School & Worthington Academy
Assessment Date (on-site; non-EEA)	2015-09-23
Kitchen Type	Full Kitchen
Cost Set:	2015
Building Name	Phoenix Middle School & Worthington Academy
Building IRN	9511
Building Address	2341 Snouffer Rd
Building City	Worthington
Building Zipcode	43085
Building Phone	614-450-4100
Acreage	32.78
Current Grades:	7-12
Teaching Stations	18
Number of Floors	1
Student Capacity	720
Current Enrollment	271
Enrollment Date	2015-09-14
Enrollment Date is the date in which the current enrollment was taken.	
Number of Classrooms	33
Historical Register	NO
Building's Principal	Adham Schirg
Building Type	Middle/High

Phoenix Middle School, which not on the National Register of Historic Buildings, and originally constructed in 1969, is a single story, 68,400 square foot brick school building located in a suburban residential setting. The existing facility features a conventionally partitioned and open concept design, and does not utilize modular buildings. The structure of the overall facility contains brick t

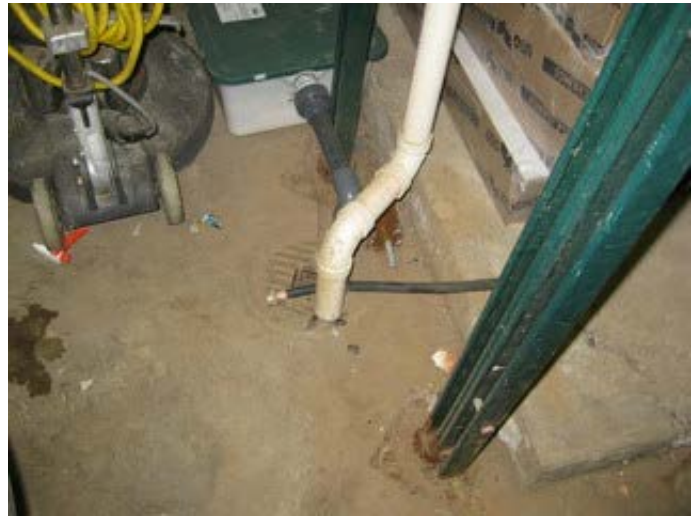
Exposed Waste in Boiler Room

Recommendations: Existing conditions require no renovation or replacement at the present time.
