**Building Information - Worthington City (45138) - Slate Hill Elementary**

Program Type	Assessment Only
Setting	Suburban
Assessment Name	Slate Hill Elementary
Assessment Date (on-site; non-EEA)	2015-09-22
Kitchen Type	Full Kitchen
Cost Set:	2015
Building Name	Slate Hill Elementary
Building IRN	110460
Building Address	7625 Alta View Blvd
Building City	Worthington
Building Zipcode	43085
Building Phone	(614) 450-5000
Acreage	16.28
Current Grades:	K-6
Teaching Stations	30
Number of Floors	1
Student Capacity	684
Current Enrollment	559
Enrollment Date	2015-09-14
Enrollment Date is the date in which the current enrollment was taken.	
Number of Classrooms	
Historical Register	<b>NO</b>
Building's Principal	Ken Pease
Building Type	Elementary

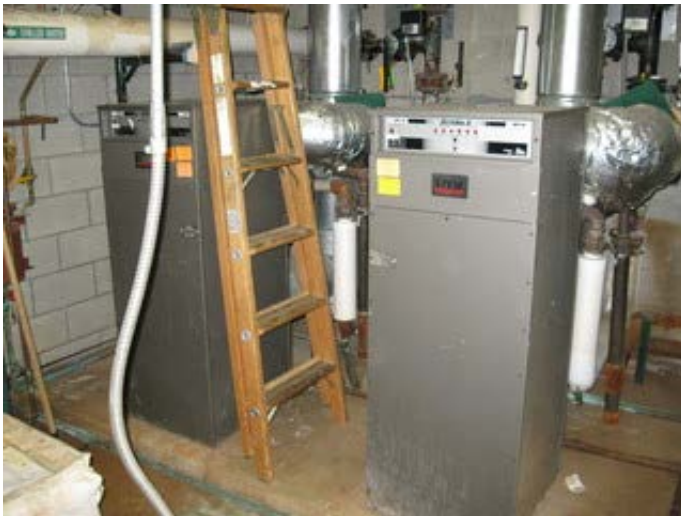
Gas Fired Boilers

The existing system for the overall facility is a gas fired heating hot water system, installed in 1991, and is in fair condition. The heating and chilled water system in the overall facility is a 4-pipe system, with a capacity for simultaneous heating and cooling operation, which is compliant with the OSDM requirements for basic system type. The 2 gas fired boilers, manufactured by RBI, were installed in 1991 and are in fair condition. Heating water is distributed to terminal units consisting of air handlers. The terminal equipment was installed in 1991 and is in fair condition. The system does comply with the 15 CFM per person fresh air requirements of the Ohio Building Code mechanical code and Ohio School Design Manual. The DDC type system temperature controls were installed in 1999 and are in good condition. The system does feature individual temperature controls in all spaces required by the OSDM. The overall system does not feature any central energy recovery systems. The facility is not equipped with louvered interior doors. The existing system is ducted, though lack of need for HVAC system replacement at this time negates any need to evaluate the potential integration of existing ductwork into a new system. The overall heating system is evaluated as being in safe and efficient working order, and long term life expectancy of the existing system is not anticipated. The structure is equipped with central air conditioning. The site does not contain underground fuel tanks.

Existing conditions require no renovation or replacement at the present time.

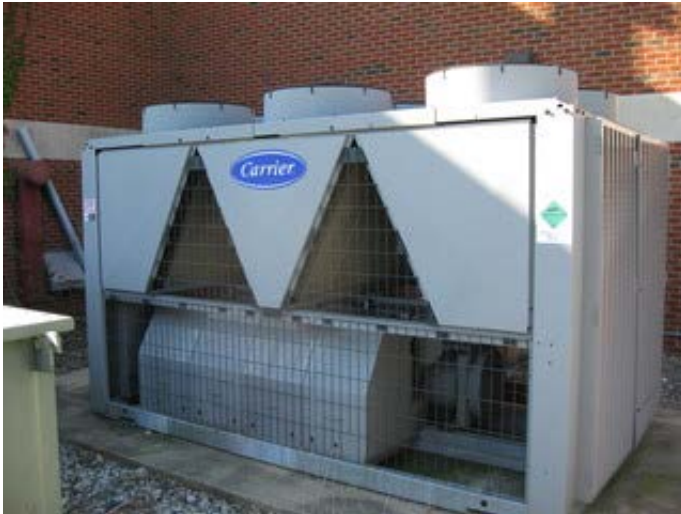
Air Cooled Chiller

**Description:** The overall facility is equipped with a chilled water type central air conditioning system, which is in fair condition. An air cooled chiller creates chilled water and the system pumps send the chilled water to the terminal units. The equipment is in fair condition. The ventilation system in the overall facility consists of air handlers, installed in 1991 and in fair condition, providing fresh air to Classrooms, and air handlers, installed in 1991 and in fair condition, providing fresh air to other miscellaneous spaces such as Gymnasiums, Student Dining, and Media Center. Relief air venting is provided by ceiling plenums. The ventilation system does meet the Ohio Building Code 15 CFM per occupant fresh air requirement. The overall system is compliant with Ohio Building Code and Ohio School Design Manual requirements. Dust collection systems are not required in this facility. The Art program is equipped with a kiln, and existing kiln ventilation is adequate, and in good condition. General building exhaust systems for Restrooms, Storage Rooms, Art Rooms, and Custodial Closets are adequately placed, and in good condition.

**Recommendations:** Existing conditions require no renovation or replacement at the present time.

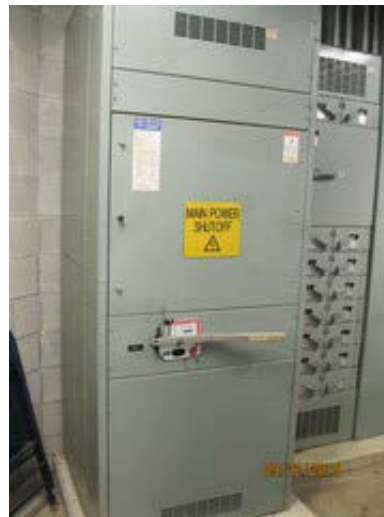
Main Distribution Equipment

**Description:** The electrical system provided to the overall facility is a 120/208-volt, 3-phase, 4-wire, 200-amp, 2,000-amp main fused switch system installed in 1990, and is in good condition. Power is provided to the school by a single utility owned, pad-mounted transformer located in exterior fenced-in area, and in good condition. The panel system, installed in 1990, is in good condition, and can be expanded to add additional capacity. The Classrooms are not equipped with adequate electrical outlets. The typical Classroom contains 20 general purpose outlets, 4 dedicated outlets for each Classroom computer, and 2 dedicated outlets for each Classroom television. Some Classrooms are equipped with as many as 26 general purpose outlets, while others are equipped with as few as 18 general purpose outlets. There are not any spaces that have no electrical outlets. The Corridors are equipped with adequate electrical outlets for servicing. Adequate GFI protected exterior outlets are not provided around the perimeter of the building. The facility is equipped with a suitable emergency generator. Adequate lightning protection safeguards are not provided. Stage lighting power system including control panel, breakers, and dimmers is inadequately provided, and does not meet OSDM requirements. The overall electrical system does not meet Ohio School Design Manual requirements in supporting the current needs of the school, and will not be adequate to meet the facility's future needs.

**Rating:** 3 Needs Replacement

**Recommendations:** The entire electrical system requires replacement to meet Ohio School Design Manual guidelines for Classroom capacity and lack of OSDM-required features. Provide additional panels (circuits / outlets) to increase capacity for Classrooms. Provide control panel, dimmers, and breakers to support the Stage lighting system. Provide adequate lightning protection safeguards.

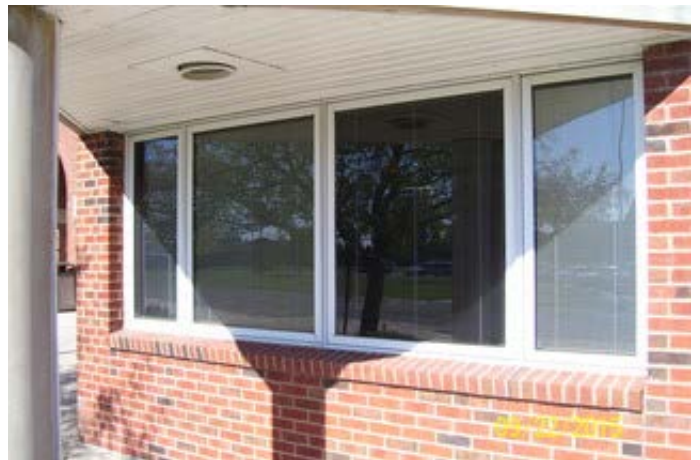
Typical Exterior Window

**Rating:** 3 Needs Replacement

**Recommendations:** Replace skylight system in the overall facility.
