Building Information - Worthington City (45138) - Worthington Hills Elementary

Program Type	Assessment Only
Setting	Suburban
Assessment Name	Worthington Hills Elementary
Assessment Date (on-site; non-EEA)	2015-09-24
Kitchen Type	Warming Kitchen
Cost Set:	2015
Building Name	Worthington Hills Elementary
Building IRN	64089
Building Address	1221 Candlewood Dr
Building City	Columbus
Building Zipcode	43235
Building Phone	(614) 450-4700
Acreage	12.00
Current Grades:	K-6
Teaching Stations	24
Number of Floors	1
Student Capacity	606
Current Enrollment	461
Enrollment Date	2015-09-14
Enrollment Date is the date in which the current enrollment was taken.	
Number of Classrooms	24
Historical Register	NO
Building's Principal	Joe Jude
Building Type	Elementary

Building Construction Information - Worthington City (45138) - Worthington Hills Elementary (64089)

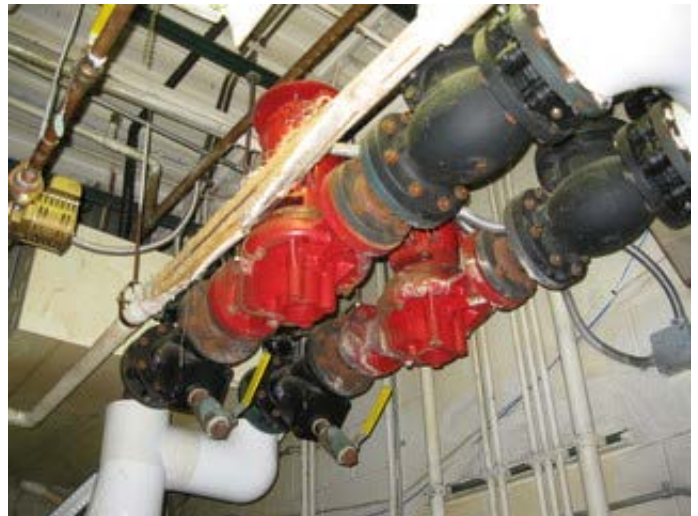
Pumps

The existing system for the overall facility is a gas fired heating hot water system, installed in 1999, and is in fair condition. The heating water system in the overall facility is a 2-pipe system, with a capacity for simultaneous heating and cooling operation, which is compliant with the OSDM requirements for basic system type. The 2 gas fired boilers, manufactured by PK, were installed in 1999 and are in fair condition. Heating water is distributed to terminal units consisting of VAV boxes. The terminal equipment was installed in 1999 and is in good condition. The system does comply with the 15 CFM per person fresh air requirements of the Ohio Building Code mechanical code and Ohio School Design Manual. The DDC type system temperature controls were installed in 1999 and are in fair condition. The system does feature individual temperature controls in all spaces required by the OSDM. The overall system does not feature any central energy recovery systems. The facility is not equipped with louvered interior doors to facilitate Corridor utilization as return air plenums. The existing system is ducted, though lack of need for HVAC system replacement at this time negates any need to evaluate the potential integration of existing ductwork into a new system. The overall heating system is evaluated as being in safe and efficient working order, and long term life expectancy of the existing system is not anticipated. The structure is not equipped with central air conditioning. The site does not contain underground fuel tanks.

Existing conditions require no renovation or replacement at this time.

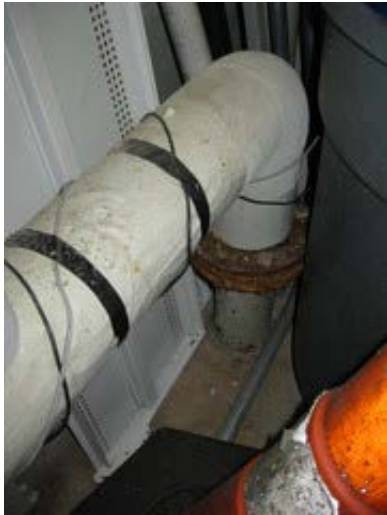
Water Main

- Description:** The domestic water supply system is tied in to the city system, features 4" service and 4" water meter, and is in good condition. The District was not able to provide water supply flow test data. The existing domestic water service appears to meet the facility's current needs. The facility is not equipped with an automated fire suppression system, and the existing water supply will not provide adequate support for a future system. The domestic water service is not equipped with a water booster pump. The system provides adequate pressure for the future needs of the school.
- Rating:** 1 Satisfactory
- Recommendations:** Provide a new city water supply line of adequate capacity to support the existing needs of the facility, as well as a future automated fire suppression system. Funding provided in Item U.
